**State of Louisiana  
Department of Natural Resources  
Coastal Engineering Division**

**2005/2006 Annual Inspection  
Report**

**BARATARIA LANDBRIDGE  
SHORELINE PROTECTION  
PROJECT – Construction Units No.  
1, 2 & 3**

State Project Number BA-27  
Priority Project List 7 & 9

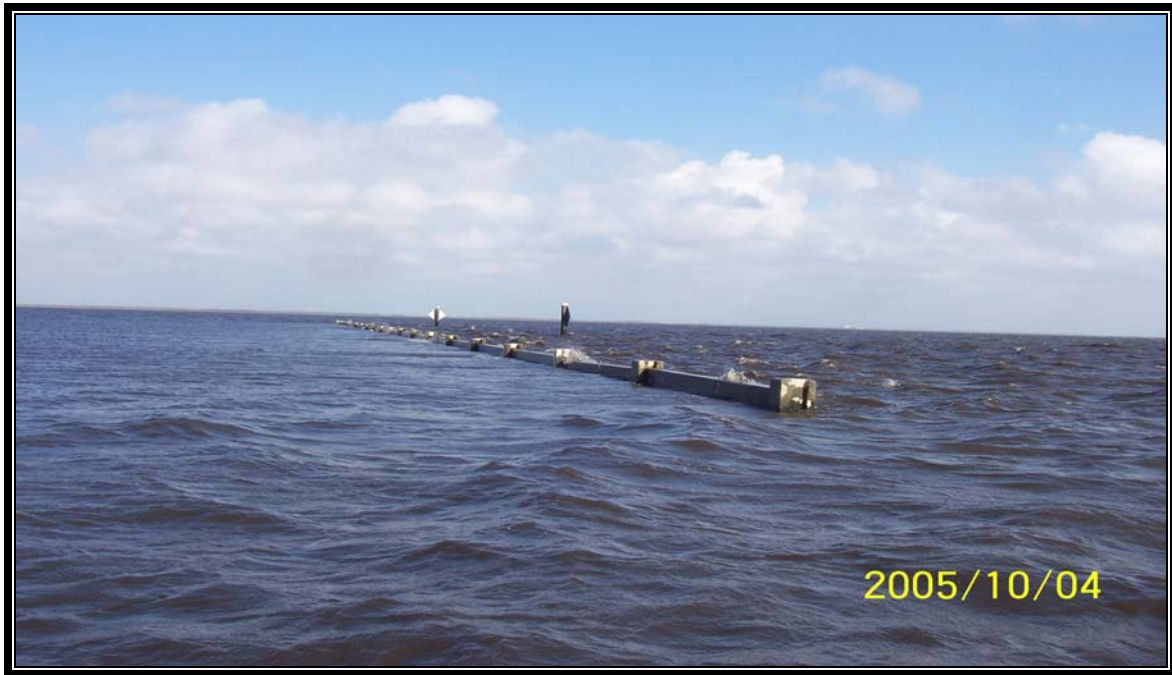
dike sections of CU#1 were submerged due to the high water levels and not visible at the time of the inspection. Several sections of the concrete wall panel had experienced movement and shifting between the concrete piles due to deterioration of the grout material in the pile notch and possible chipping of the bearing plate. The damage to concrete pile panels are due to normal wearing and not a result of Hurricane Rita. Below are damage assessment photos of the concrete pile sections along Bayou Perot:

*Land Bridge CU#1 – photo of concrete pile and wall test section along the west bank of Bayou Perot.*

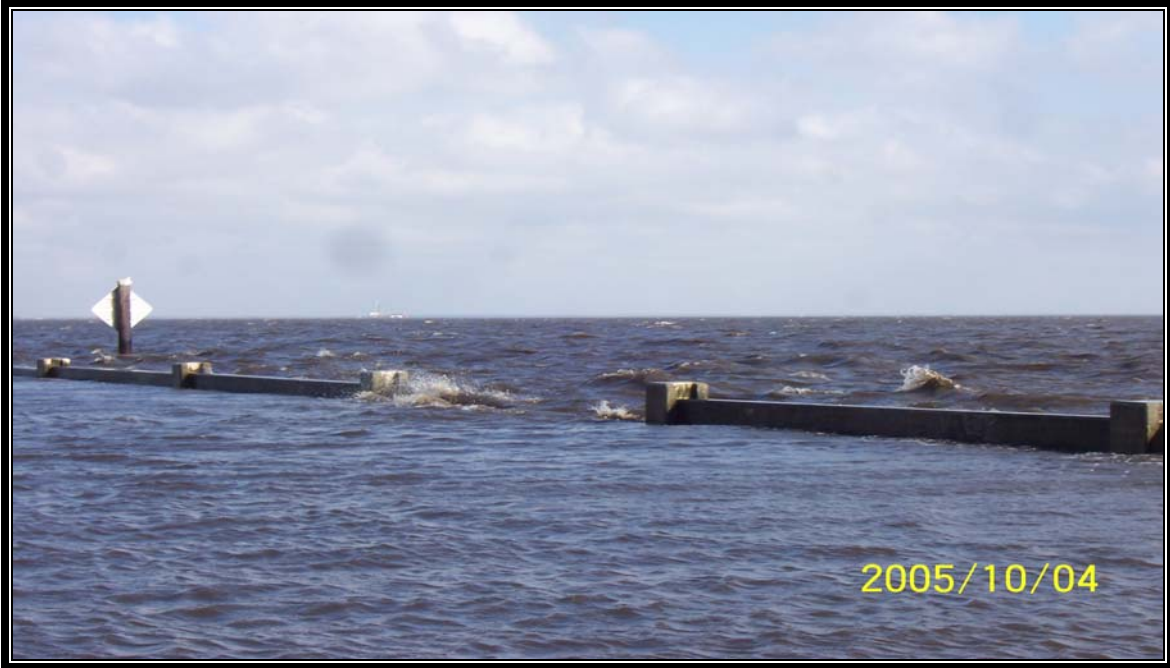
*Land Bridge CU#1 – photo of concrete panel wall panel that shifted downward on both sides.*

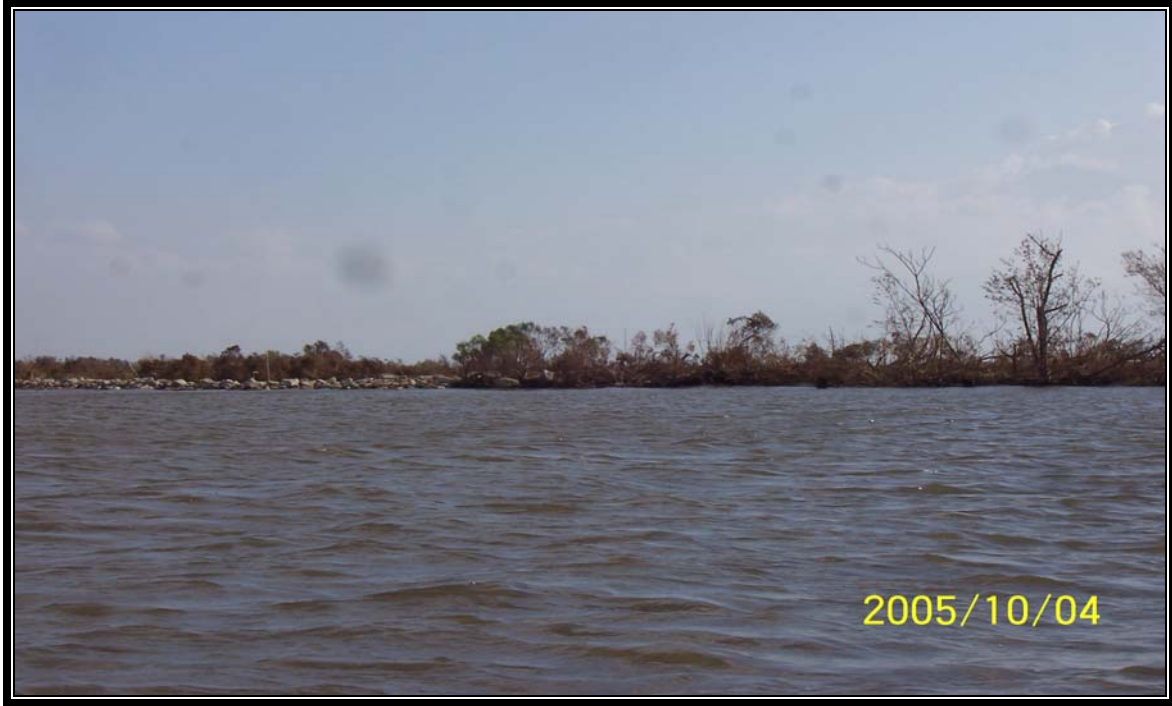
The damage assessment of CU#2 began at approximately 9:30 a.m. on the northeast bank of Little Lake near Sta. -0+42 and ended along the south bank of Bayou Rigolettes west of the Harvey Cutoff Canal near Sta. 36+83. From a visual inspection of the rock dike of CU#2, it appears that the dike was in good condition with no noticeable displacement or movement of rip rap due to Hurricane Rita. As in previous inspections, we did note several low areas along the dike which have settled since construction and will require possible maintenance in the future. The earthen tie-ins on both the east and west reach of the project were also in good condition with no signs of breaching or erosion. Other than the burnt marsh from high salinity levels resulting from the storm surge, we did not observe any significant marsh erosion behind the rock dike.

*Land Bridge CU#2 – photo of earthen/bank tie-in along the northeast bank of Little Lake at Sta. -0+42.*

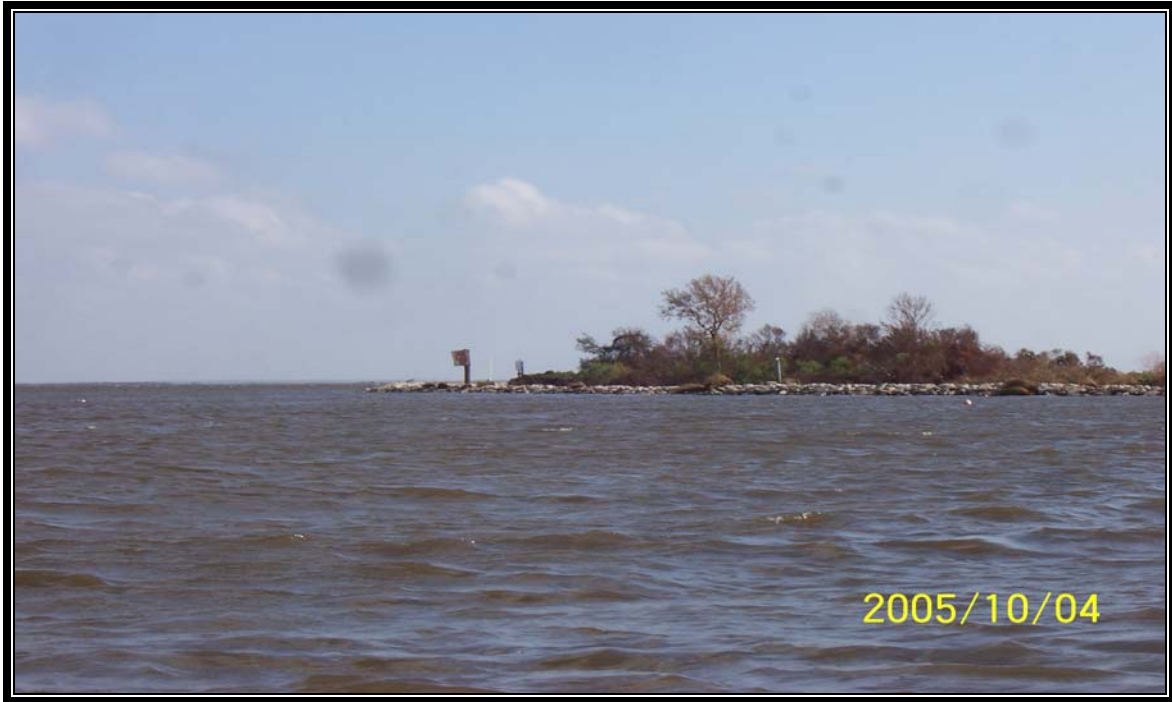
*Land Bridge CU#2 – photo of rock dike along the southern bank of Bayou Perot.*

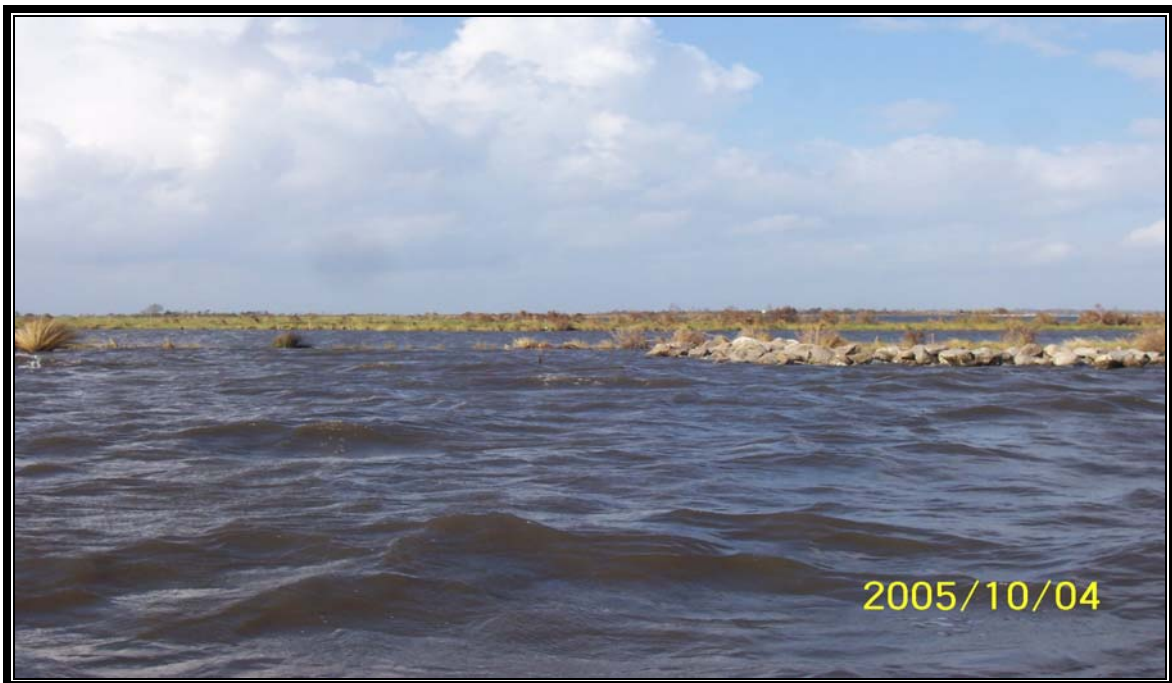
*Land Bridge CU#2 – photo of rock dike tie-in to existing marsh at the mouth of the Harvey Cutoff Canal.*

North end (Reach 2) good condition  
(Reach 1) Heavy cut off canal  
tie-in to Marsh thin and  
eroding quickly.

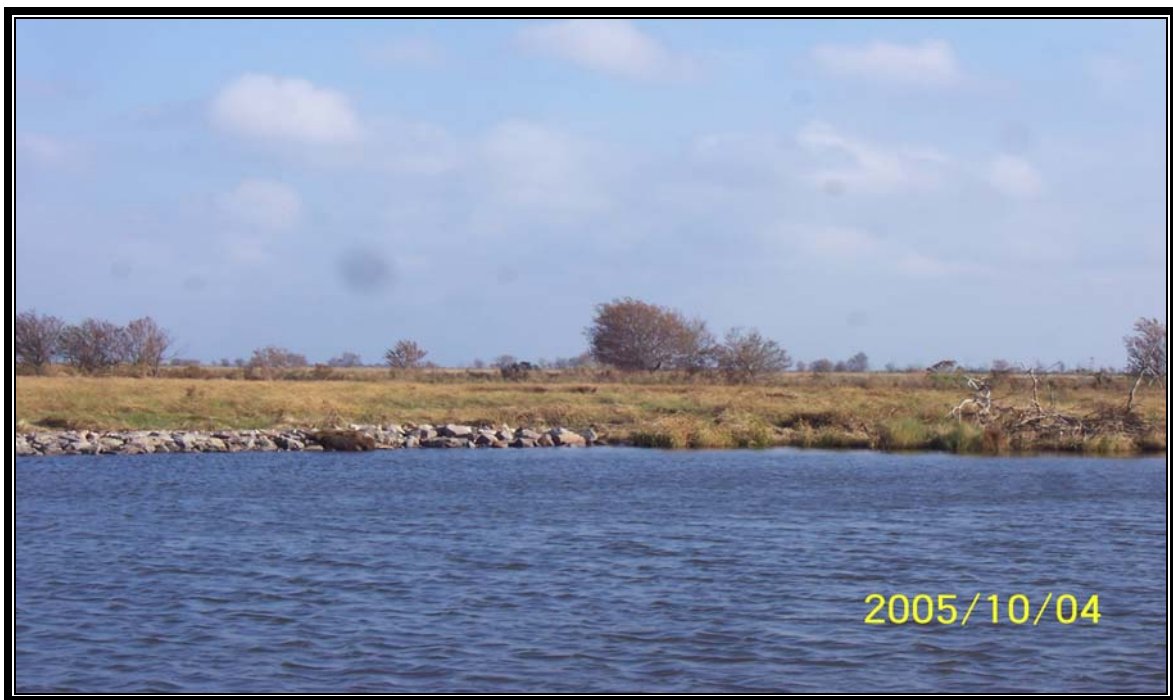
The inspection of CU#3 began at approximately 8:45 a.m. on the south end of the project area near Sta. 108+65 and proceeded northward to the mouth of Bayou Perot and northeast bank of Little Lake to the beginning of the project (Sta. 0+00). From a visual inspection of the rock dike of CU#3, it appeared that the dike was in very good condition with no displacement or movement of rip rap resulting from the storm. The rock dike to marsh tie-ins were also in good condition with no breaches or washouts present. Other than the burnt marsh mentioned in the general observations, we did not notice any significant erosion of the shoreline behind the rock dike. Below are photos from the damage assessment of CU#3.

*Land Bridge CU#3 – photo of rock to marsh tie-in located at the southern end of the project near Sta. 108+65.*

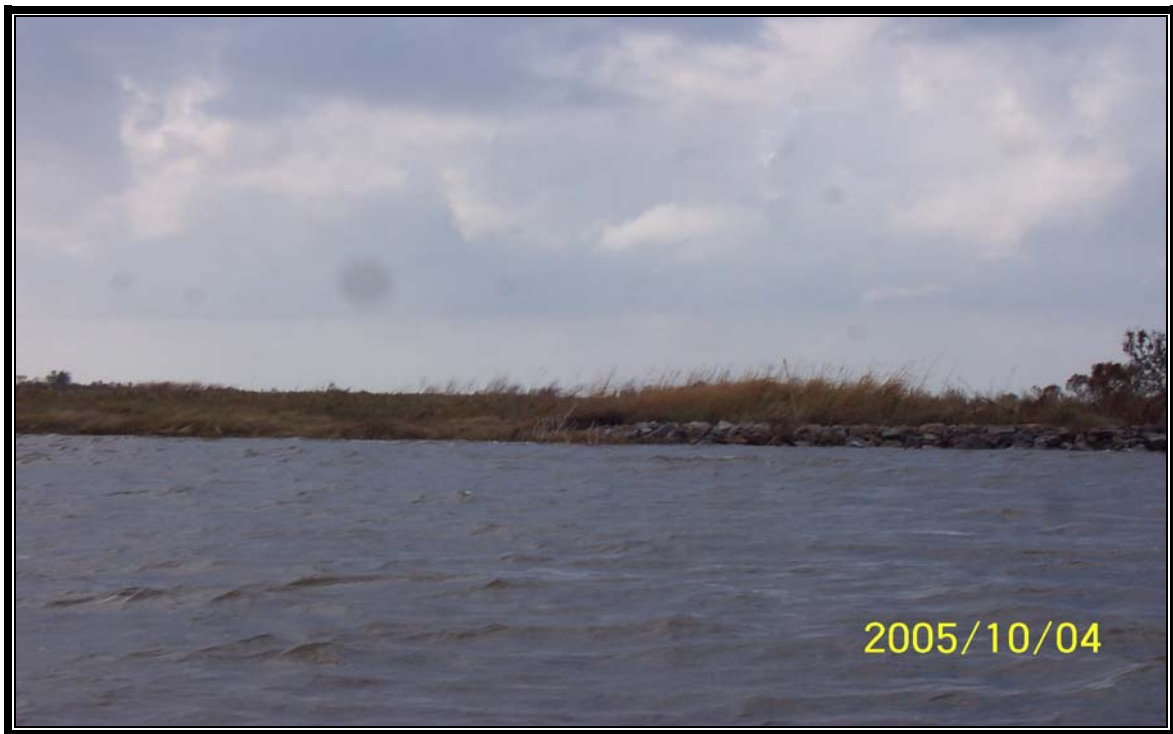
*Land Bridge CU#3 – photo of rock to marsh tie-in located at the northern end of the project near Sta. 0+00.*

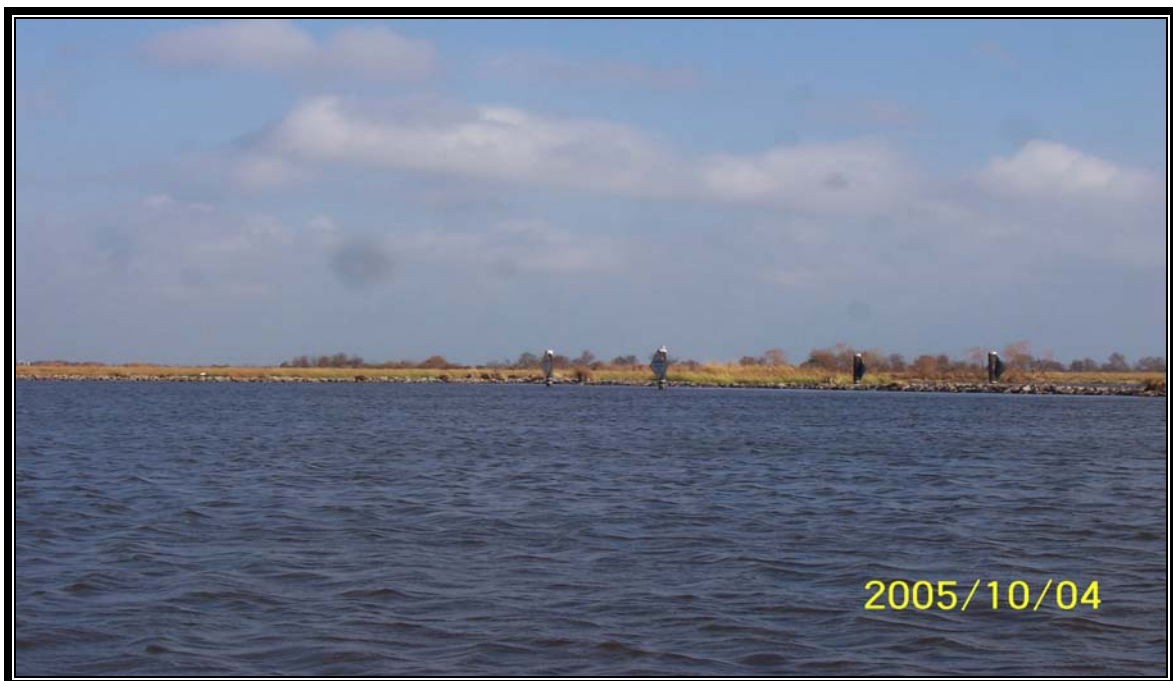
*Land Bridge CU#3 – photo of rock dike along the east bank of Little Lake near fish dip at Sta. 74+79.*
