**State of Louisiana  
Department of Natural Resources  
Coastal Restoration Division**

**2006 Annual Inspection Report**

**NAOMI OUTFALL  
MANAGEMENT**

State Project Number BA-3c  
Priority Project List 5

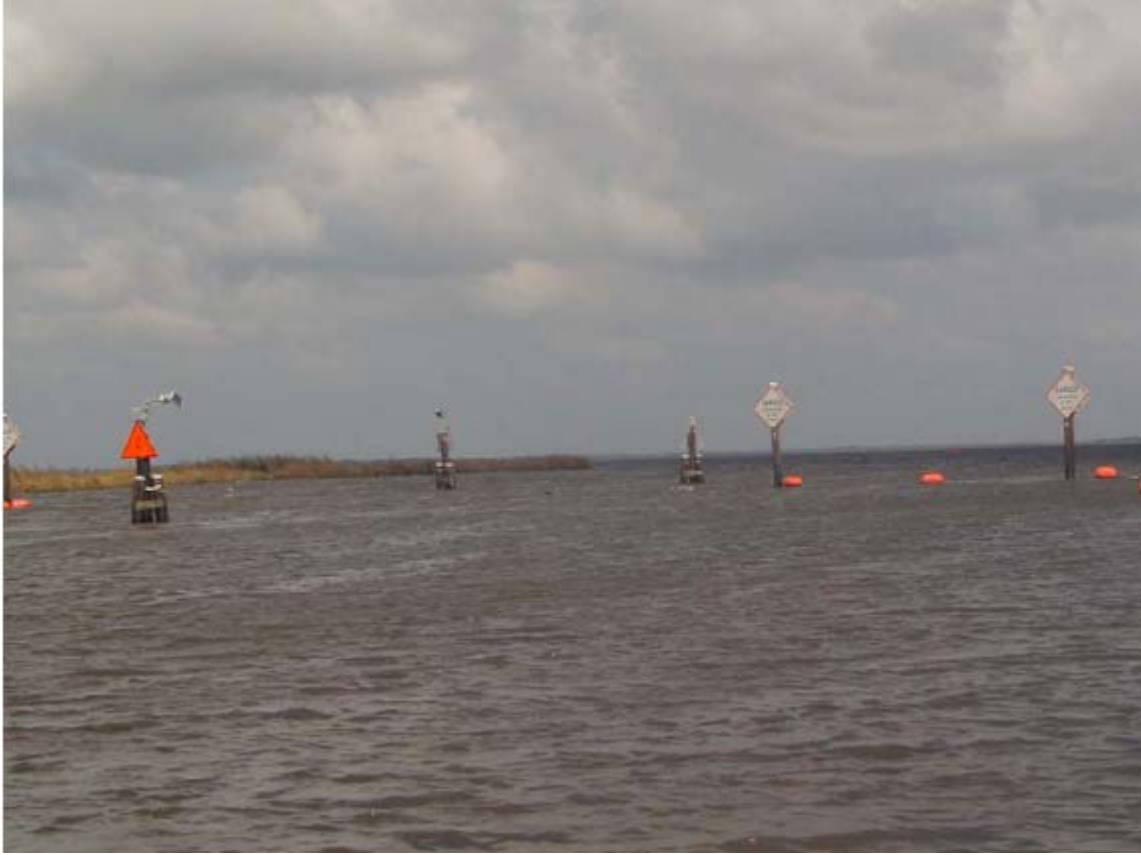
The two pilings on either side of the boat bay which were damaged at last year's inspection are still damaged (Photo #1). They are currently under contract to be replaced with buoys.

The two warning signs attached to the pilings mentioned above are missing (Photo #1). They are to be replaced by the buoys mentioned above.

All three navigation lights are damaged (Photo #1). They are being repaired in the same contract as the other two at the Goose Bayou structure.

**Photo #1 – Bayou Dupont Canal Weir.** Approaching the Bayou Dupont weir from the Barataria Waterway, looking across the weir boat bay toward the Pen. Warning signs and navigation aids, or lack thereof, are shown on either side of channel through the boat bay. Note the damaged lights.

Item	Condition	Physical Damage	Corrosion	Photo #	Observations and Remarks					
Rock Riprap	Good	None	N/A	#1	Rock appears to be holding up well.					
Creosote Piling	Fair	See Observations	None	#1	Two were missing.					
Warning Signs and Day Board	Poor	See Observations	None	#1	The two warning signs in the boat bay have been knocked down by some water vessel.					
Navigation Signs	Fair	See Observations	None	#1	aving trouble with vandalism of lights. Two broke off and another open with battery gone.					
Warning Buoys	Good	See observations	None	#1	They are no longer attached to pilings since those are gone; but they are holding position well.					
Vandalism	-	See observations	-	#1	The lights are constantly being broken into and the batteries are always missing.

- A contract was awarded on June 29, 2006, to address the repair issues with the navigation lights, pilings, and warning signs.
- The lights should be checked periodically for functionality.

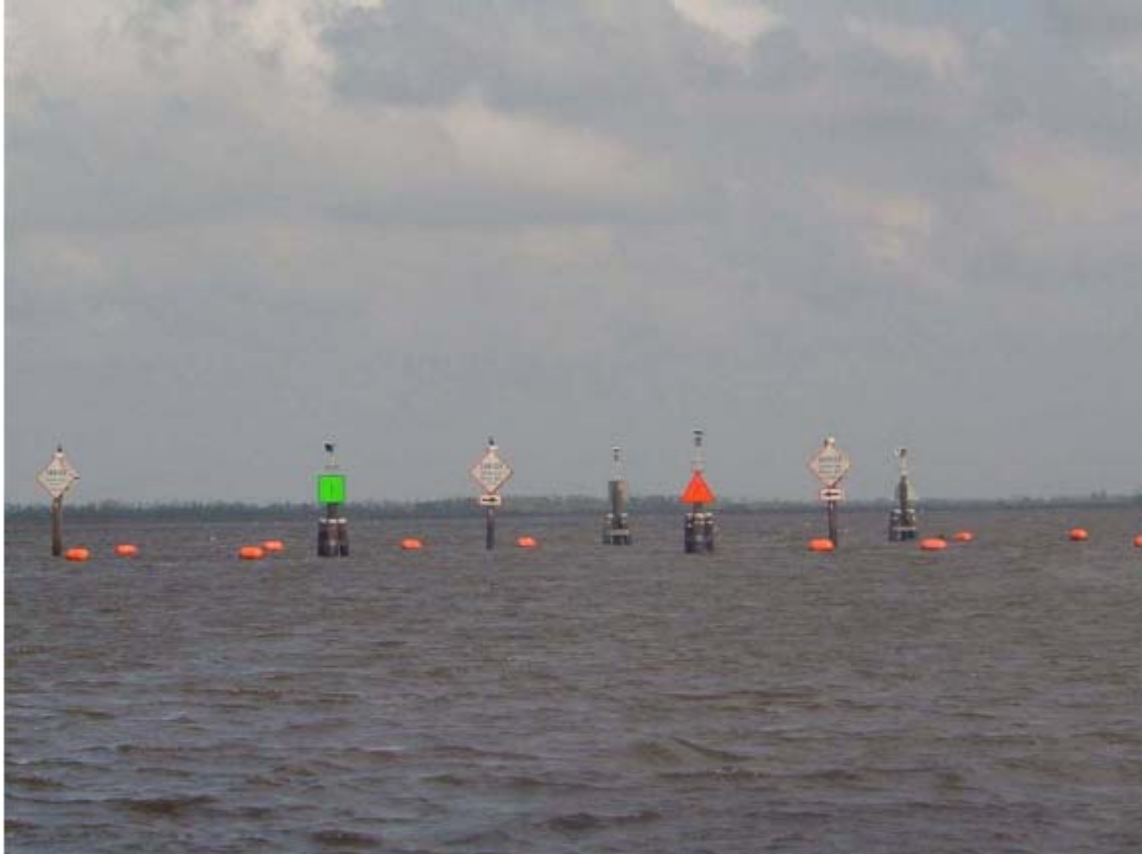
All pilings visually appeared to be damage-free and in good condition (Photo #2).

All signs appeared to be in satisfactory condition with no indication of significant damage (Photo #2).

Two of the four navigation lights were damaged due to Hurricanes Katrina and Rita (Photo #2). They are currently under contract to be repaired.

**Photo #2 – Goose Bayou Canal Weir.** Approaching the Goose Bayou weir from the Barataria Waterway side, looking across the weir boat bay toward the Pen. Warning signs and navigation aids are shown on either side of channel through the boat bay. Note the damaged lights.

FIELD INSPECTION CHECK SHEET									
Project No. / Name:	Naomi Outfall Management	Date of Inspection:	10/4/2005	Time:	8:30				
Structure No.	<b>Goose Bayou Canal</b>	Inspector(s):	Richard, Boddie, Bernard, Kaintz, Kinler						
Structure Description:	Stone Weir	Water Level:	N/A	Inside:	Outside:	Approx. 1.9 ft			
Type of Inspection:	Post Storm Event	Weather Conditions:	Clear skies, Windy						
Item	Condition	Physical Damage	Corrosion	Photo #	Observations and Remarks				
Rock Riprap	Good	None	N/A	#2					
Creosote Piling	Excellent	None	None	#2					
Warning Signs and Day Board	Excellent	None	None	#2					
Navigation Signs									
Navigation Aid Lights	Good	None	None	#2	Two Damaged in Hurricanes.				
Warning Buoys	Good	None	None	#2					
Vandalism	-	None	-	-	There appeared to be no signs of vandalism either on the lights or the structure.
