**State of Louisiana
Department of Natural Resources
Coastal Restoration Division and
Coastal Engineering Division**

2004 Operations, Maintenance, and Monitoring Report

NAOMI OUTFALL MANAGEMENT and BARATARIA BAY WATERWAY EAST

State Project Numbers BA-03c and BA-26
Priority Project Lists 5 and 6

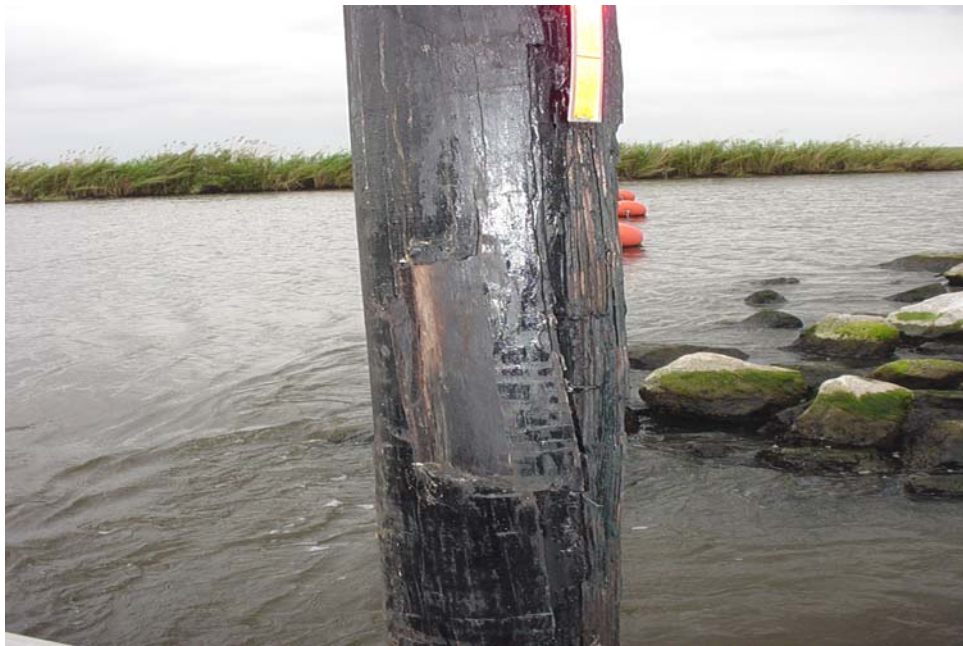
All pilings were in good condition except for the piling on the right side (as one cross into the Pen) of the boat bay. This piling **may** have been damaged during construction; however, there was no threat of failure. It will continue to be examined during regular inspections (Photograph 1)

Photograph. 1 – Bayou Dupont Canal Weir. Damaged pile at right side of boat bay as one enters the Pen from Barataria Waterway. Pile was damaged by boat collision during construction. Pile may eventually need to be replaced or reinforced.

The damaged piling at the Bayou Dupont weir will be checked periodically and, if necessary, will be braced or replaced.
