**2004 Operations, Maintenance, and
Monitoring Report**

**Caernarvon Diversion Outfall
Management**

State Project Number BS-03a
Priority Project List 2

May 2007
Plaquemines Parish

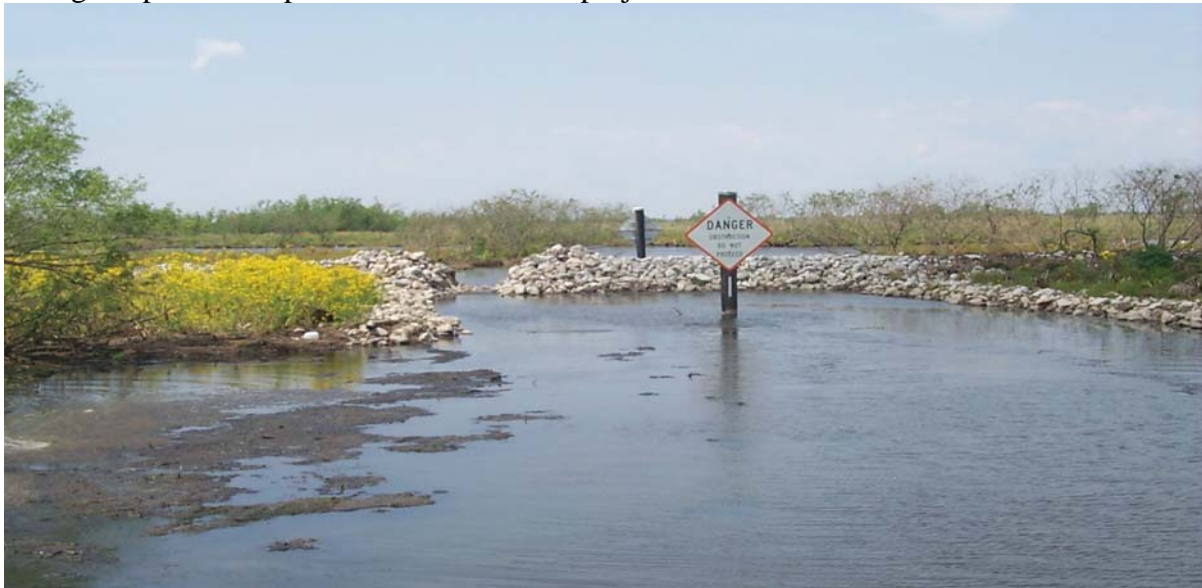
Site/Structure # 32 - Overall condition was good with the exception that vandals had removed enough rock to create a breach in the plug whereby boats could be pulled through to bypass the plug (picture 1). The inspectors on the present inspection trip filled (by hand labor) approximately 50 % of breach with rock. The remainder of the breach will be filled by LDNR during the periodic trips that are made to the project.

Picture1. Site #32 looking west, showing the breach in the rock closure caused by vandals, possibly trappers, in the area.

No immediate repairs are suggested. However, during the inspection field trip a breach created by vandals at site 32 was repaired by the inspection team. Approximately 50% of the breach was repaired, with the remainder to be addressed by LDNR/CED during the periodic trips made to the project. There was a presence of water hyacinths throughout the outfall area. This could possibly be a problem in the future. It may be necessary to address control of these hyacinths, not only on the present diversions but on future projects.

Structure 32 was vandalized and has since been partially repaired. The structure should be completely repaired as soon as possible to ensure it performs as was designed.
