Lake Salvador Shoreline Protection – Demonstration Project BA-15

BA-15 Lake Salvador Shoreline Protection

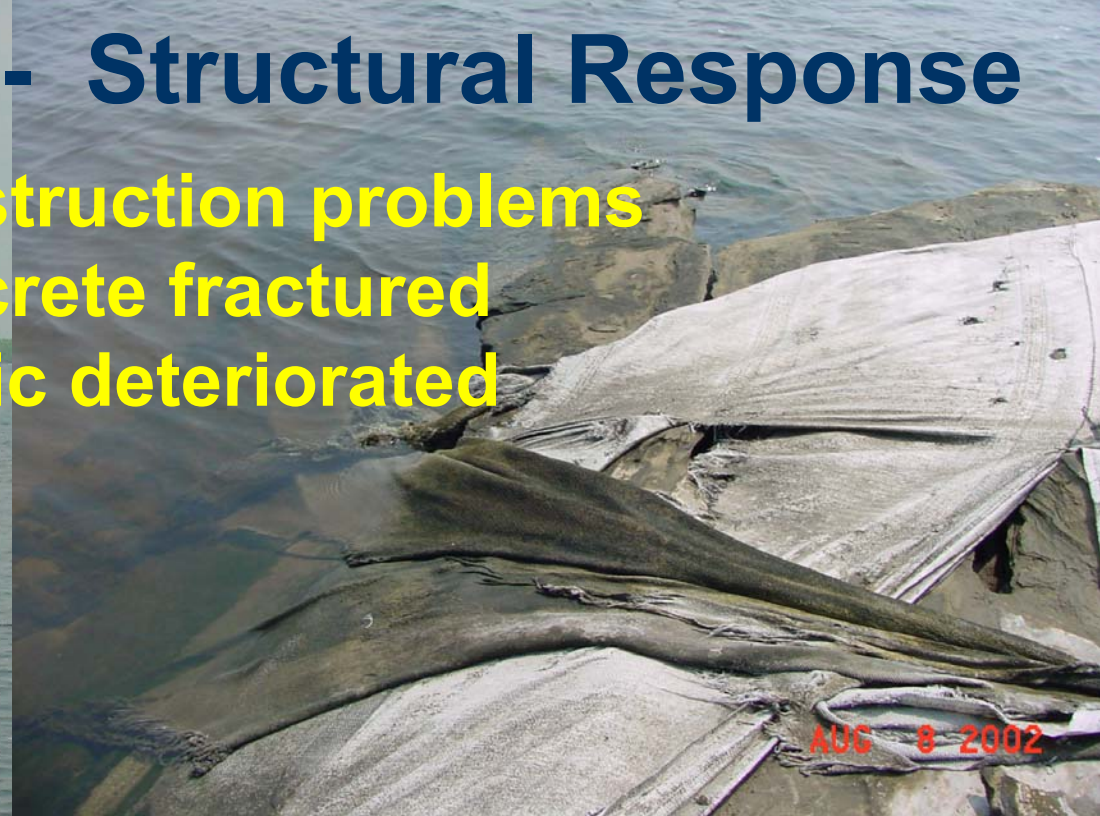
Geotextile Tubes - Structural Response

Construction problems
Concrete fractured
Fabric deteriorated

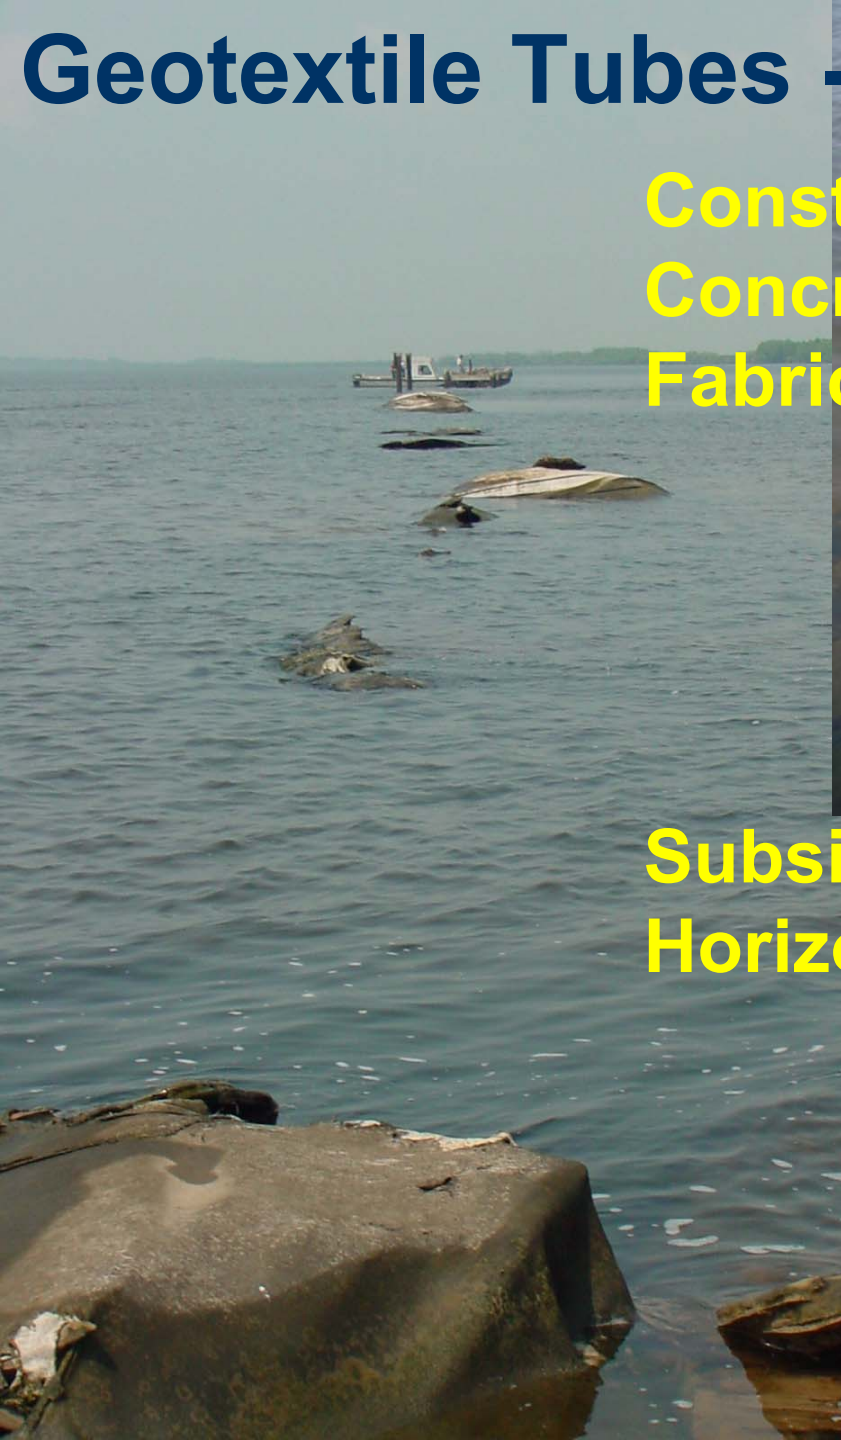
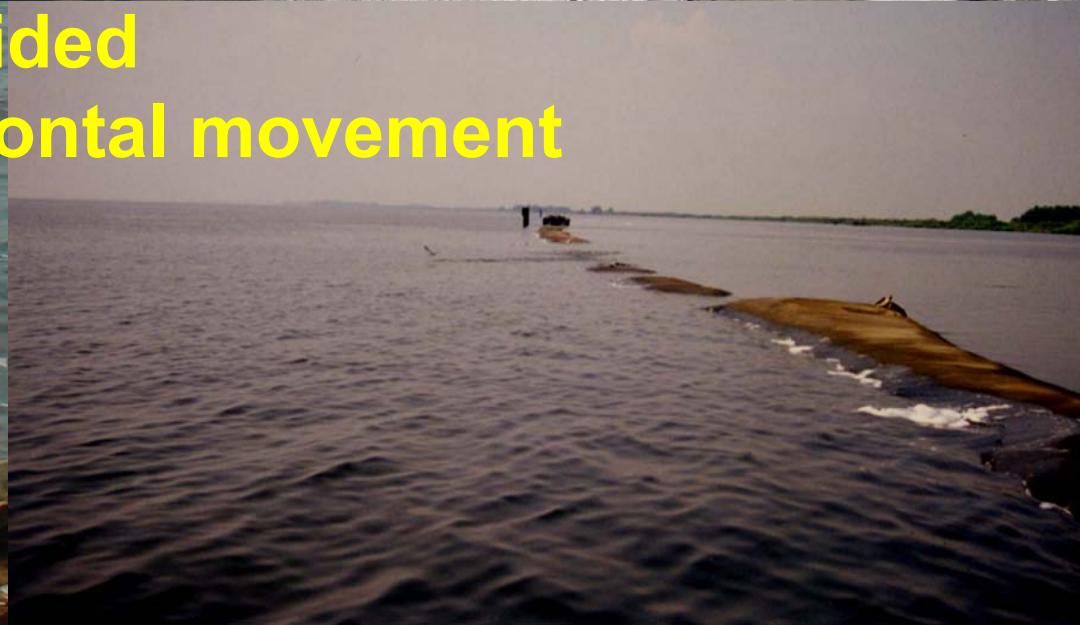
Subsided
Horizontal movement

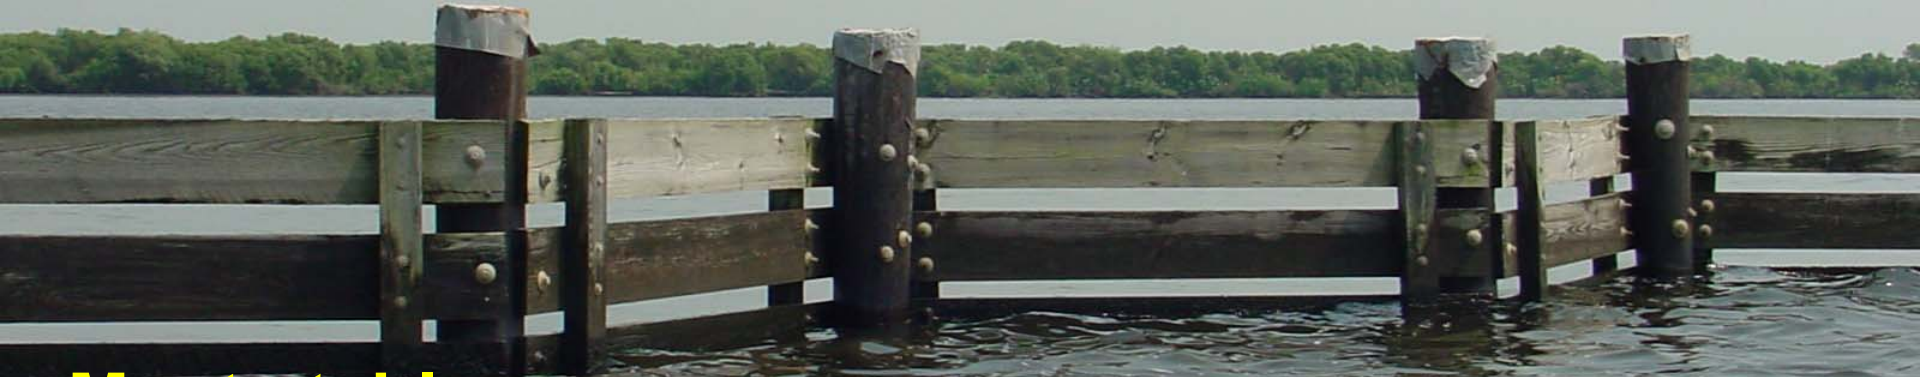
Angled Timber Fence – Structural Response

Most stable
Minor deterioration/damage
Hardware in good condition

**Minimal vertical and
horizontal movement**

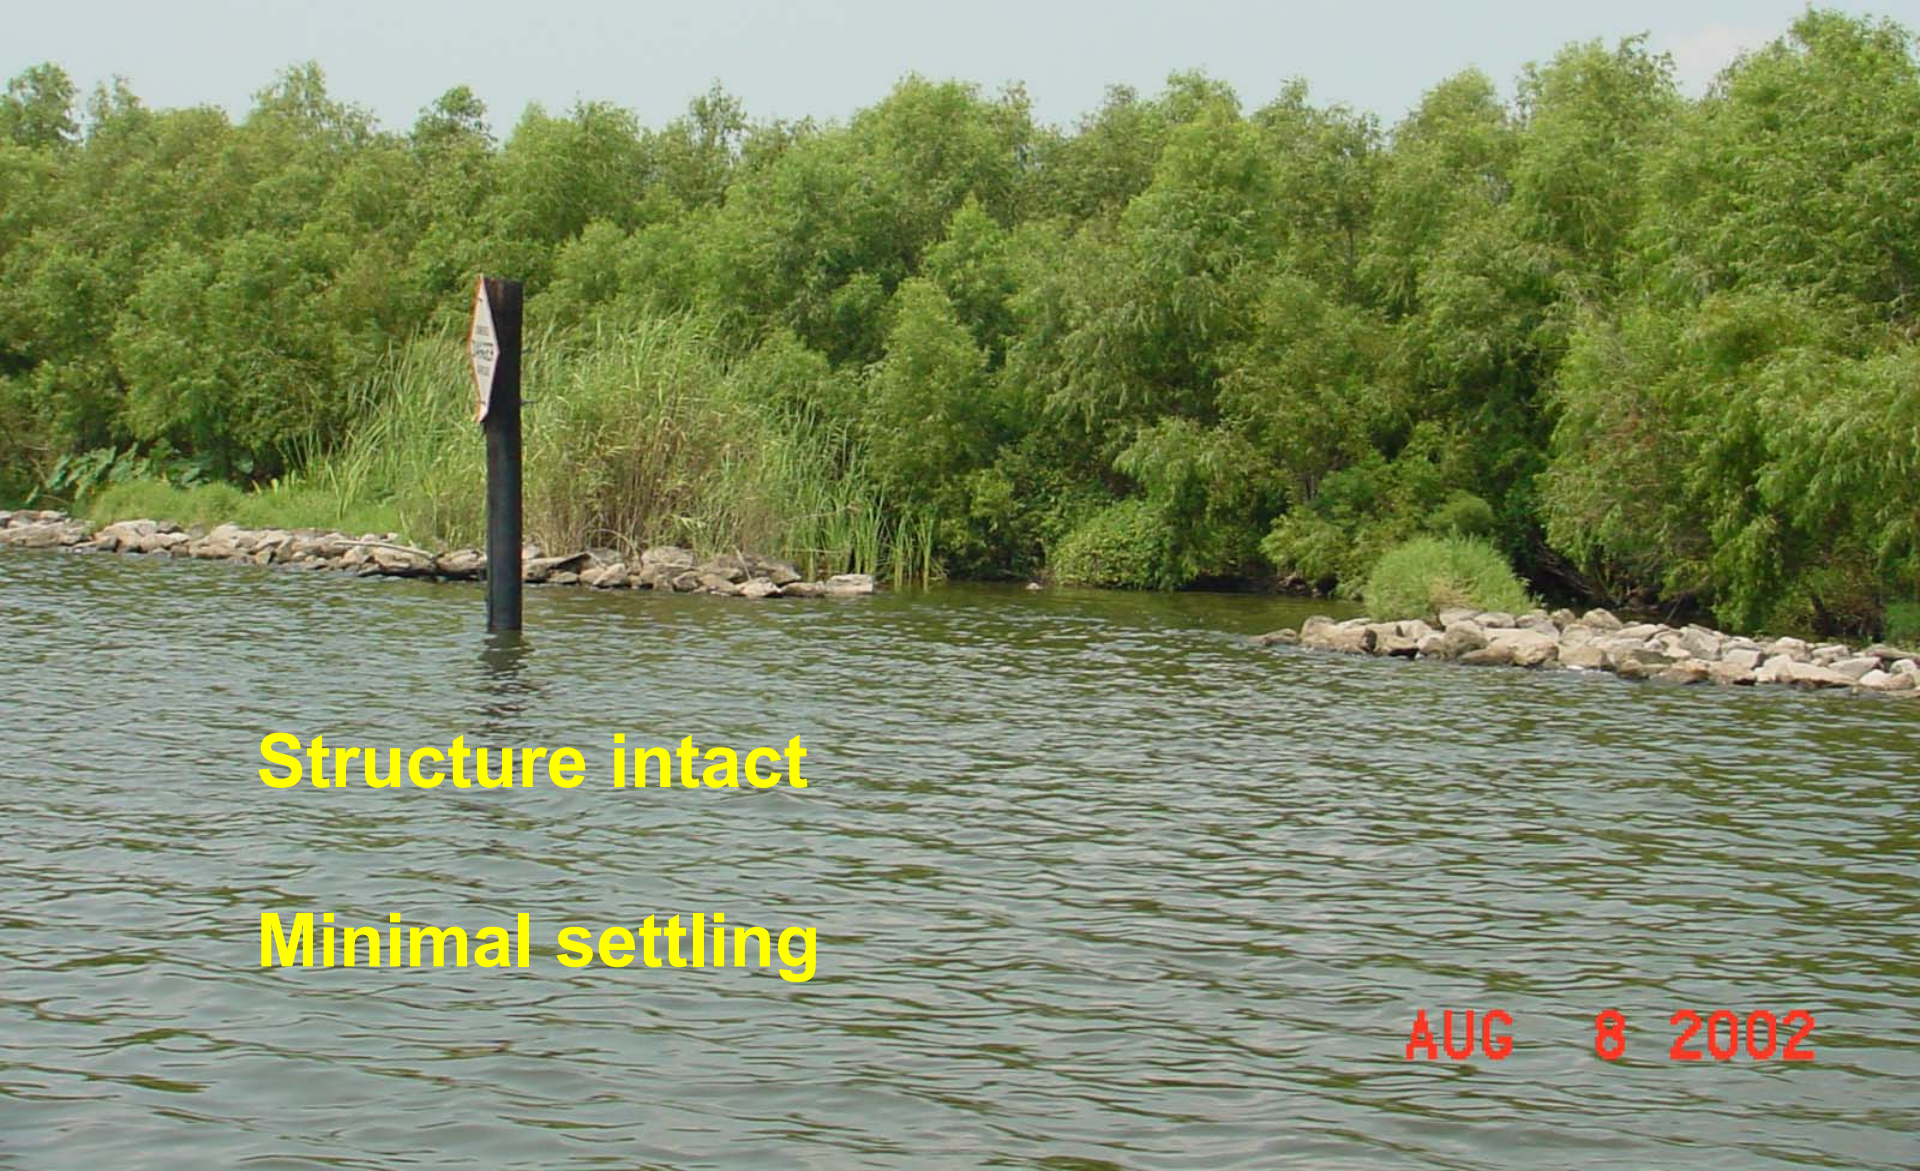
Phase II – Structural Response

Structure intact

Minimal settling
