**State of Louisiana
Department of Natural Resources
Coastal Restoration Division**

2007 Annual Inspection Report

**Barataria Bay Waterway East
Bank Protection**

State Project Number BA-26
Priority Project List 6

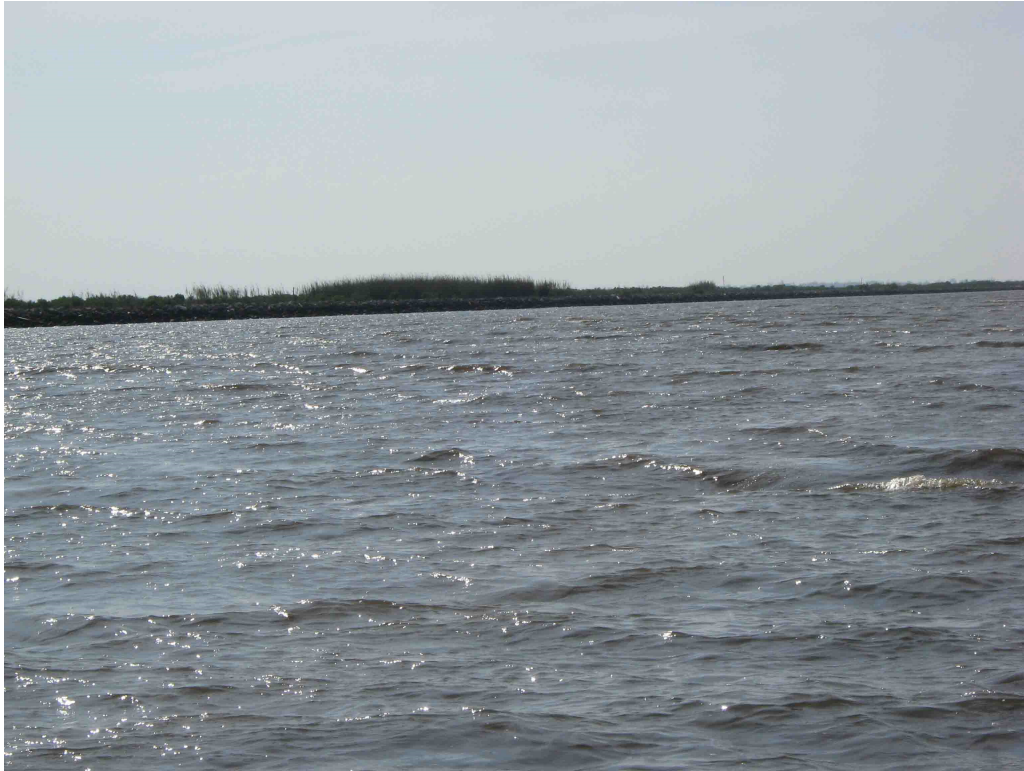
There are no noticeable damages to the rock structure since the previous inspection (Photos #1 & #2). A small gap in the rock structure was seen at approximate coordinates N29.61380°, W 090.07905°. This gap is probably the result of vandalism and should be monitored (Photo #3).

Photo #1 – Shoreline Protection Looking South

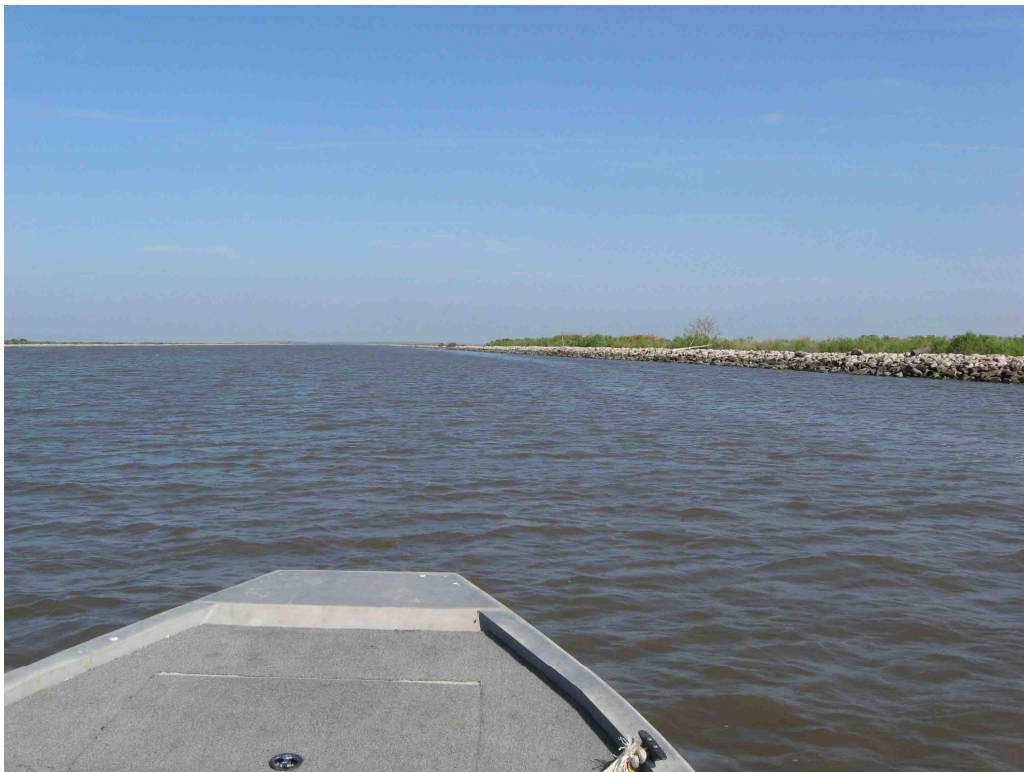
Photo No. 2 – Shoreline Protection Looking North

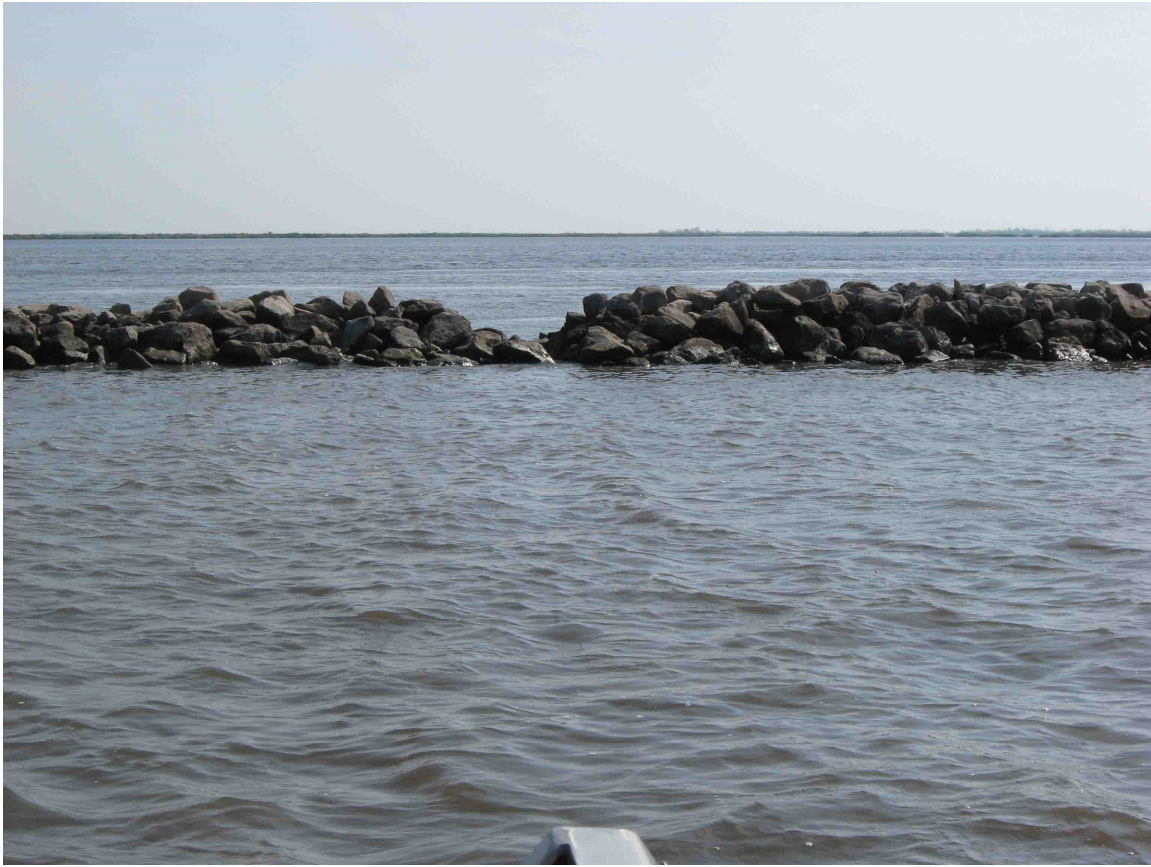
Photo No. 3 – Small gap in Shoreline Protection.

Item	Condition	Pysical Damage	Corrosion	Photo #	Observations and Remarks
Foreshore Rock Dike	Good	small gap	None	1,2,3	
					small gap at approx. coordinates N29.61380, W090.07905
Settlement Plates	Good	None	None		
Signage /Supports	Good	None	None
