**State of Louisiana
Department of Natural Resources
Coastal Restoration Division**

2007 Annual Inspection Report

**Barataria Bay Waterway West
Bank Protection**

State Project Number BA-23
Priority Project List 4

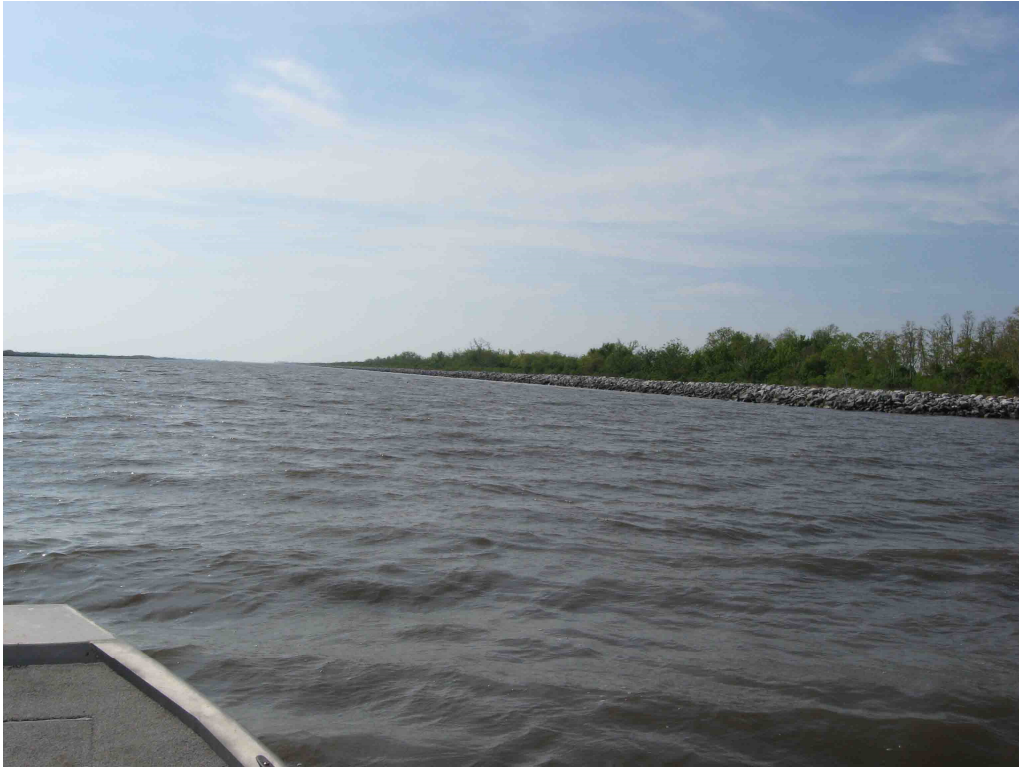
The rock structure appeared to be in good condition at the time of the inspection (Photos #1 & #2).

Photo #1 – Shoreline Protection Looking South.

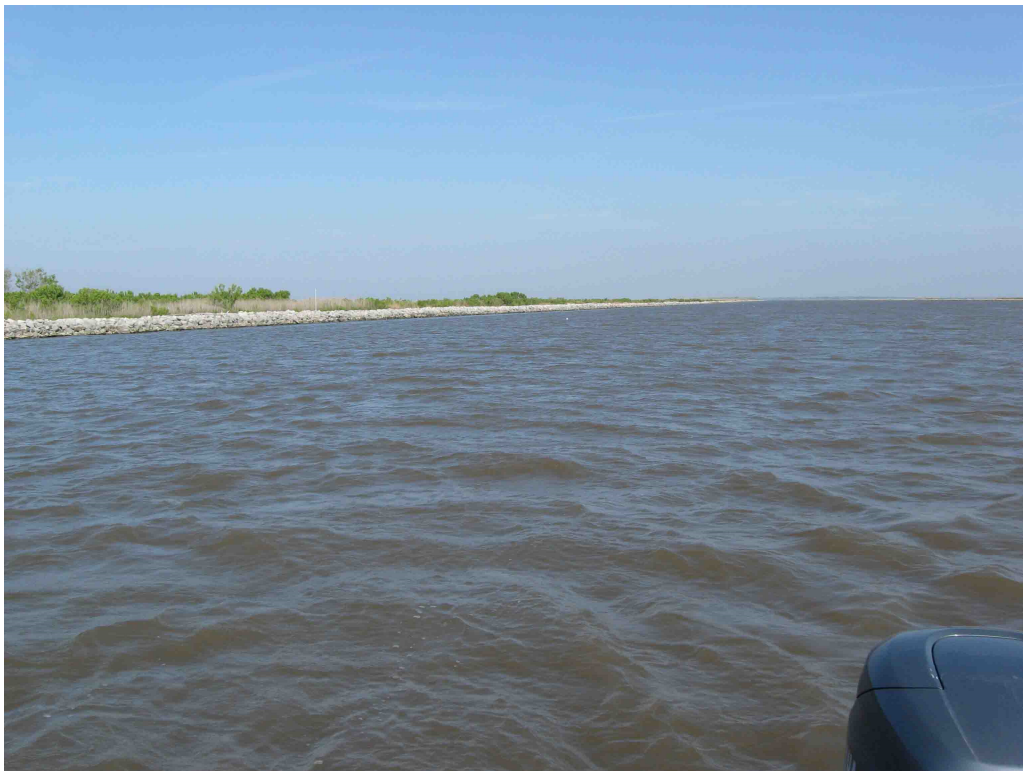
Photo #2 – Shoreline Protection Looking North.
