2010 Annual Inspection Report

Barataria Bay Waterway East Bank Protection

State Project Number BA-26
Priority Project List 6

December 13, 2010
Jefferson Parish

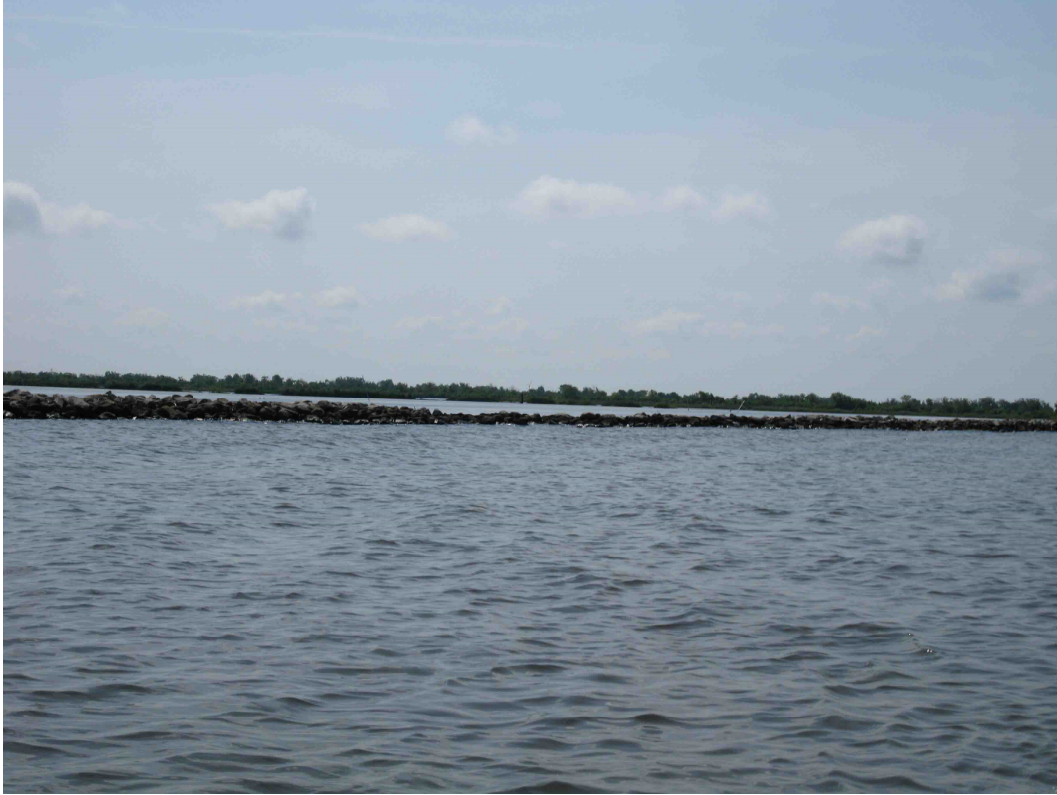
Photo #1 – Shoreline Protection

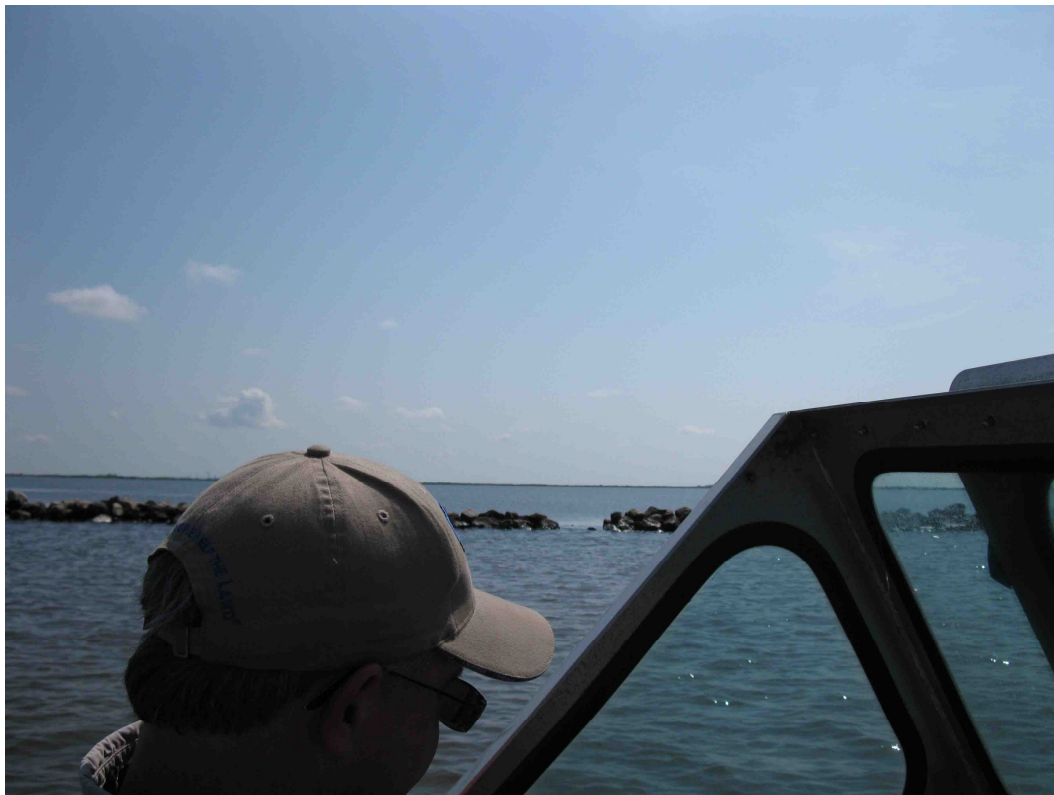
There are no noticeable damages to the rock structure since the previous inspection (Photo #1). Some settlement has been observed. A small gap in the rock structure was seen at approximate coordinates N29.61380°, W 090.07905°. This gap is probably the result of vandalism and should be monitored (Photo #2). Some accretion and vegetation was observed behind the rock structure at the north end of the project.

Photo # 2 – Small gap in Shoreline Protection.
