**State of Louisiana  
Office of Coastal Protection and  
Restoration  
Operations Division**

**2010 Annual Inspection Report**

**DELTA MANAGEMENT AT  
FORT ST. PHILLIP  
(BS-11)**

State Project Number BS-11  
Priority Project List PPL-10

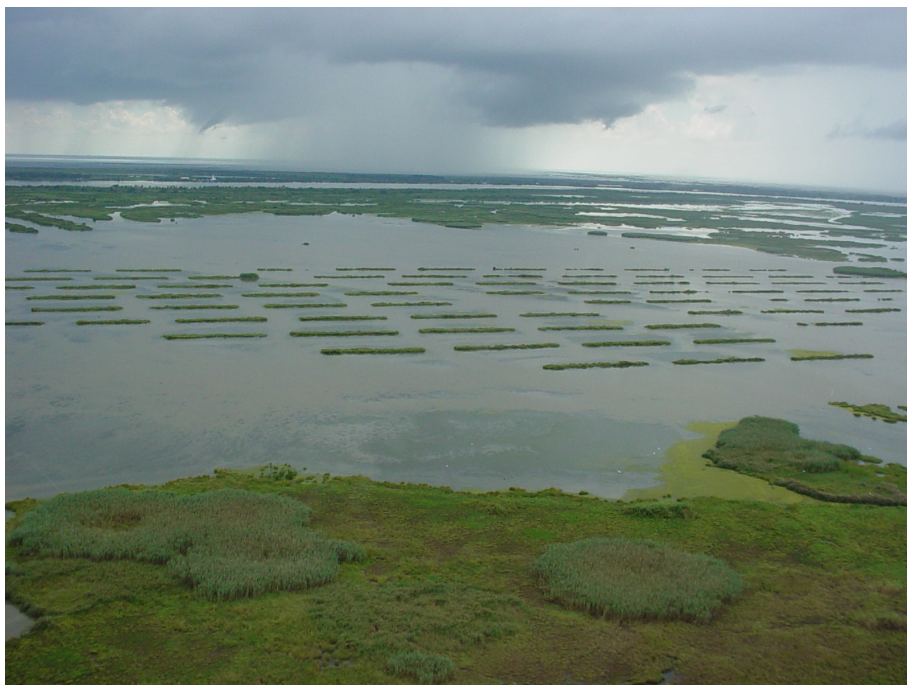
- A. Terraces: The terraces have held up very well since they were constructed in the fall of 2006. There are a few that were built on the north side with soft / unsuitable material that have developed some washout areas in their perimeter; however, most of the terraces are in excellent condition and have vegetated heavily since the time that they were planted. Tides were relatively high at the time of the inspection, but the terrace heights above the water showed that they had maintained mostly all of their original elevations. Moderate current containing river sediments are obvious throughout the terrace field.

**Terrace Field in Bay Denesse (View 1) Looking South**

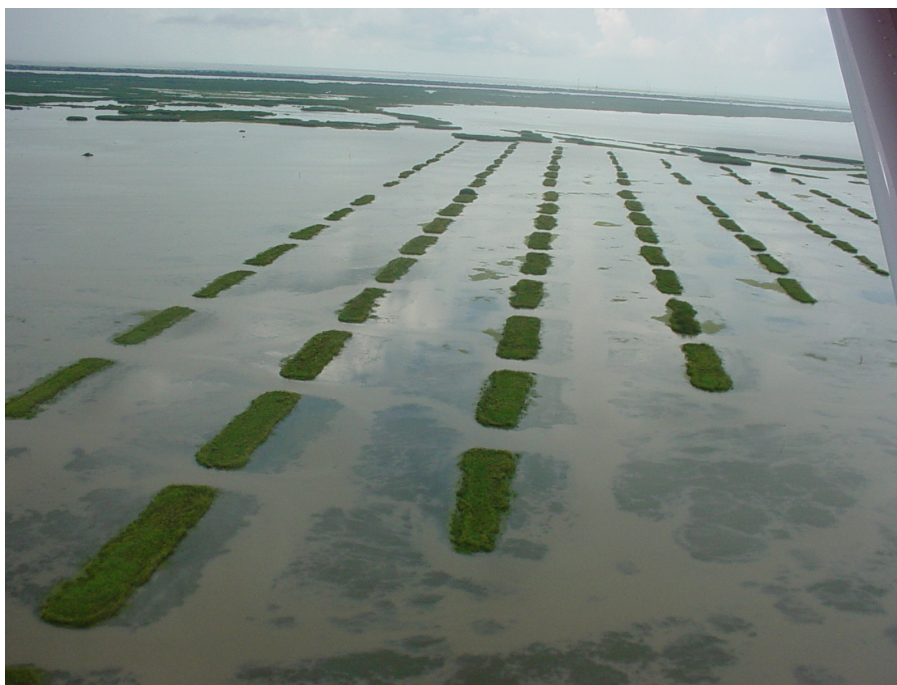
**Terrace Field in Bay Denesse (View 2) Looking West**

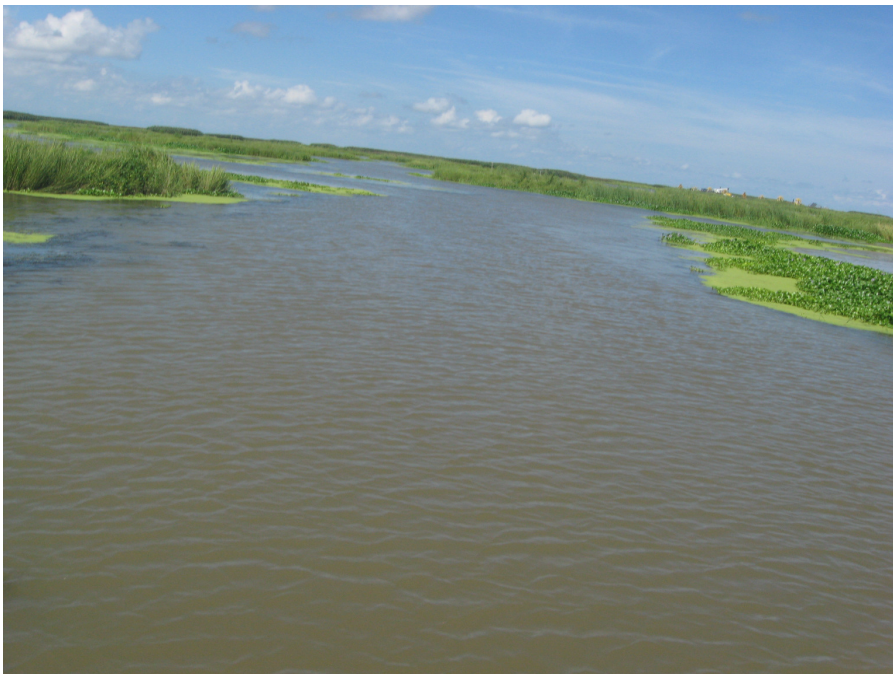
**Terrace Field in Bay Denesse**

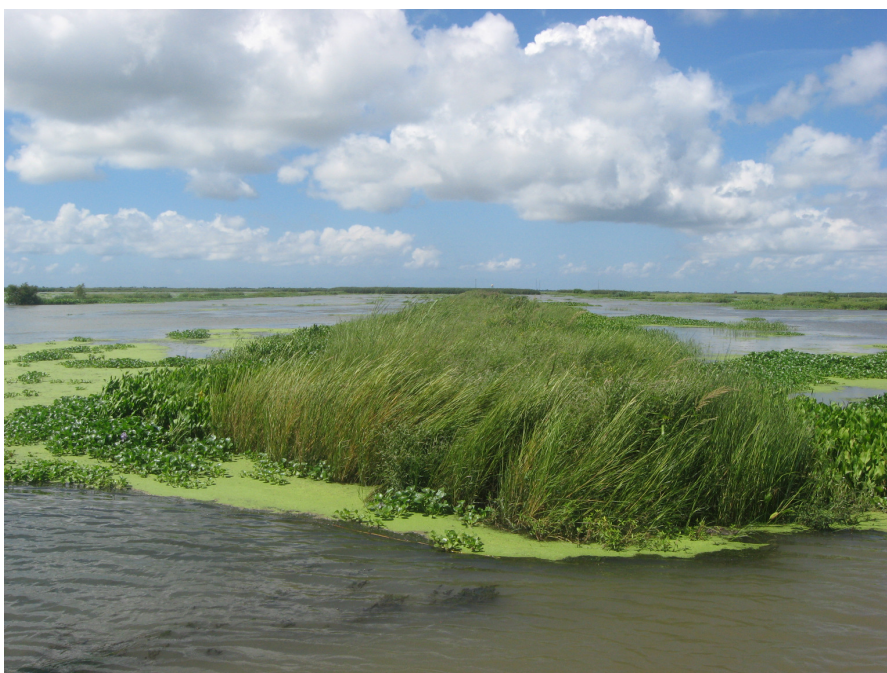
**Terrace Field in Bay Denesse**

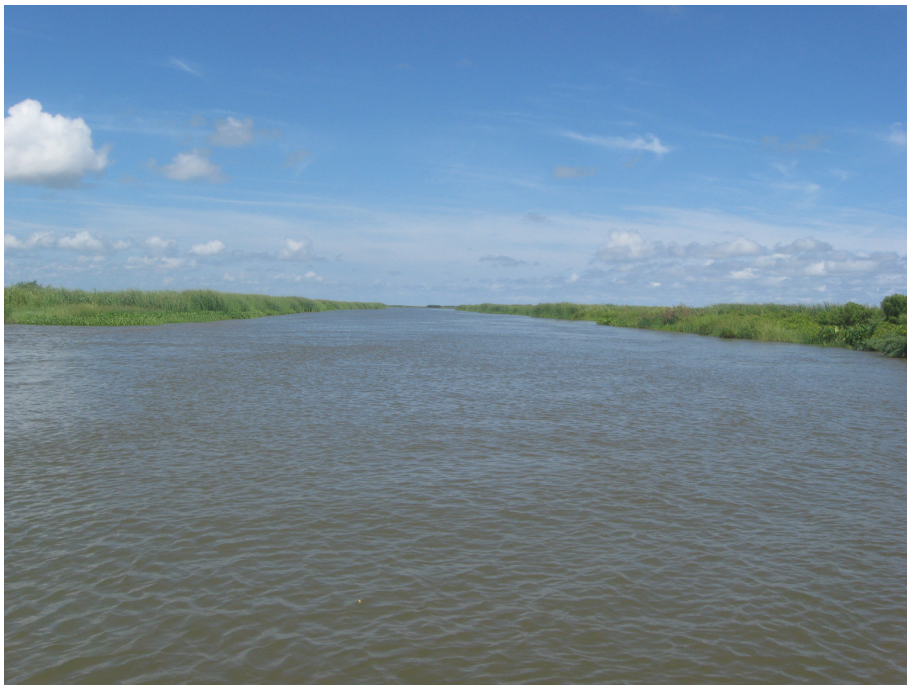
- B. Crevasse No. 1A: This crevasse is the longest of all, and funnels river water directly into Bay Dennesse, where the terraces were constructed. Currents through this crevasse were swift and appeared to be carrying plenty of river sediment into the terrace area. Soundings showed that there is good depth throughout the length of the crevasse, and the crevasse spoil was well vegetated.

**Crevasse A-1, Looking North towards the terrace field.**

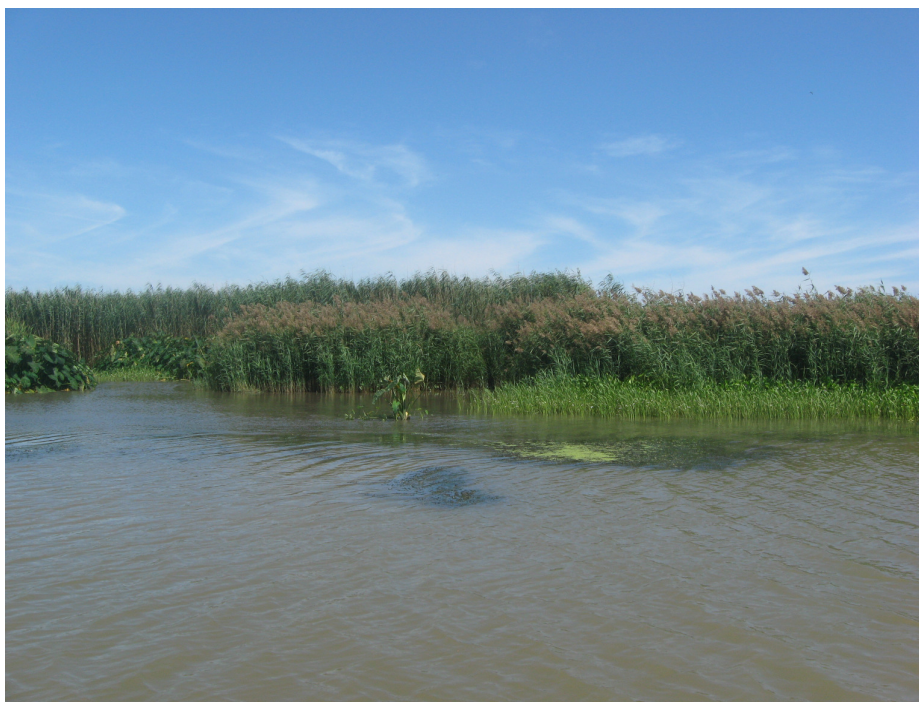
- G. Crevasse No. 2C: This crevasse is also one of the longest of the project and it is evident, from the amount of flow, and from soundings, that it has maintained its constructed depth throughout its length. The spoil from the crevasse excavation has vegetated very nicely and there is plenty current to carry river sediments into the interior marsh areas.

**Crevasse 2-C Interior Marsh Build Up**

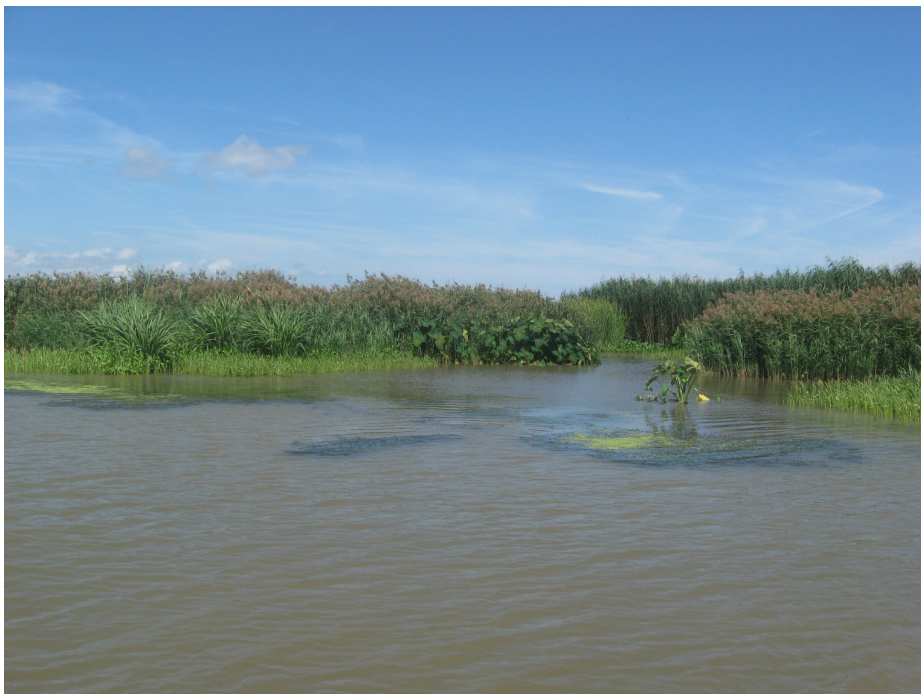
- C. Crevasse No. 1B: This crevasse, which is the shortest of all, feeds a small area of marsh. Currents through this cut were light. The spoil banks appeared to be very heavily vegetated. Soundings show that the original depth is being maintained.

**Crevasses 1-B Interior Marsh Build Up**

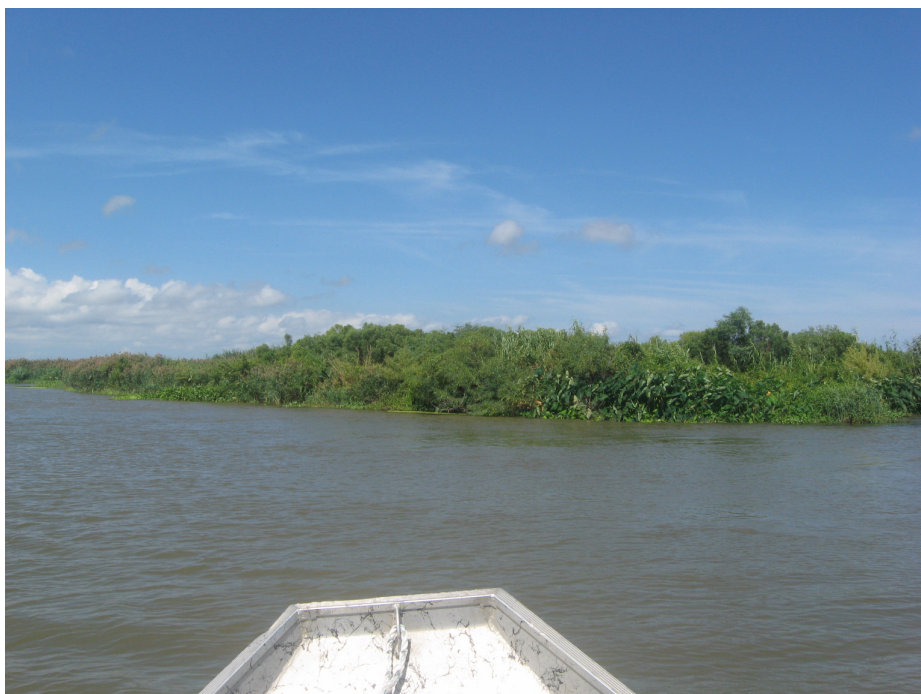
**Vegetated Crevasse Spoil Bank**
