2010 Annual Inspection Report

NAOMI OUTFALL MANAGEMENT

State Project Number BA-03c
Priority Project List 5

December 13, 2010
Jefferson Parish

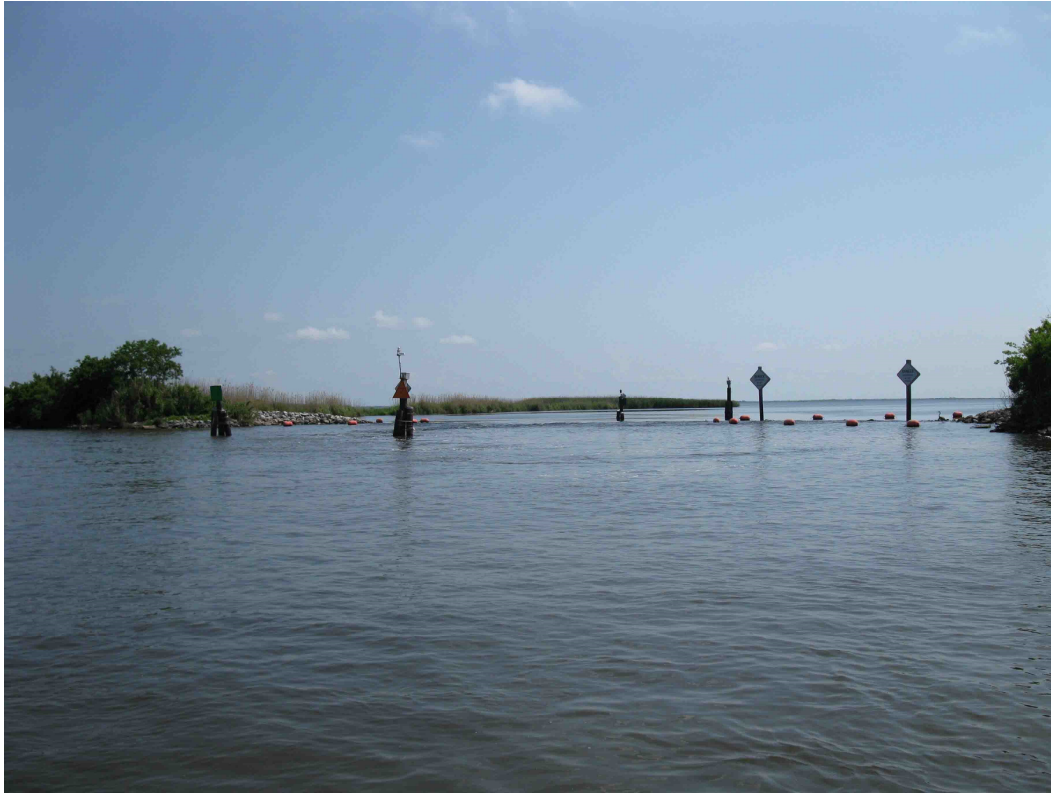
The two pilings on either side of the boat bay which were damaged have been replaced with regulatory marker buoys. Both of these buoys are now missing. The damaged piling clusters supporting the navigation lights have been repaired and another cluster is now damaged.

Both buoys are missing.

Photo #1 – Bayou Dupont Canal Weir. Approaching the structure from the Barataria Waterway, looking toward the Pen.

- Bayou Dupont Canal weir repairs will be addressed upon completion of the BA-41 project.
- A survey of the Goose Bayou Canal weir is needed to determine if maintenance is needed.
- At the Goose Bayou Canal, the string of orange warning buoys on the north side need to be securely anchored to keep it in its proper position.

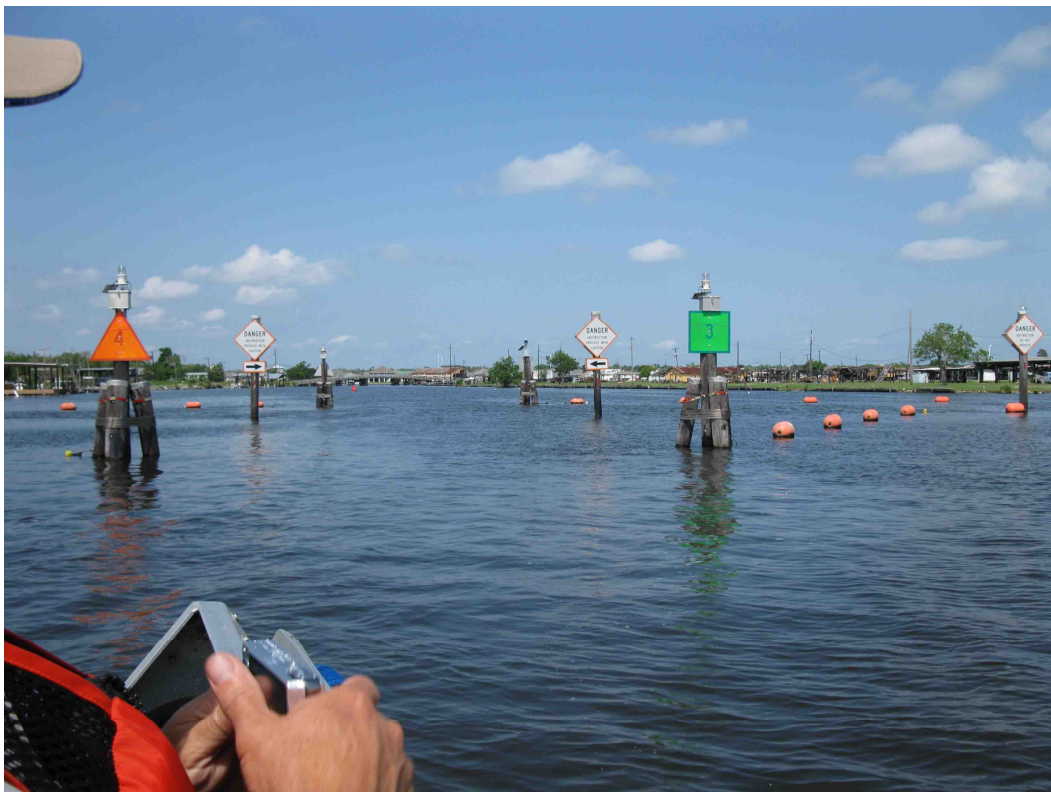
The rock appears to be settling as it is rarely visible above the water line. A survey is warranted to determine if maintenance is needed.

Some of the signs are losing their lettering due to weathering. The orange warning buoys on the north side came loose from the anchors in 2009. They were temporarily repaired and one string had come loose again for the inspection. This string was tied to a piling so it doesn't drift. Further repair is warranted.

Photo #2 – Goose Bayou Canal Weir. Looking West.

Item	Condition	Physical Damage	Corrosion	Photo #	Observations and Remarks
Rock Riprap	Good	None	N/A		Possible settlement, survey needed.
Creosote Piling	Good	None	None	#2	
Warning Signs and Day Board	Good	None	None	#2	Weathering of lettering, possible replacement needed. Continue to observe.
Navigation Signs					
Navigation Aid					
Lights	Good	None	None	#2	
Warning Buoys	Good	None	None	#2	Temporary repair after strings broke loose in 2009. One string loose again, tied to warning sign. Permanent repair needed.
Vandalism	N/A	N/A	N/A
