2010 Annual Inspection Report

Pass Chaland to Grand Bayou Pass Barrier Shoreline Restoration

State Project Number BA-35 Priority Project List 11

August 31, 2011 Plaquemines Parrish

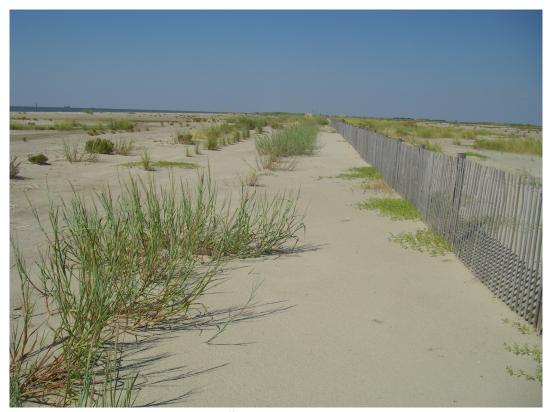
Approximately 14,360 linear feet of sand fencing was installed during project construction. Sand accumulation is evident along the entire length of the installed fencing. There is no damage to report at this time. (Photo #1)

Photo #1 – Sand Fencing.

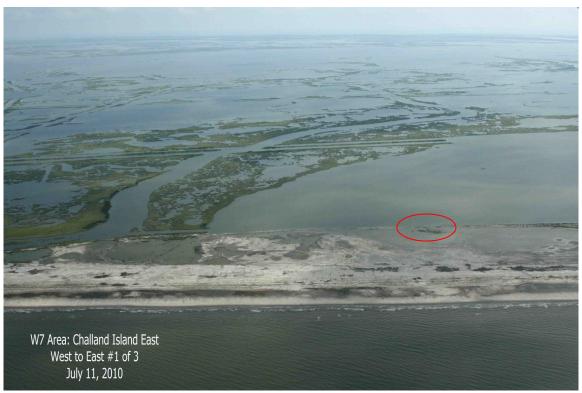
The containment dike was not degraded upon demobilization from the construction site. During the period between demobilization and this inspection the dike has been slowly degrading due to natural processes. One gap was observed to have been naturally created just east of the western shoreline of Bay Joe Wise. (Photo #2)

Photo #2 – Natural Dike Gap.

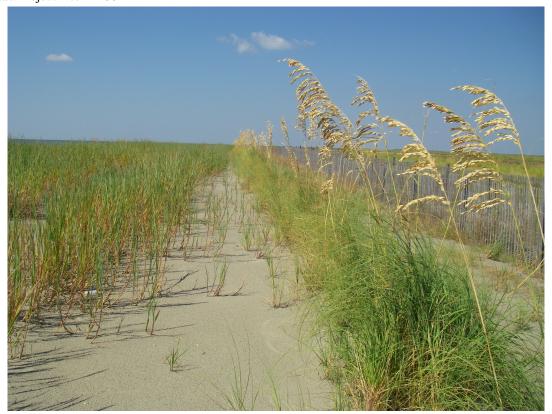
The vegetation has established very well on the dune and beach platform. The plantings in the marsh have not fared as well. There was about 15% loss on the beach and dune platform and about 30% loss in the marsh. (Photos 3 and 4)

Photo #3 – Beach and Dune Vegetative Plantings.

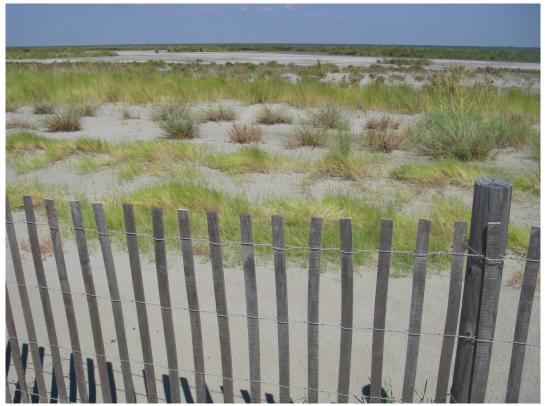
Photo #4 -Vegetative Plantings Looking North from Sand Fence.
