Coastal Protection and Restoration Authority of Louisiana

2011 Annual Inspection Report

Barataria Barrier Island Complex Project: Pelican Island and Pass La Mer to Chaland Pass Restoration

State Project Number BA-38
Priority Project List 11

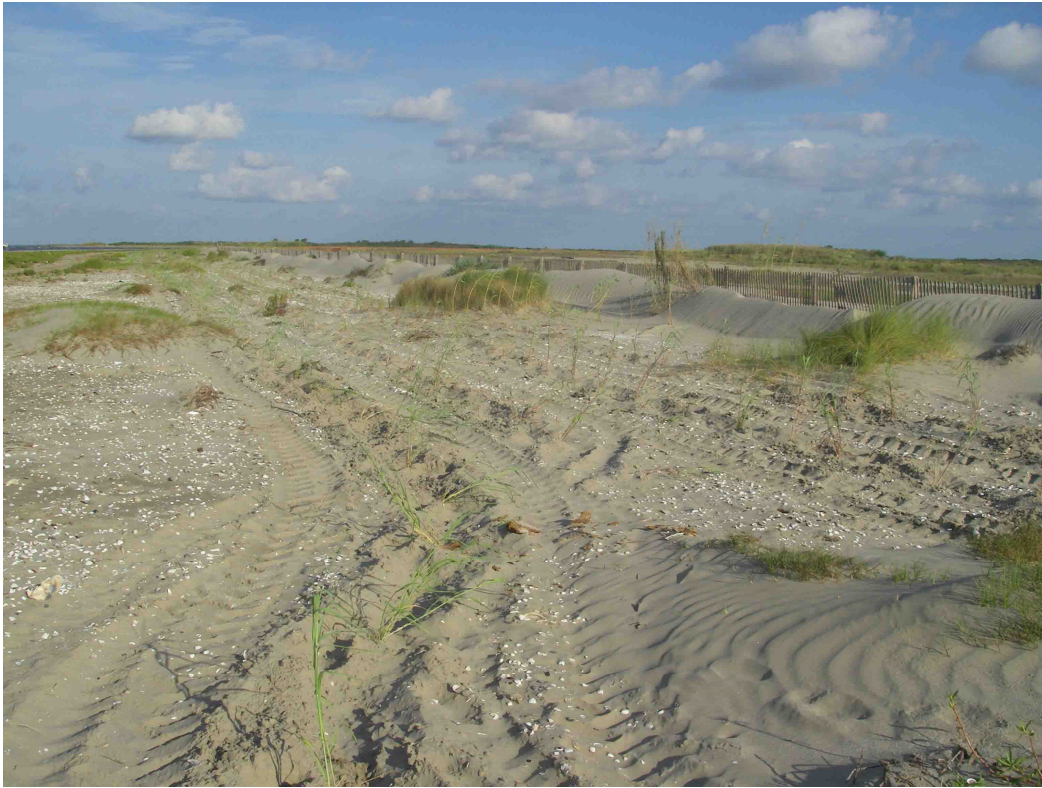
The sand fencing replaced by the BIMP was in good condition and is performing very well (Photo #1, #2). There are many locations where the sand is near the top of the fencing. The new (2011) sand fence was placed in the gaps left by the BIMP fencing (Photo #3, #4).

Photo #1 – Old Fencing (BIMP January 2010), note sand deposition.

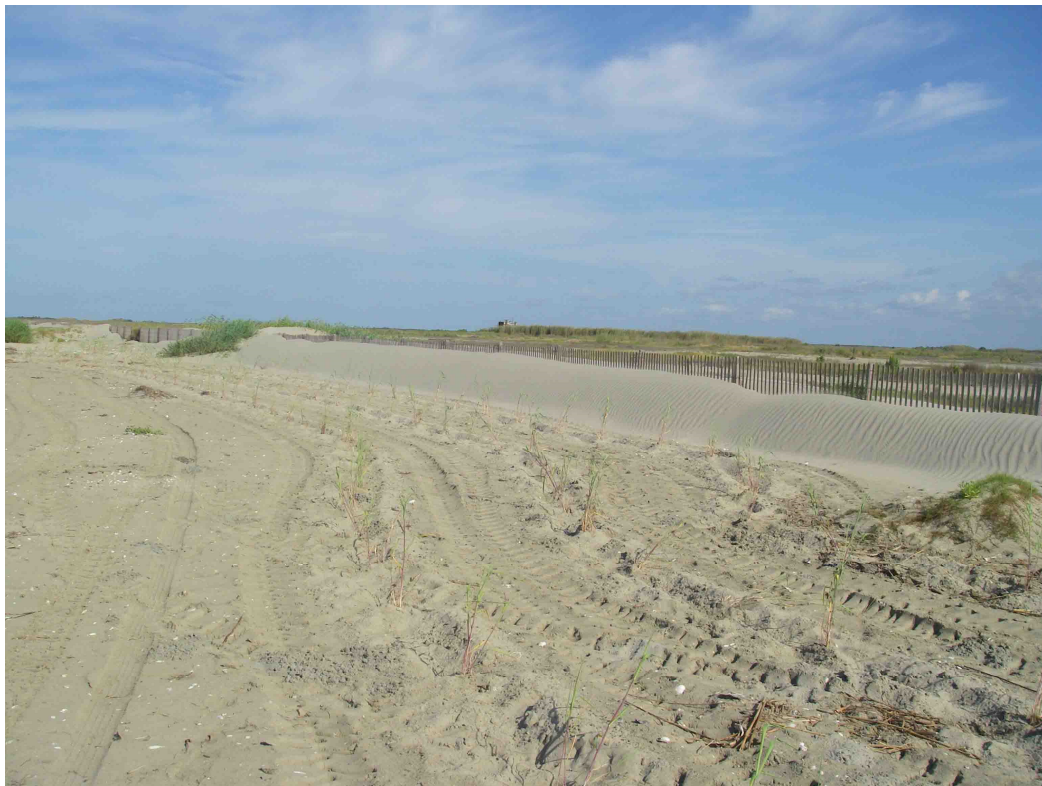
Photo #2 – Old Fencing (BIMP January 2010), note sand deposition.

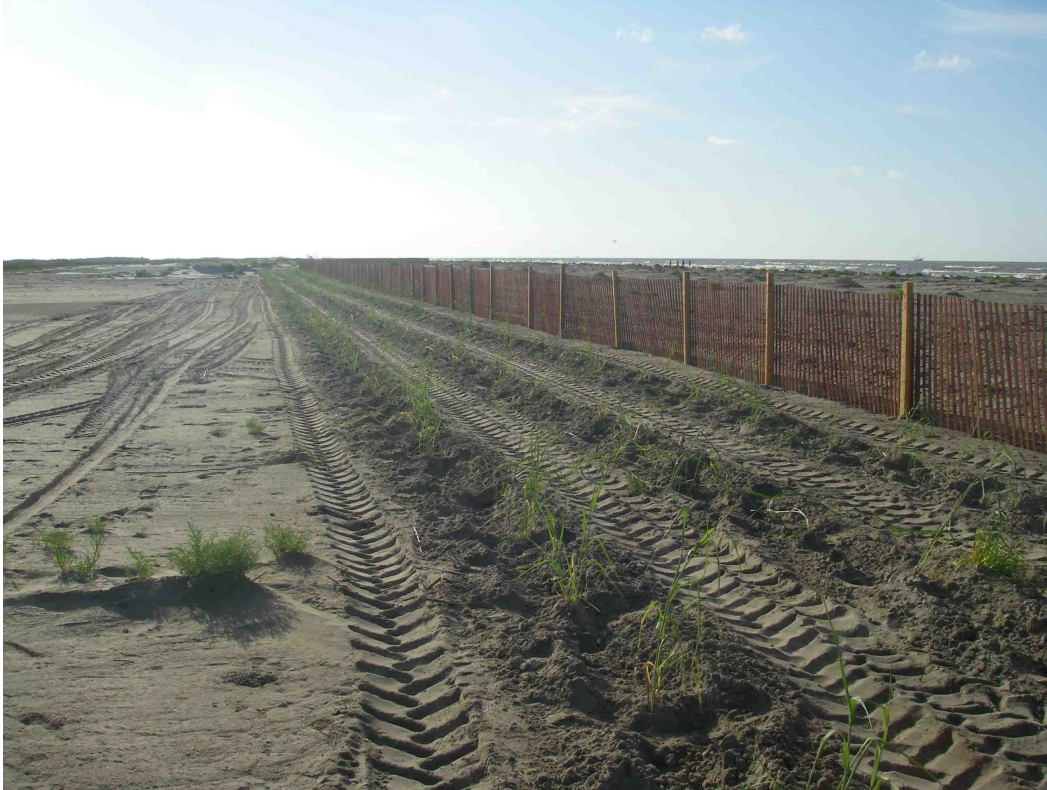
Vegetative plantings were replaced in May on the beach and dune. They were planted around the natural vegetation so as not to destroy what is already there. The only species planted was Bitter Panicum as this seemed to work best for the construction plantings on the beach and dune. (Photo #3, #4)

Photo #3 – New (May 2011) Fencing and Plantings.

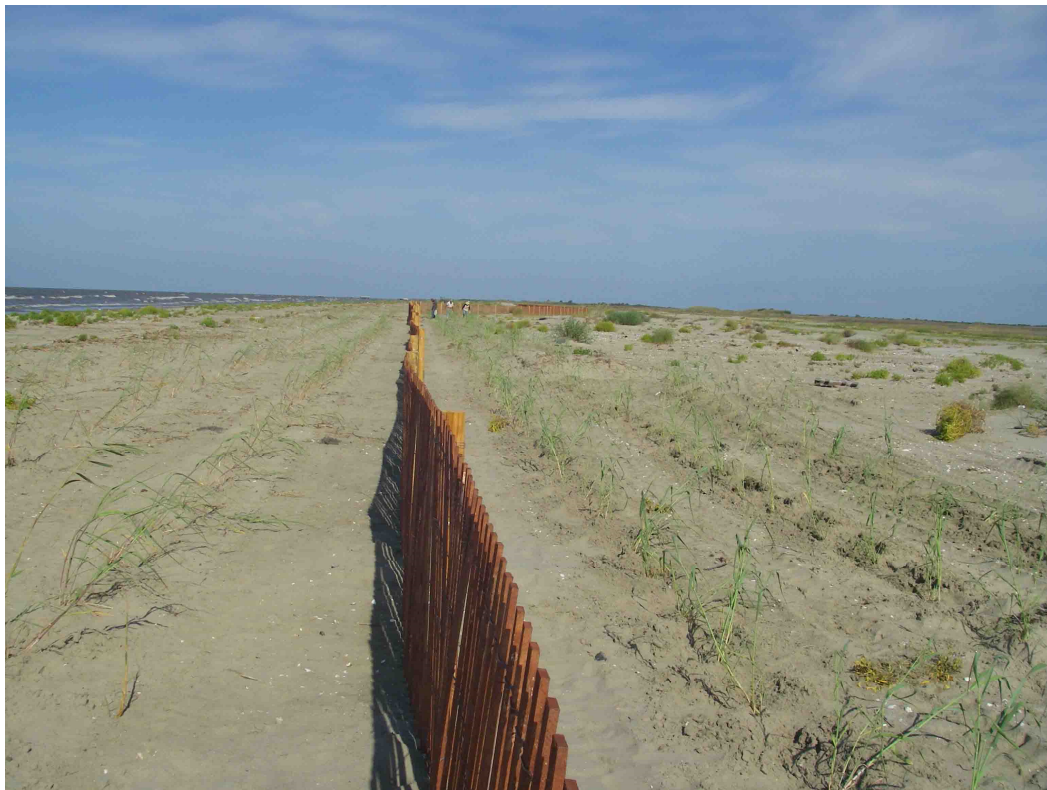
Photo #4 – New (May 2011) Fencing and Plantings.
