## **Coastal Protection and Restoration Authority of Louisiana**

## **2011 Annual Inspection Report**

### **Barataria Bay Waterway East Bank Protection**

State Project Number BA-26  
Priority Project List 6

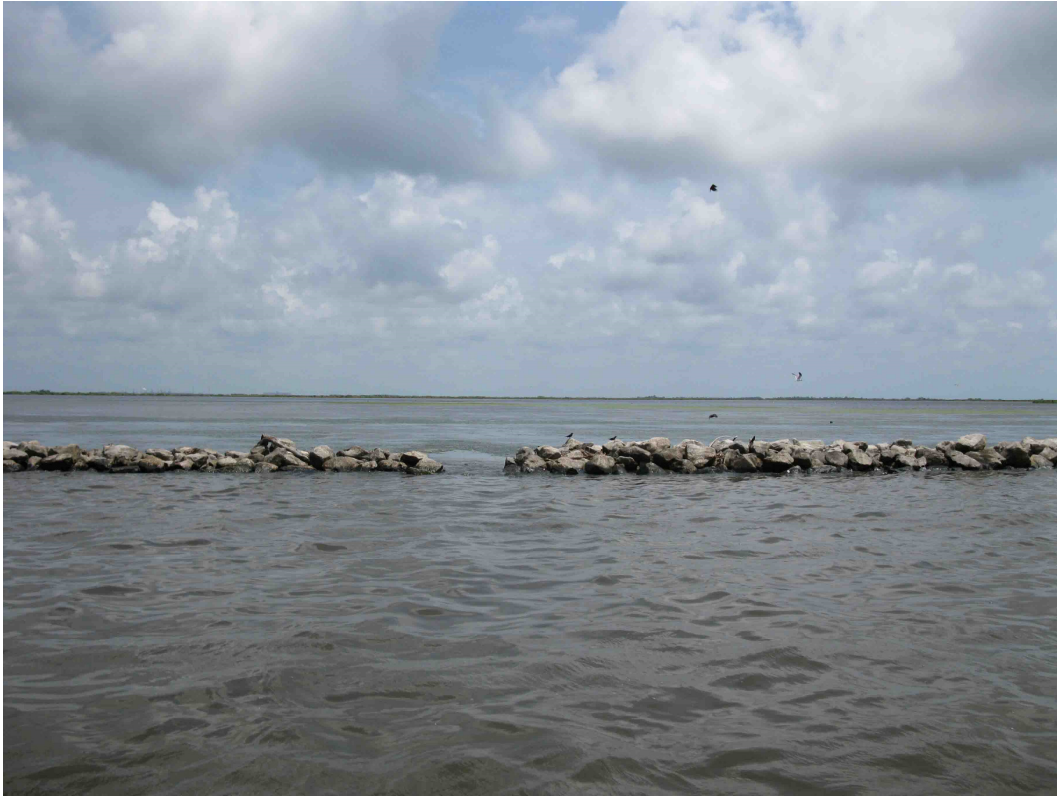
There are no noticeable damages to the rock structure since the previous inspection (Photo #1). More settlement has been observed in front of the marsh creation portion of the South Shore of the Pen Project (BA-41, Photo #2). A small gap in the rock structure was seen at approximate coordinates N29.61380°, W 090.07905°. This gap is probably the result of vandalism and should be monitored (Photo #3). Some accretion and vegetation was observed behind the rock structure at the north end of the project.

**Photo #1 – Gap.**

- Continue to monitor the settlement of the rock structure.

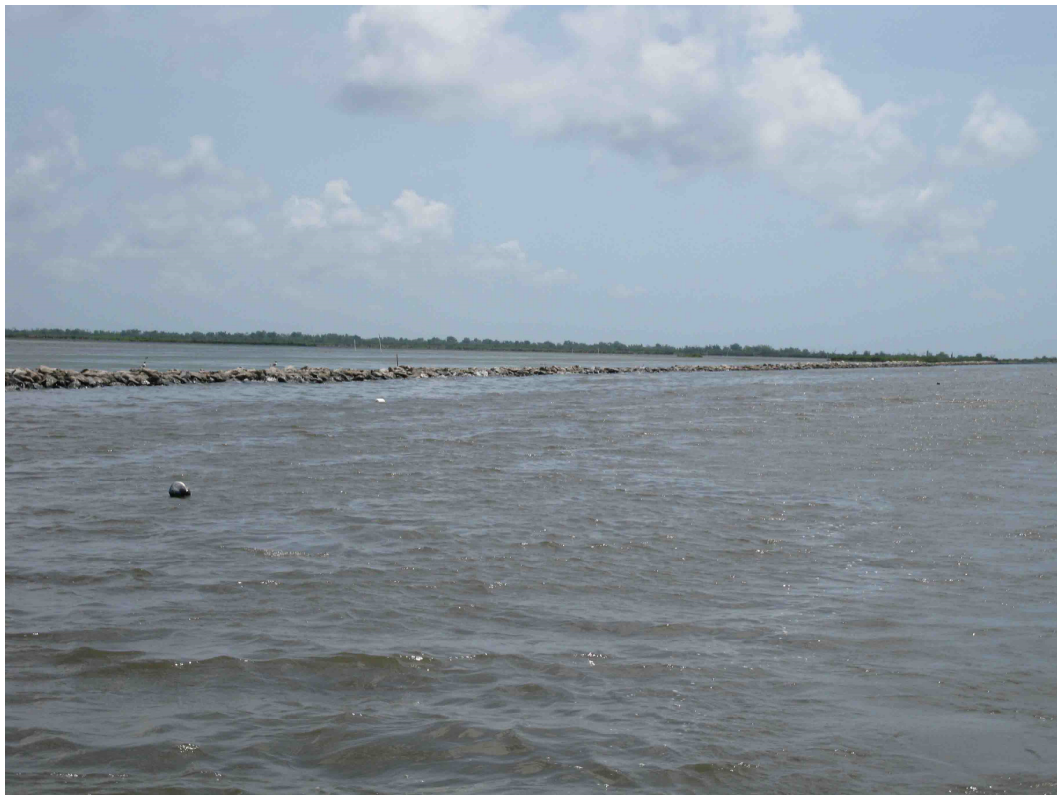
**Photo # 2 – Shoreline Protection.**

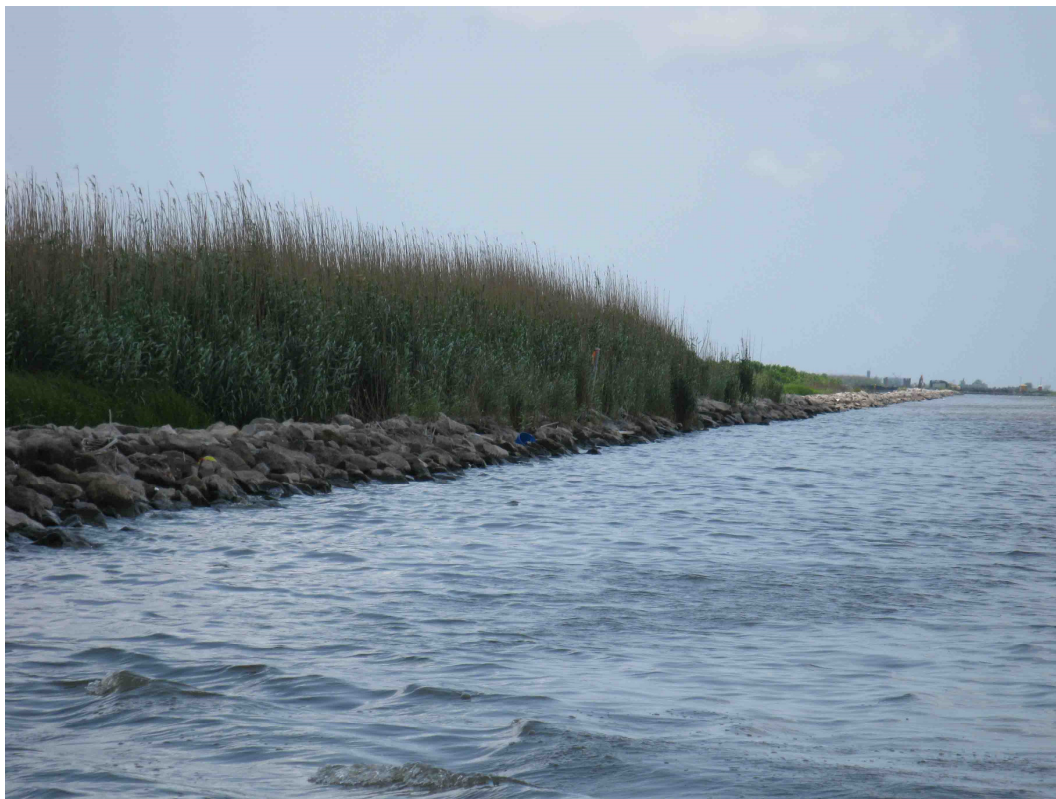
**Photo # 3 – Accretion.**
