Coastal Protection and Restoration Authority of Louisiana

2011 Annual Inspection Report

Bayou Chevee Shoreline Protection

State Project Number PO-22
Priority Project List 5

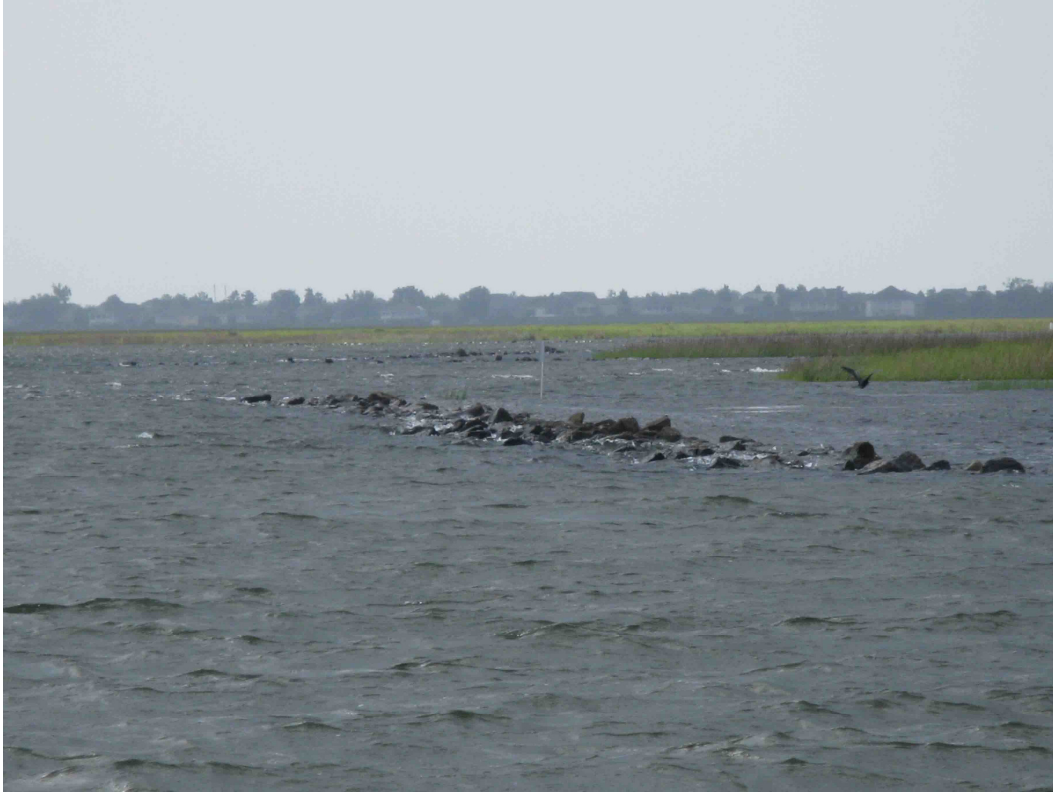
There was no visible damage to the dikes. The southern reach and the southern portion of the northern reach are showing noticeable signs of settlement. The northern portion of the northern reach is still at an acceptable grade.

While the water level was higher than normal, the settlement of approximately 70% of the project feature was evident. At some points it was below the water level and at most it was just above. The northern section of the project is still at an acceptable elevation to provide shoreline protection, however the majority of the project is low enough that it is providing little or no protection to the shoreline from normal and abnormal tidal actions.

Photo #1 – A low portion of Southern Reach.

It is recommended that a lift be conducted for the portions of the project that are no longer performing as designed.

- Add rock to low sections of dike.

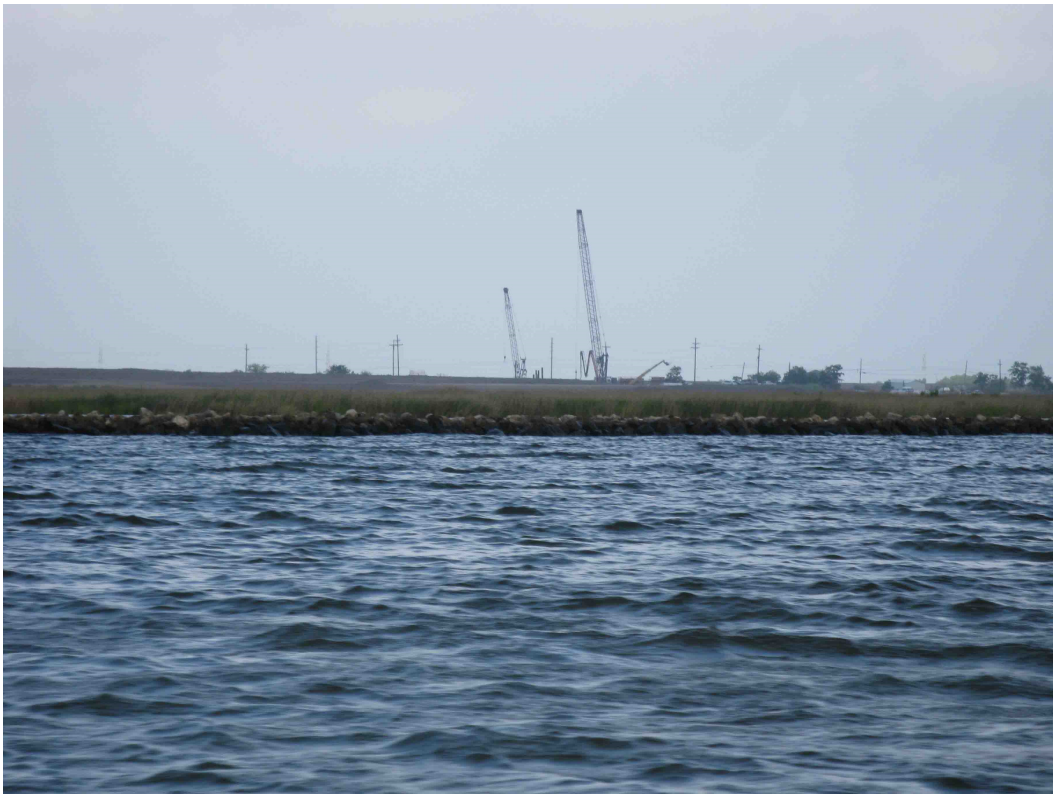
Photo #2 – Acceptable portion of Northern Reach.
