2011 Annual Inspection Report

Fritchie Marsh Restoration

State Project Number PO-06
Priority Project List 2

November 1, 2011
St. Tammany Parish

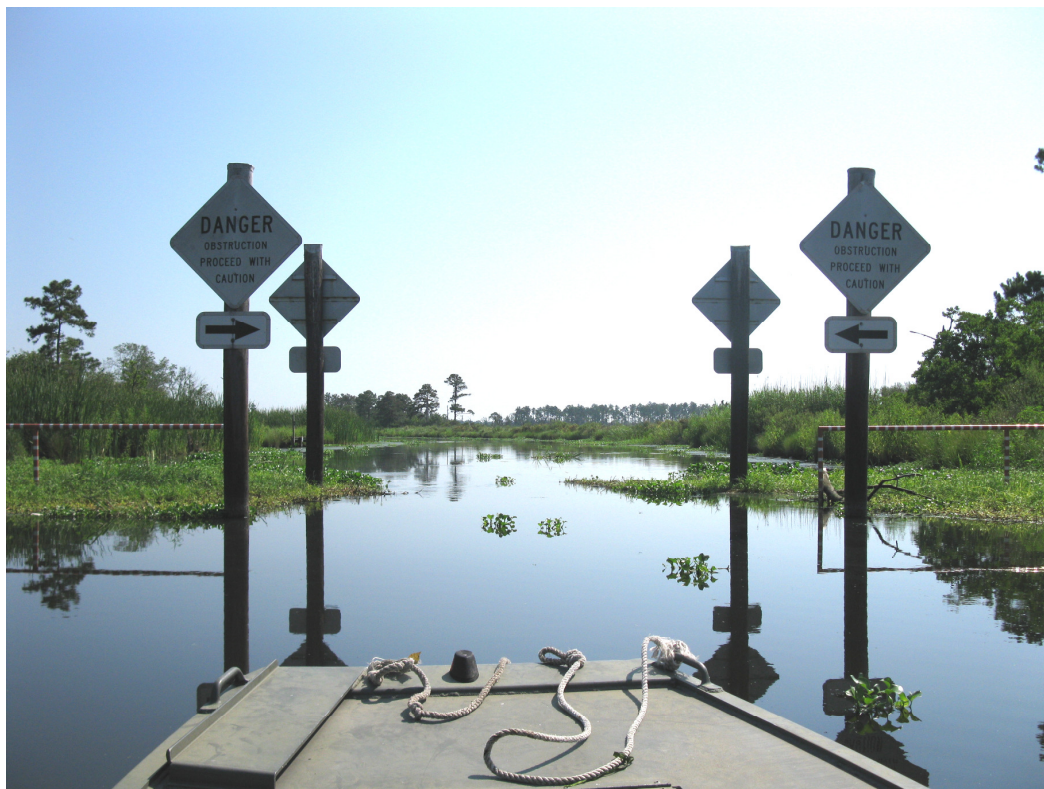
W-14 Weir

There was no visible damage to this structure and it appears to be operating as designed.

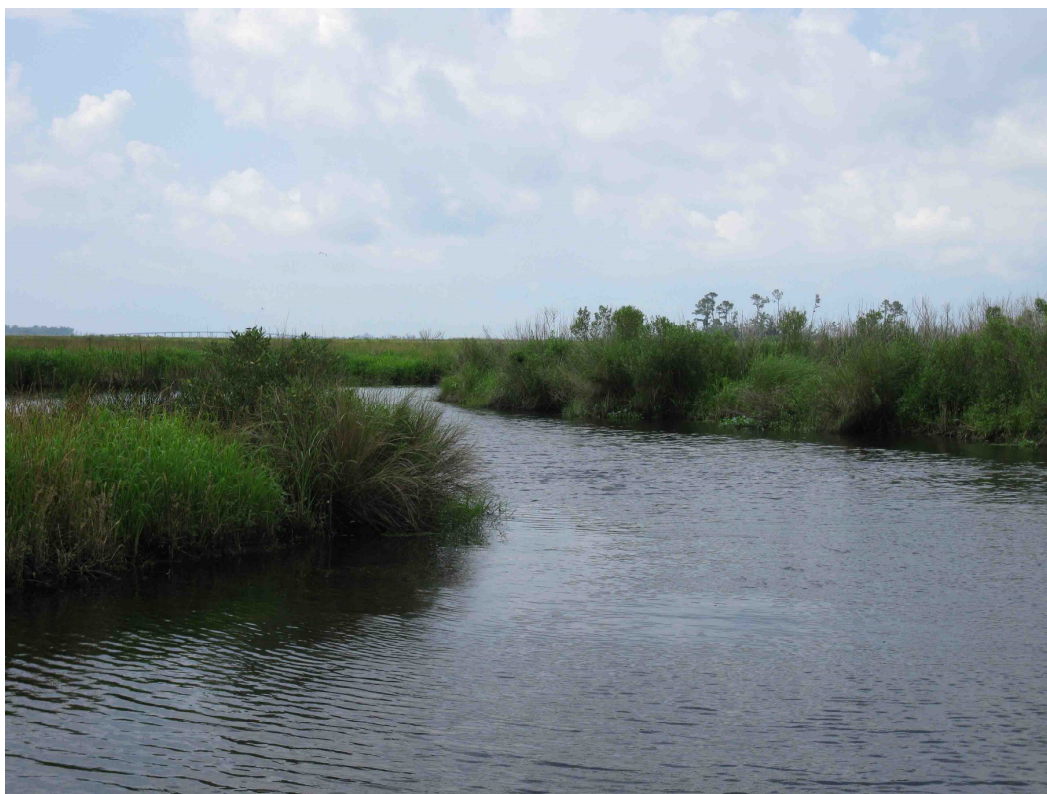
W-14 Diversion Channel Beyond Dredging

There is no visible damage to this feature. It appears to be diverting the water from the north as designed.

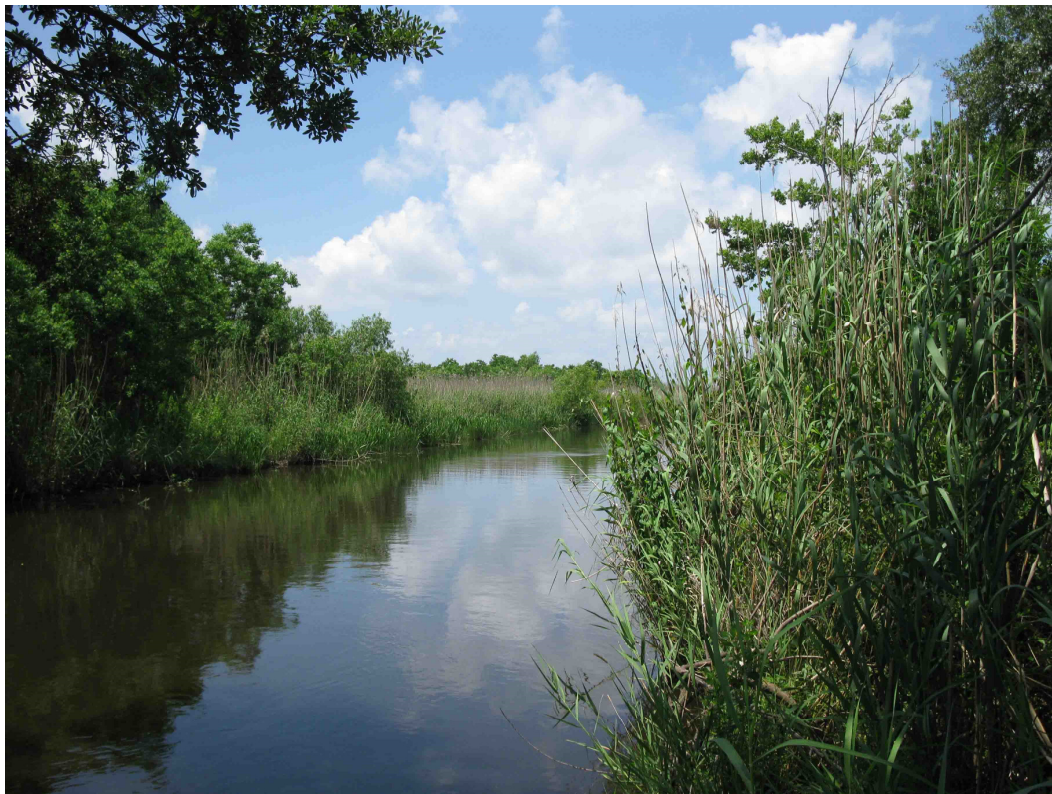
Salt Bayou from Culverts

There was not a detailed inspection performed of this feature. The inspection consisted of boat travel halfway down the bayou from the west and observations made from Hwy 90 at the culverts. There was no damage observed at the areas inspected. The worst sections from the previous inspection, where breaches and infilling occurred, were not inspected.

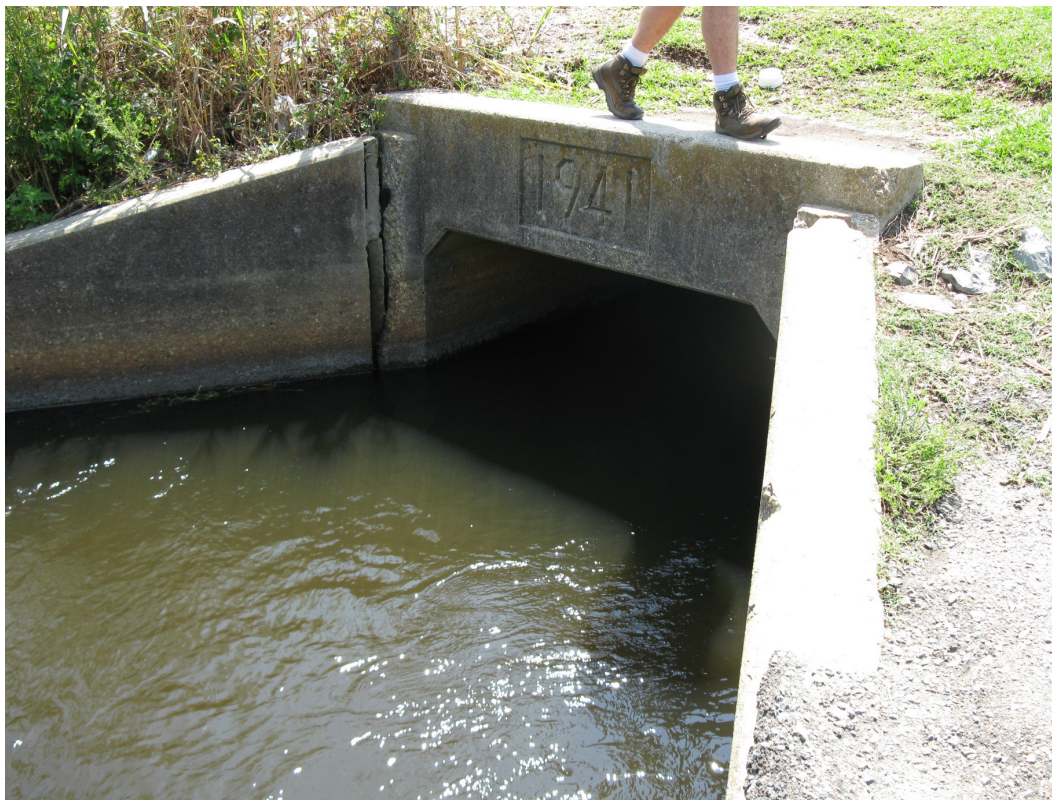
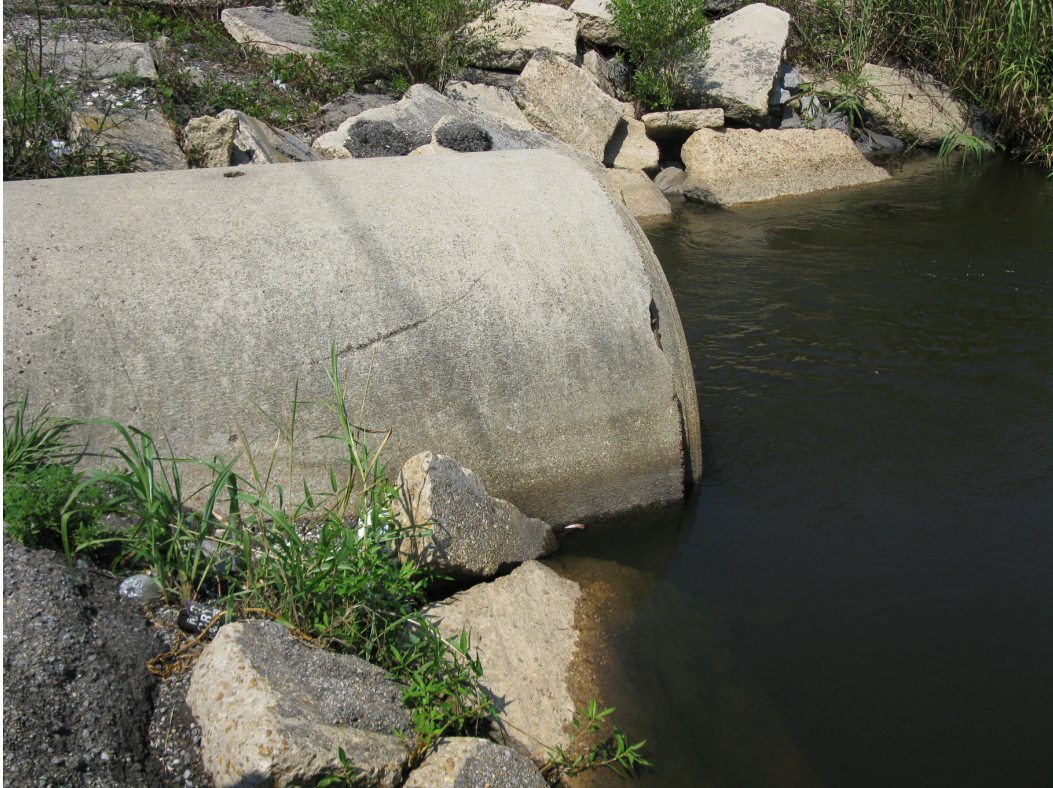
Culverts from Project Side

There is no change in this structure from the previous inspection. The bank scour reported in previous inspection reports is still of concern, however it is vegetating very nicely.
