2011 Annual Inspection Report

Hopedale Hydrologic Restoration

State Project Number PO-24
Priority Project List 8

February 1, 2012
St. Bernard Parish

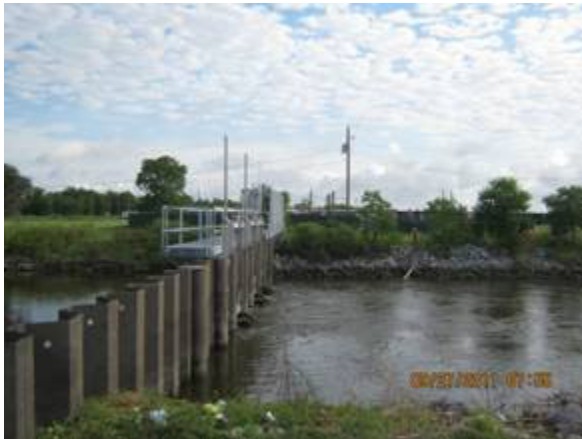
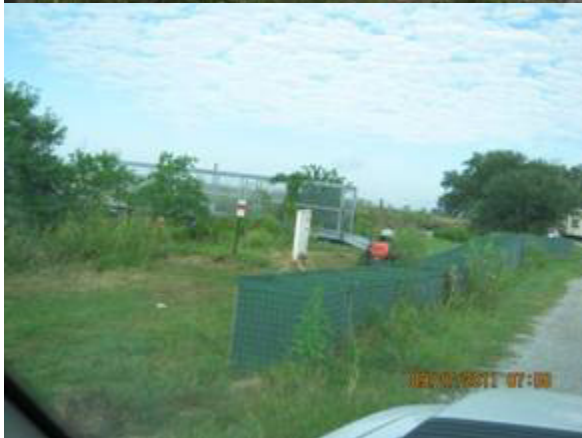
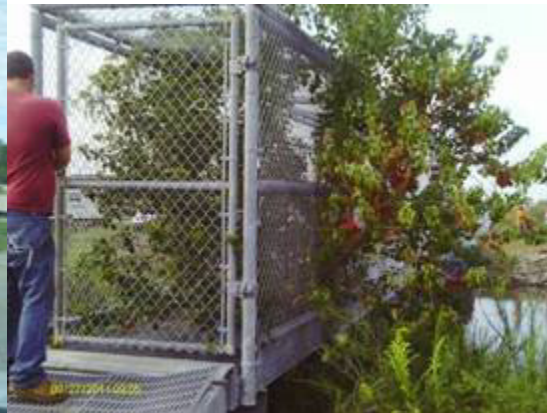
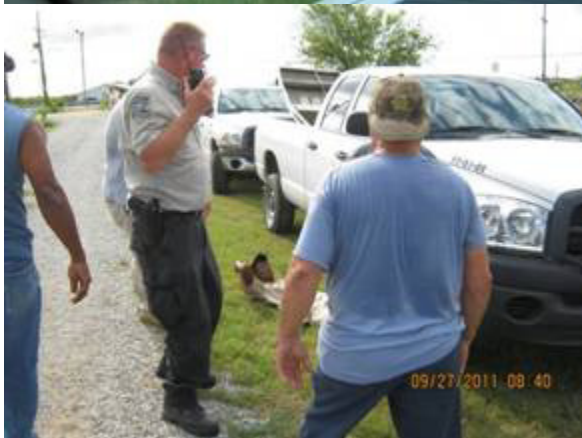
We removed 2 large trees, 1 from the far outside structure and 1 from the far inside structure. We also removed several small trees growing through the rip rap. Let me know if you need more photos. I have them!
