## **2012 Annual Inspection Report**

### **DELTA MANAGEMENT AT FORT ST. PHILIP (BS-11)**

State Project Number BS-11  
Priority Project List PPL-10

August 7, 2012  
Plaquemines Parish

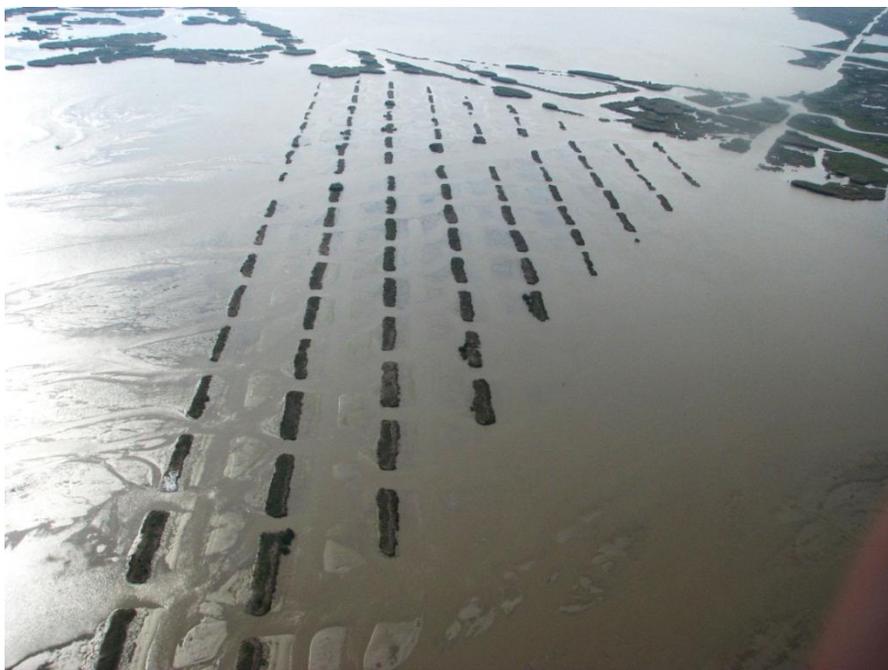
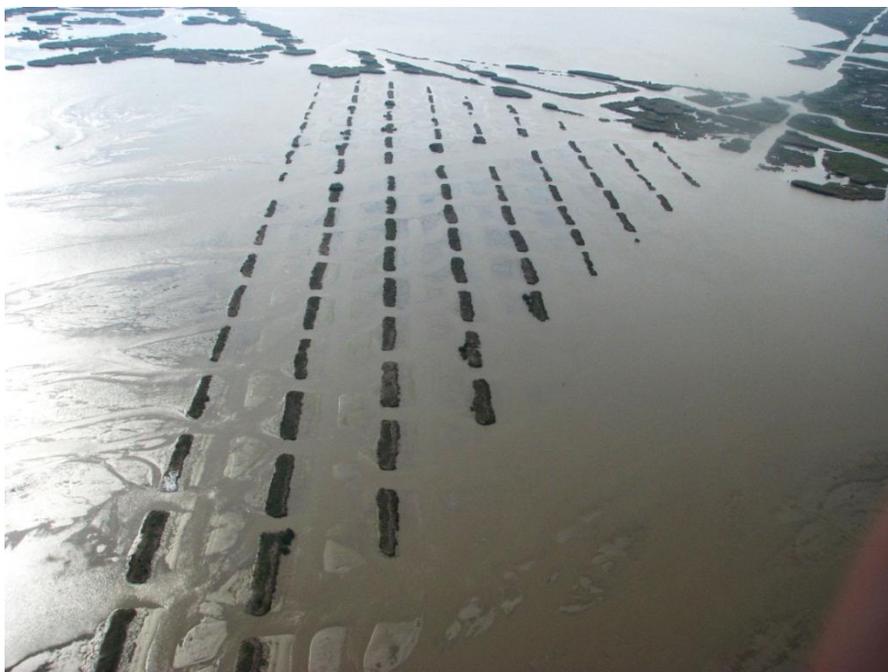
- A. Terraces: Terraces built on the northeastern side with soft, unsuitable material have developed some washout areas within some terraces. The terraces on the southern end – at the end of crevasse 1A – are degrading due to their placement as the front row of the terrace field. Their original constructed elevations have slightly decreased. Vegetation densely covers each terrace.

**Terrace Field (12/08/2011)**

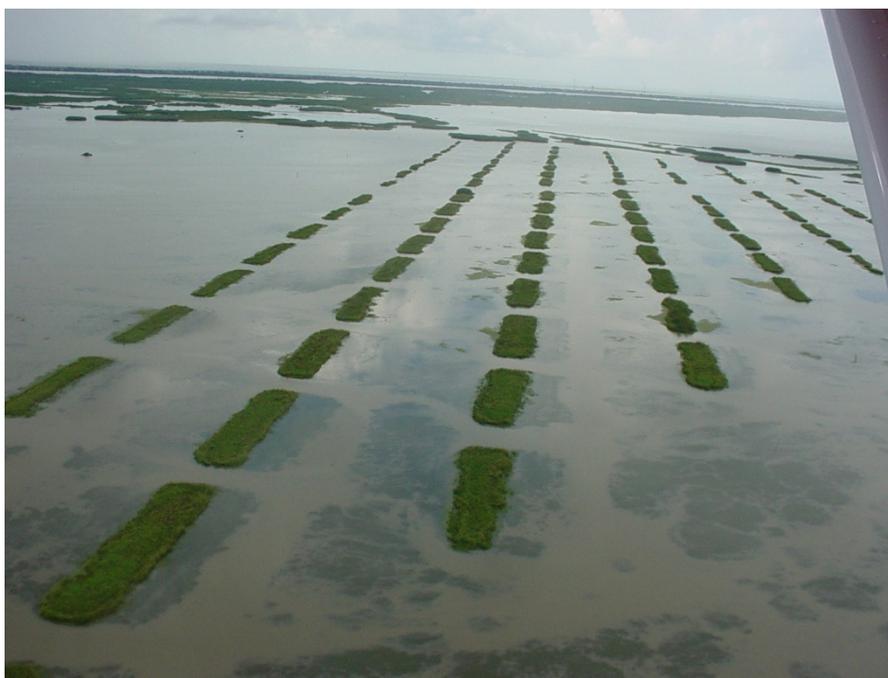
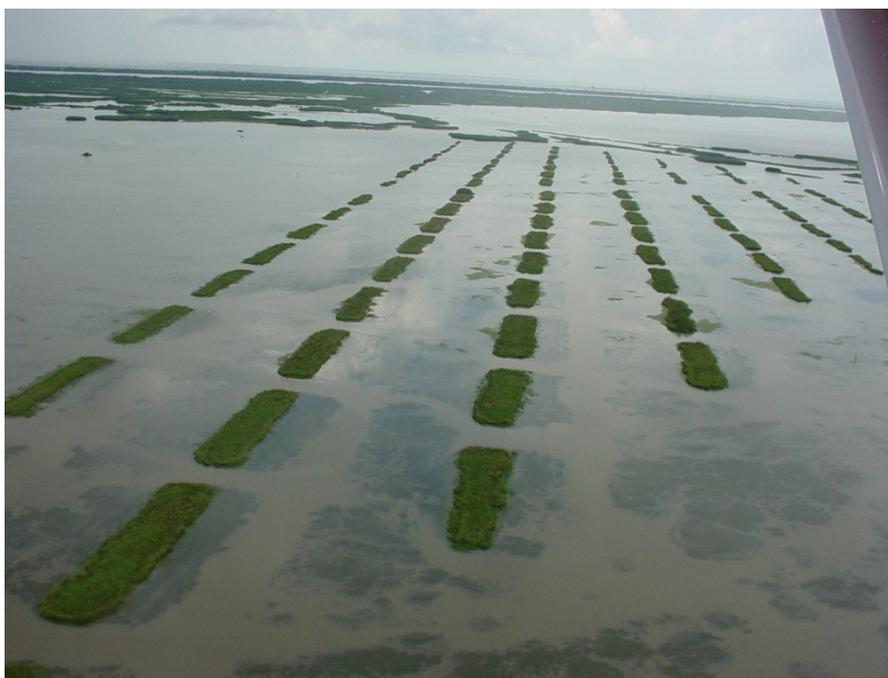
**Terrace Field in Bay Dénesse Looking West (2010 Stock Photo)**

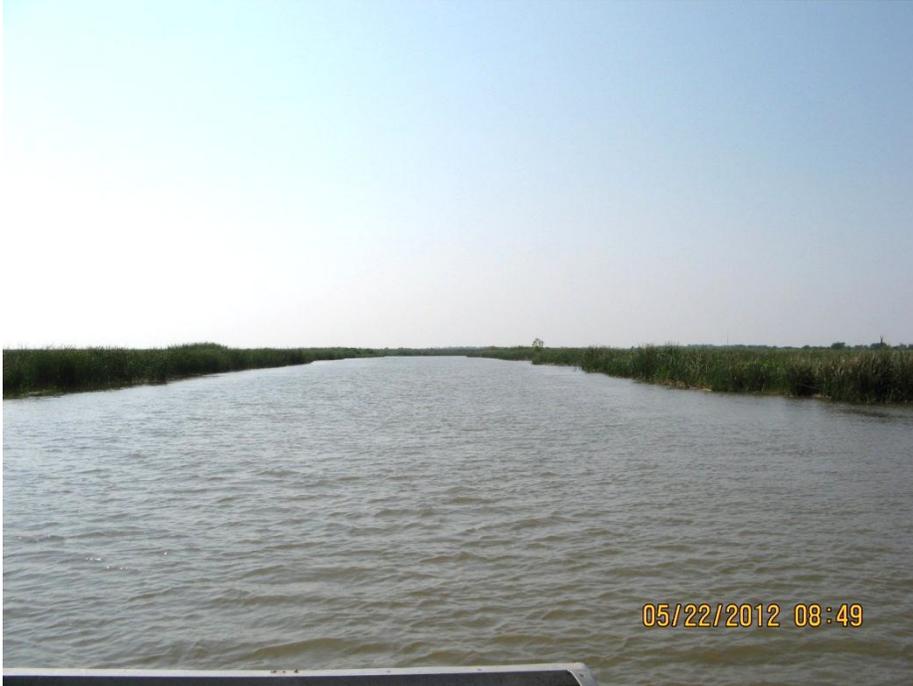
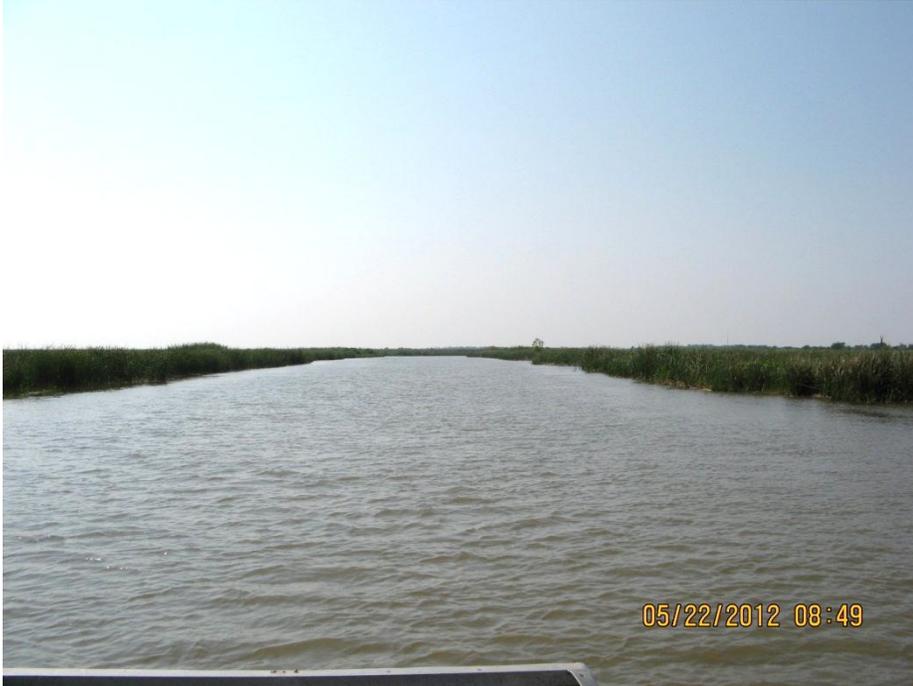
- B. Crevasse No. 1A: This crevasse is the longest of all, and funnels river water directly into the Bay Denesse terrace field. Currents through this crevasse were swift and appeared to be carrying plenty of river sediment. The November 2011 survey indicates that this crevasse has deepened since construction.

**Channel 1-A exiting the Terrace Field in Bay Denesse**

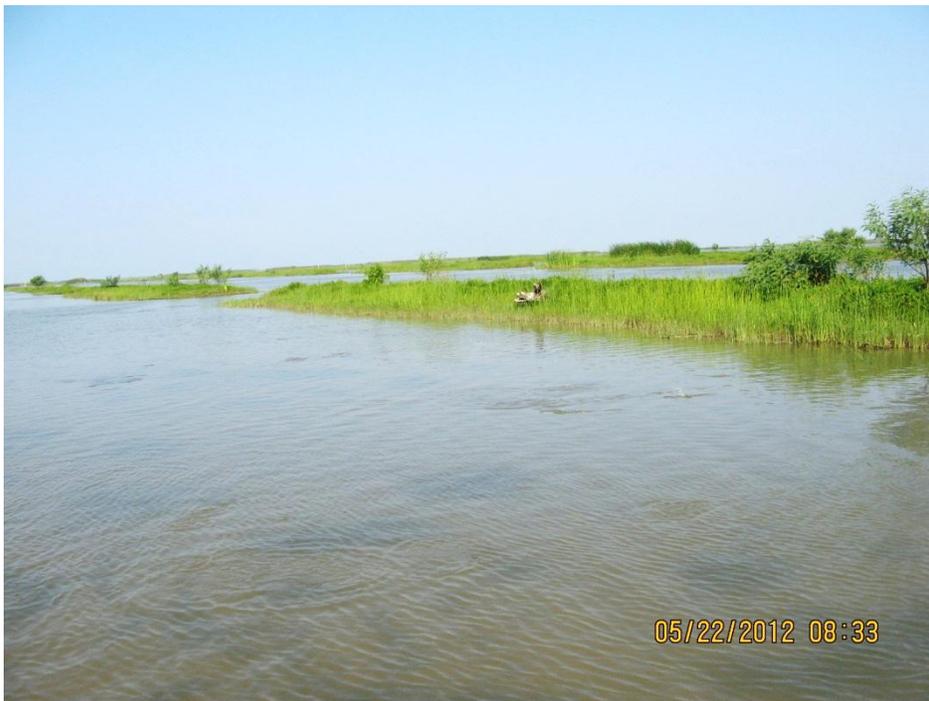
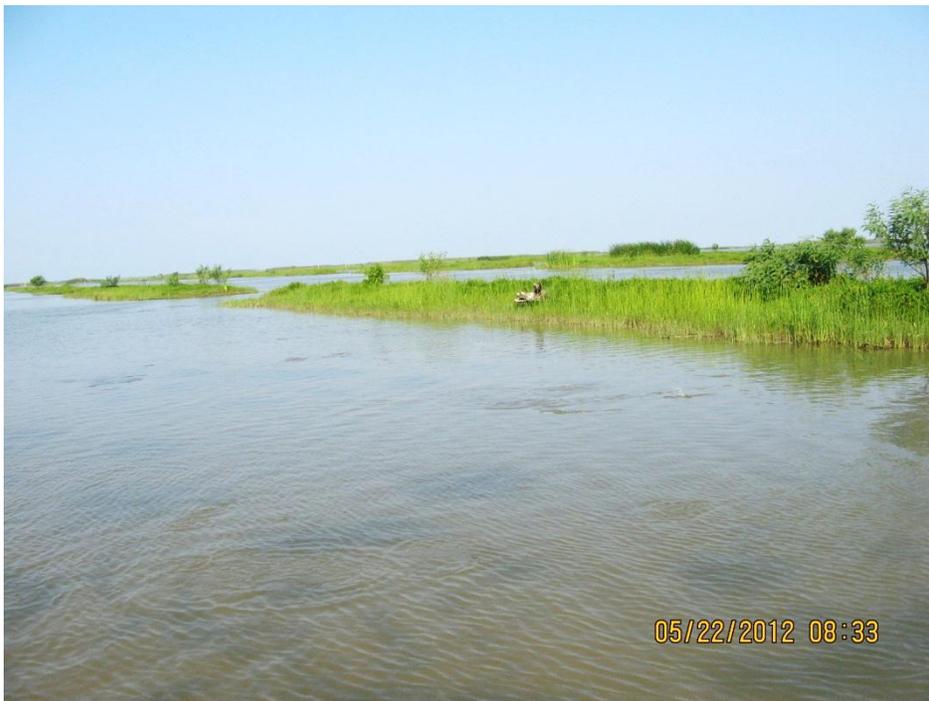
**Terrace Field in Bay Denesse**

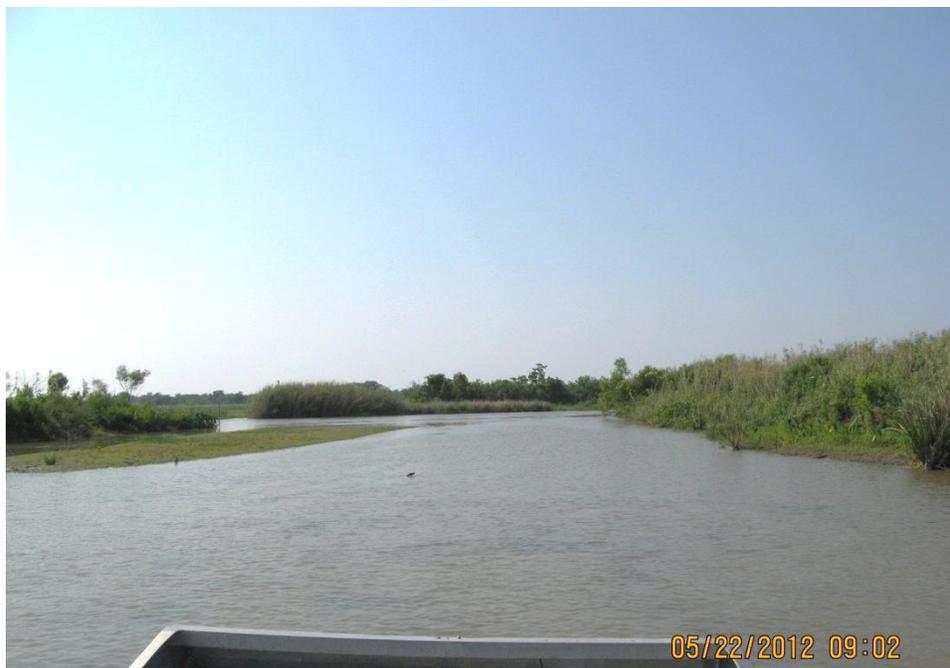
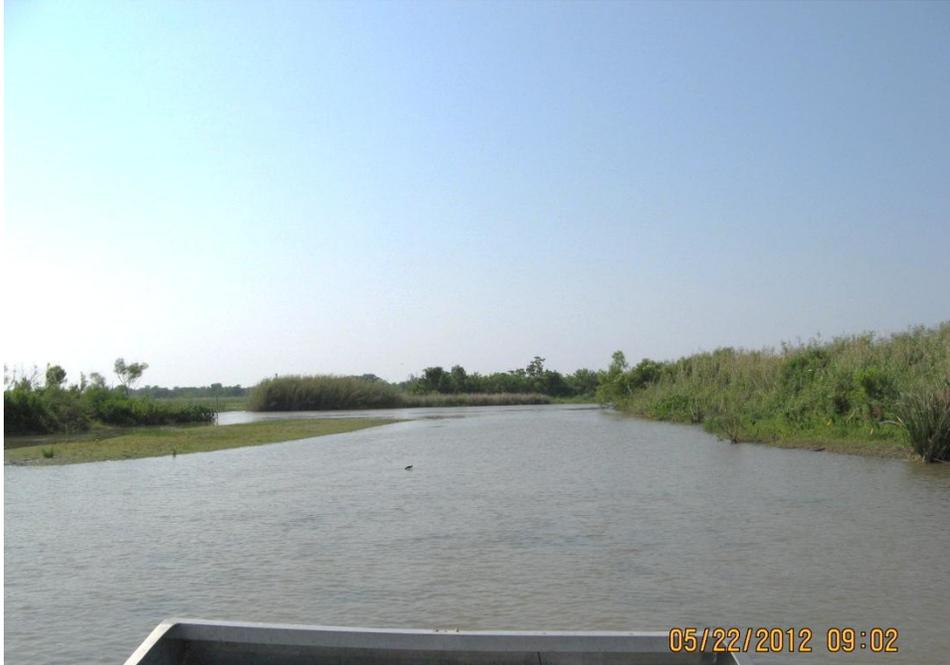
- C. Crevasse No. 1B: This crevasse, which is the shortest of all, feeds a small area of marsh. Grasses have sprouted on the island formed in the crevasse after the 2011 high river event. Mudflats within the receiving bay are visible above the water surface.

**Crevasse 1-B Channel shoaling**

As a result of the inspection, the inspection team concluded that maintenance dredging of the crevasses should be considered to keep the project functioning as designed. Surveys from November of 2011 of the crevasses indicate that shoaling is occurring within the crevasses. The operations and monitoring teams will be submitting a cost estimate for maintenance dredging of all six crevasses. Alternatives will be discussed in which some crevasses will be eliminated from further maintenance.

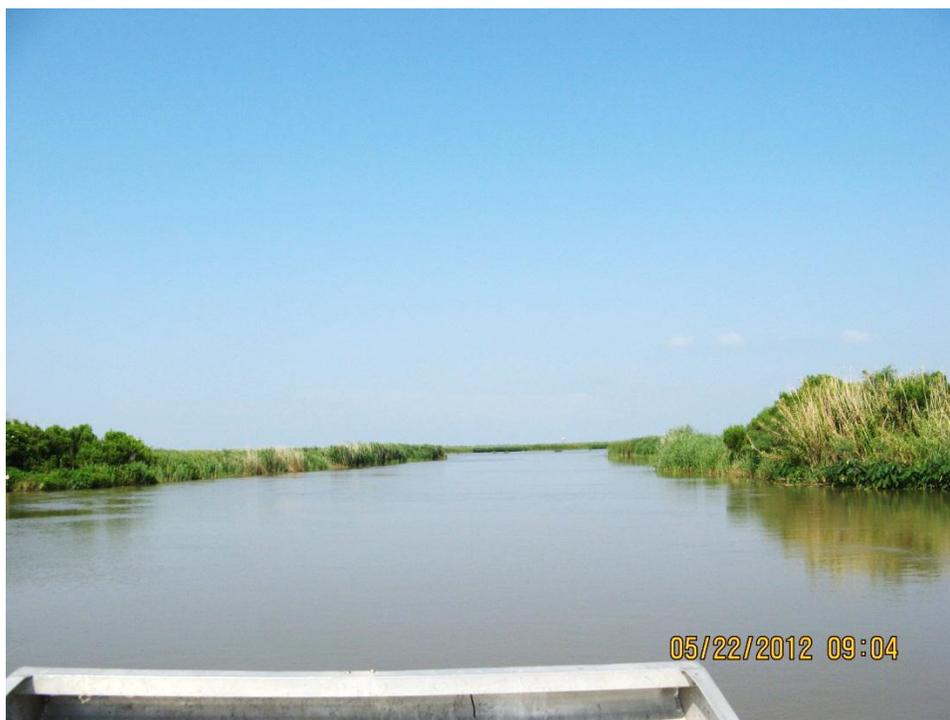
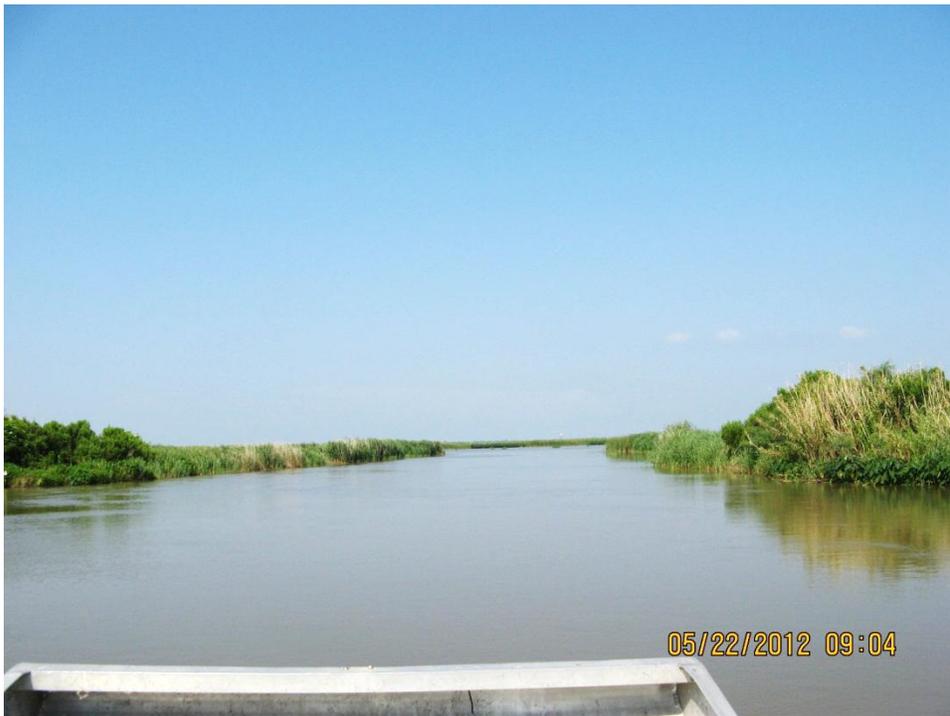
**Crevasse 1-C**

- D. Crevasse No. 1C: The 2011 survey indicates this crevasse has begun infilling. The channel outfall shows emergent vegetation, active with wildlife.

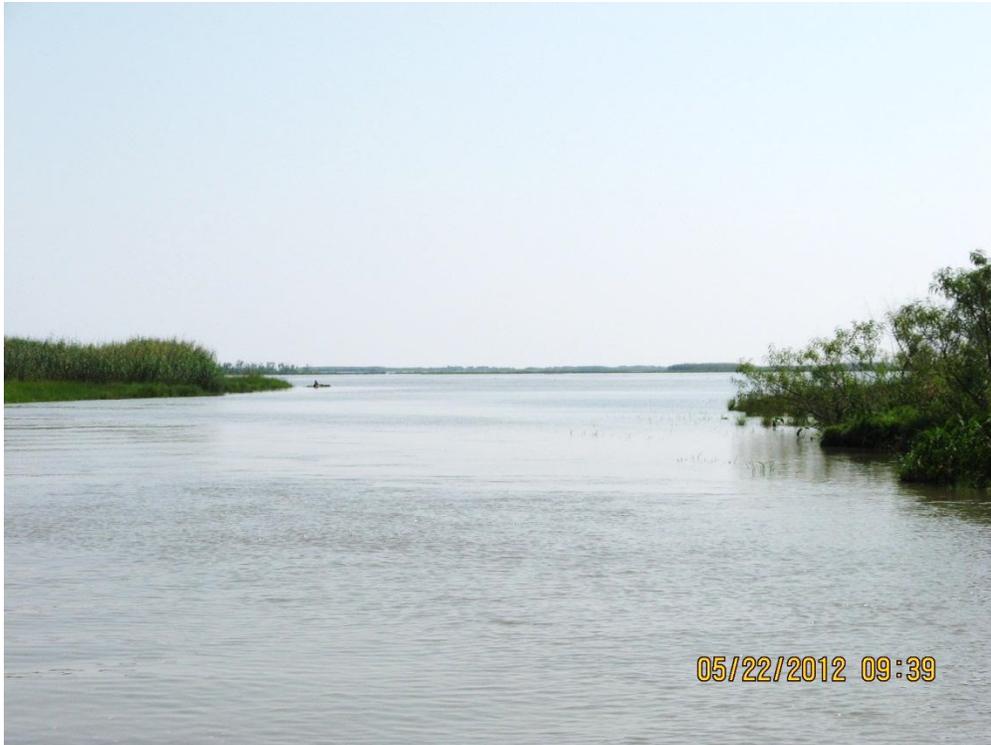
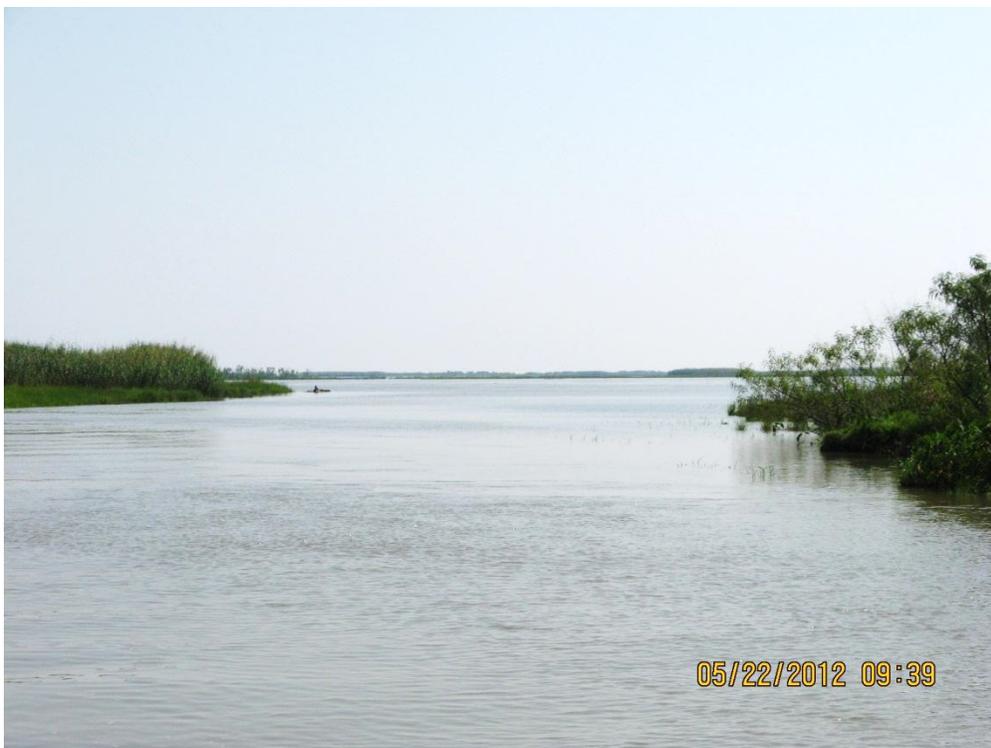
- E. Crevasse No. Alt. 2A: Flow is maintained within the channel. The channel has begun infilling. The SAV blooms throughout the receiving area are evidence of sediment deposits filling in the bay.

**Crevasse Alt 2-A Channel with vegetated spoil bank**

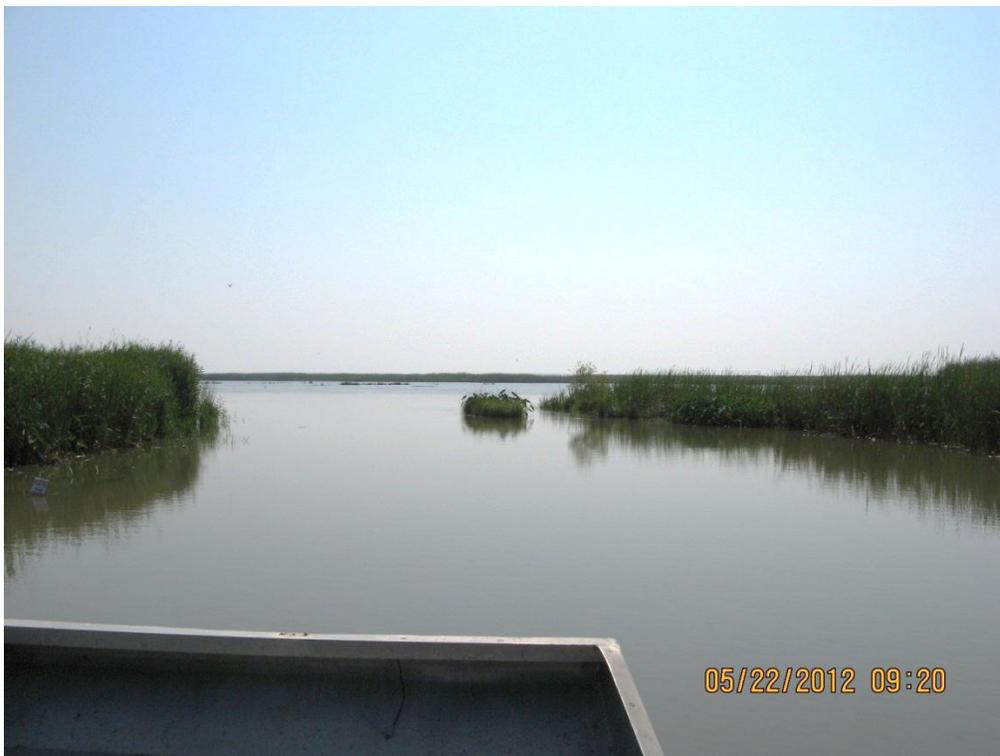
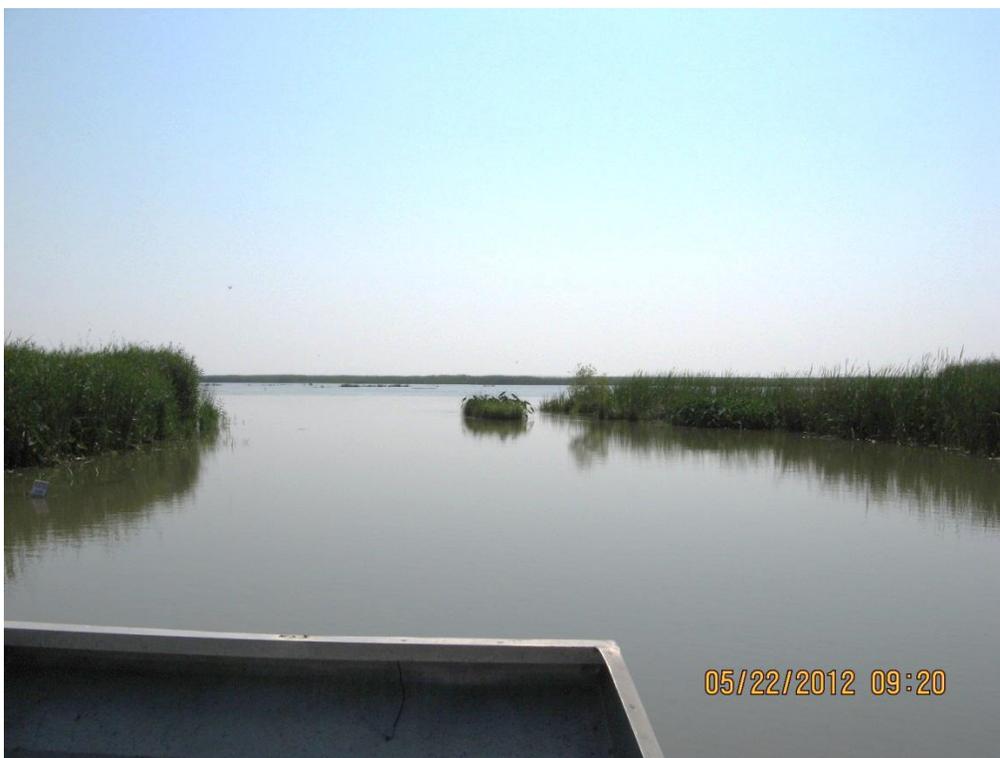
- F. Crevasse No. 2B: Flow is maintained within the channel. Sporadic vegetated islands are emerging within the receiving bay. The channel has begun filling in; the deepest part of the channel runs along the northern bank.

**Crevasse 2-B Channel outlet, interior marsh growth.**

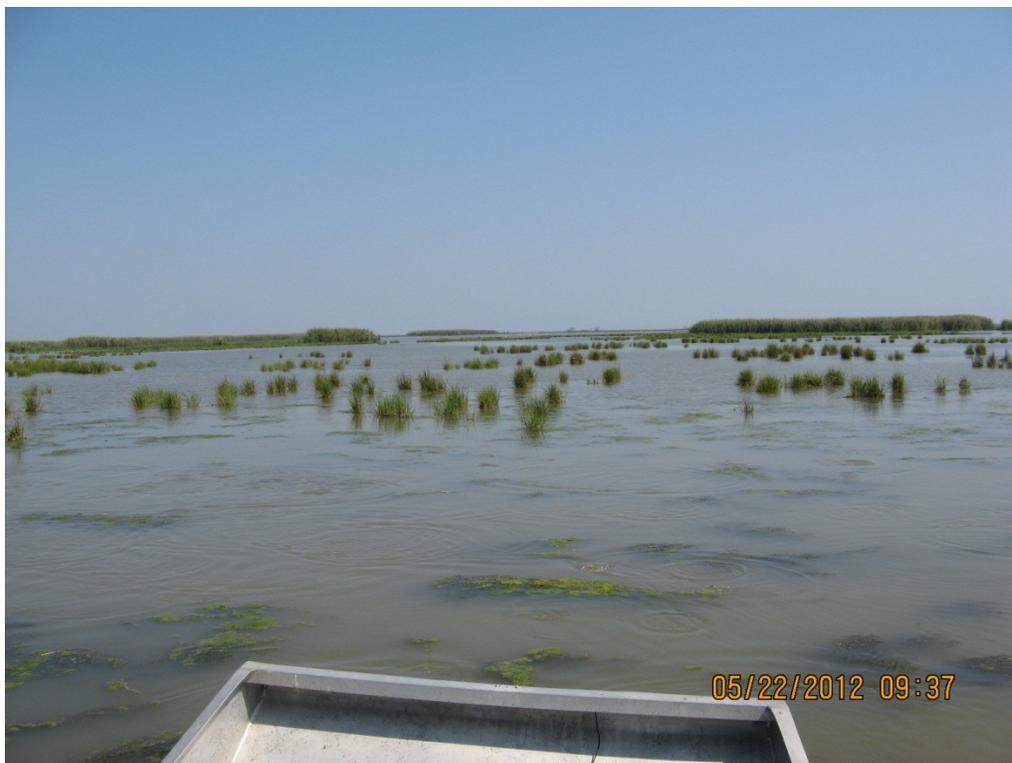
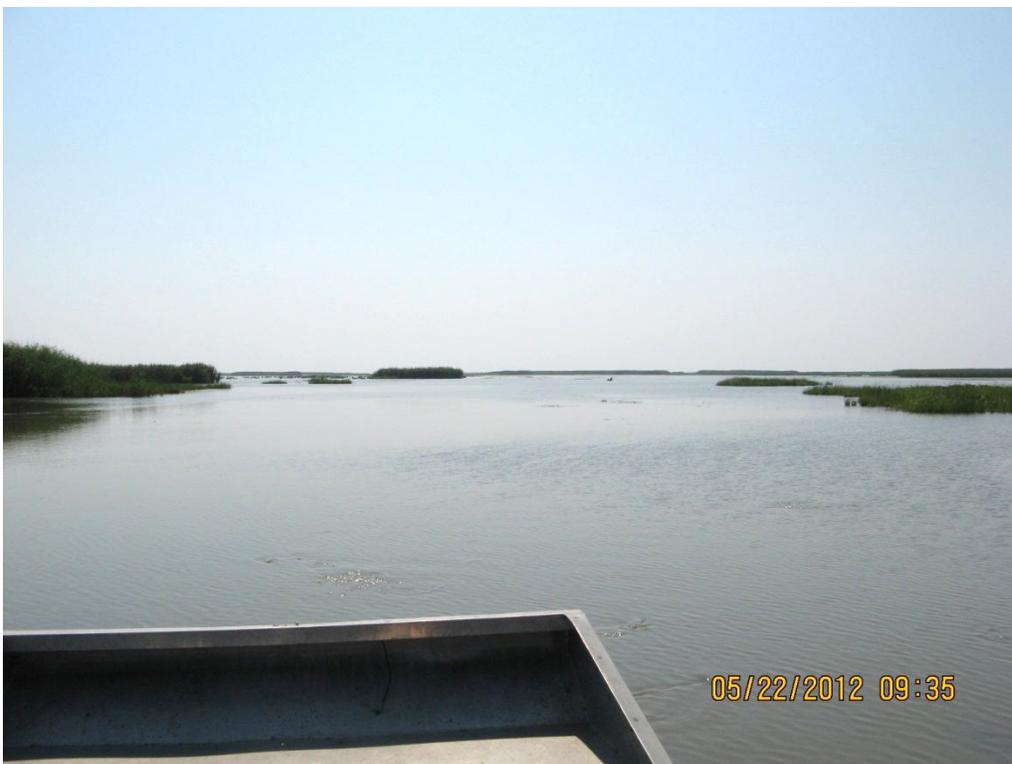
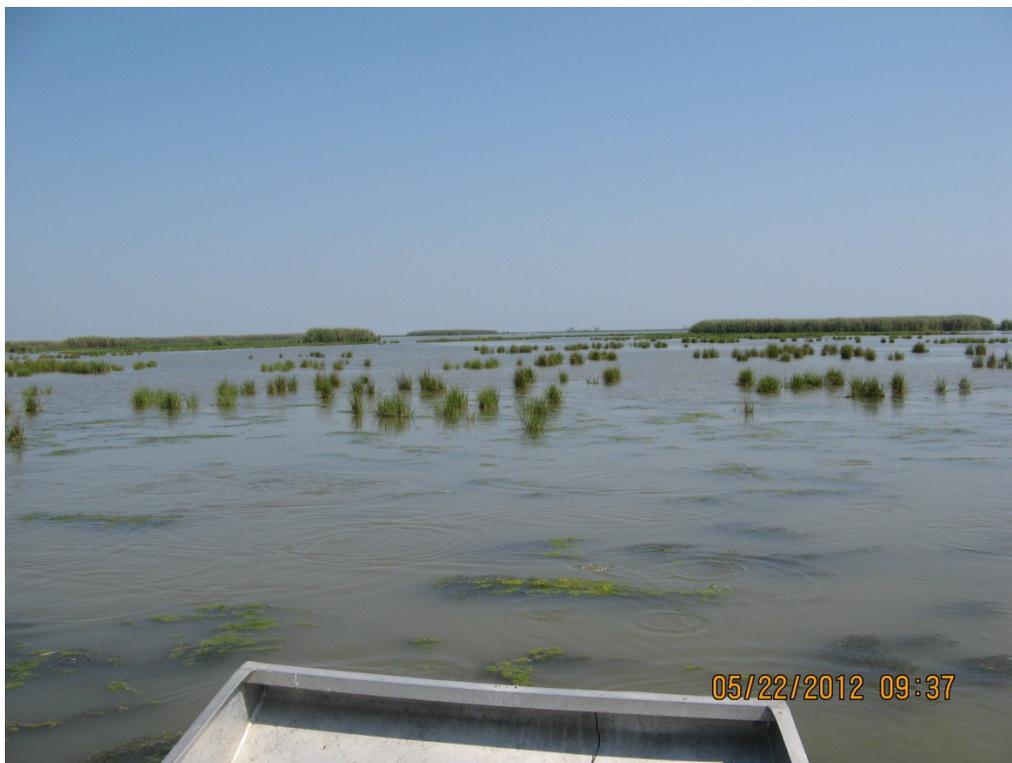
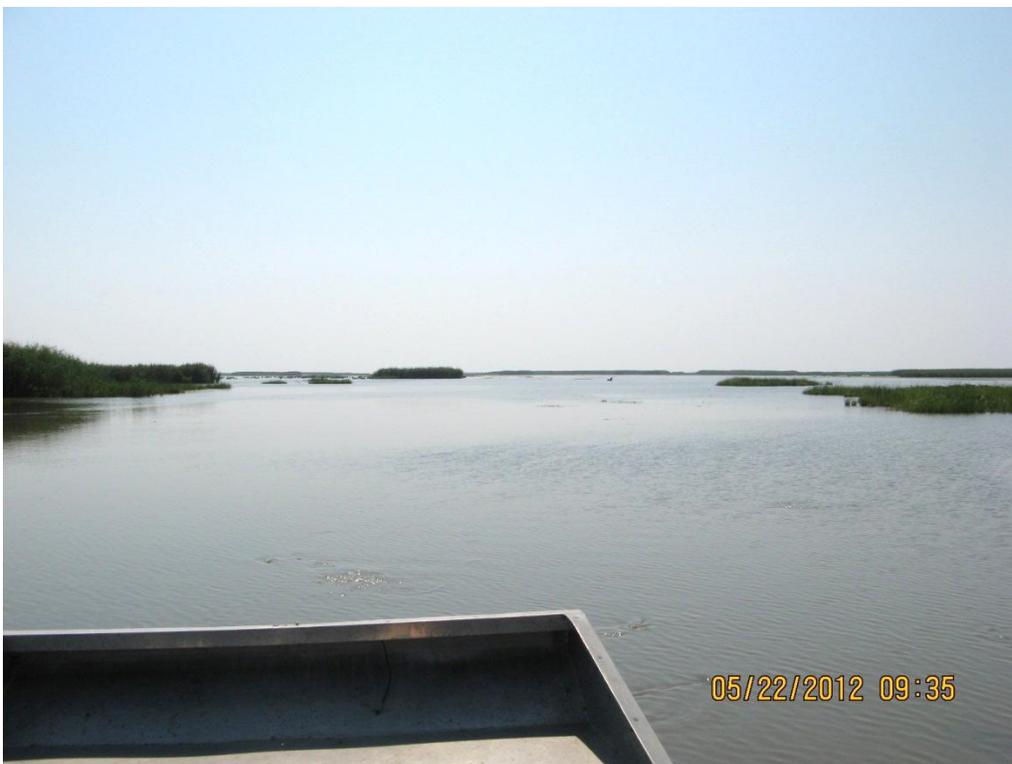
- G. Crevasse No. 2C: The channel has begun infilling, but flow is maintained within the channel. As more sediment gets deposited, grass growth is becoming more visible throughout much of the receiving bay.

**Crevasse 2-C Interior marsh growth**
