## **2013 Annual Inspection Report**

### **Mississippi Sediment Delivery System – Bayou Dupont**

State Project Number BA-39  
Priority Project List 12

July, 2013  
Jefferson Parish &  
Plaquemines Parish

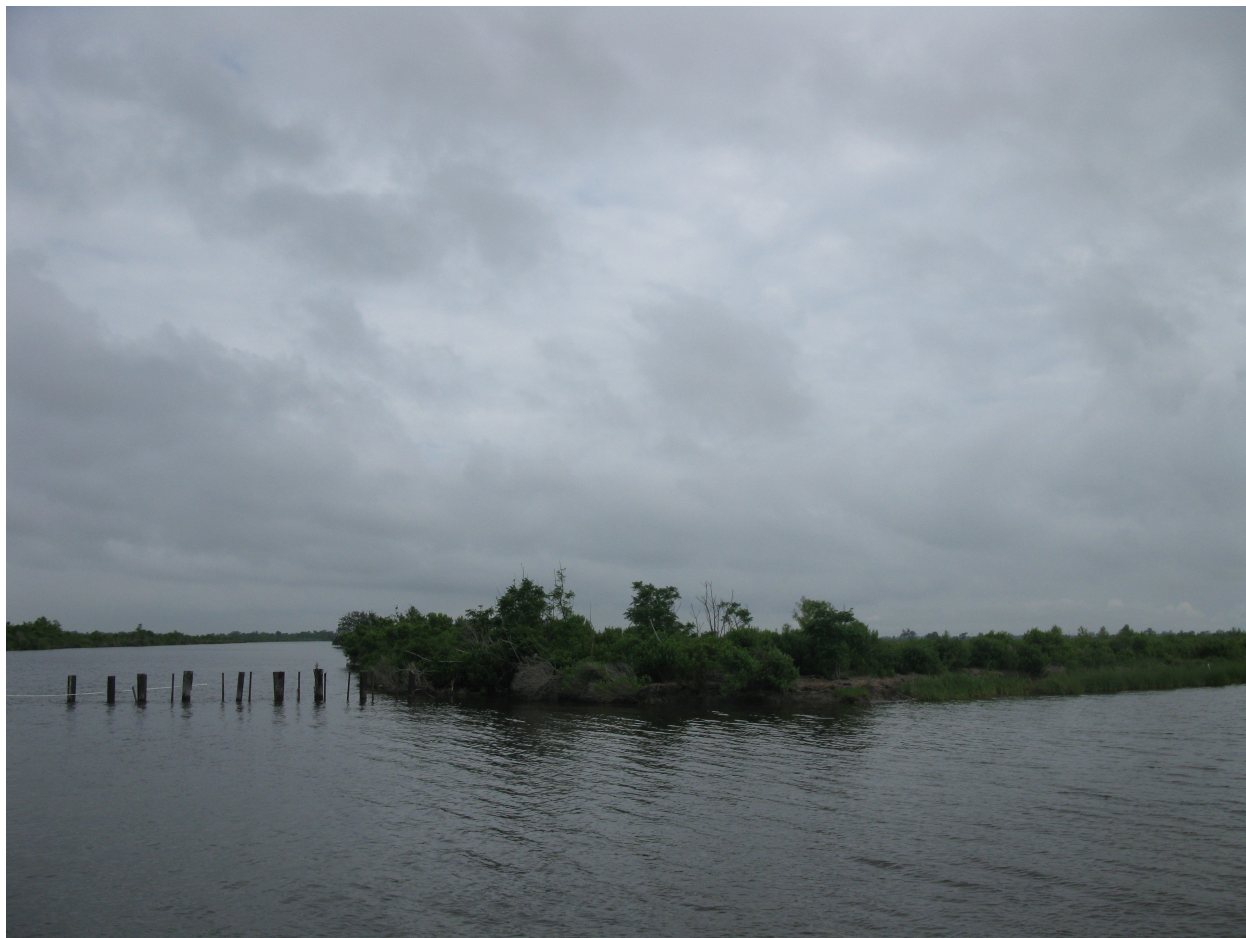
**Photo #1 – South Containment Dike Marsh Creation Area 2  
at junction with canal looking northeast**

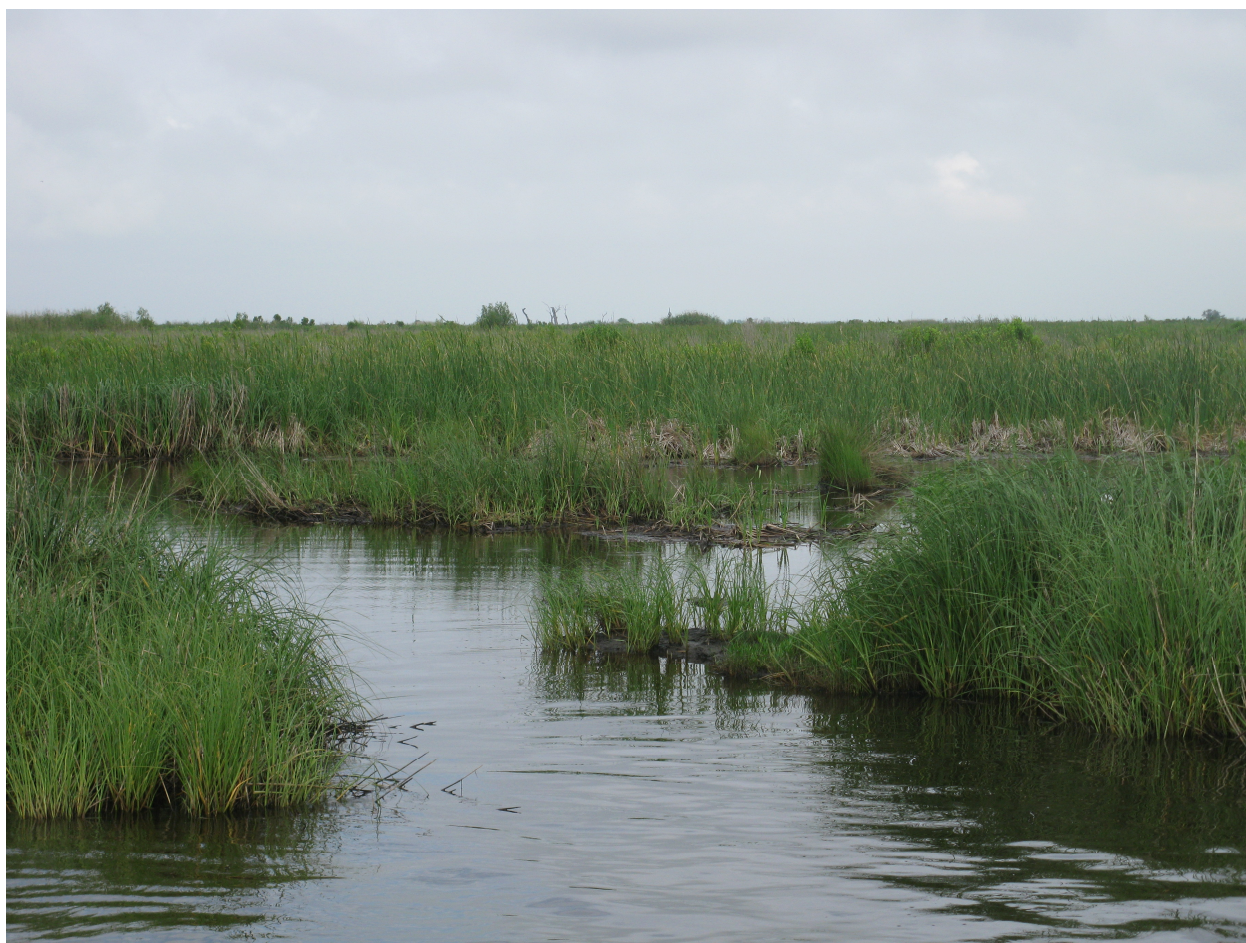
**Photo # 2 – Containment Dike Gap - Marsh Creation Area 2**

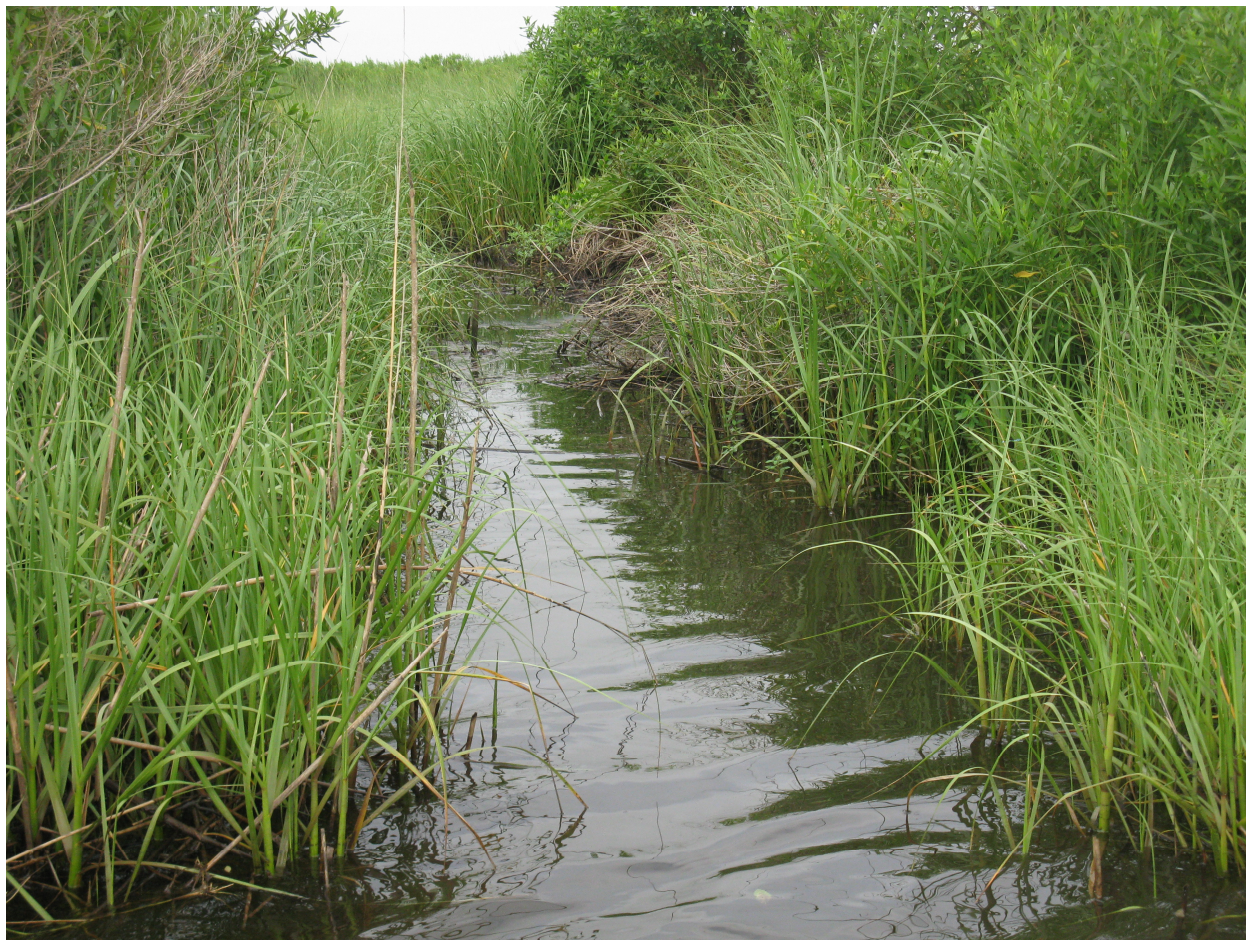
**Photo # 3 – Containment Dike Gap - Marsh Creation Area 1**

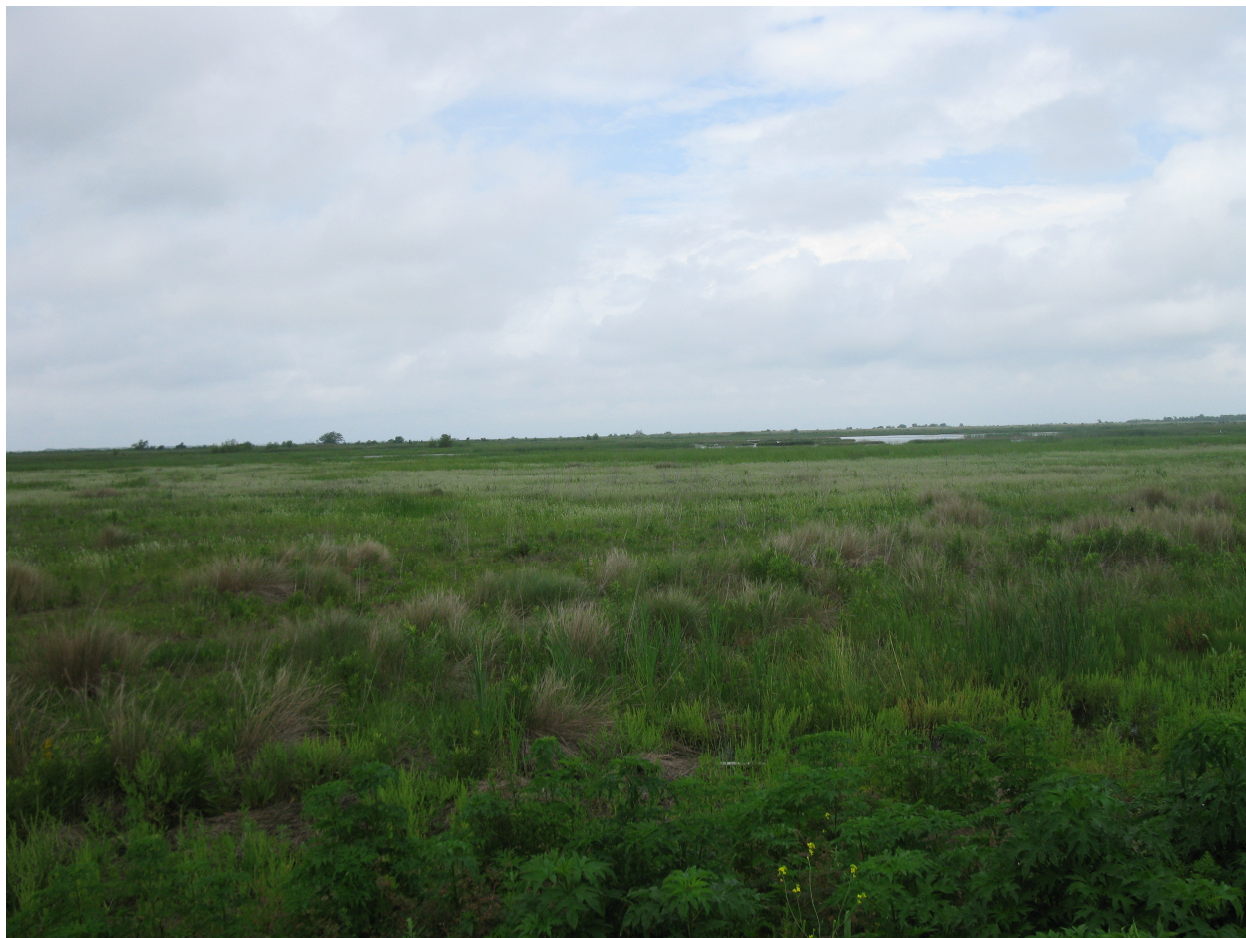
**Photo # 4 – Marsh Creation Area 2 Looking West from back levee**
