**State of Louisiana
Coastal Protection and Restoration Authority
Operations Division**

2014 Annual Inspection Report

Barataria Bay Waterway East Shoreline Protection

State Project Number BA-26
Priority Project List 6

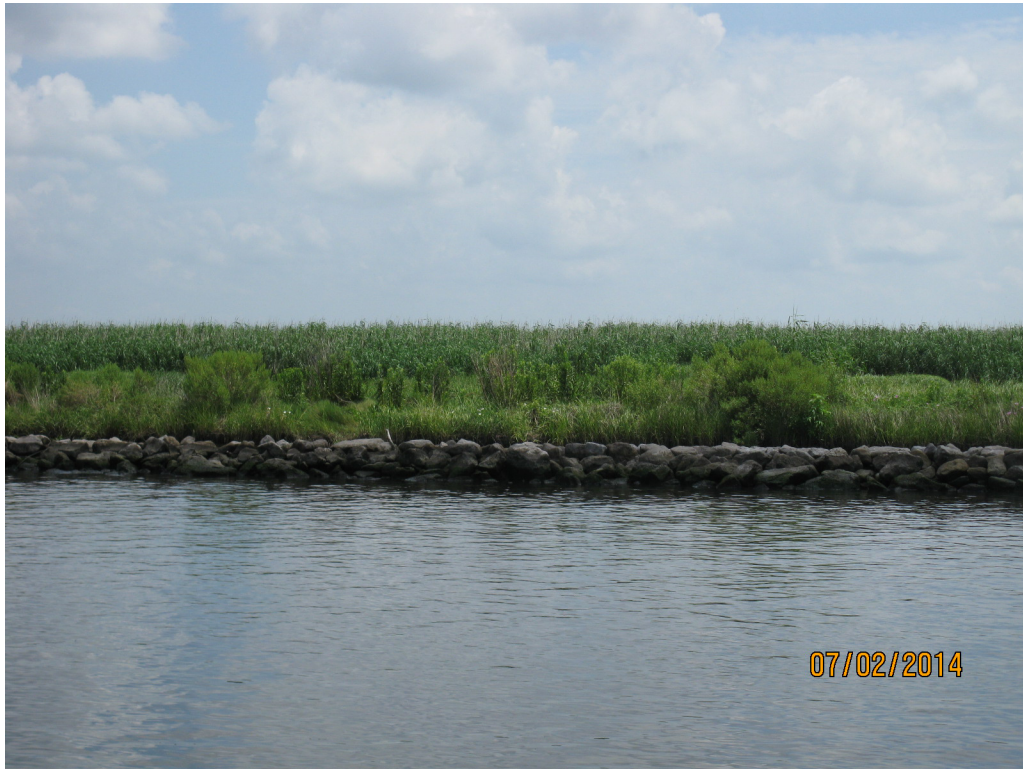
The overall condition of the rock shoreline protection structure was good (Photo #1). Some settlement was observed south of the marsh creation portion of the South Shore of the Pen Project (BA-41, Photo #2). A small gap in the rock structure was noted at approximate coordinates N29.61380°, W 090.07905°. This gap is probably the result of vandalism and should be monitored (Photo #3). Some accretion and vegetation was observed behind the rock structure at the north end of the project (Photo #4).

Photo #1 – Shoreline Protection

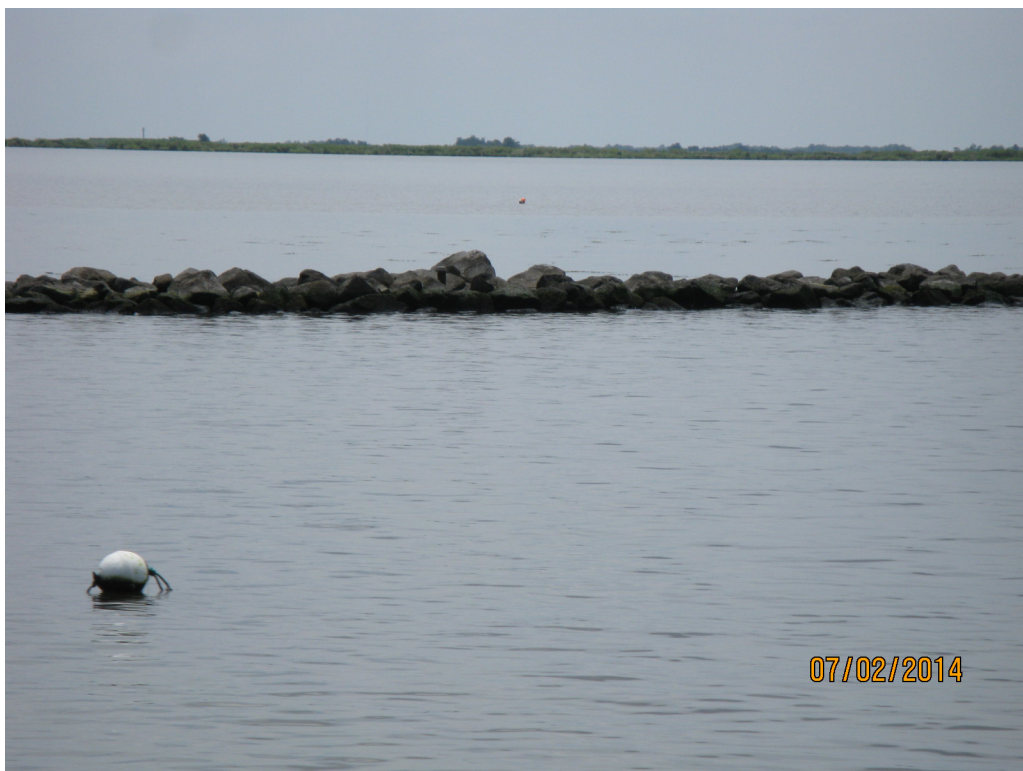
The Barataria Bay Waterway East Protection Project (BA-26) is performing as intended. The rock dike is protecting the existing marsh as designed. Some settlement has been observed and will continue to be monitored; however, the structure should perform adequately through the next programmed maintenance lift.

Photo # 2 – Slight Settlement Noted

- Continue to monitor the settlement of the rock structure.

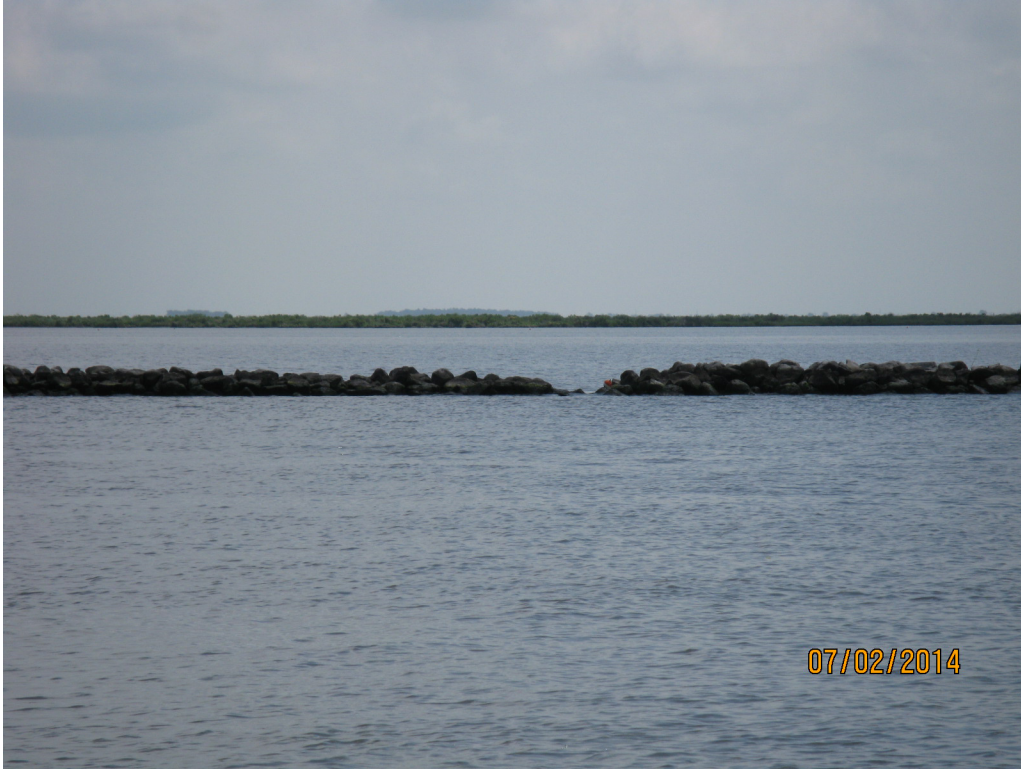
Photo # 3 – Gap in Structure

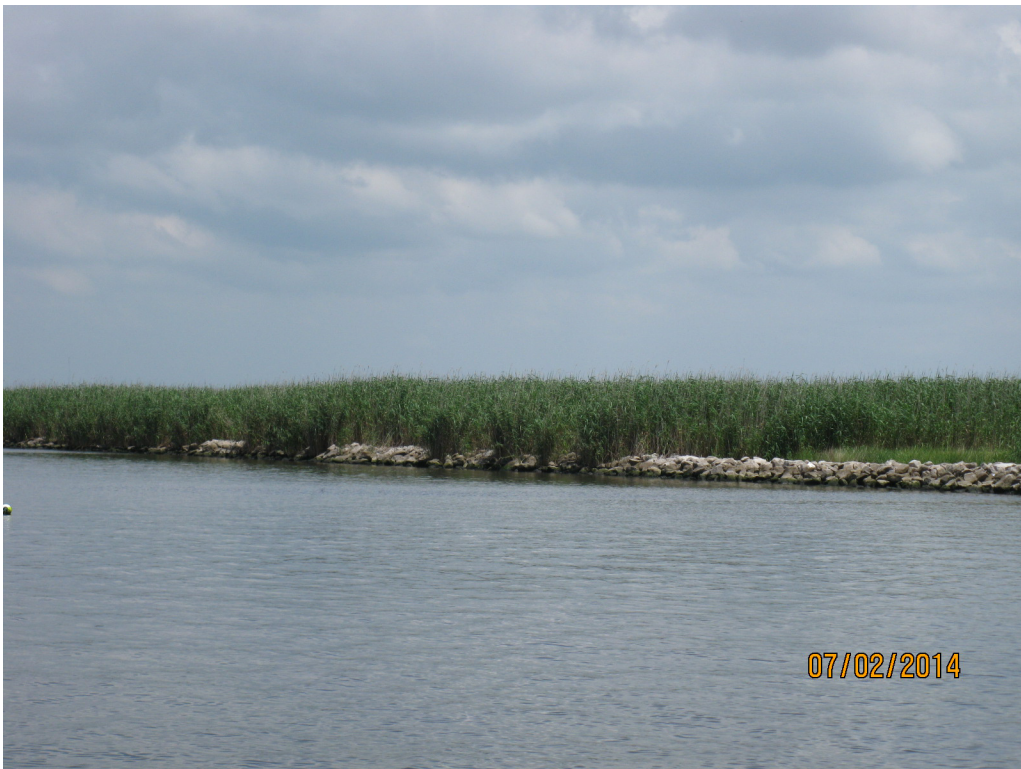
Photo # 4 – Accretion & Vegetation
