**State of Louisiana
Office of Coastal Protection and
Restoration
Operations Division**

2014 Annual Inspection Report

**CAERNARVON OUTFALL
MANAGEMENT
(BS-03a)**

State Project Number BS-03a
Priority Project List 2

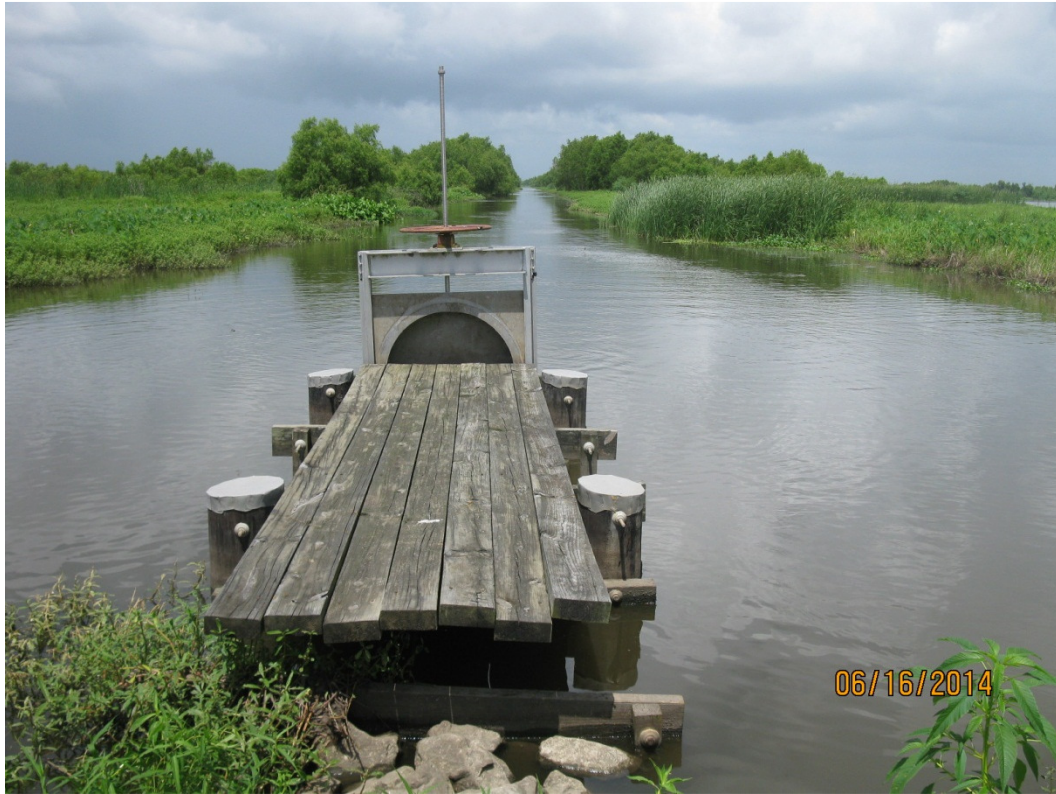
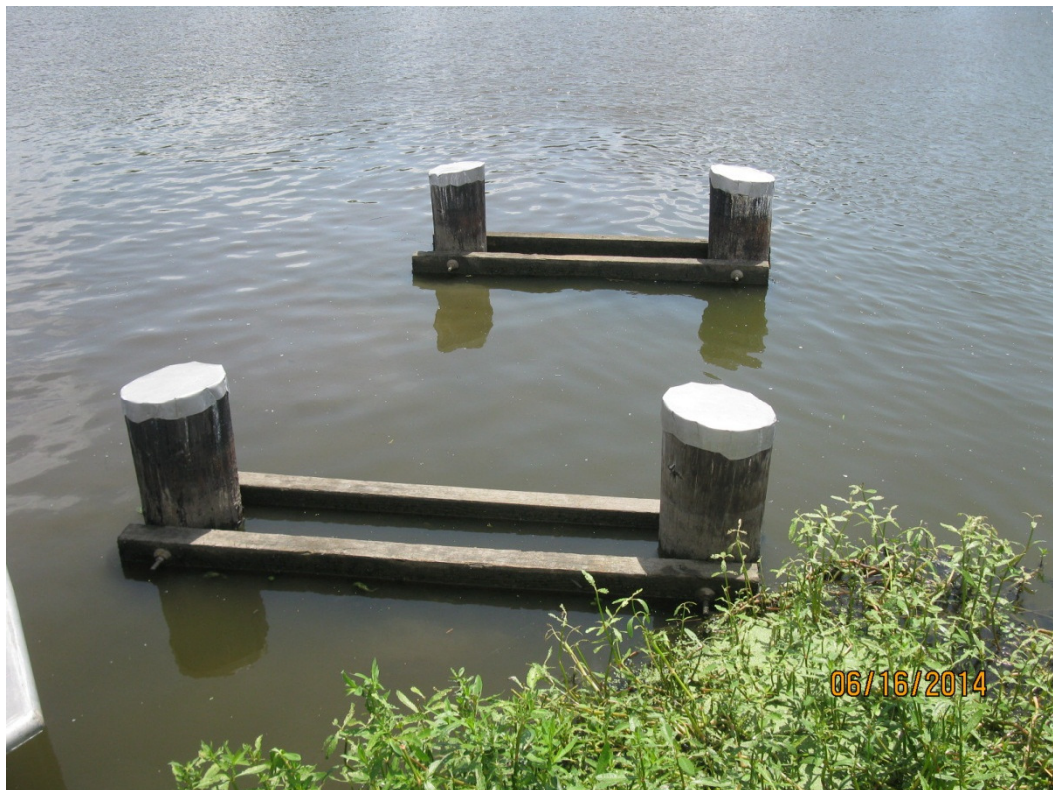
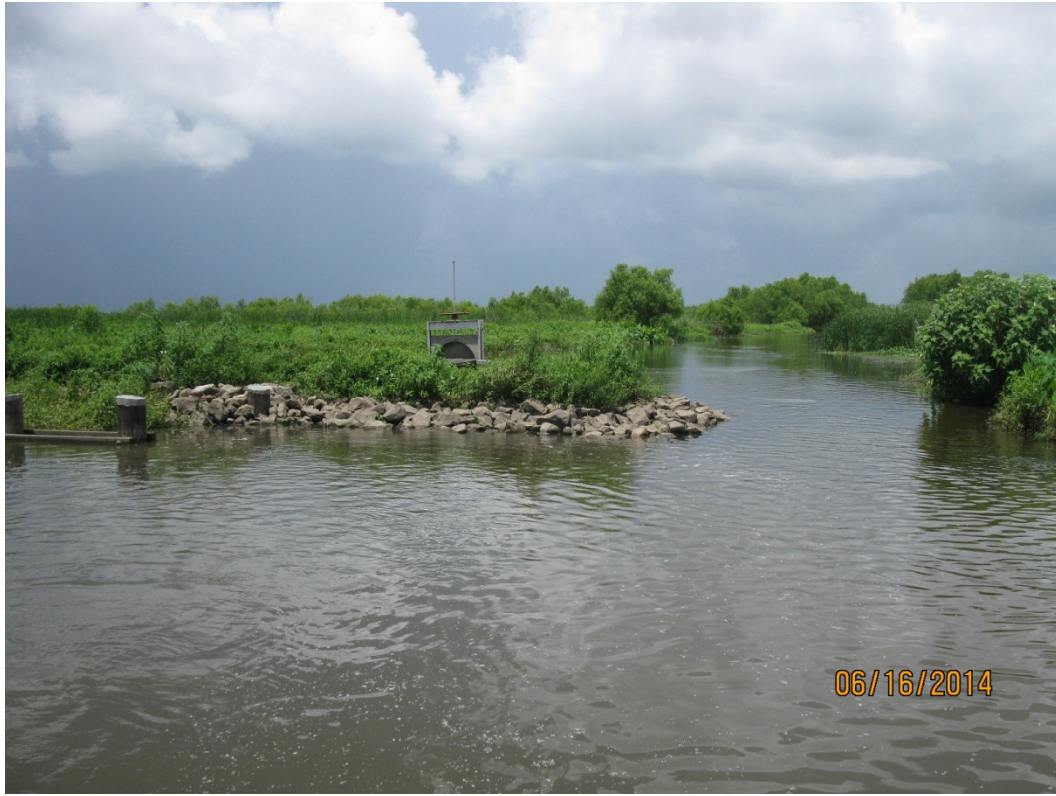
- A. Site/Structure # 13** – On the north end of the rock dike, there is a gap which is allowing water to flow freely into and out of that sector. The combination gate was in the up/open operating position to allow maximum uninterrupted tidal exchange into the marsh. The gate has a slight tilt, but it is not affecting the function. The timber walkway still lays separated from its support beam at one end. (See Photo 1, 2 & 3)

It is recommended to fill the gaps noted along Bayou Mandeville adjacent to structure #13 and structure #50 as these gaps allow flow that does enter the marsh south of Big Mar to short-circuit back to Bayou Mandeville where the vast majority of diversion flow is already going. From past experiences regarding spoil bank repairs at the site, light weight rip rap is subject to vandalism in which unauthorized persons move rocks to clear a passage for navigation and earthen repairs tend to wash away when subjected to higher diversion flows, at least until they are well vegetated with

deep-rooted flora. Therefore, it is recommended that these gaps be closed with a larger class of rip rap that cannot be easily moved without specialized equipment.

Another recommendation is to repair the decks at structures #13 and #50. The deck at structure #13 is not attached to the supports at one end, and the deck at structure #50 is bowed.

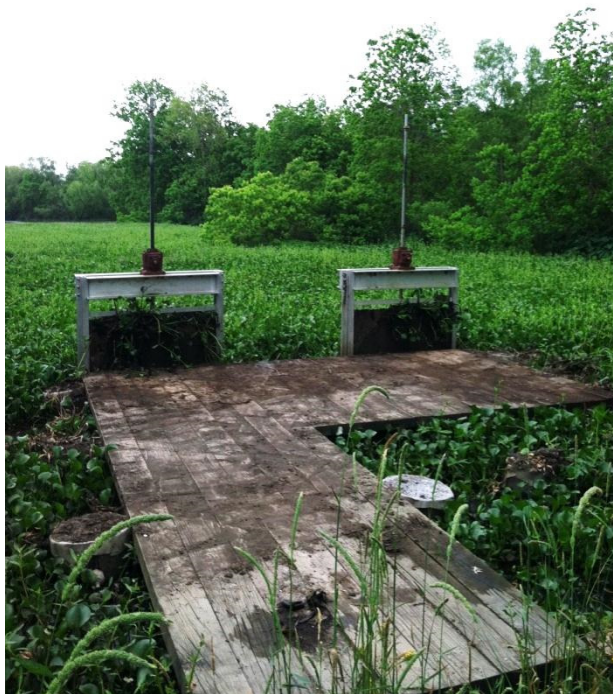
Photo No. 4, Site 25 (pre-Isaac 2012)

- B. Site/Structure # 25** – The inspection team did not attempt to inspect this feature due to inaccessibility at the time of the inspection. (Pre-Isaac 2012 Photo 4)

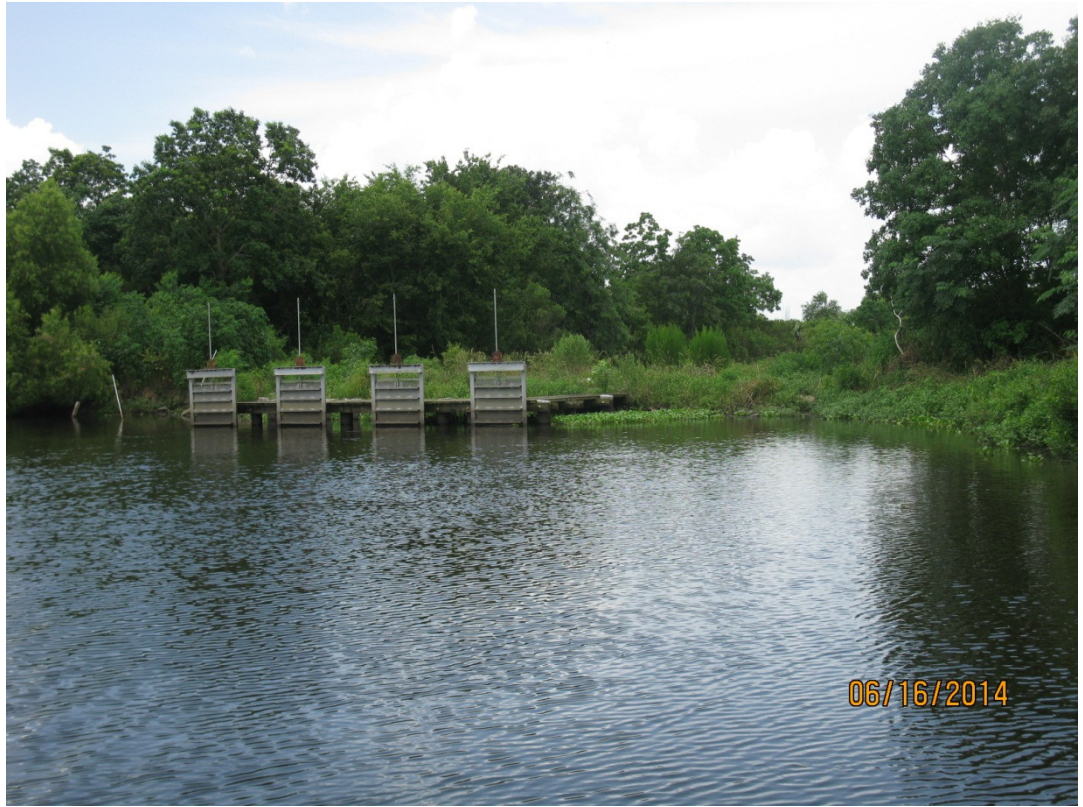
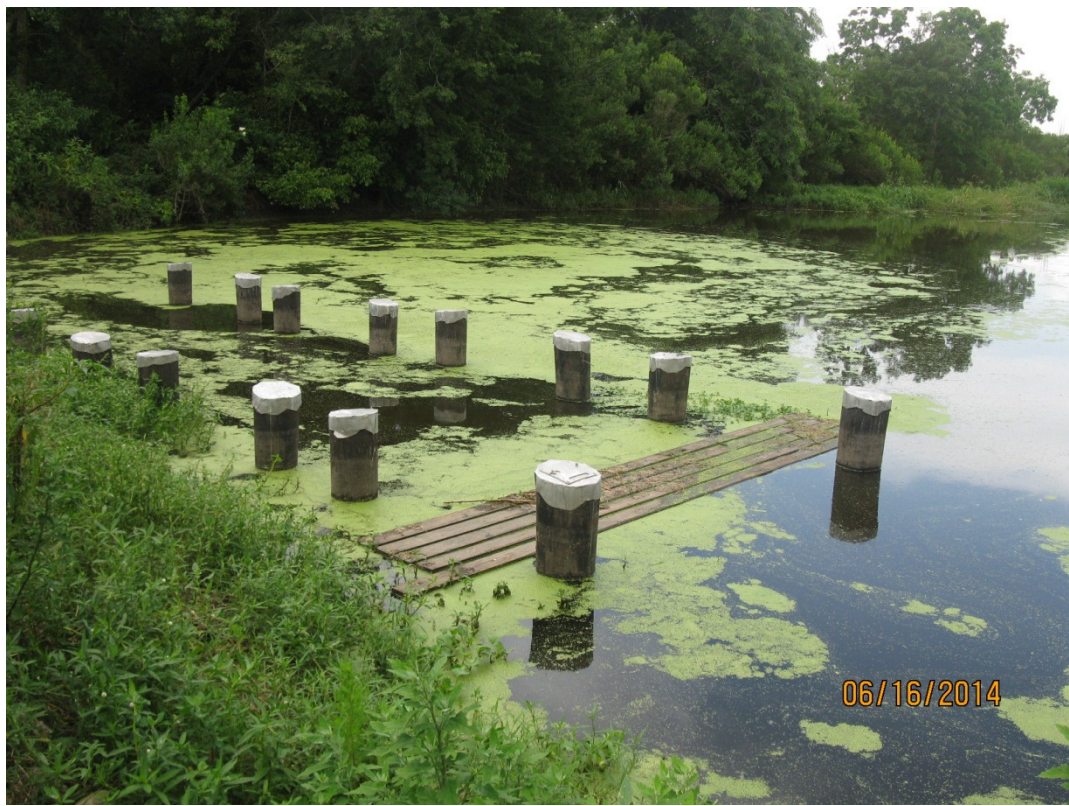
- C. Site/Structure # 26** – The gates were in the open position allowing water flow. There is thick vegetation covering the earthen/rock closure. The flow meter at this site was damaged during Isaac in September 2012, and was subsequently removed based on the decision to discontinue flow monitoring at this structure. The structure and outfall channel appeared to be in good condition. (See Photos 5 & 6)

In 2012, the flow meter at structure #26 was removed after the sensor was damaged. The decision was made to discontinue the flow monitoring at this site rather than to replace the damaged instrument.

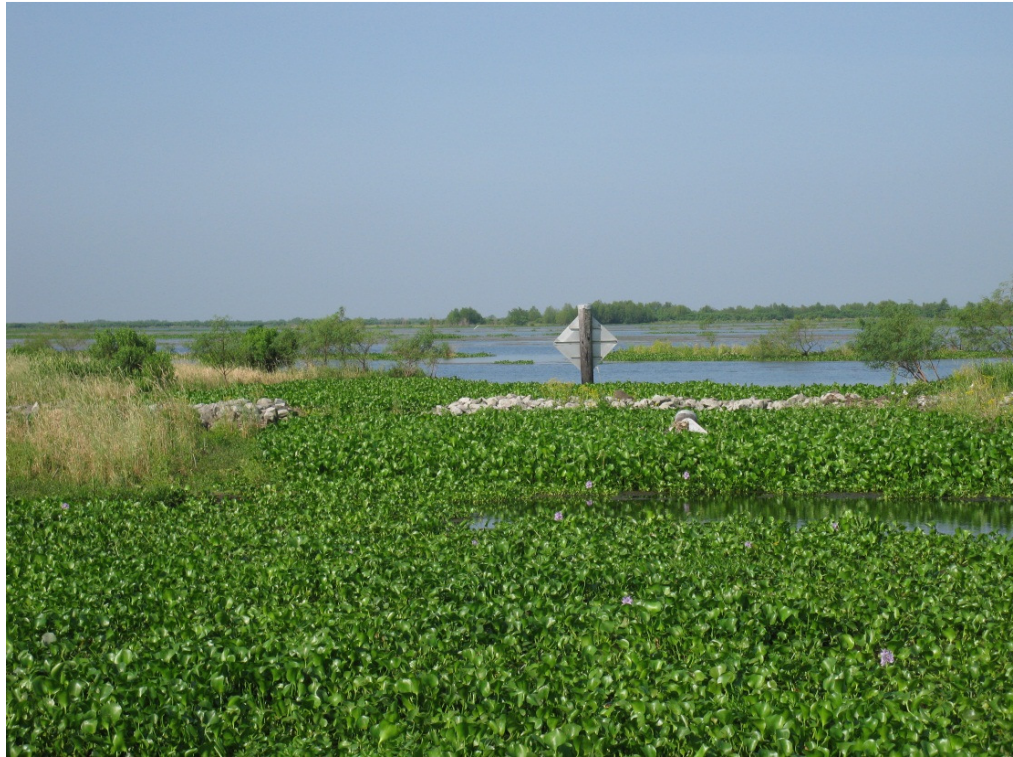
Photo No. 7, Site 32 (2012 pre-Isaac)

- D. Site/Structure # 32** – The team did not inspect this feature because the depth of Lake Lery was too shallow for the boat to pass. Hurricane Katrina devastated that portion of the lake rim rendering this structure ineffective. (Photo 7)

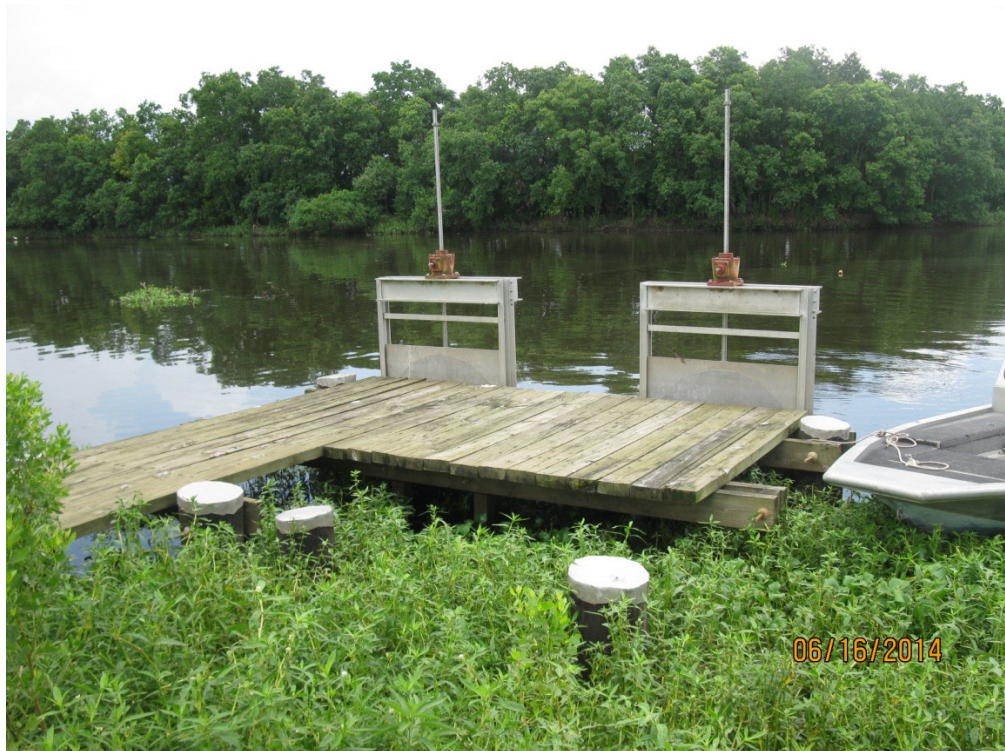
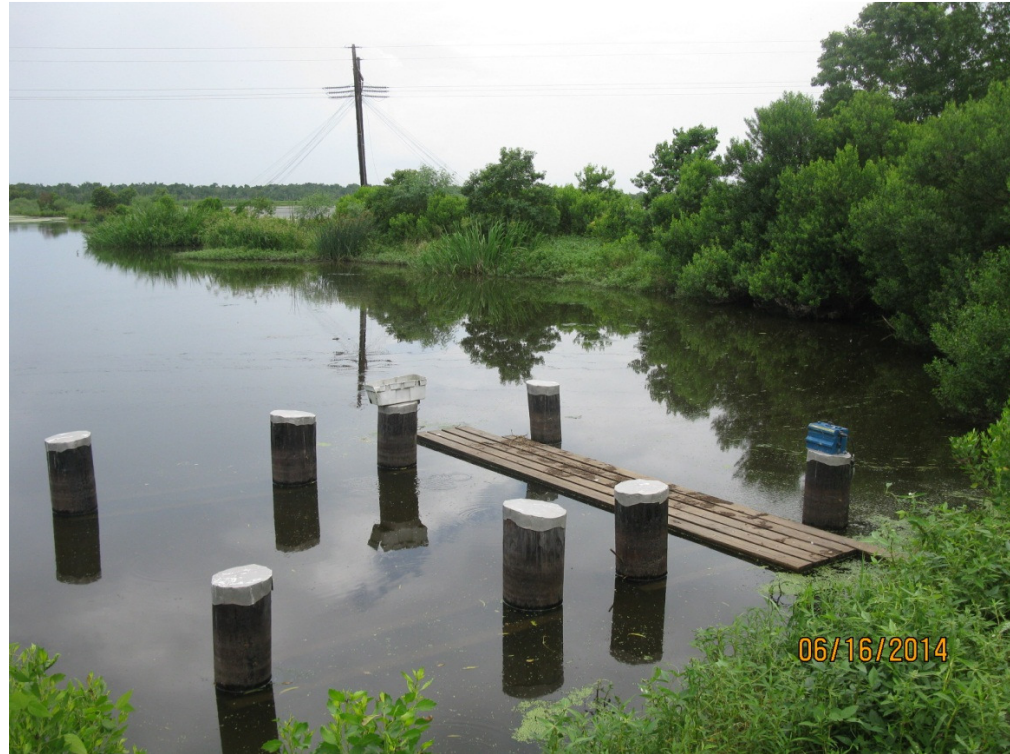
- E. Site/ Structure # 40** – The gates remain in the open position. The structure and outfall channel are in good condition. (See Photos 8 & 9, flow meter site)

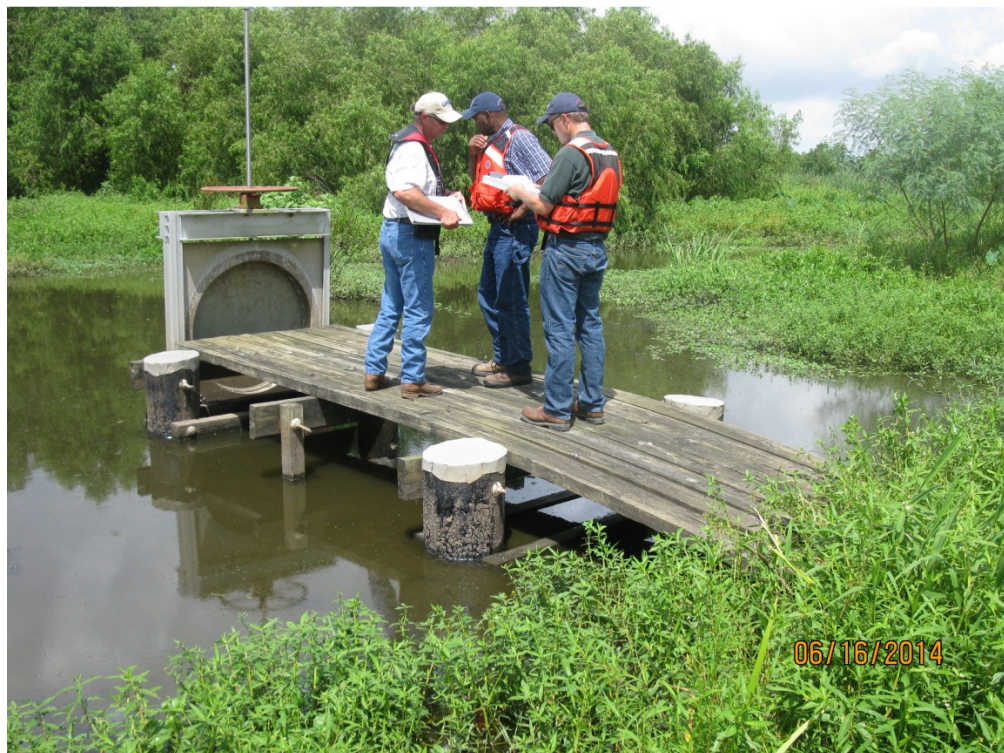
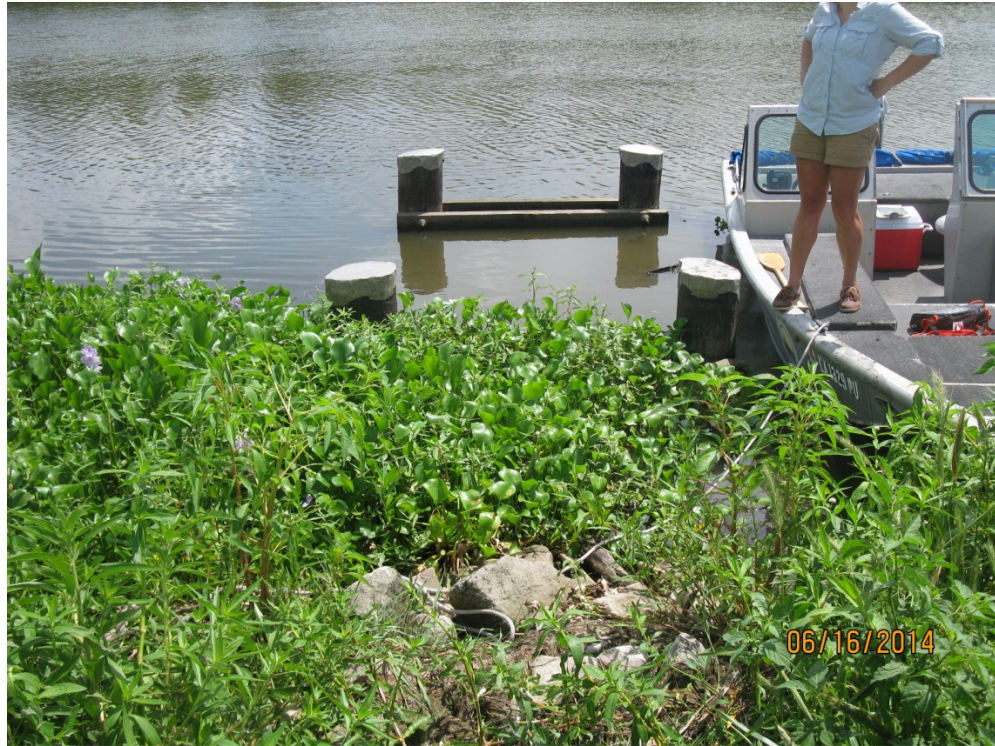
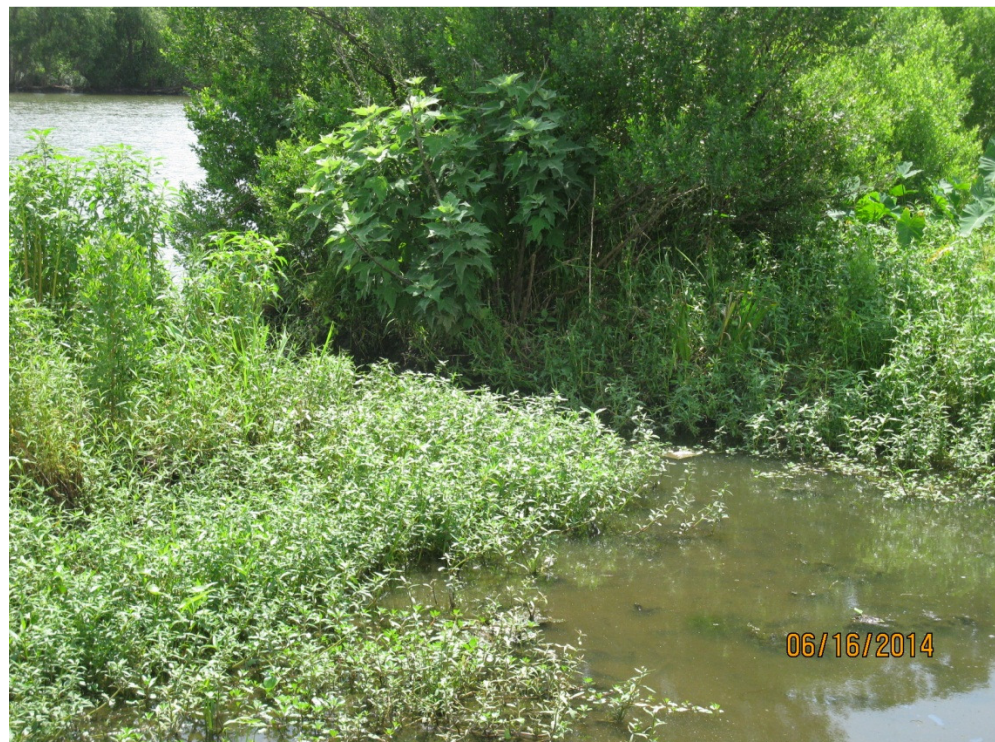
- F. Site/Structure # 50** – The combination gate was in the up/open position. Water was observed flowing around the structure at the tie-in to the south. During the 2013 inspection when the water surface was at the crest of the structure and the diversion flow was 717 cfs, water was observed flowing around the structure at each tie-in. Although no water was observed flowing around the structure tie-in to the north during the 2014 inspection, that may be due to the extremely low water level and lack of diversion flow. The timber walkway remains bowed. (See Photos 10, 11 & 12)

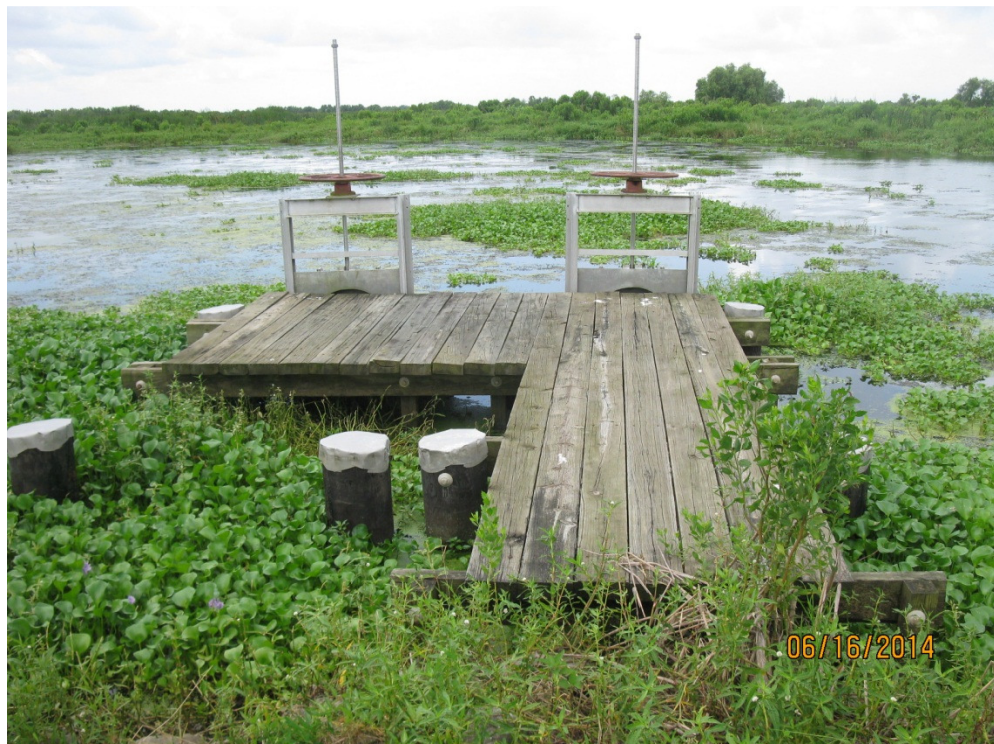
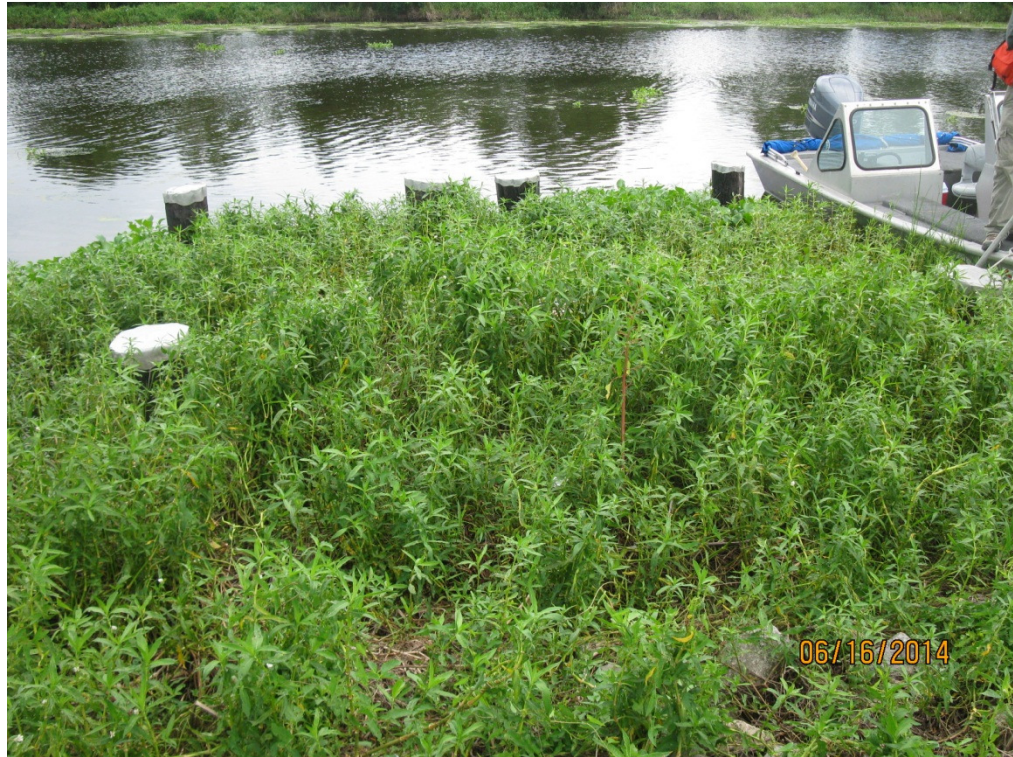
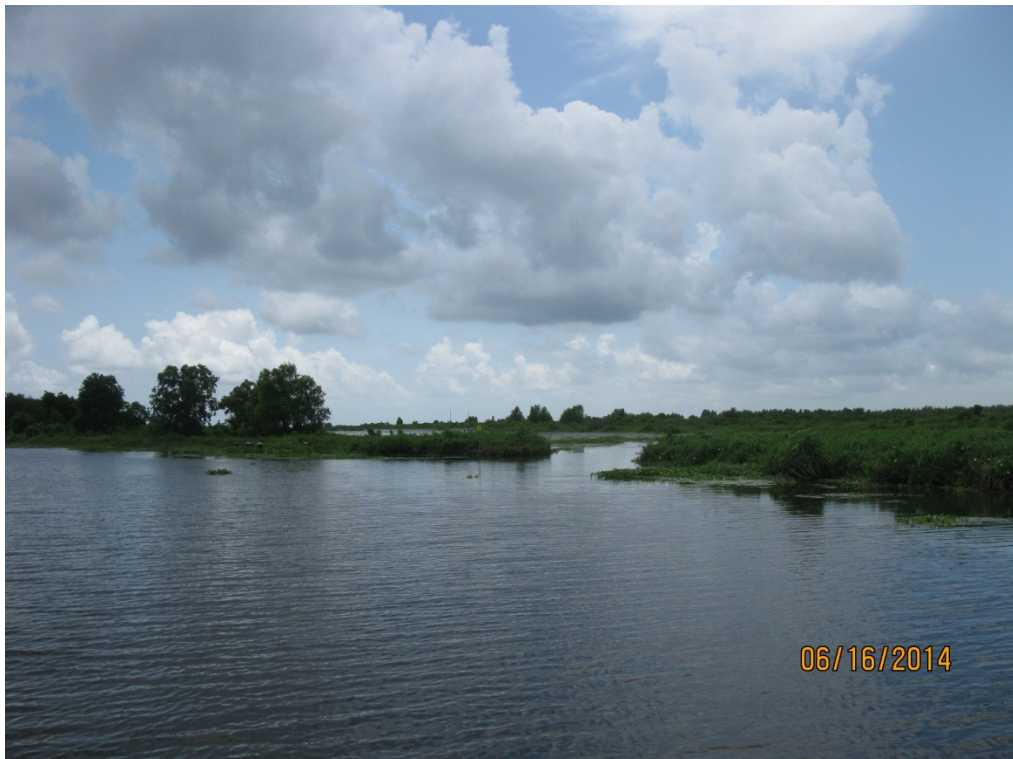
- G. Site/Structure #52** – The two combination gates were in the up/open position. The breach previously repaired by the dredging contractor has been re-opened and is between 10-15 feet in

width. The breach is allowing unimpeded flow between the channel and marsh. (Photos 14, 15 & 16)

In addition to the gaps at structure #13 and structure #50, there is also a gap adjacent to structure #52 and a low area by structure #60. A thorough investigation of the spoil bank along the D.P. Canal and the Reggio Canal should be conducted to determine if there are other gaps that may render repairs at #52 and #60 ineffective. Since the outfall project was designed to be effective at diversion flow of 2,000 cfs or less, it is recommended that such the spoil bank inspections be conducted during a period of approximately 2,000 cfs of diversion flow.

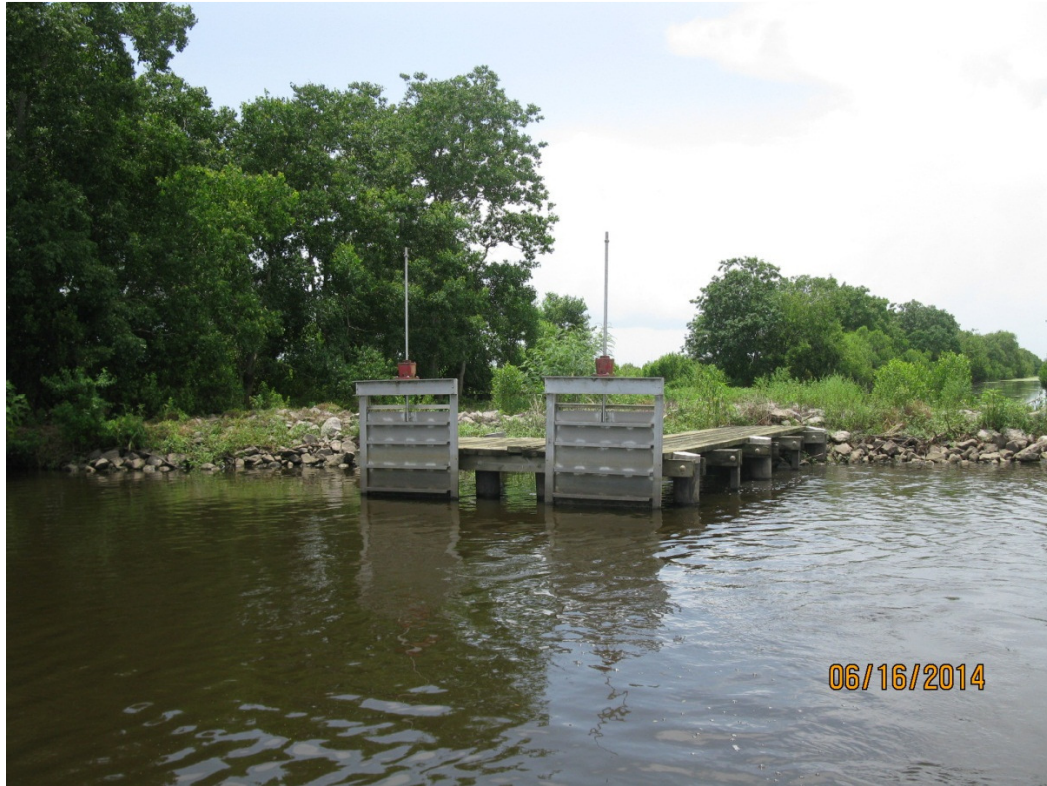
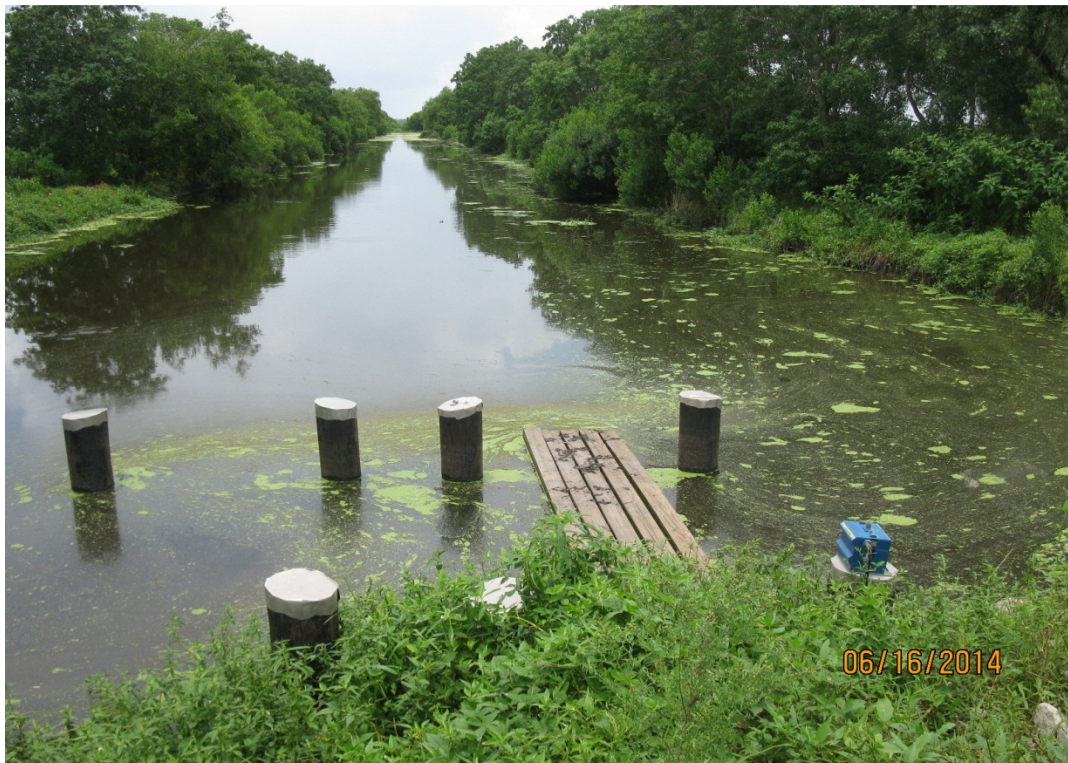
- H. Site/Structure # 54** – The gates remain in the open position. No flow was visible through the culverts. (Photos 17 & 18, flow meter site)
- I. Site/ Structure # 56** – Although the water level was lower than the rock dike crest, the water was observed to overtop the rock during the 2013 inspection with a diversion flow of 717 cfs and a marsh gage reading of +1.76 feet NGVD. Vegetation remains on the entire rock closure. Soon after construction, the middle section of the plug subsided approximately 0.5 feet more than the sides. One warning sign is still leaning severely and is partially submerged (Hurricane Katrina damage). (Photo 19)

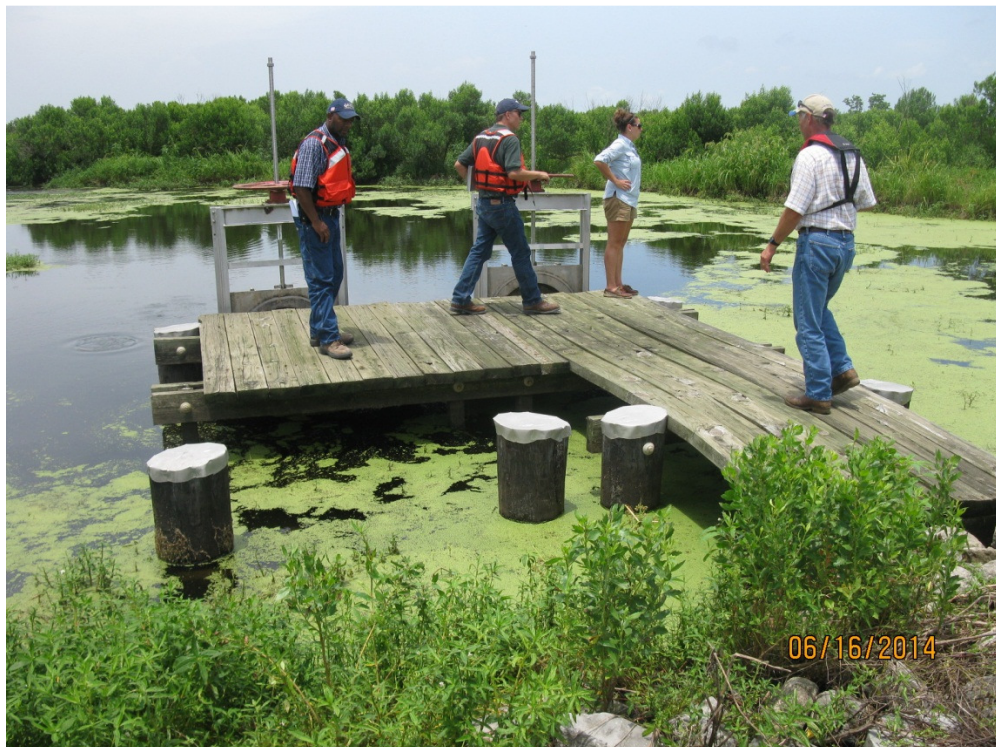
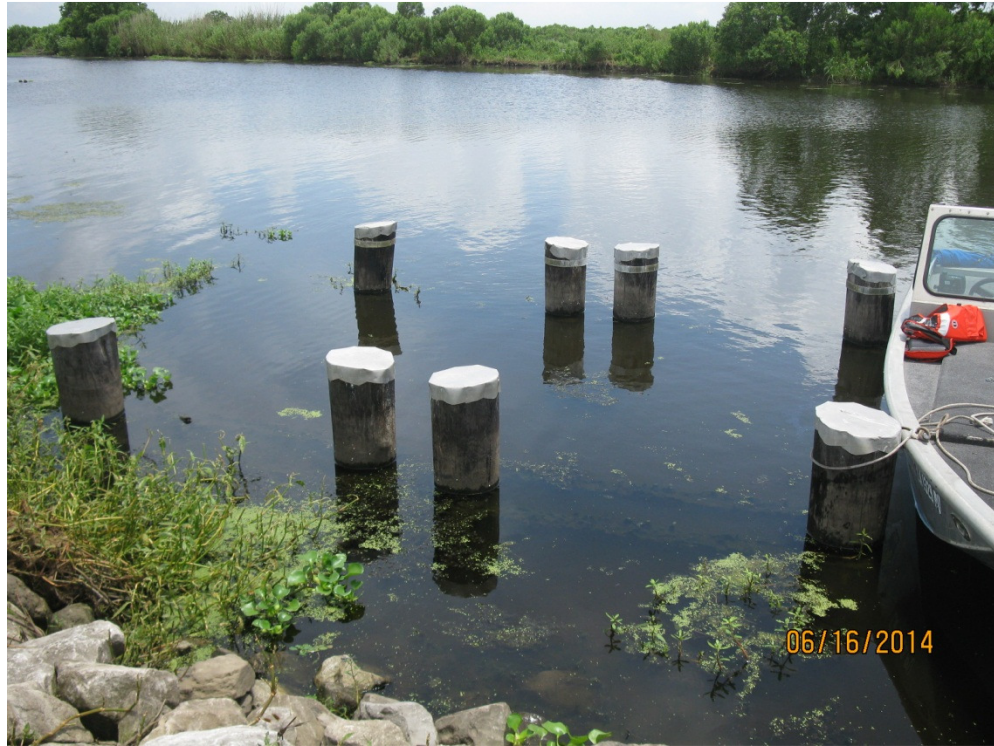
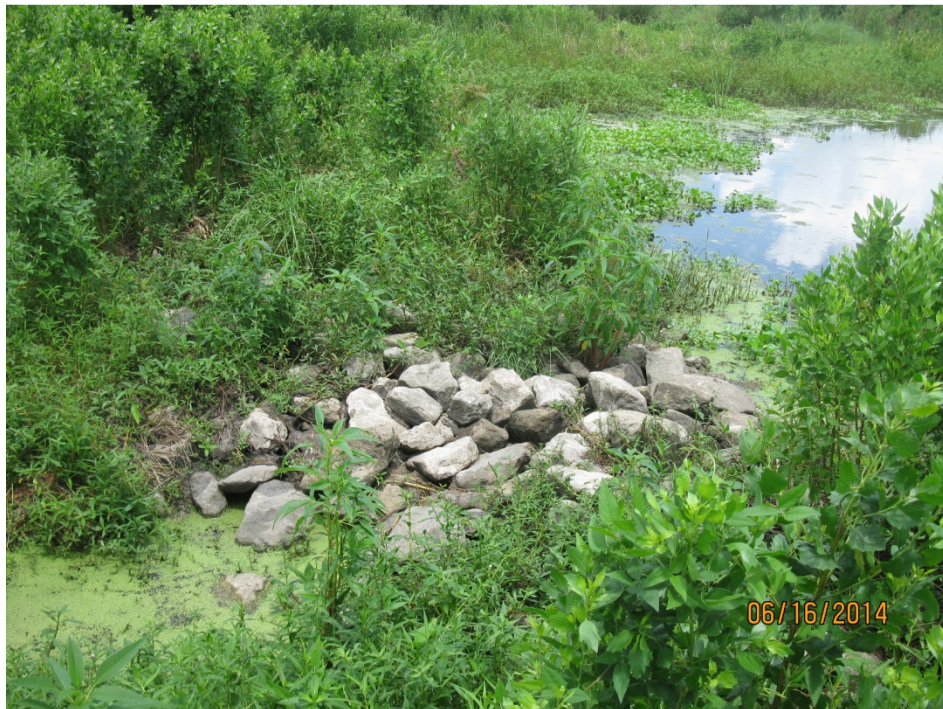
- L. Site/Structure # 60** – The two combination gates were in the up/open position. The overall condition of the structure is good. There is a low area of the rock adjacent to the structure that water flows over at higher marsh water levels. (Photos 20, 21 & 22)
