**State of Louisiana
Coastal Protection and Restoration Authority
Operations Division**

2014 Annual Inspection Report

Fritchie Marsh Restoration

State Project Number PO-06
Priority Project List 2

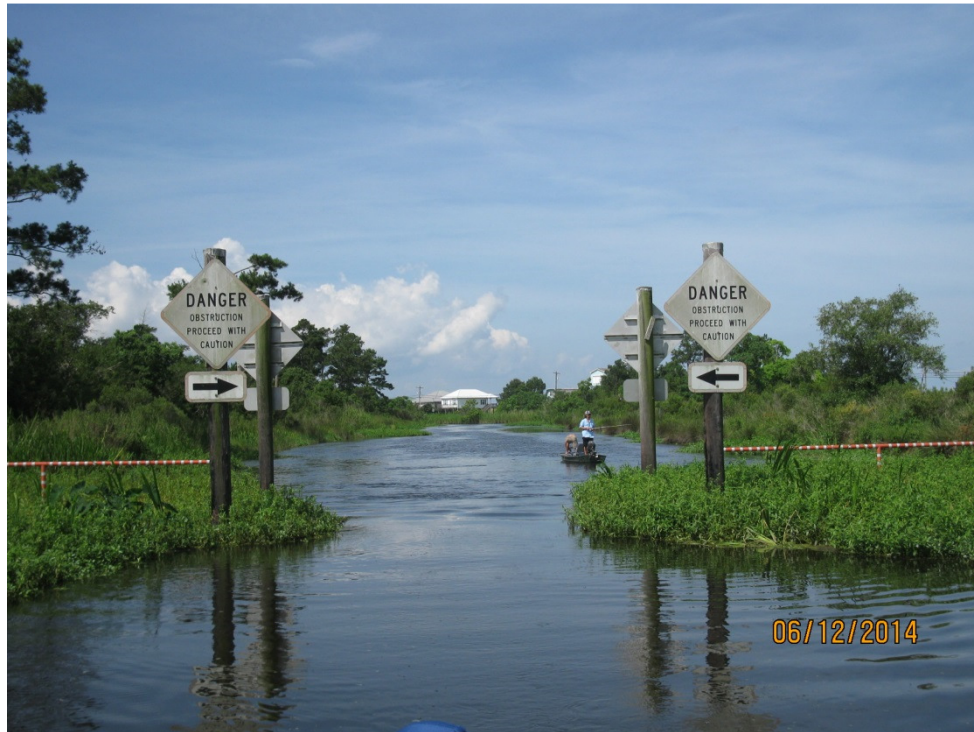
Photo 1: W-14 Weir

There was no visible damage to the weir structure or handrails. The warning signs exhibited some fading from continuous sunlight exposure, but were still legible. The weir structure was operating as designed.

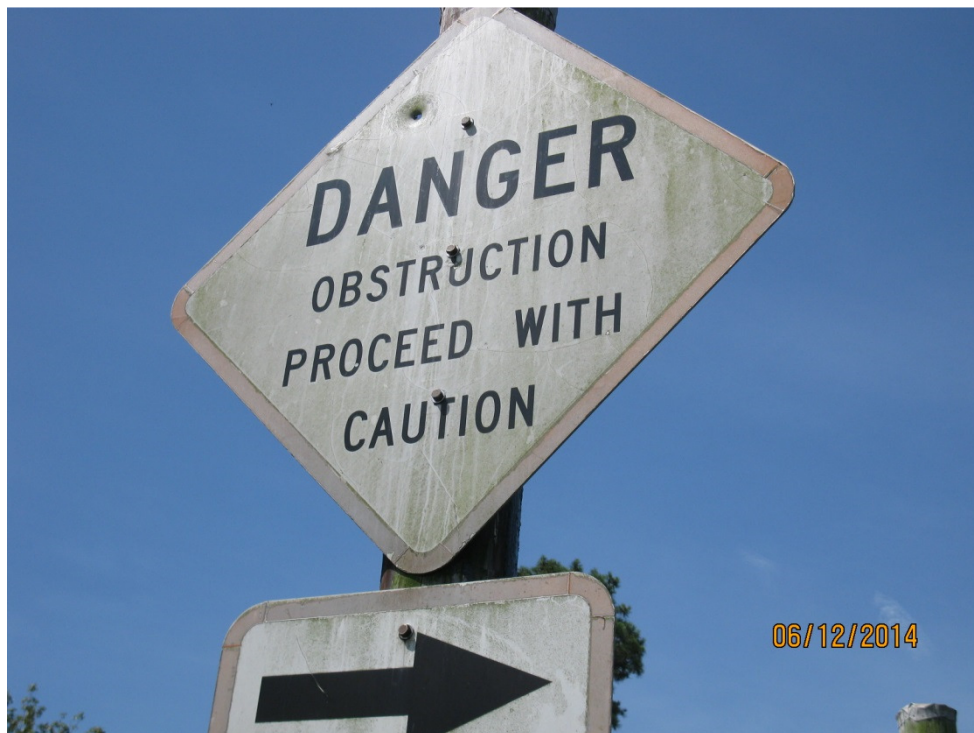
Photo 2: Warning Sign at W-14 Weir

Item	Condition	Physical Damage	Corrosion	Photo #	Observations and Remarks
Steel Bulkhead / Caps	Good	None	None	8	Good condition.
Handrails, Grating, Hardware, etc.	Good	None	None	3	Vegetation surrounding railings, overall condition is good.
Signage, Supports	See Remarks	See Remarks	None	1, 2	Wood support piles are in good condition. Signage and angle braces appear structurally sound. Large-caliber bullet hole in one sign. Reflective finish is faded but signs are legible.
Rock RipRap channel lining	Good	None	None	6	Good condition. Rip-rap covered by concrete debris on South bank.
W-14 Weir structure	Good	None	None	1	Submerged; flow visible.
W-14 diversion channel dredge	Good	N/A	None	4	Emergent vegetation in outfall.
Salt Bayou dredging	See Remarks	N/A	None	7	Boat access not possible. Inspection performed from culverts at Hwy 90. Deadfall in channel, but flow moving well into project area.
72" Diameter culvert	Good	None	None	6	Functioning properly. Structure appears sound.

Continue to inspect the project features for functionality. Repair the warning signs at the W-14 Weir. CPRA will coordinate the sign repair in consultation with NRCS.

- Warning sign repair at W-14 Weir as determined by CPRA and NRCS.

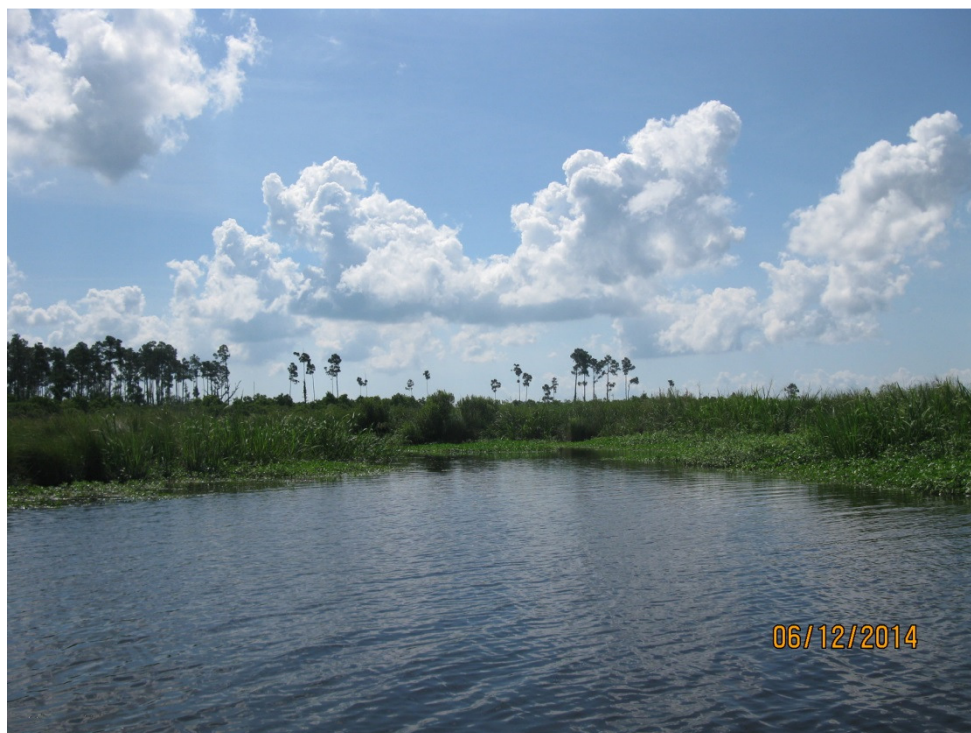
Photo 4: W-14 Diversion Channel

The channel depth was measured to be approximately 4.5 feet and was free of obstructions. A patch of emergent vegetation was visible in the channel outfall. The diversion channel appeared to be functioning as designed.

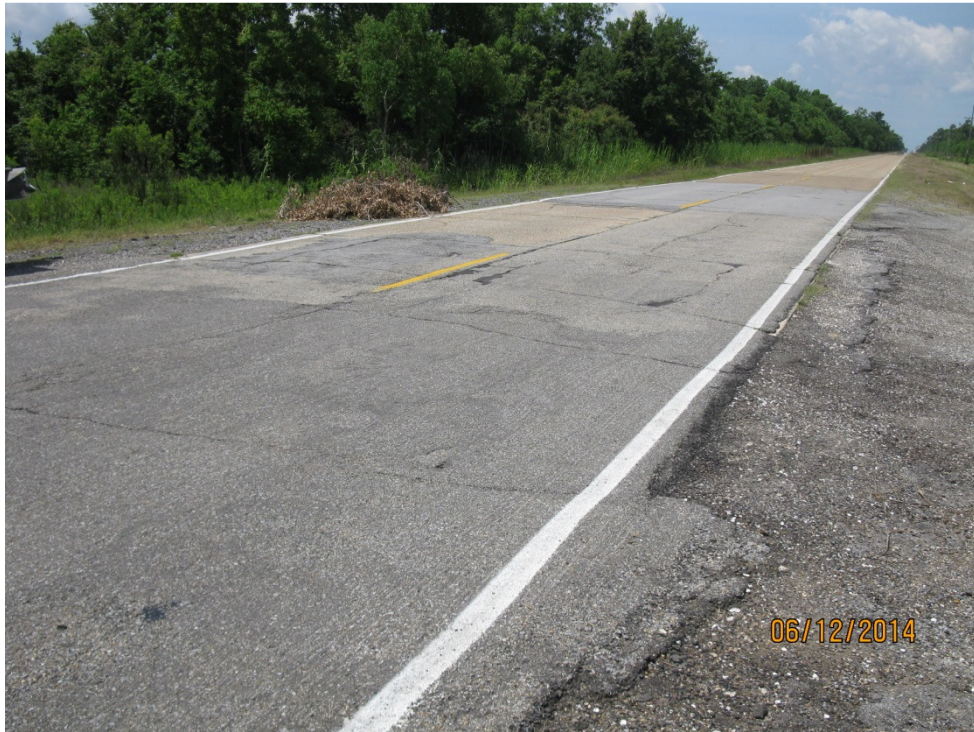
Photo 5: Hwy. 90 Road Surface Above Culverts

HWY 90 road surface	Good	None	None	5	Road surface appeared to be in generally good condition. Some minor cracking; asphalt appeared to have been ground and patched in areas.

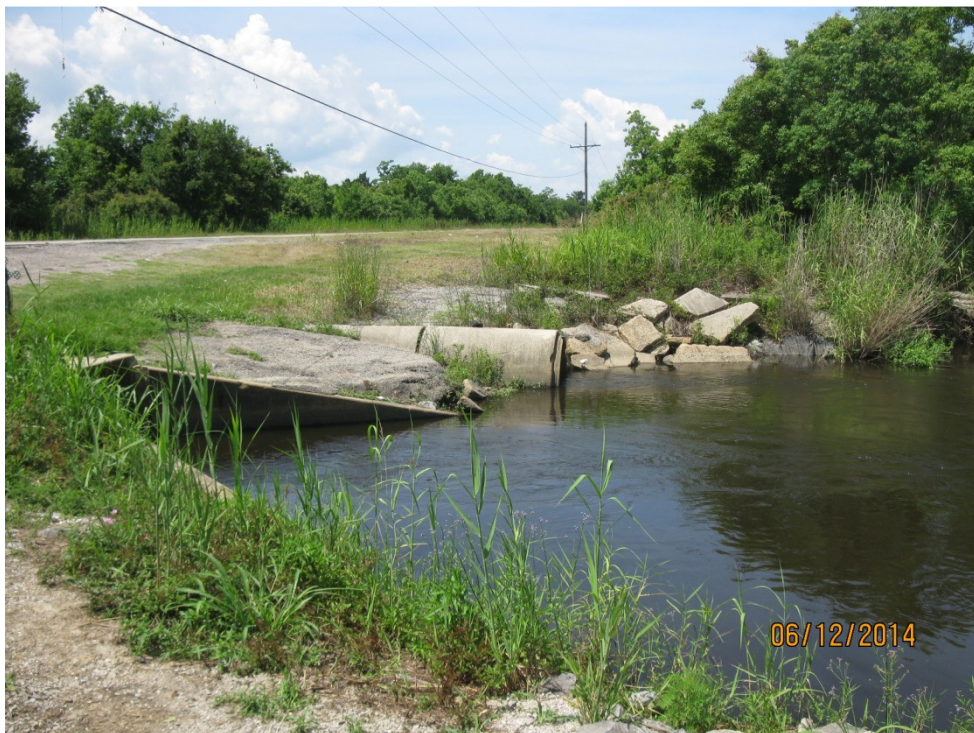
Photo 6: Culverts from Project Side

There is little change in this structure from the previous inspection. The bank scour reported in previous inspections appears to be ongoing, but does not currently pose a threat to the structure. A low area has developed in the north bank of the Salt Bayou channel near the revetment which appears to allow overbank flow of fresh water to directly enter the marsh during high water events. This area deserves continued observation during future inspections.

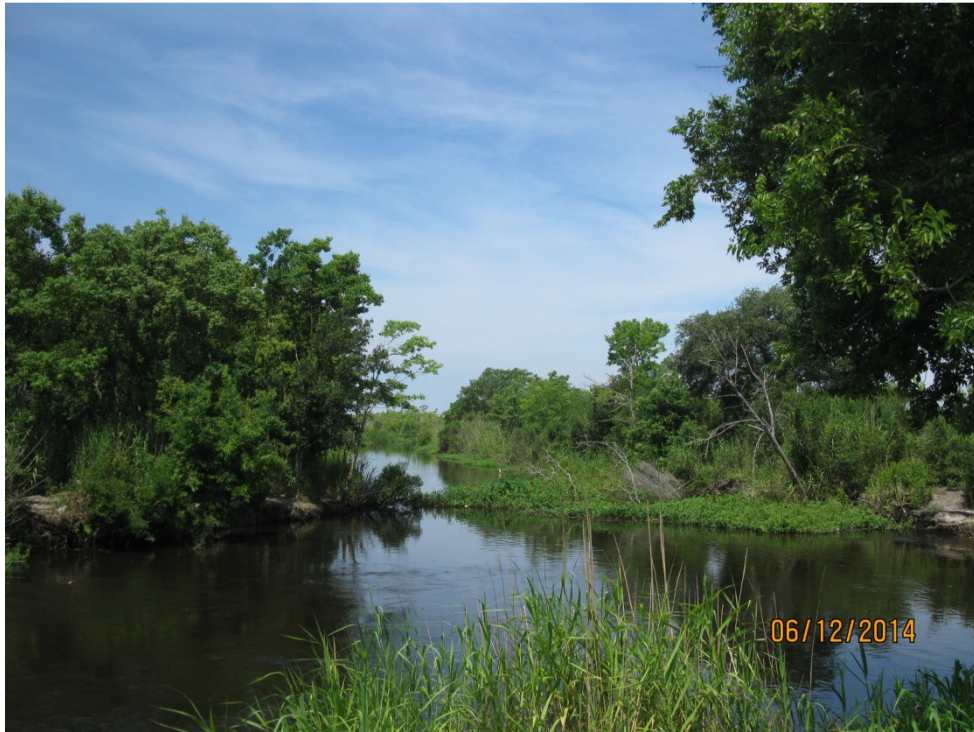
Photo 7: Salt Bayou Flowing into Project Area

Due to steep bank conditions and the presence of numerous fishermen occupying the revetment area, the inspection team was not able to access Salt Bayou by boat. Visual observation was performed from the Highway 90 shoulder adjacent to the culverts and revetment. As noted on a previous inspection, deadfall and aquatic vegetation were partially obstructing the bayou approximately 200 feet from the culvert outlet; however, flow was moving swiftly from the culverts into the project area.
