**State of Louisiana  
Coastal Protection and Restoration Authority  
Operations Division**

**2014 Annual Inspection Report**

**Jonathan Davis Wetland Protection**

State Project Number BA-20  
Priority Project List 2

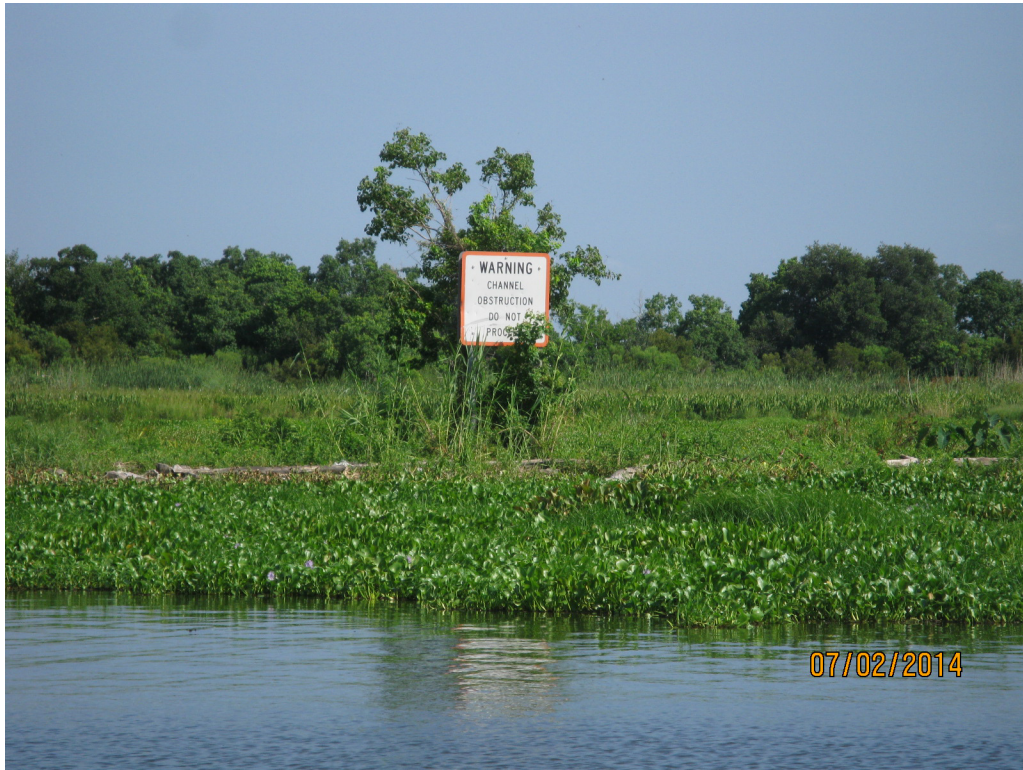
**Photo #1 – Structure #12**

The structure was in good condition; some slight settling was observed. All of the signs and supports were in good condition. No maintenance needs were identified for this location at this time.

Item	Condition	Physical Damage	Corrosion	Photo #	Observations and Remarks	
Signage and supports	Good			#1	<b>Observations:</b> There have been no changes since the last inspection. NRCS and CPRA agree that no maintenance is required at this time.	
Armored Plug	Good			#1		
Earthen Embankment	Good					
<b>Construction Unit No.1</b>						
Structure Description: 294 linear ft. rock rip-rap armored rock-filled plug located in a pipeline channel north of Bayou Perot, west of Bayou Barataria, and east of the GIWW						
The crest of the weir was set at an elevation of +3.9 ft. NGVD. The rock-filled plug contains 2,689 tons of rock filled with 2,518 tons of rip-rap armor. Aluminum warning signs are also located through the rock embankment.

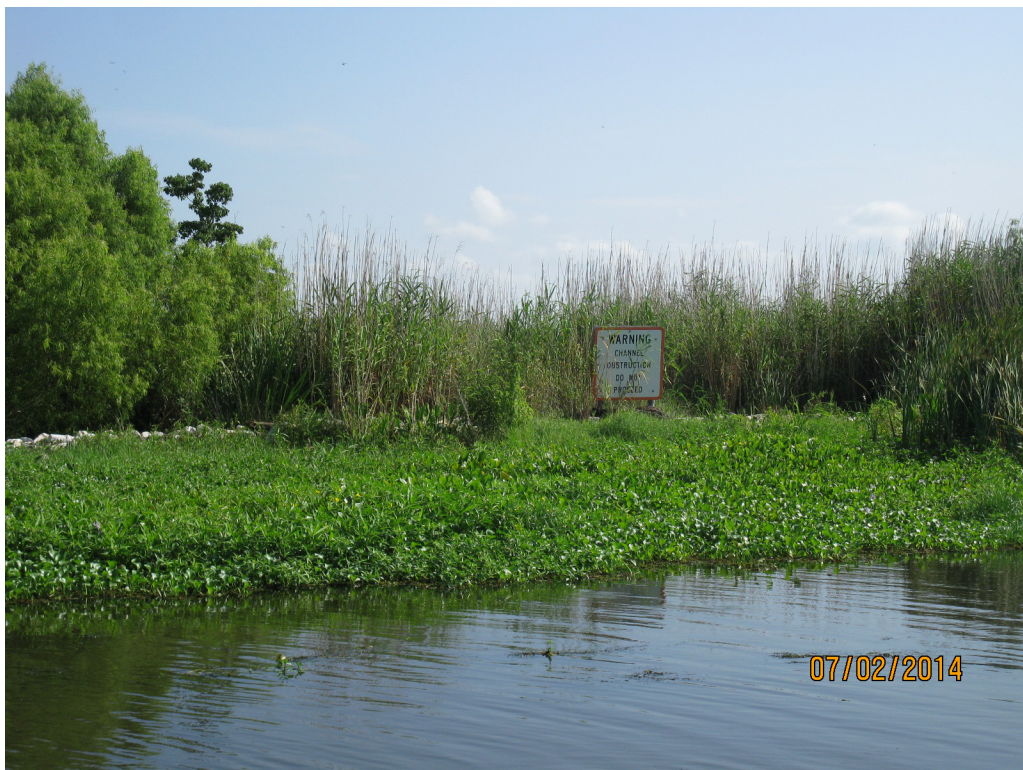
**Photo #2 – Structure #14**

The rock plug exhibited some minor settlement; however, the overall condition was good. There is currently no need for maintenance on this structure.

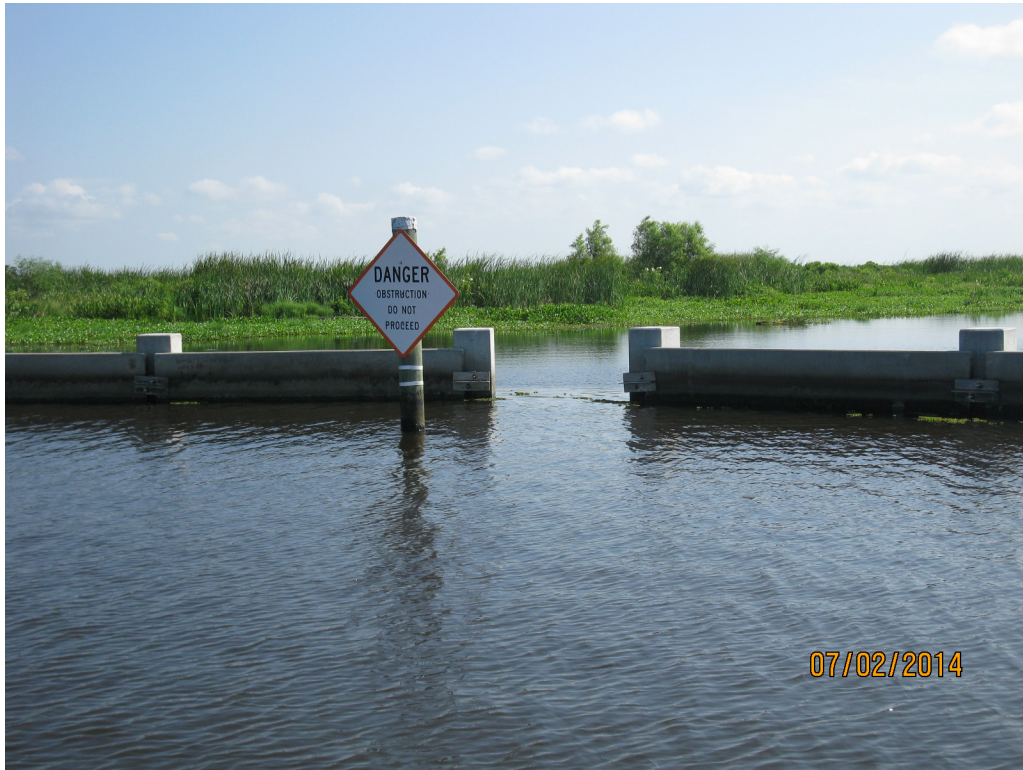
**Photo #3 – C.U. #4 Concrete Panel Wall**

The concrete panel wall sections along the north end of Bayou Perot and Bayou Rigolettes were in good condition. There was no observed damage to the concrete panels, piles, or stainless steel fastening hardware. Warning signs and support piles were also in generally good condition.

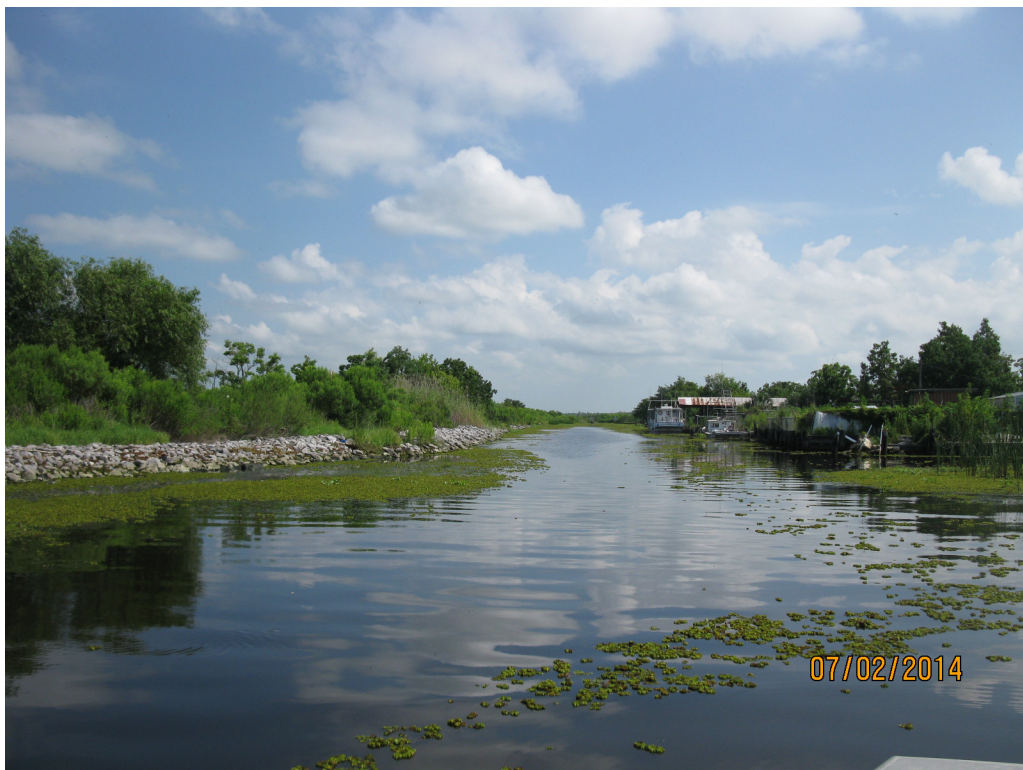
**Photo #4 – Structure #22A**

The structure appeared to be in good condition, with little to no sign of settlement. Heavy vegetation growth was observed. CPRA and NRCS agree that maintenance of this structure is not needed at this time.
