**State of Louisiana
Office of Coastal Protection and
Restoration
Operations Division**

2015 Annual Inspection Report

**CAERNARVON OUTFALL
MANAGEMENT
(BS-03a)**

State Project Number BS-03a
Priority Project List 2

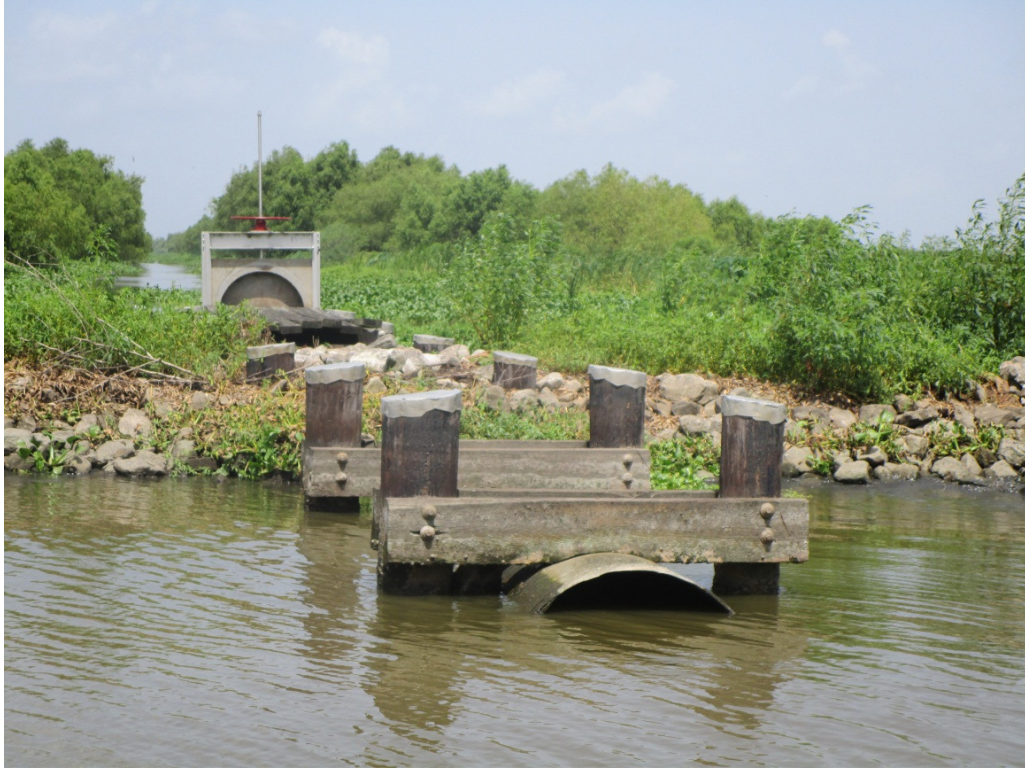
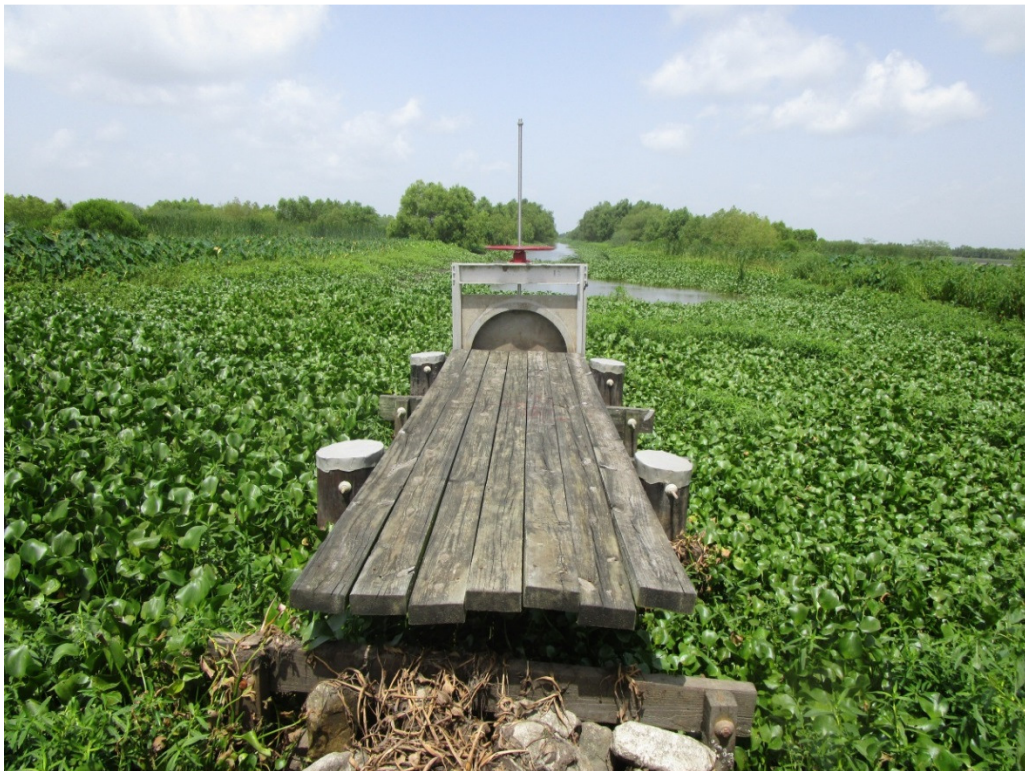
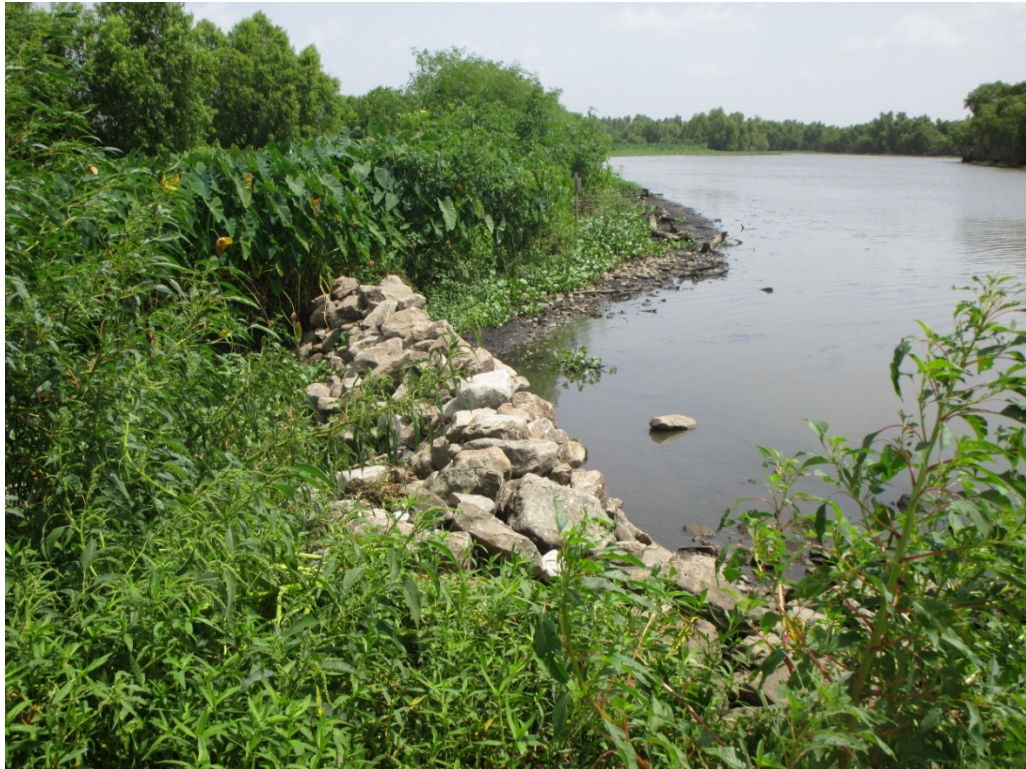
- A. Site/Structure # 13** – The gap that previously was observed on the north end of the rock dike had been repaired with material from Site #32 . There was no flow between the marsh and Bayou Mandeville observed and the newly placed rock appeared to be stacked to the proper elevation. The combination gate was in the up/open operating position to allow maximum uninterrupted tidal exchange into the marsh. The gate has a slight tilt, but it is not affecting the function. The timber walkway still lays separated from its support beam at one end. (See Photos 1, 2 & 3)

Another recommendation is to repair the decks at structures #13 and #50. The deck at structure #13 is not attached to the supports at one end, and the deck at structure #50 is bowed.

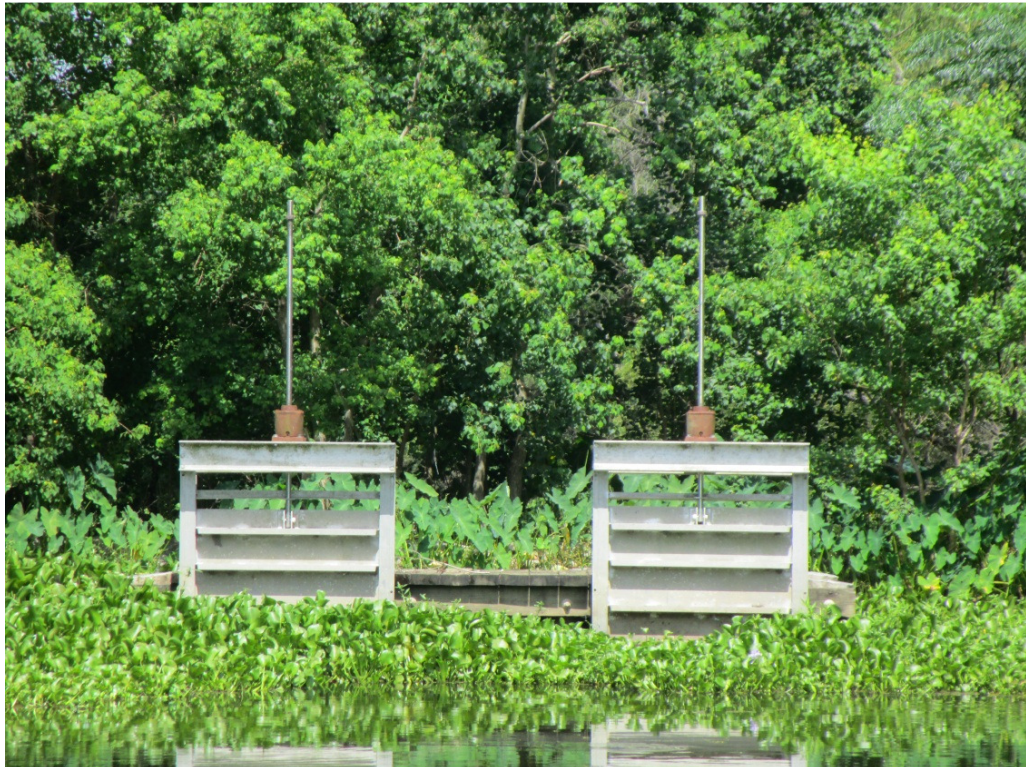
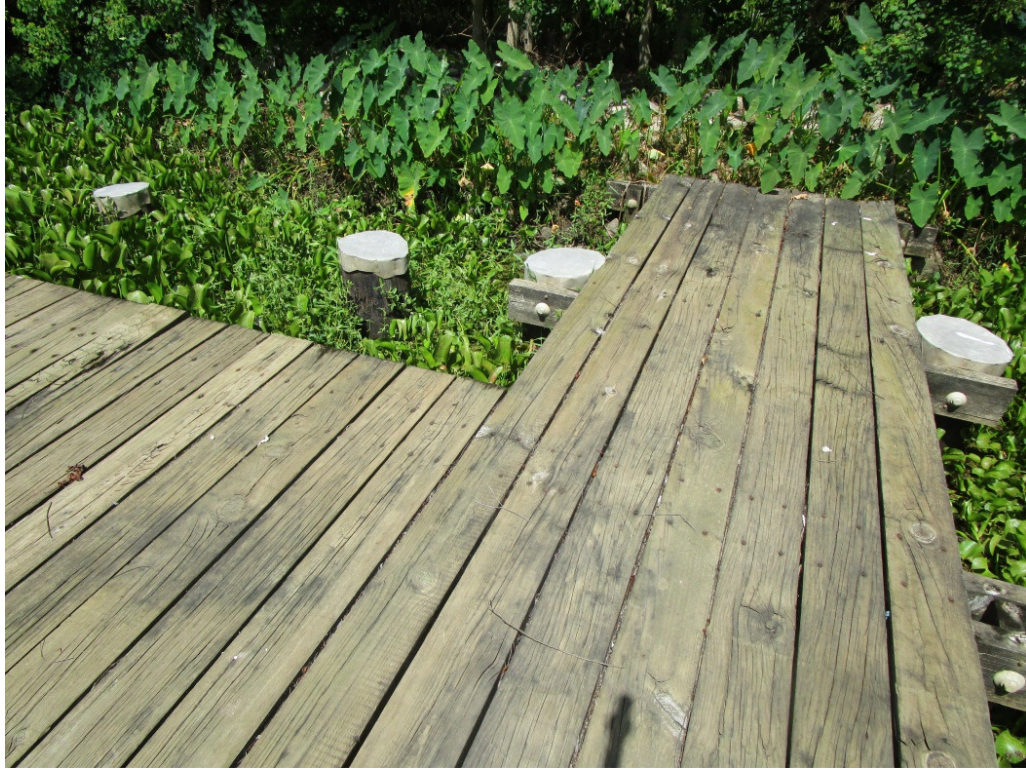
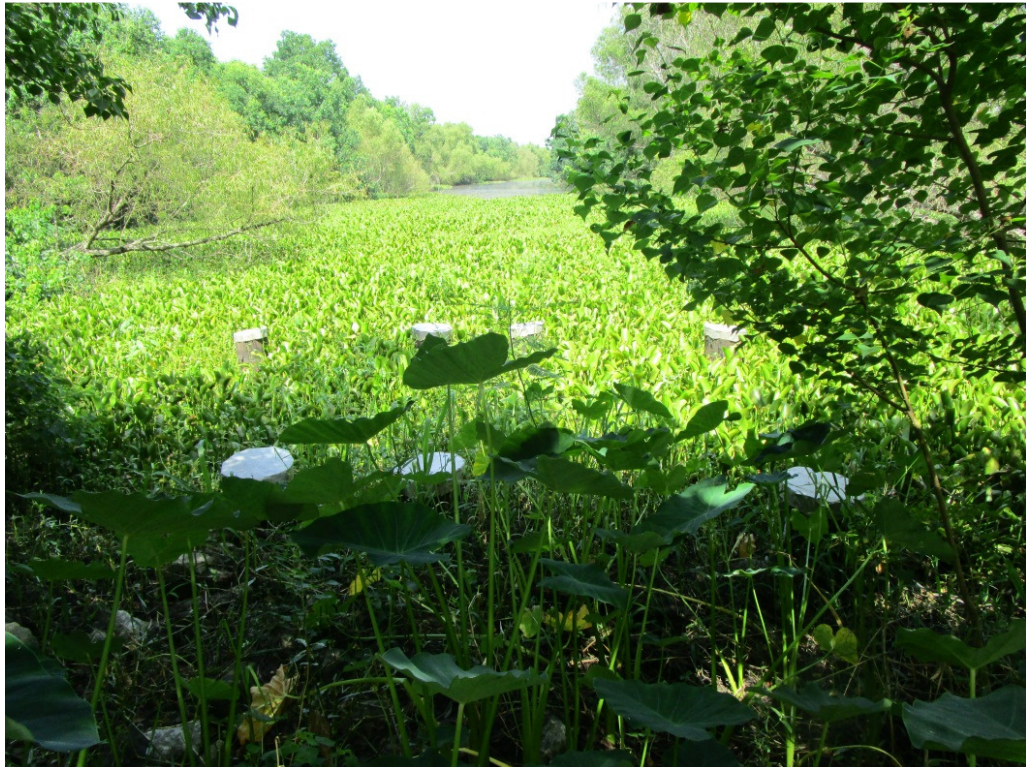
- B. Site/Structure # 25** – The inspection team did not attempt to inspect this feature due to inaccessibility at the time of the inspection. During a June 23, 2015 inspection, the structure appeared to be in good condition, although the gates were overdue to be greased on exercised. (See Photos 4, 5 & 6 taken 6/23/15)

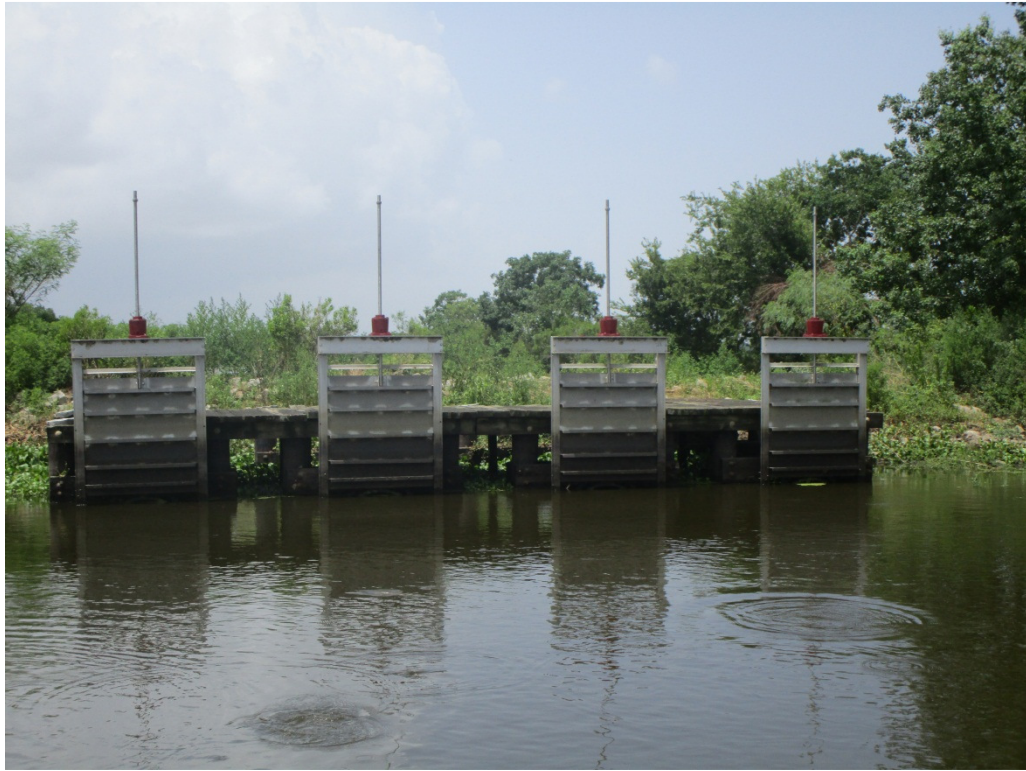
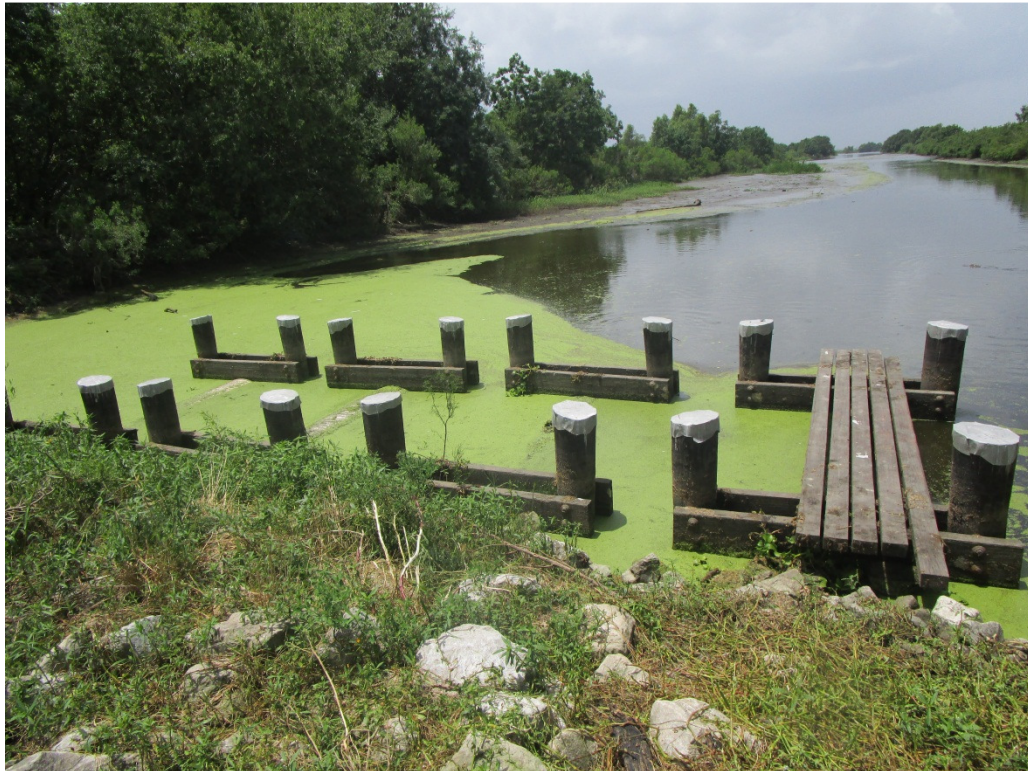
- C. Site/Structure # 26** – The gates were in the open position allowing water flow. There is thick vegetation covering the earthen/rock closure. The flow meter at this site was damaged during Isaac in September 2012, and was subsequently removed based on the decision to discontinue flow monitoring at this structure. The structure and outfall channel appeared to be in good condition. (See Photos 7 & 8)

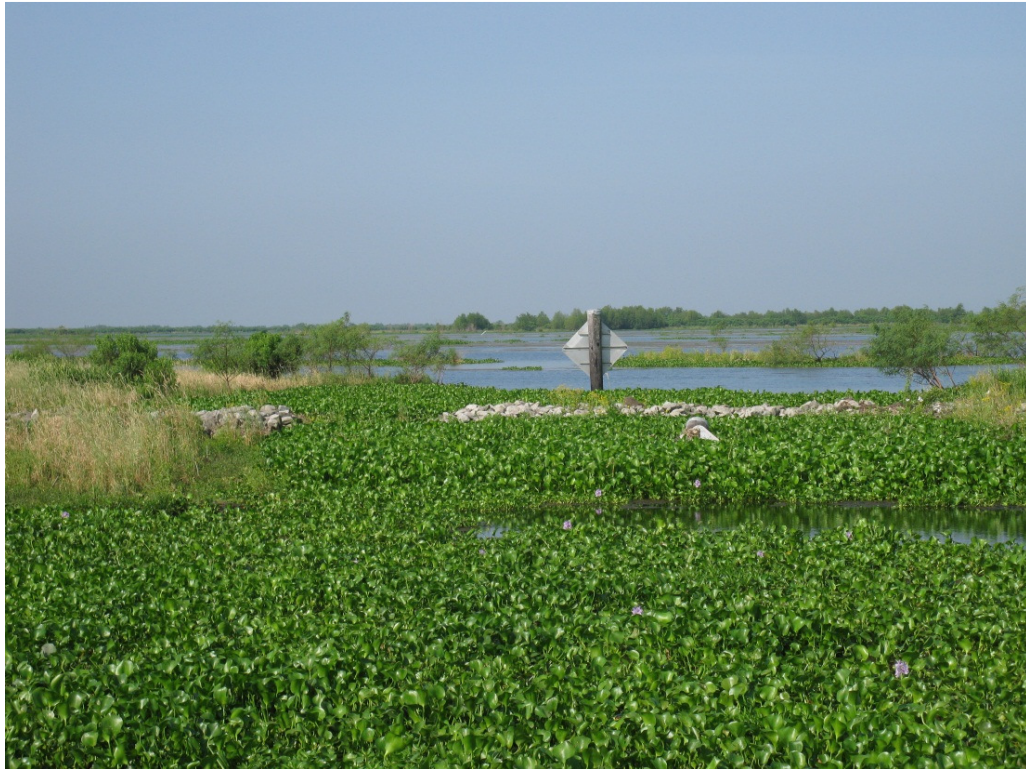
[Photo No. 9, Site 32 \(2012 pre-Isaac\)](#)

- D. Site/Structure # 32** – The team did not inspect this feature because this rock closure will be incorporated into the BS-16 project which will restore the shoreline along this section of Lake Lery. Additionally, Hurricane Katrina devastated this portion of the lake rim rendering the structure ineffective. (Photo 9)

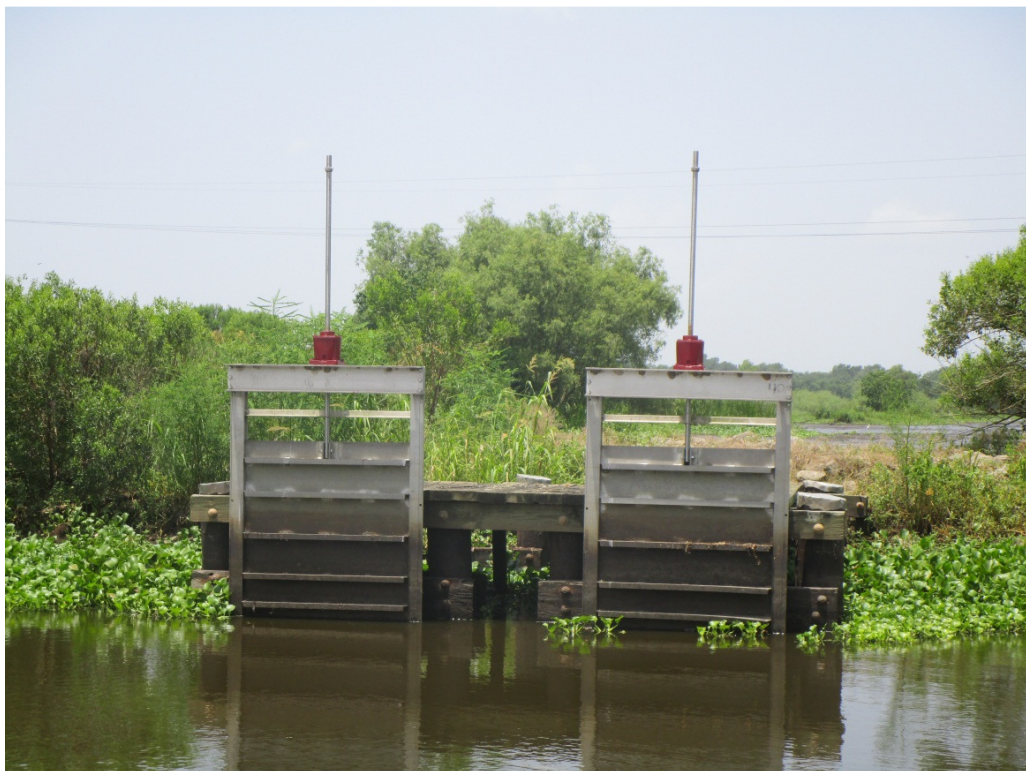
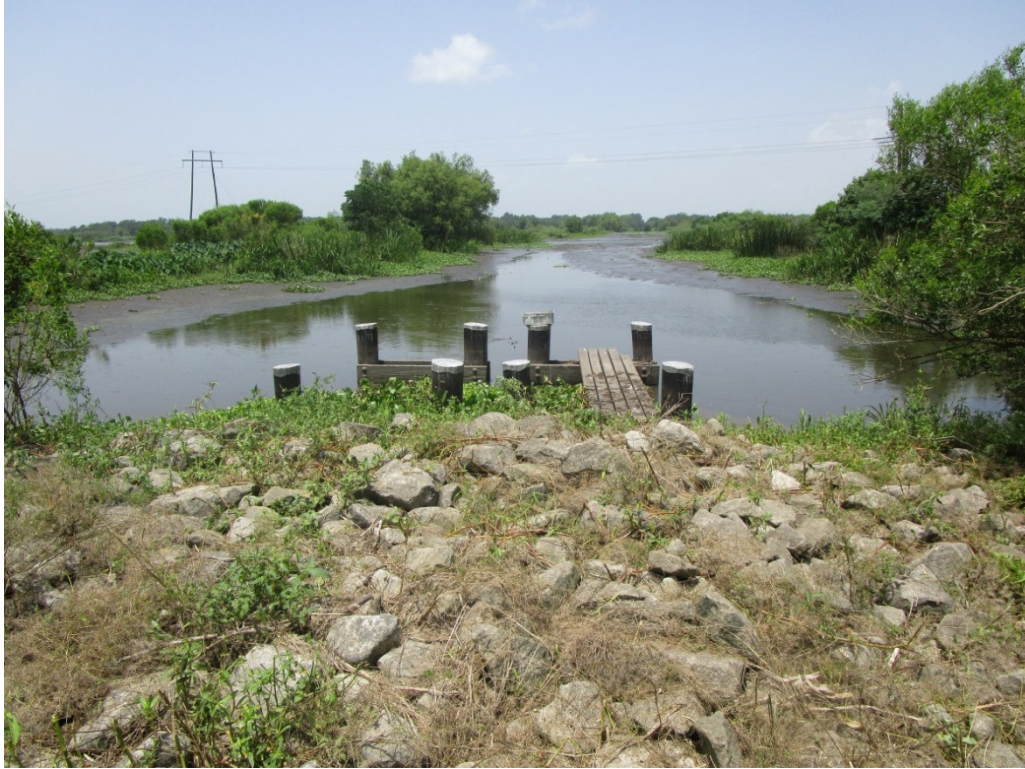
- E. Site/ Structure # 40** – The gates remain in the open position. The structure and outfall channel are in good condition. The flow meter at this site was removed in December 2014 based on the decision to discontinue flow monitoring at this structure. (See Photos 10 & 11)

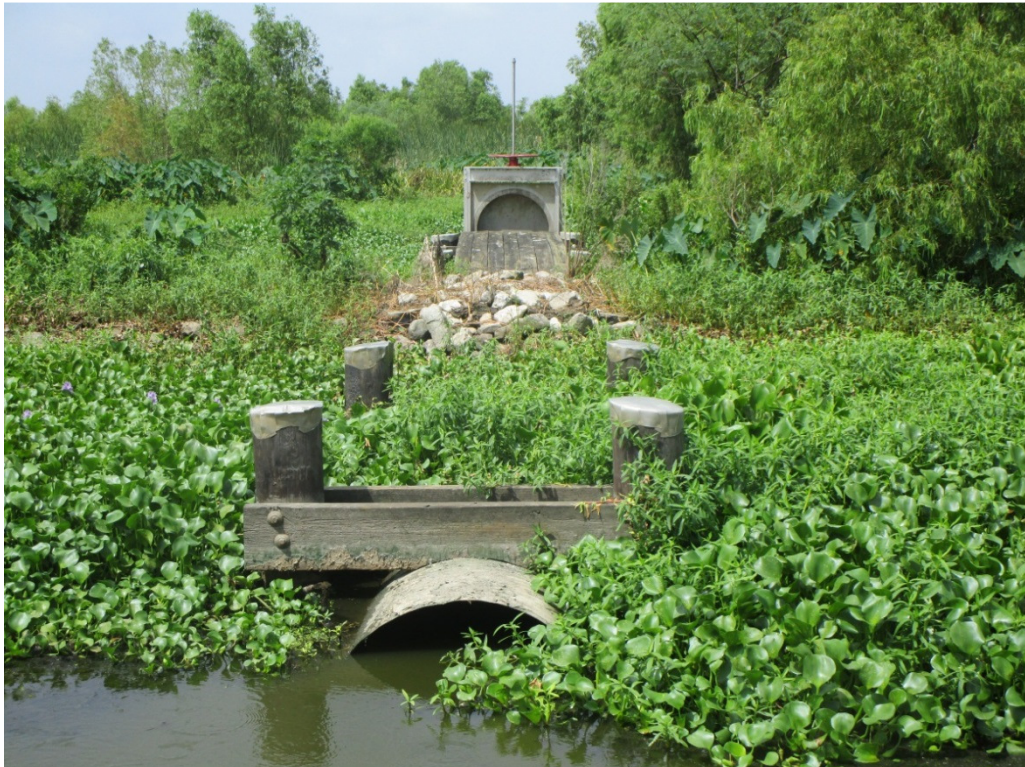
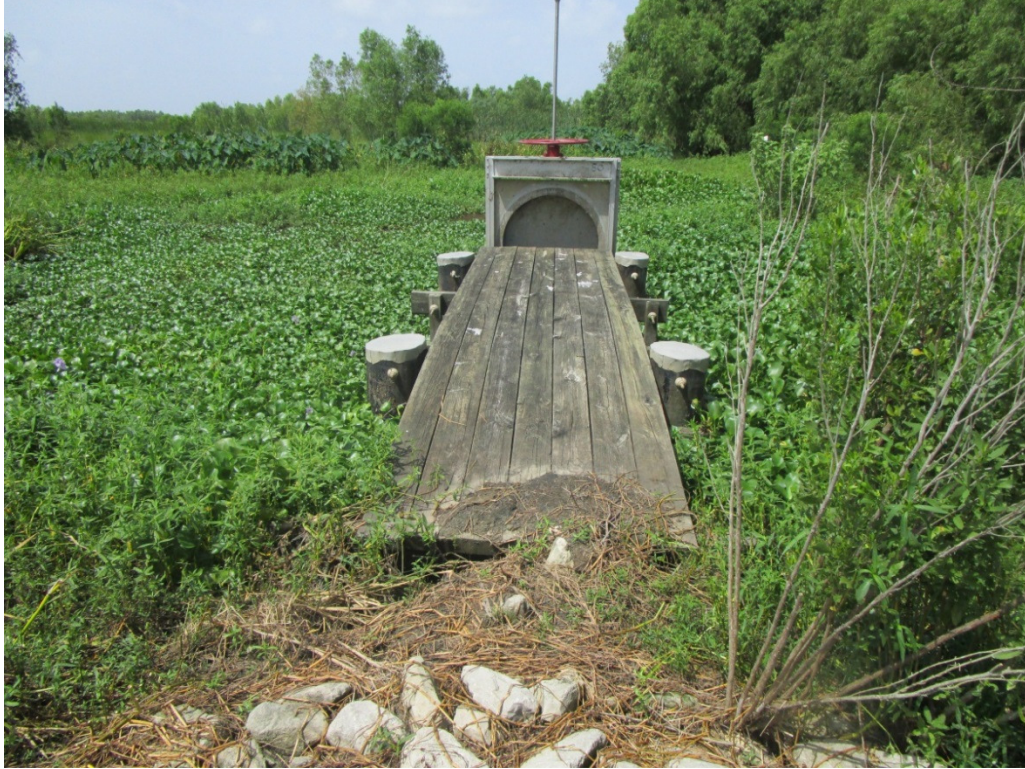
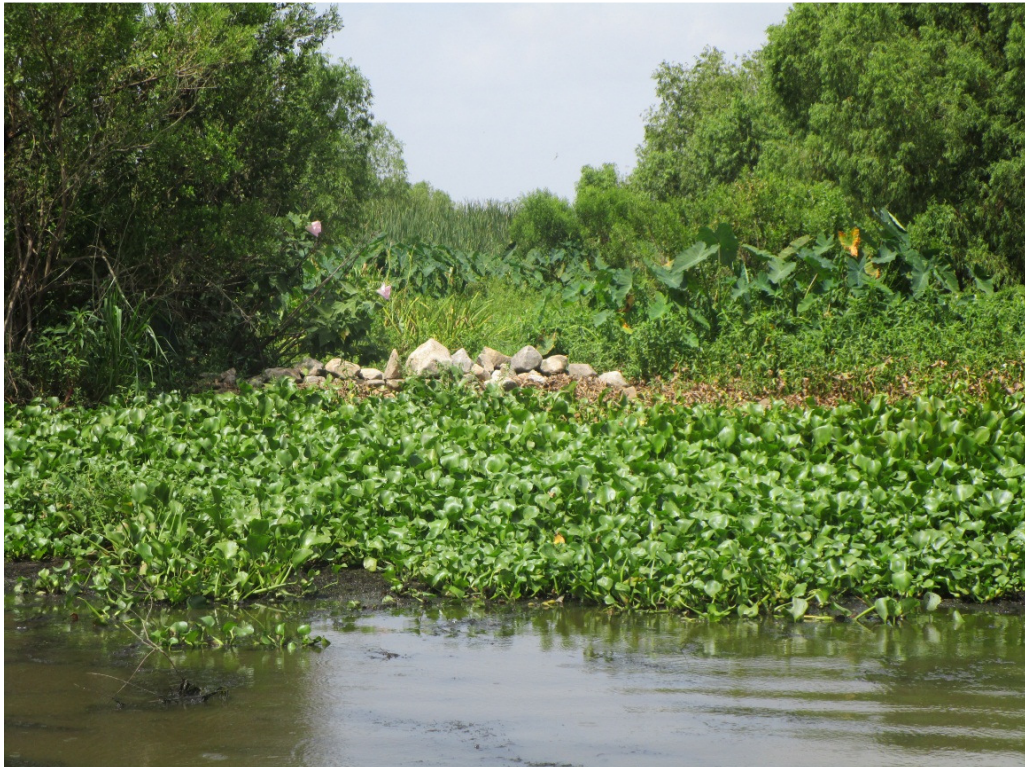
- F. Site/Structure # 50** – The combination gate was in the up/open position. The breaches that previously were observed at the structure tie-ins to the south and to the north had been repaired with material from Site #32 . There was no flow between the marsh and Bayou Mandeville observed and the newly placed rock appeared to be stacked to the proper elevation. The timber walkway remains bowed. (See Photos 12, 13 & 14)

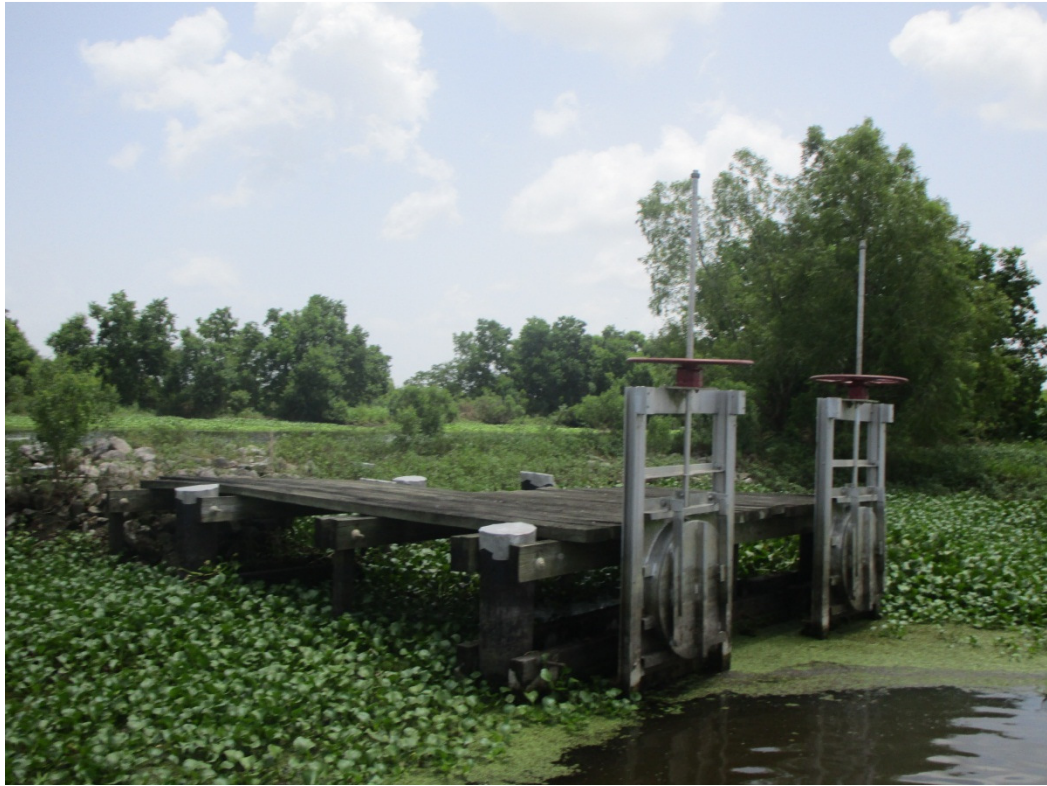
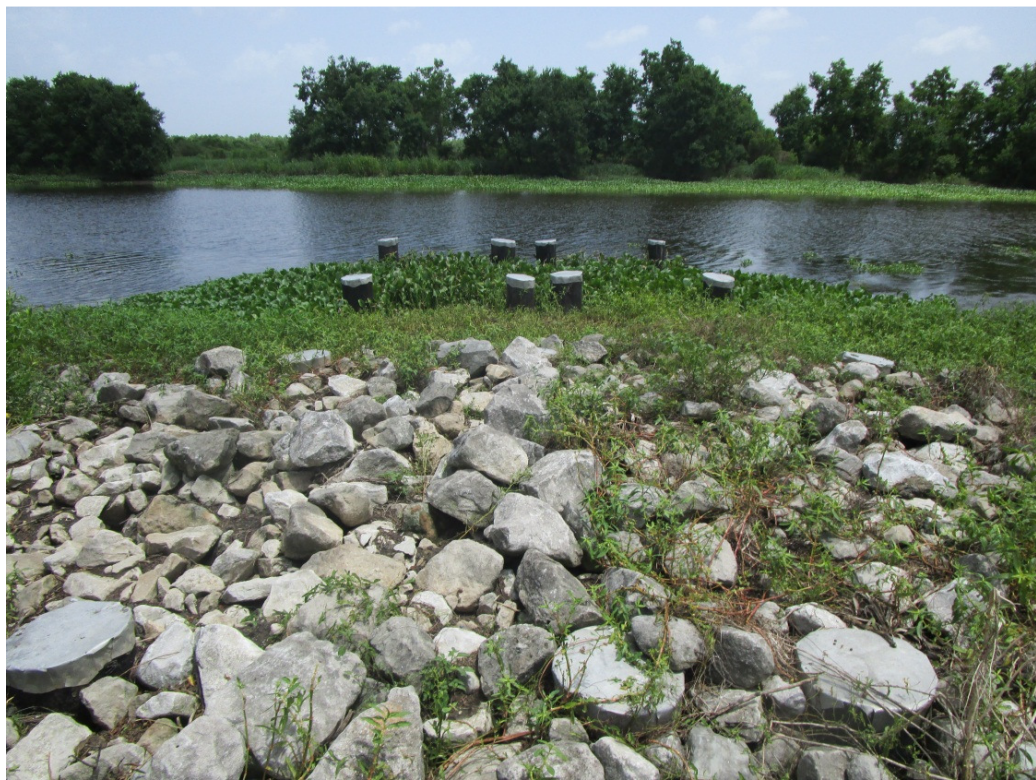
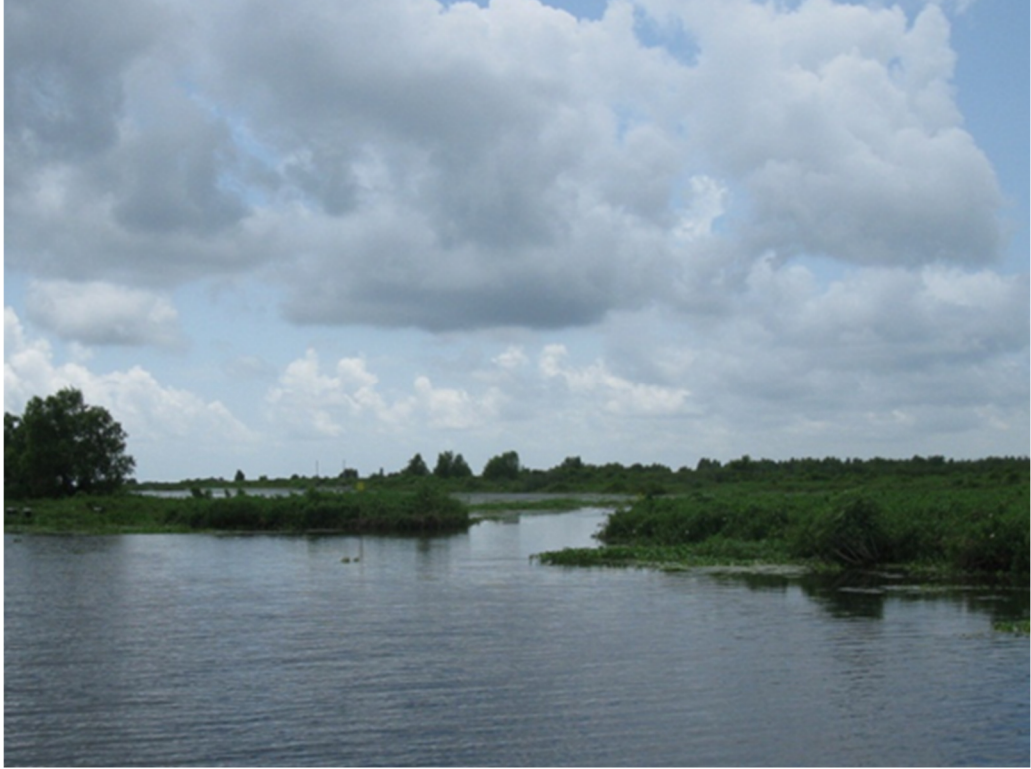
- G. Site/Structure #51** – Plug is heavily vegetated. Maintenance is not required at this structure. (No Photo)
- H. Site/Structure #52** – The two combination gates were in the up/open position. The breach previously repaired by the dredging contractor has been re-opened and is between 10-15 feet in width. The breach is allowing unimpeded flow between the channel and marsh. (Photos 15, 16 & 17)

In addition to the gaps at structure #13 and structure #50, there is also a gap adjacent to structure #52 and a low area by structure #60. An investigation of the spoil banks along the various canals in the outfall area revealed the presence of several other gaps that would render repairs at #52 and #60 ineffective. However, once the BS-16 project is completion of the western shoreline of Lake Lery is restored, it is recommended that the effectiveness of these structures and the outfall project, in general, be evaluated to identify maintenance items or modifications that can enhance the goals of the project while working in a complimentary fashion with the new topography and flow regimes of the system.

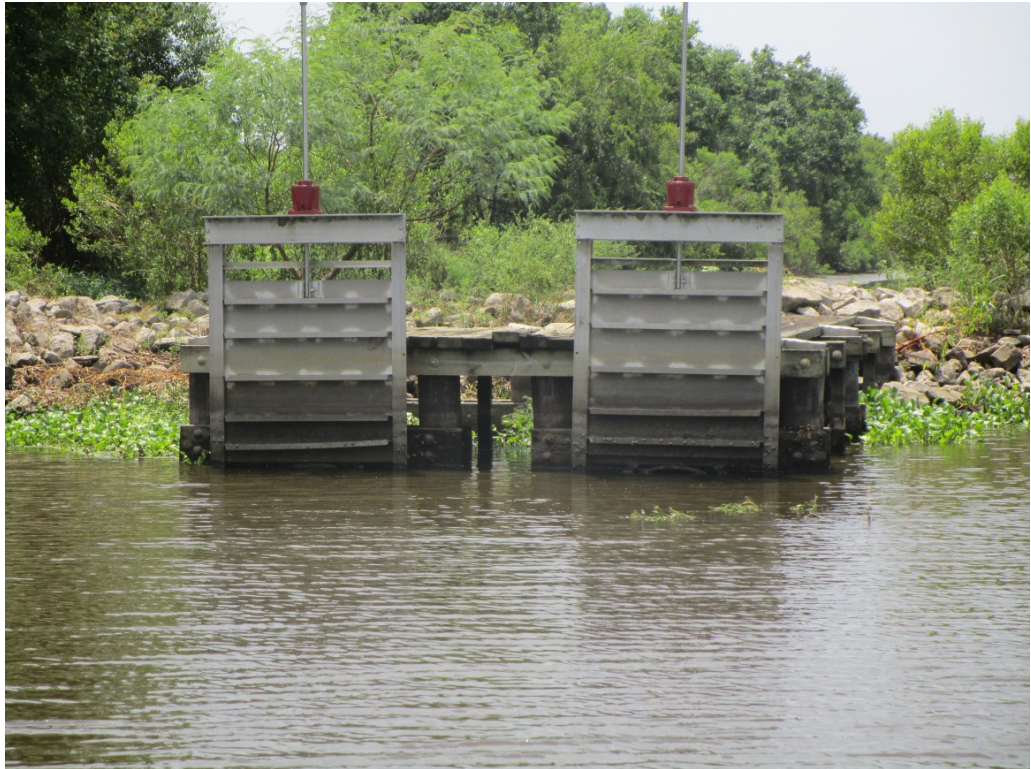
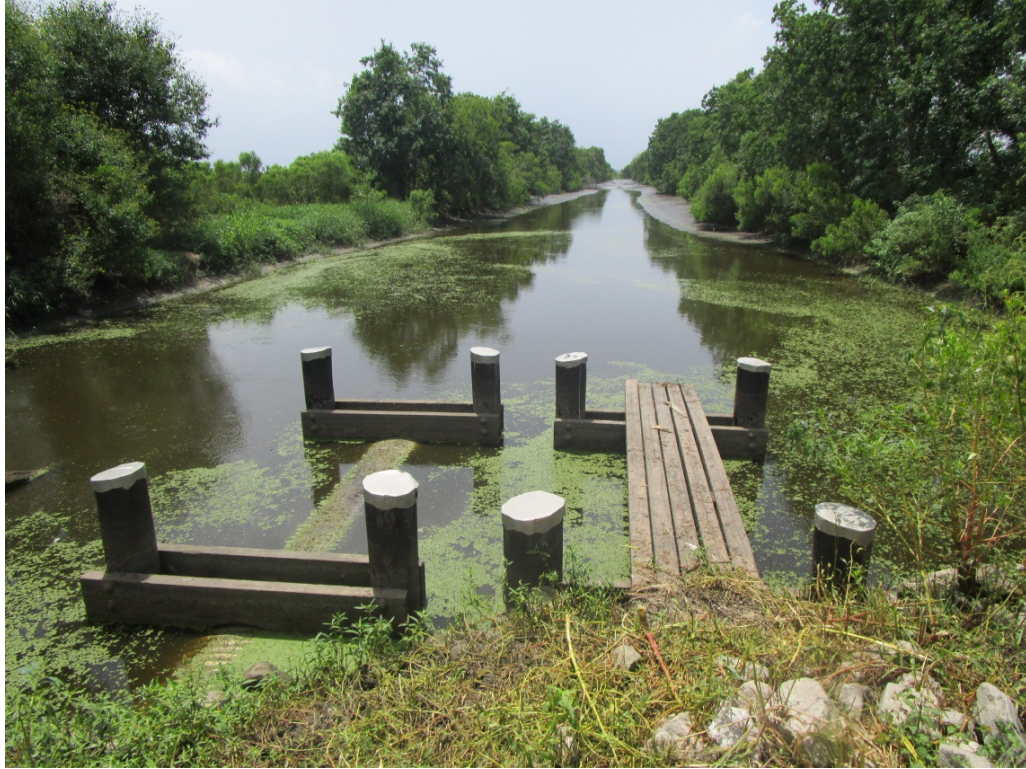
- I. Site/Structure # 54** – The gates remain in the open position. No flow was visible through the culverts. The flow meter at this site was removed in December 2014 based on the decision to discontinue flow monitoring at this structure. (Photos 18 & 19)

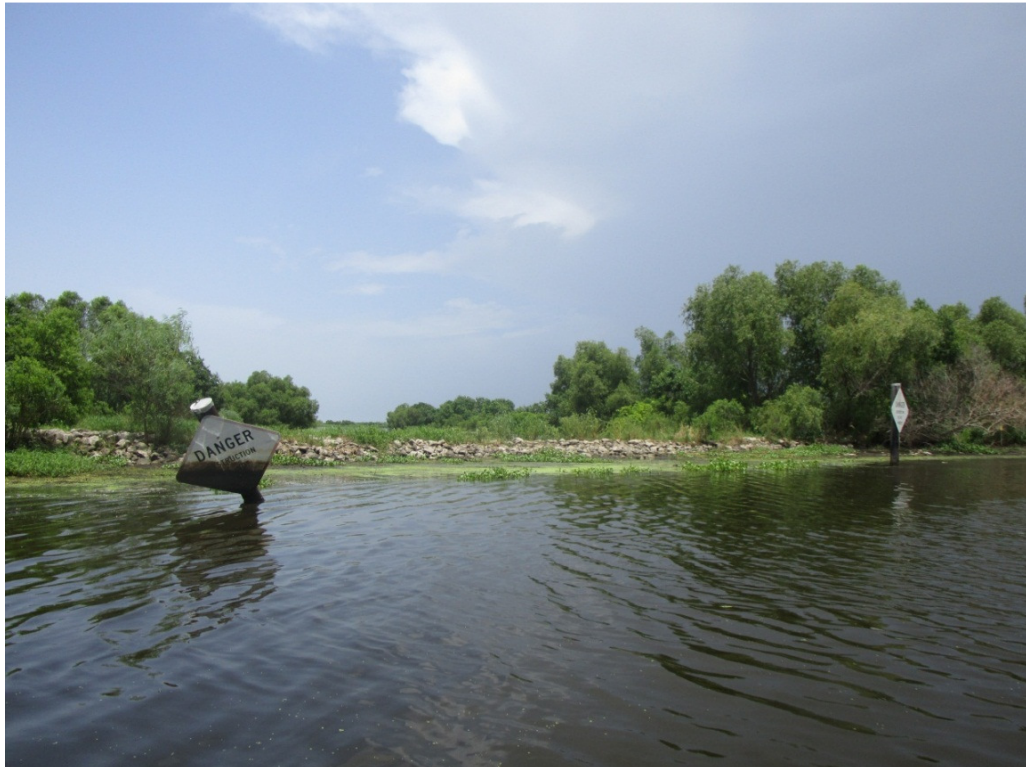
Photo No. 20, Site 56

- J. Site/ Structure # 56** – Although the water level was lower than the rock dike crest, the water was observed to overtop the rock during the 2013 inspection with a diversion flow of 717 cfs and a marsh gage reading of +1.76 feet NGVD. Vegetation remains on the entire rock closure. Soon after construction, the middle section of the plug subsided approximately 0.5 feet more than the sides. One warning sign is still leaning severely and is partially submerged (Hurricane Katrina damage). (Photo 20)

The warning sign at site #56 needs to have the piling re-driven in an upright position.

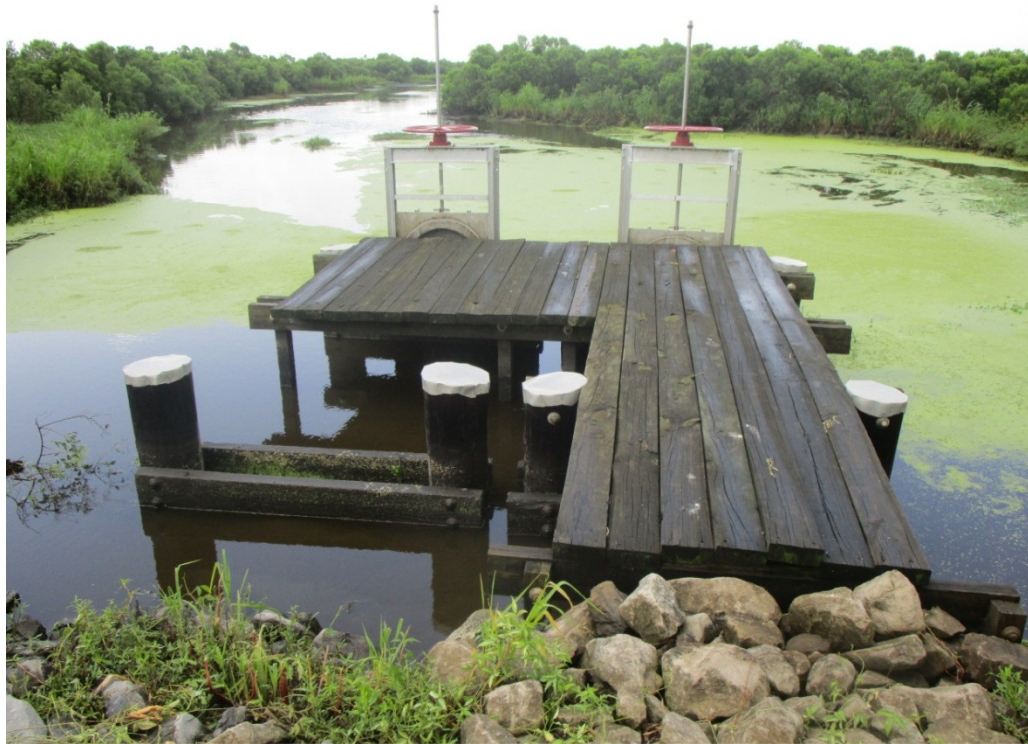
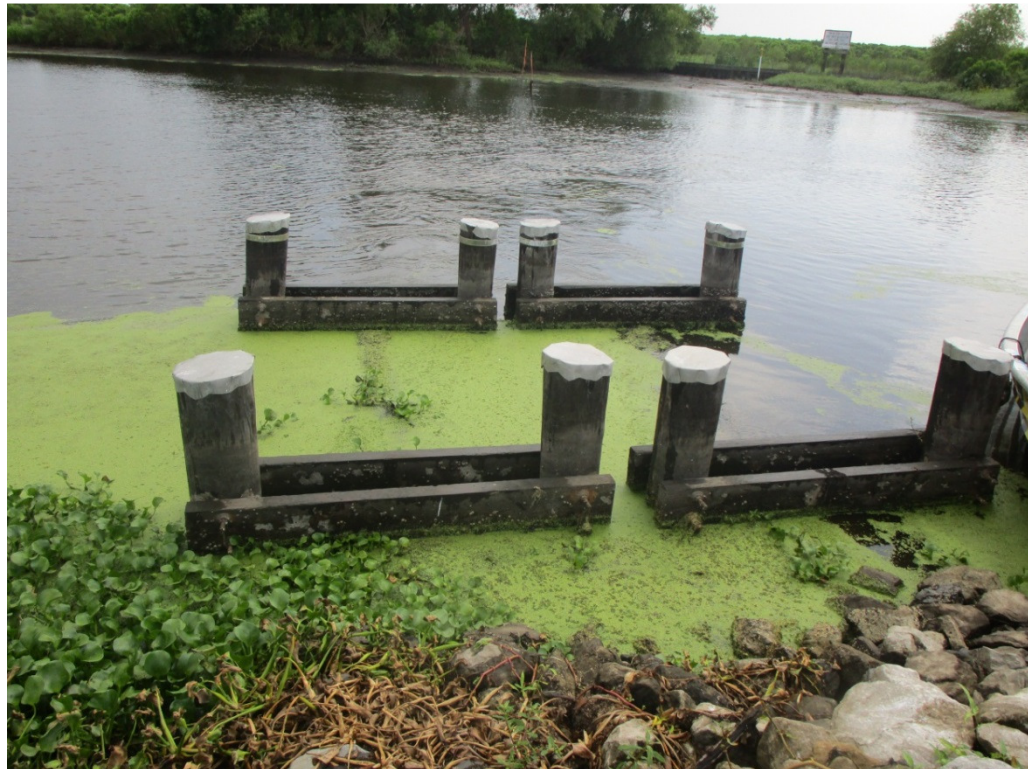
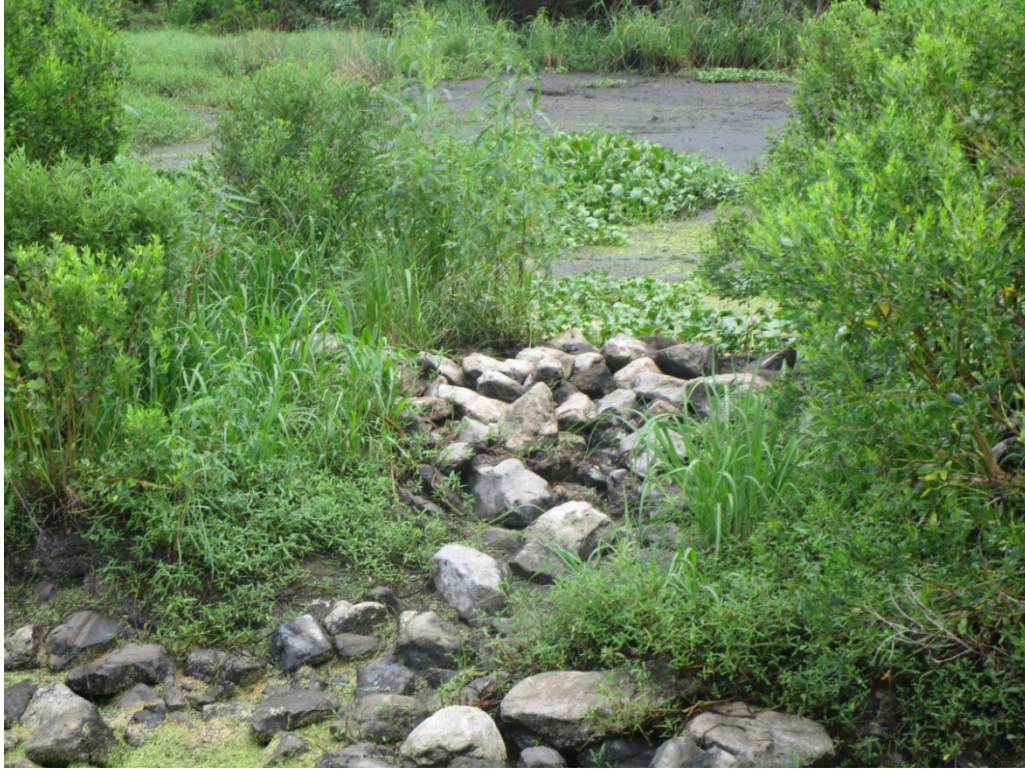
- M. Site/Structure # 60** – The two combination gates were in the up/open position. The overall condition of the structure is good. There is a low area of the rock adjacent to the structure that water flows over at higher marsh water levels. (Photos 21, 22 & 23)
