2015 Annual Inspection Report

Pass Chaland to Grand Bayou Pass Barrier Shoreline Restoration

State Project Number BA-35
Priority Project List 11

March 2, 2016
Plaquemines Parrish

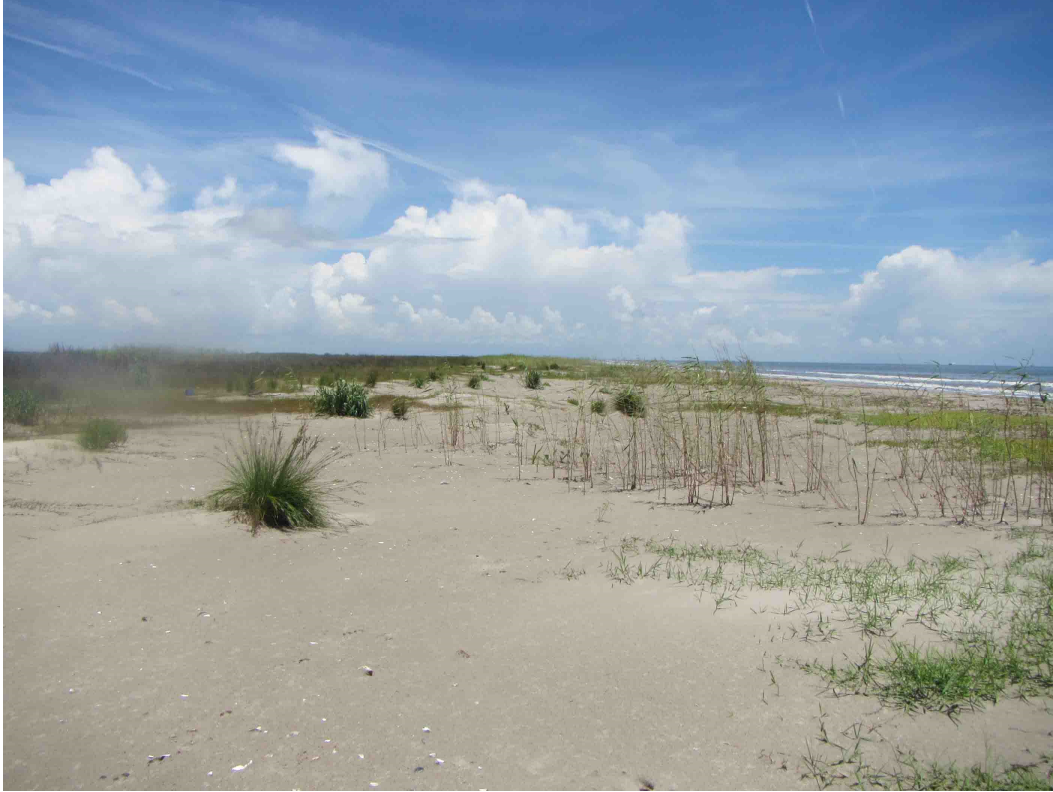
The vegetative plantings are performing well. The natural vegetation has also filled in the gaps nicely.

Photo #1 – West End Beach Looking East.

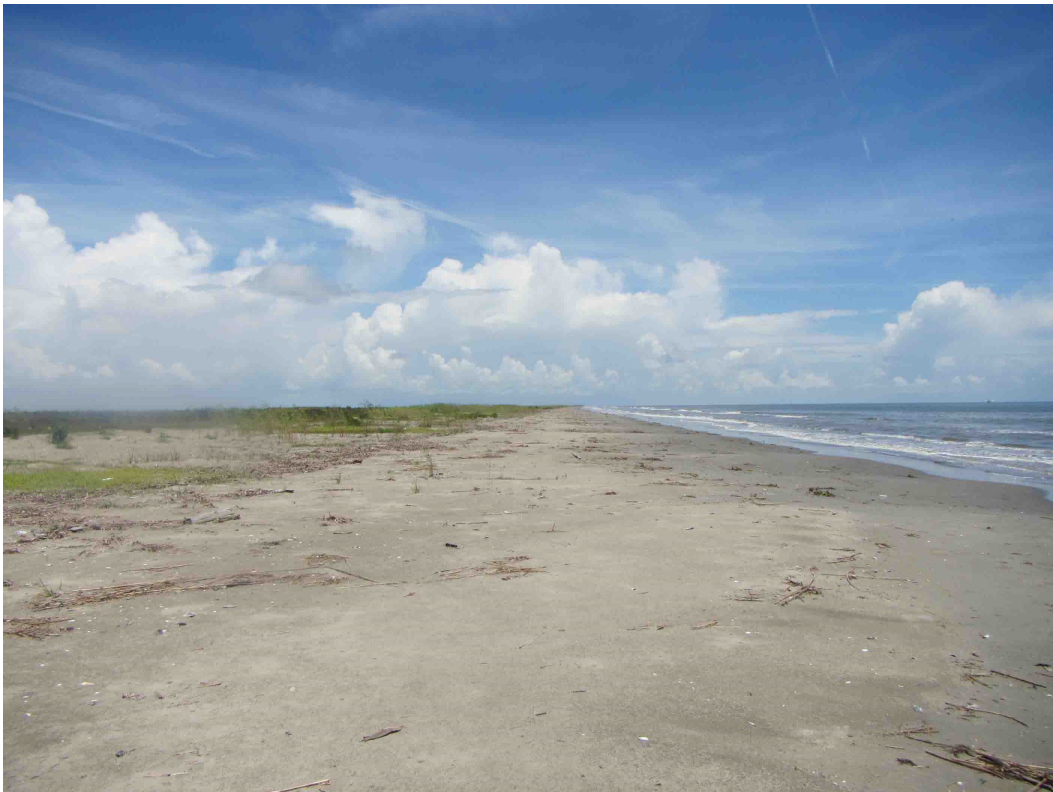
Photo #2 – West End Shoreline Looking East.

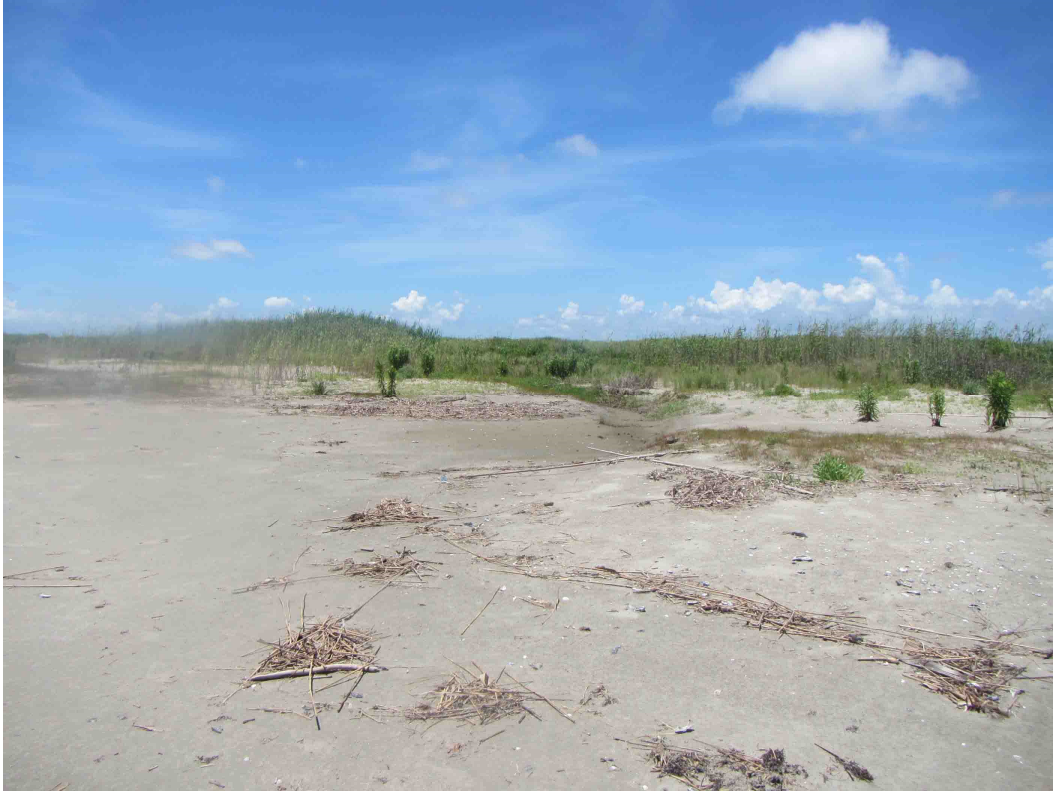
Photo #3 – Tidal Creek on Beach, Looking North.
