**State of Louisiana
Coastal Protection and Restoration Authority**

2015 Annual Inspection Report

South Shore of The Pen Shoreline Protection and Marsh Creation

State Project Number BA-41
Priority Project List 14

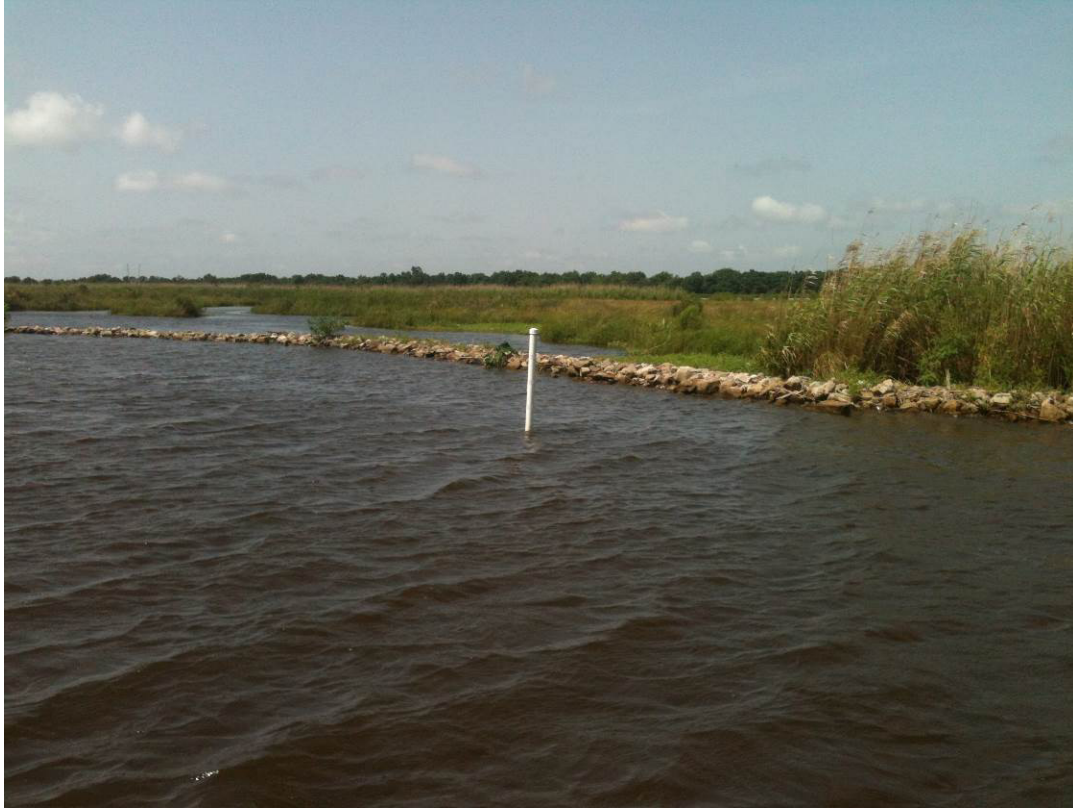
The West project reach was observed to be in generally good condition and was performing the project goal of protecting the marsh to the south (Photo #1). Portions of the rock structure along the Central and East reaches have experienced significant settlement (Photos #2 and #3). A contract has been executed for a maintenance rock lift to restore these areas to the design elevation.

Photo #1 – Shoreline Protection, West Reach

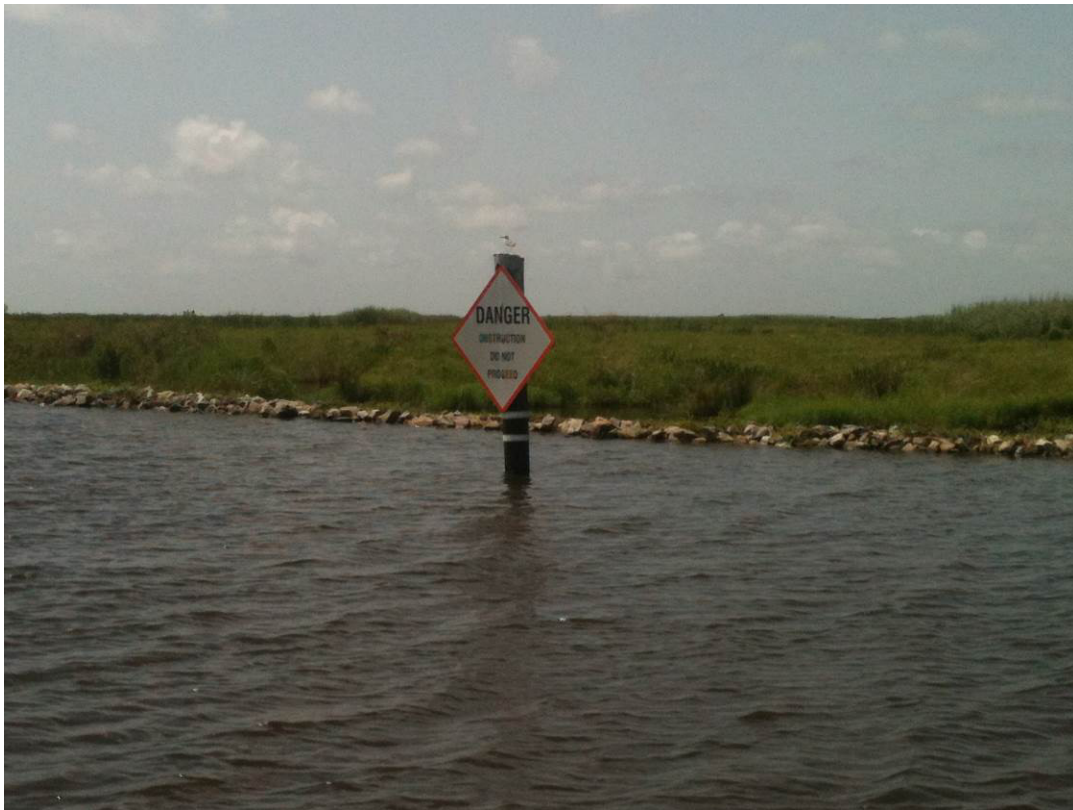
Photo #2 – Shoreline Protection, Central Reach

- Perform rock lift on Central and East Reaches.

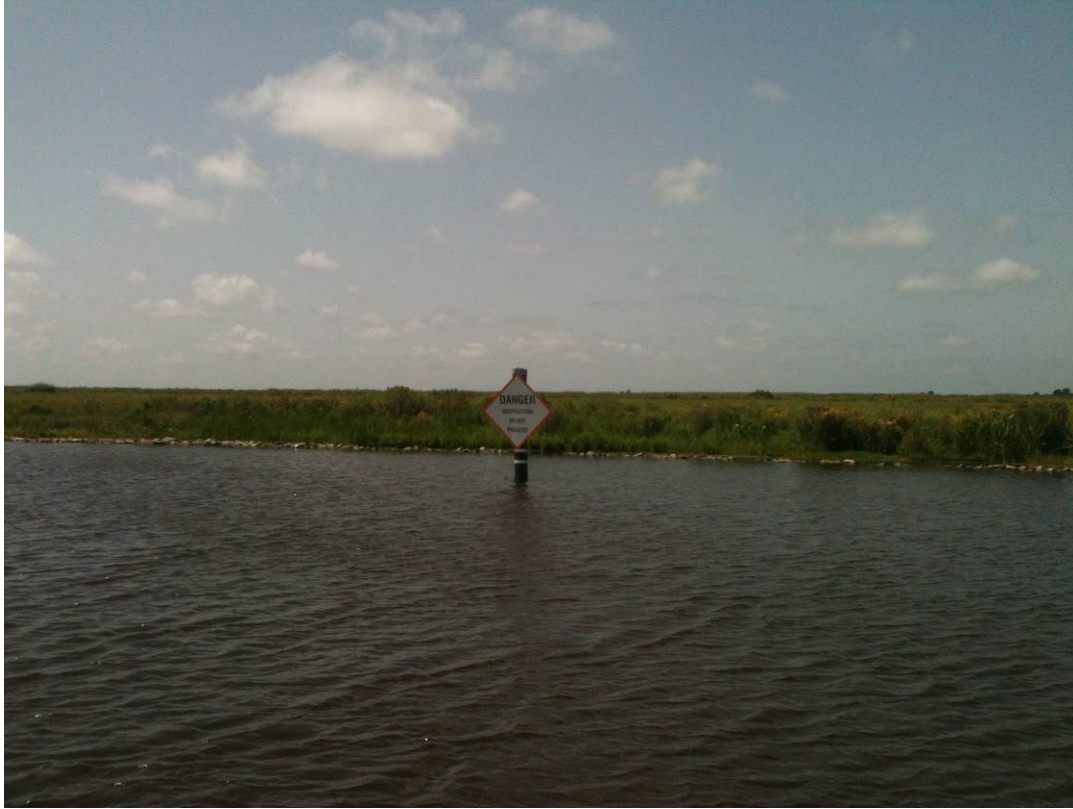
Photo #3 – Settlement in Central Reach

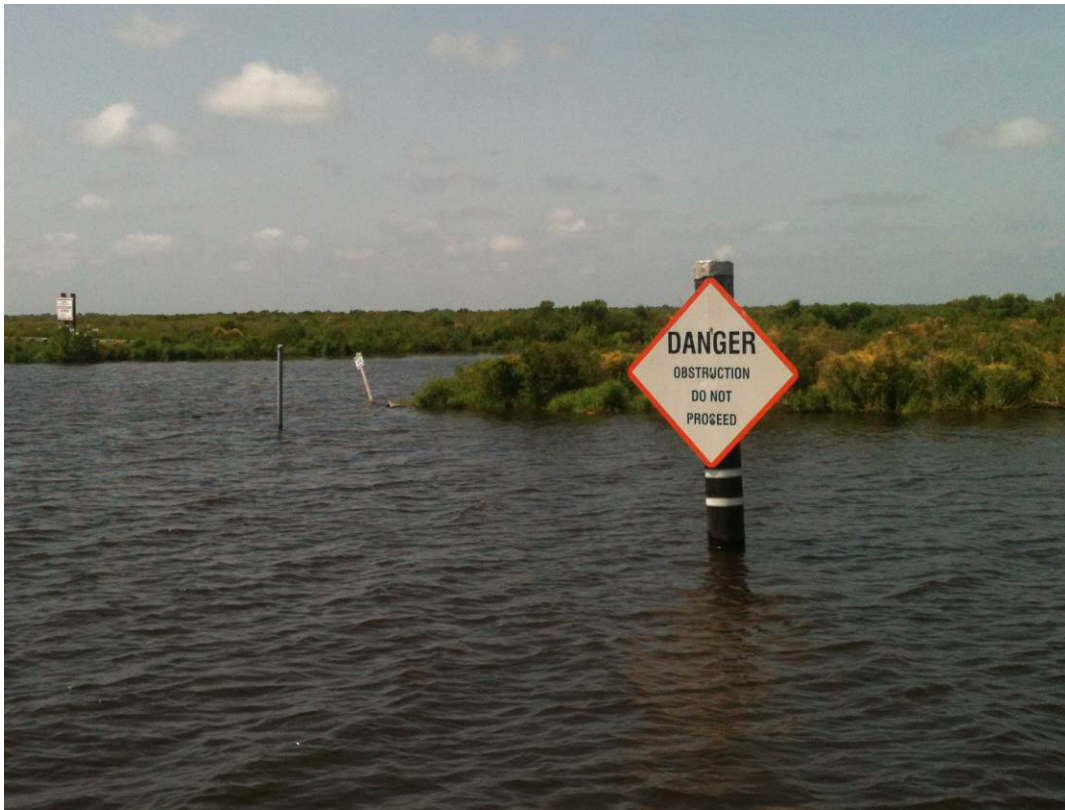
Photo #4 – End of East Reach at Bayou Dupont and Pipeline Canal

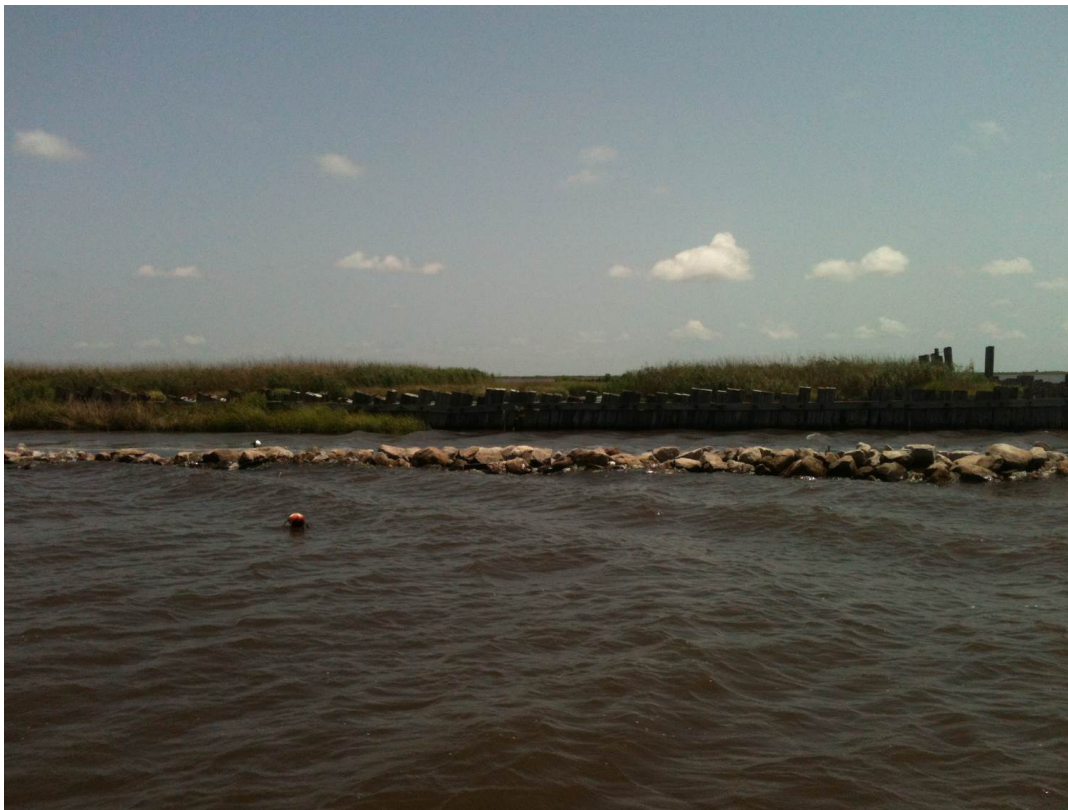
Due to the draft limitations of the inspection vessel, access to the marsh creation area was not feasible. Inspection of this feature was performed visually from outside the shoreline protection feature and from the Barataria Bay Waterway. The marsh creation area appeared well-vegetated with healthy marsh grass and Roseau cane (Photo #5). No maintenance needs were identified for this area.

Photo #5 – Marsh Creation Area Viewed from Baratavia Waterway
