**State of Louisiana
Coastal Protection and Restoration Authority**

2016 Annual Inspection Report

**CAERNARVON OUTFALL
MANAGEMENT
(BS-03a)**

State Project Number BS-03a
Priority Project List 2

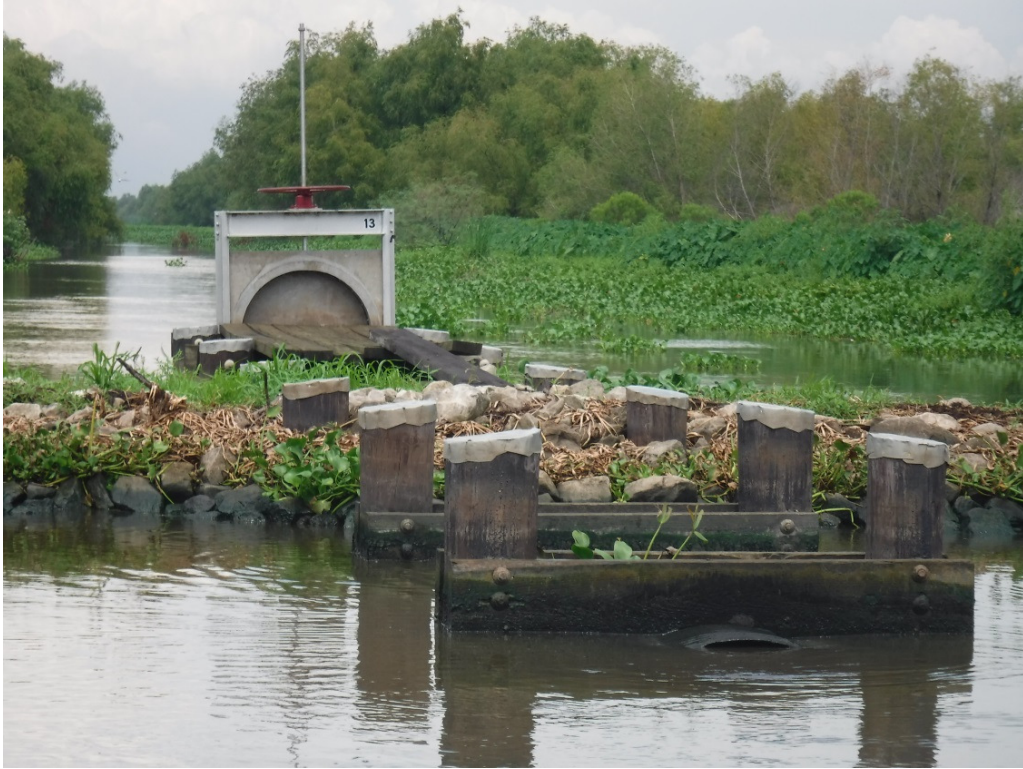
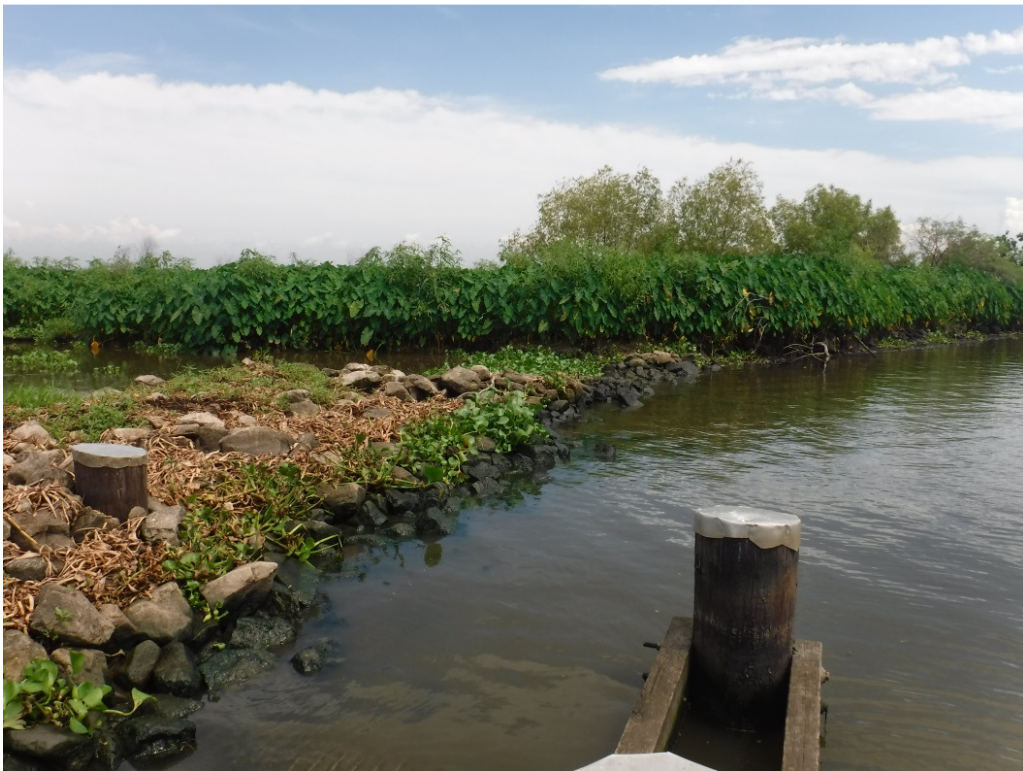
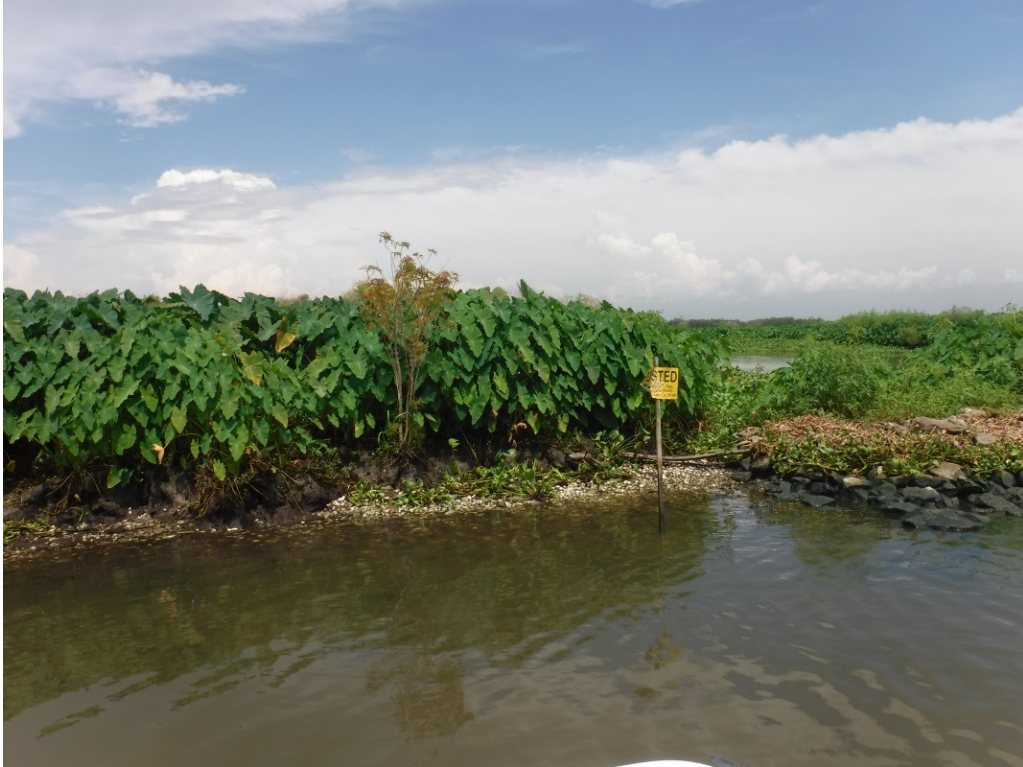
- A. **Site/Structure # 13** –The combination gate was in the up/open operating position to allow maximum uninterrupted tidal exchange into the marsh. The gate has a slight tilt, but it is not affecting the function. The timber walkway still lays separated from its support beam at one end and the boards are uneven. There is a wood plank in place connecting the rock dike to the wooden platform. The rock from Site #32 used to plug the breach in the rock dike remains in place and at proper elevation. (See Photos 1 - 3)

Another recommendation is to repair the decks at structures #13 and #50. The deck at structure #13 is not attached to the supports at one end, and the deck at structure #50 is bowed with one plank detached. The operator mentioned his plan to drill a new hole and nail down the detached plank at structure #50.

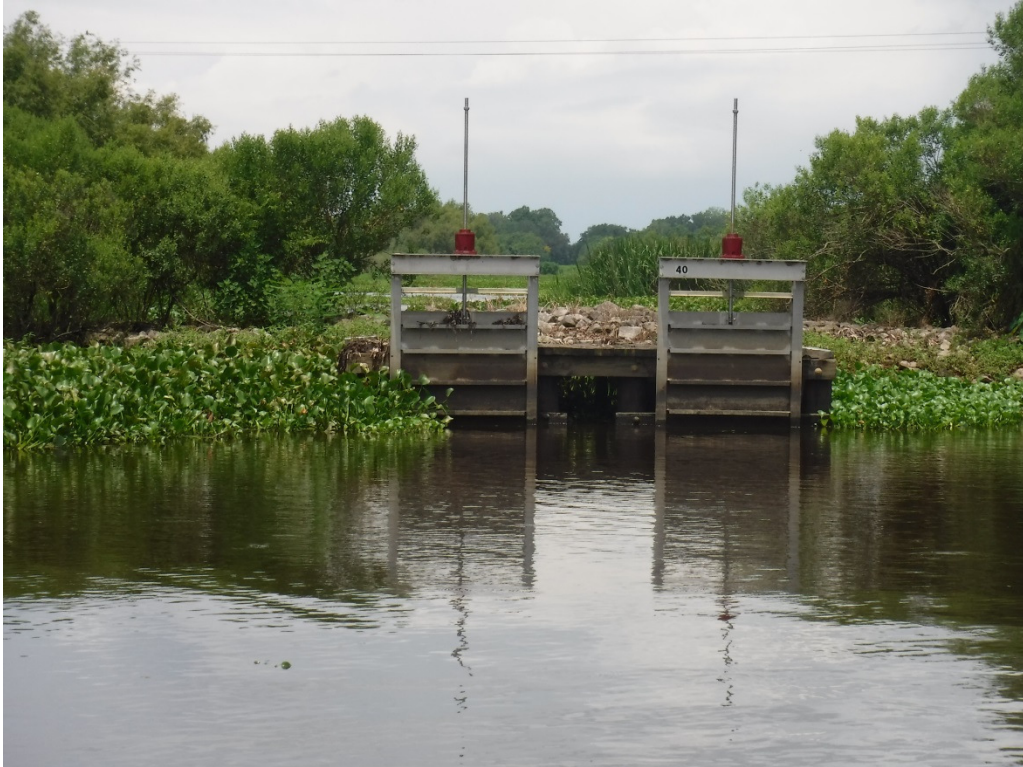
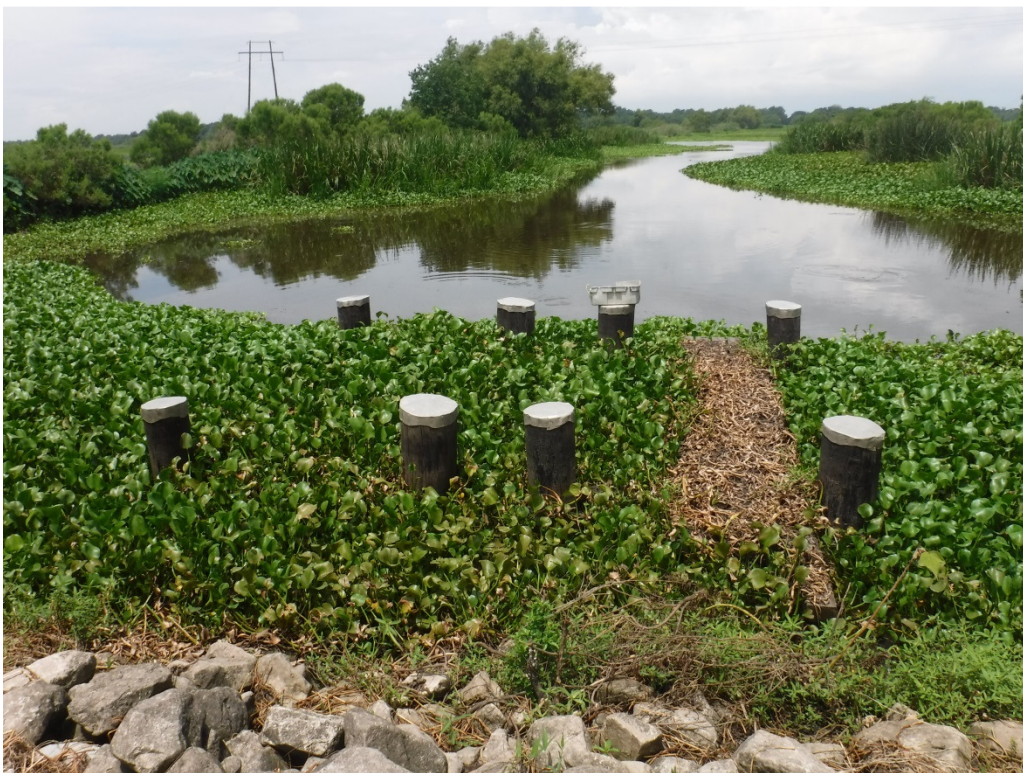
- E. **Site/ Structure # 40** – The gates remain in the open position. The structure is in good condition. Dead water hyacinth covers the boardwalk on the back side of the structure. The flow meter at this site was removed in December 2014 based on the decision to discontinue flow monitoring at this structure.(See Photos 9 & 10)

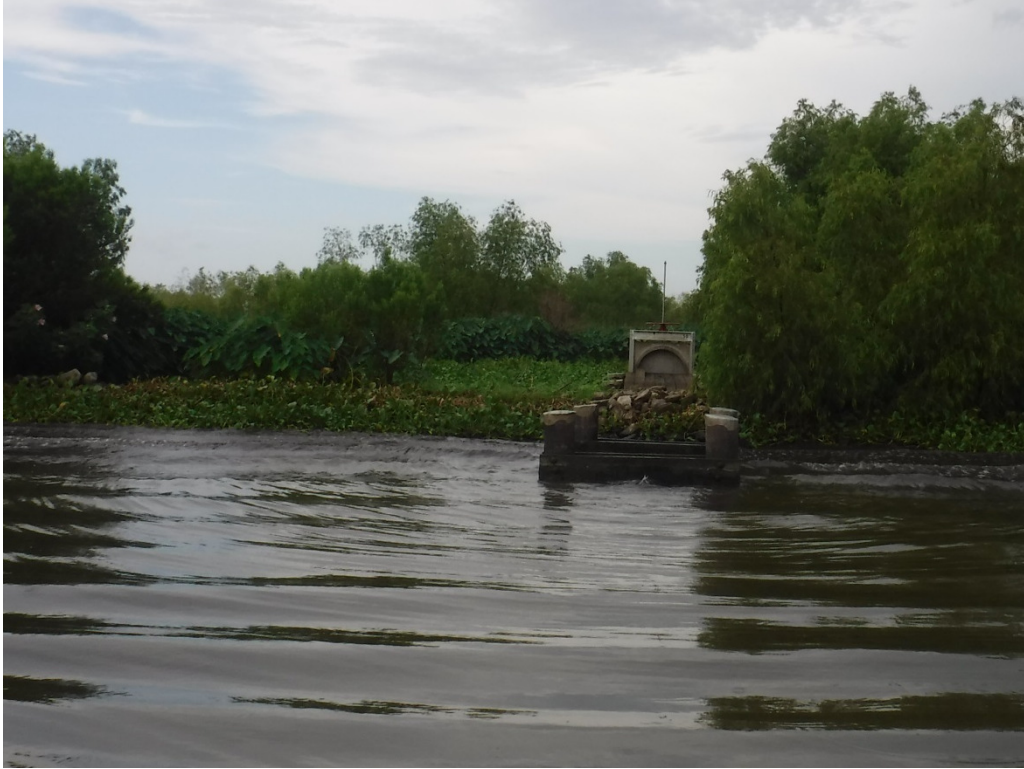
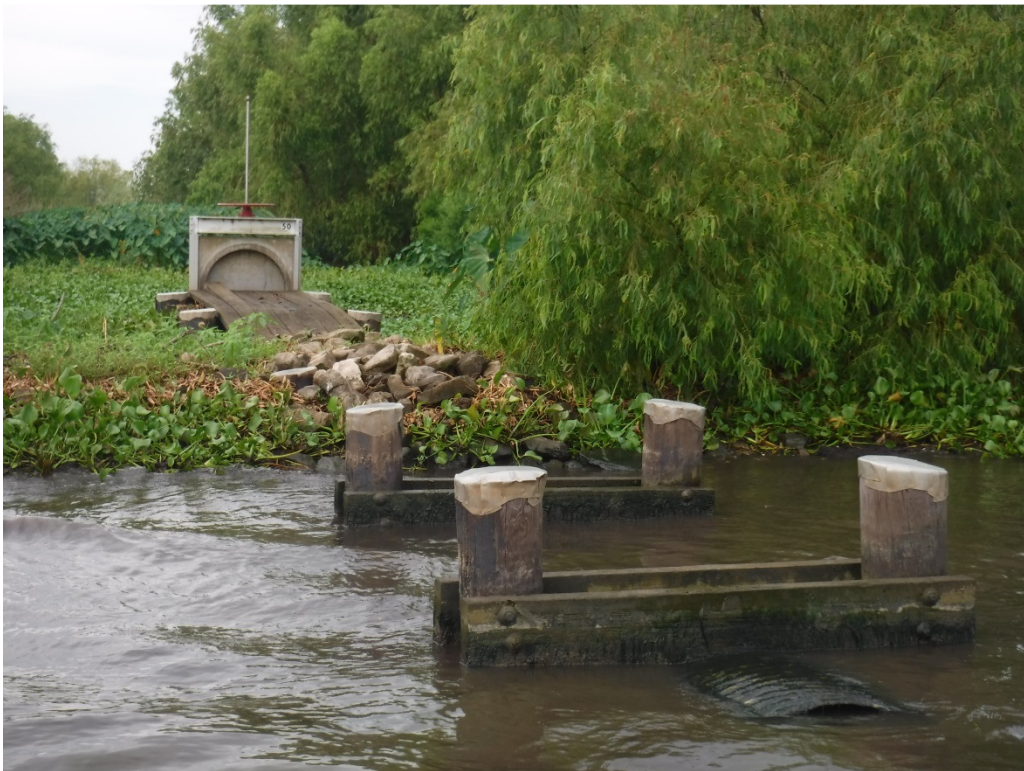
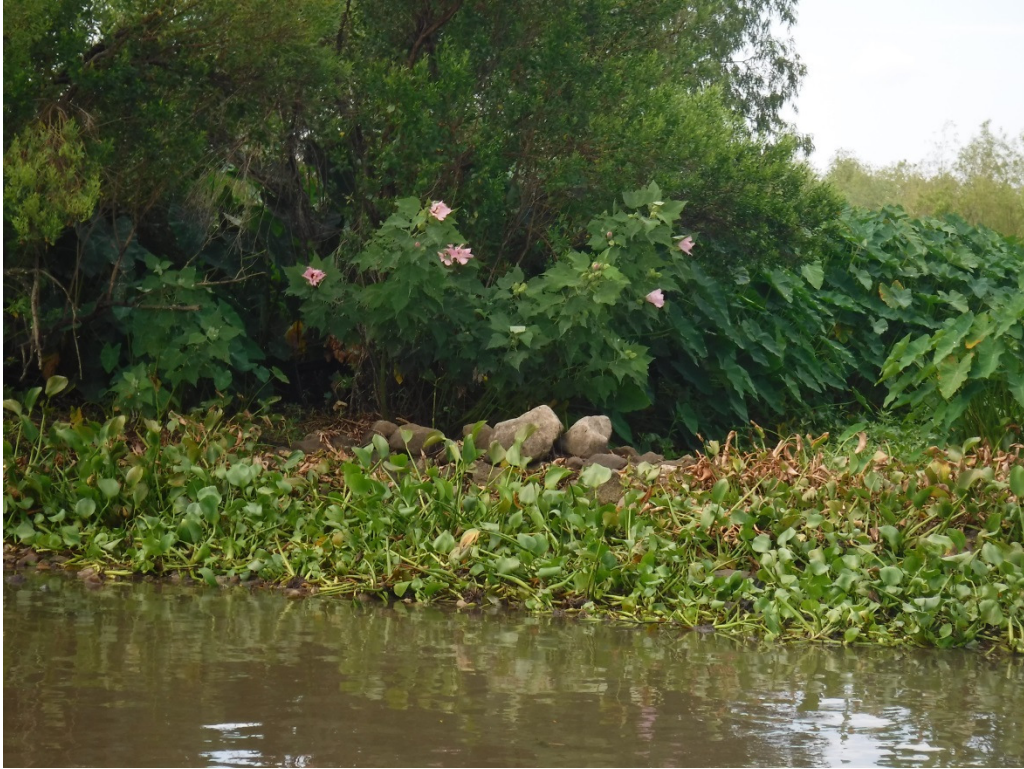
- F. **Site/Structure # 50** – The combination gate was in the up/open position. The breach in the rock dike was repaired with material from Site #32 and remains intact. The boardwalk remains bowed with one plank that is not attached to the support beams. There is vegetation covering about 70% or the rock dike. (See Photos 11 – 13)

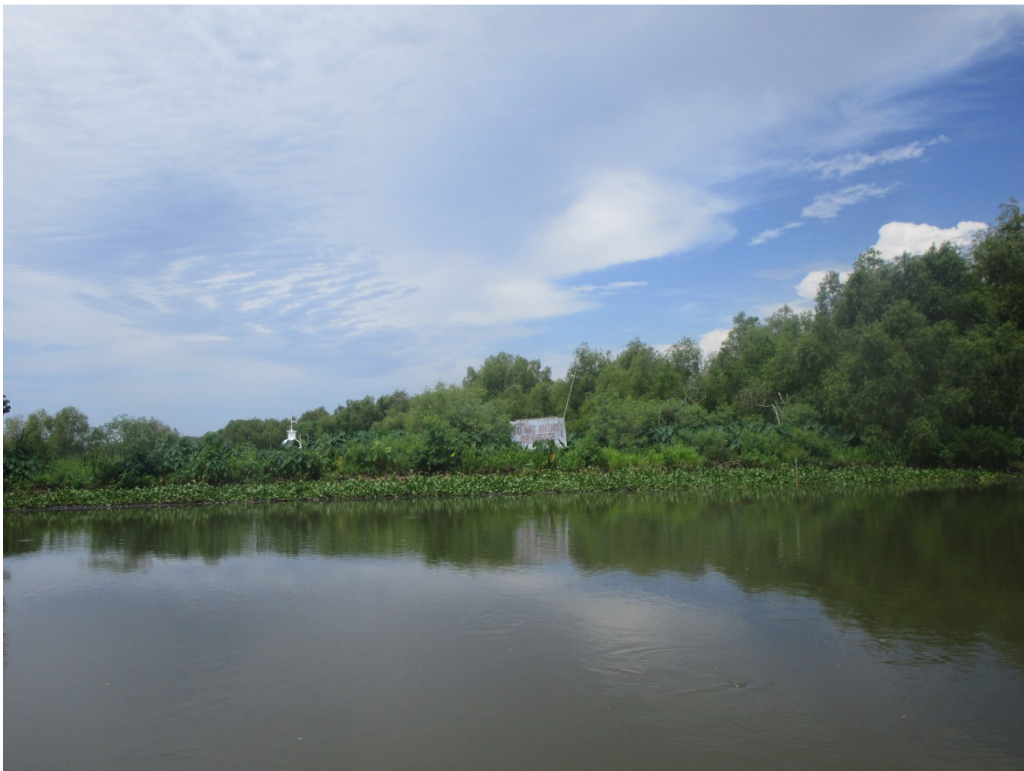
Photo No. 14, Site 51

- G. **Site/Structure #51** – Plug is heavily vegetated. Maintenance is not required at this structure. (See Photo 14)
- H. **Site/Structure #52** – The two combination gates were in the open position. A breach previously repaired by the dredging contractor has been re-opened and is between 20-25feet in width and estimated to be about 7 feet deep. The breach is allowing unimpeded flow between the channel and marsh. The boards are uneven when walked on and detached in some areas. (Photos 15 - 17)

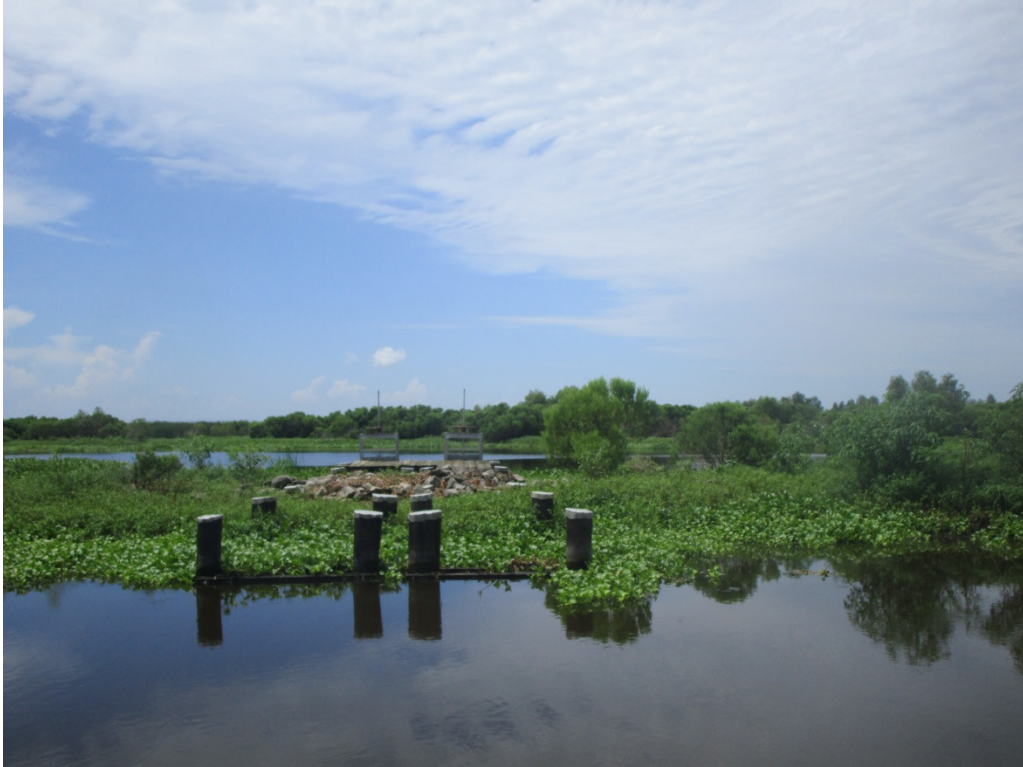
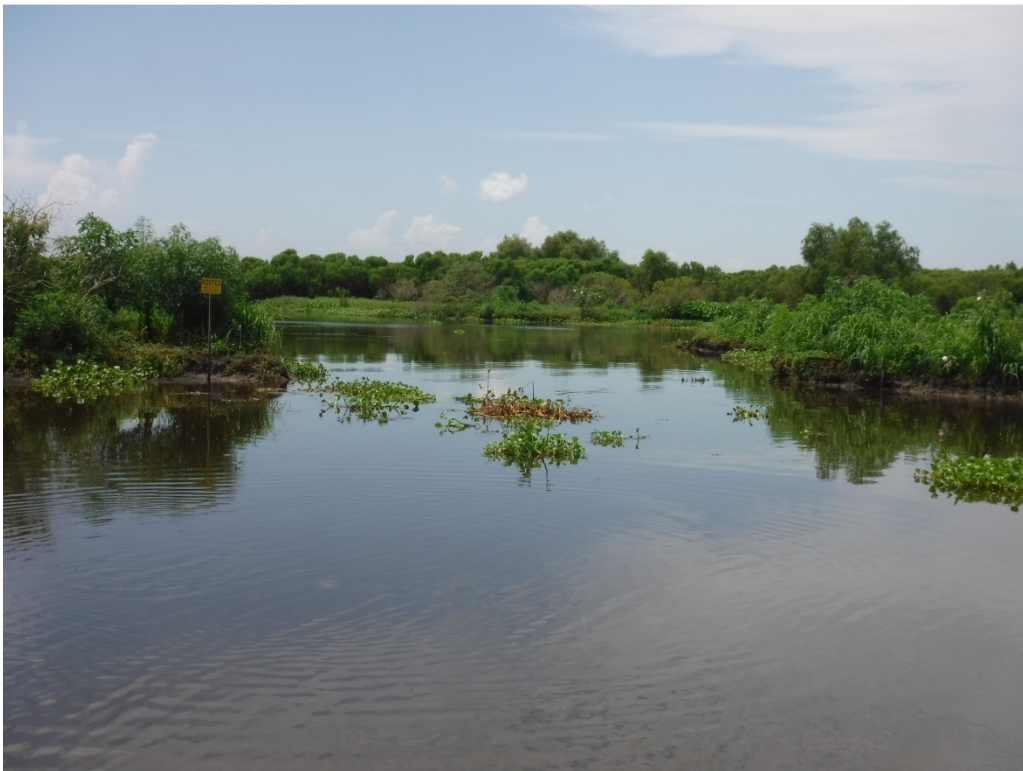
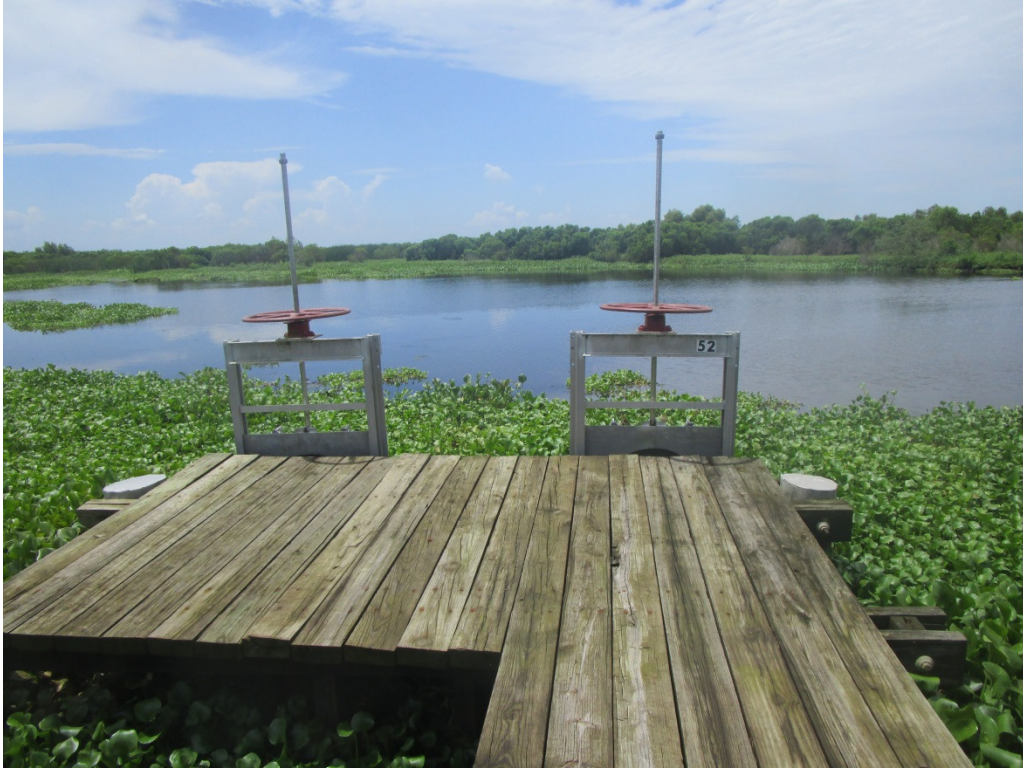
There is a gap at Site #52 which has been growing in size over the past few years. It is estimated to be 20 to 25 feet in width and the depth of the water is estimated to be around 7 feet. CPRA

and NRCS discussed with the contractor the possibility of using material from site #32 to plug the breach.

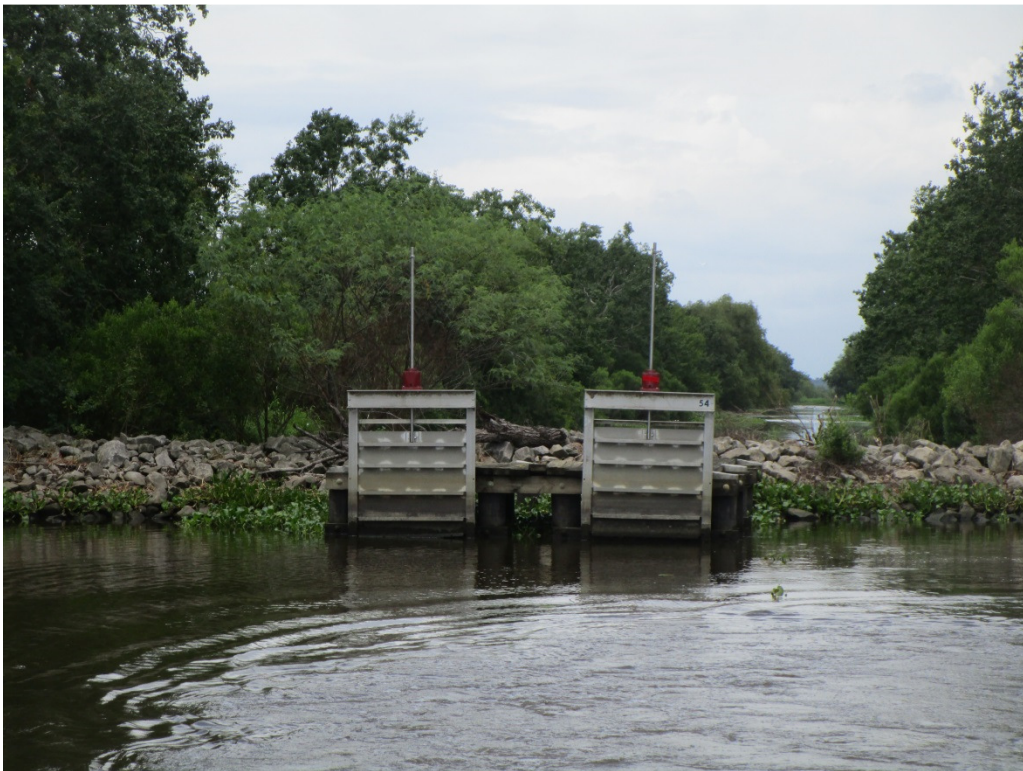
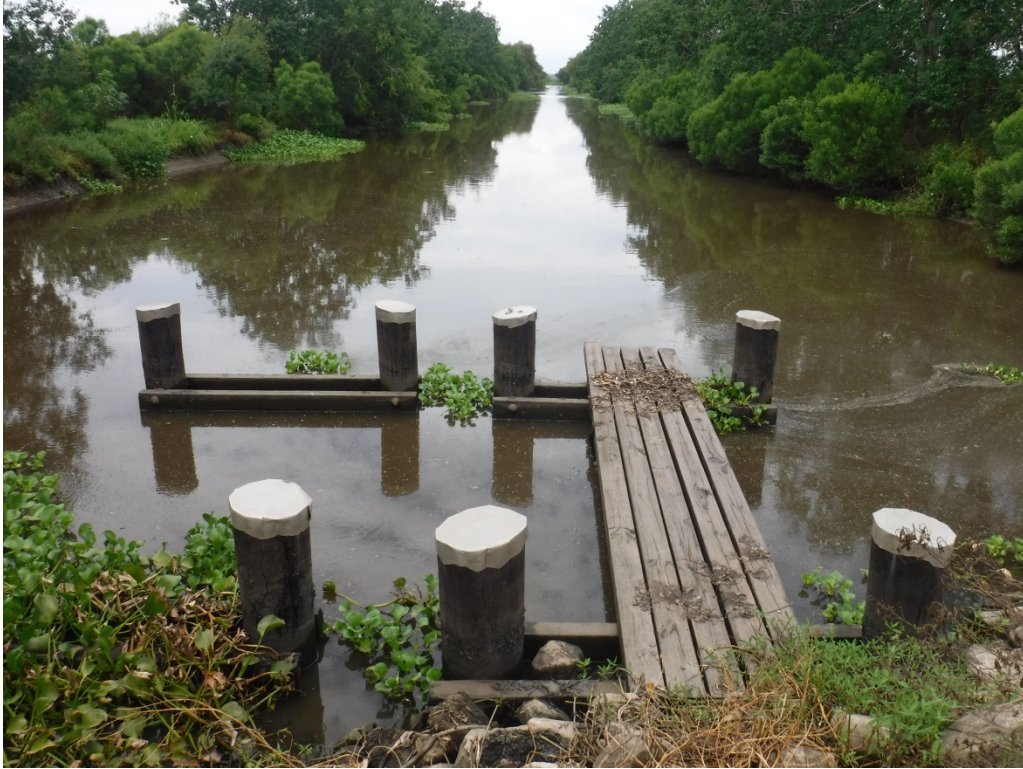
- I. **Site/Structure # 54** – The gates remain in the open position. No flow was visible through the culverts. The flow meter at this site was removed in December 2014 based on the decision to

discontinue flow monitoring at this structure. The rocks have been cleared of most vegetation. There are some barnacles on the gate and pilings, although they appear to be dead. (See 2012 Photos 18 & 19)

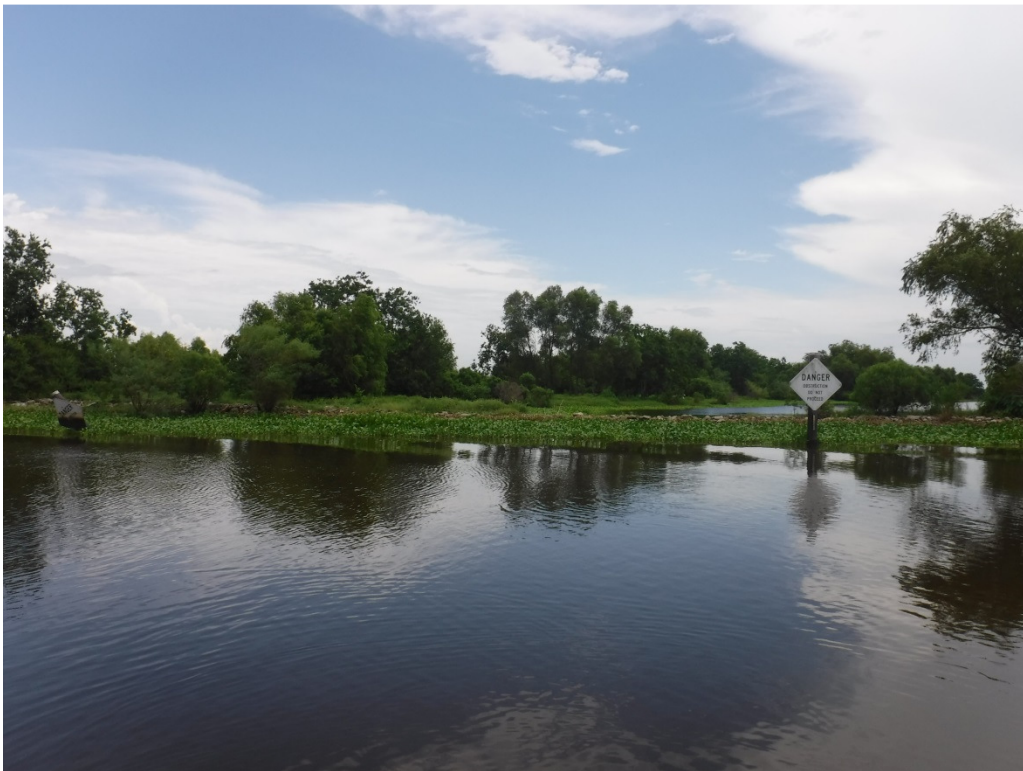
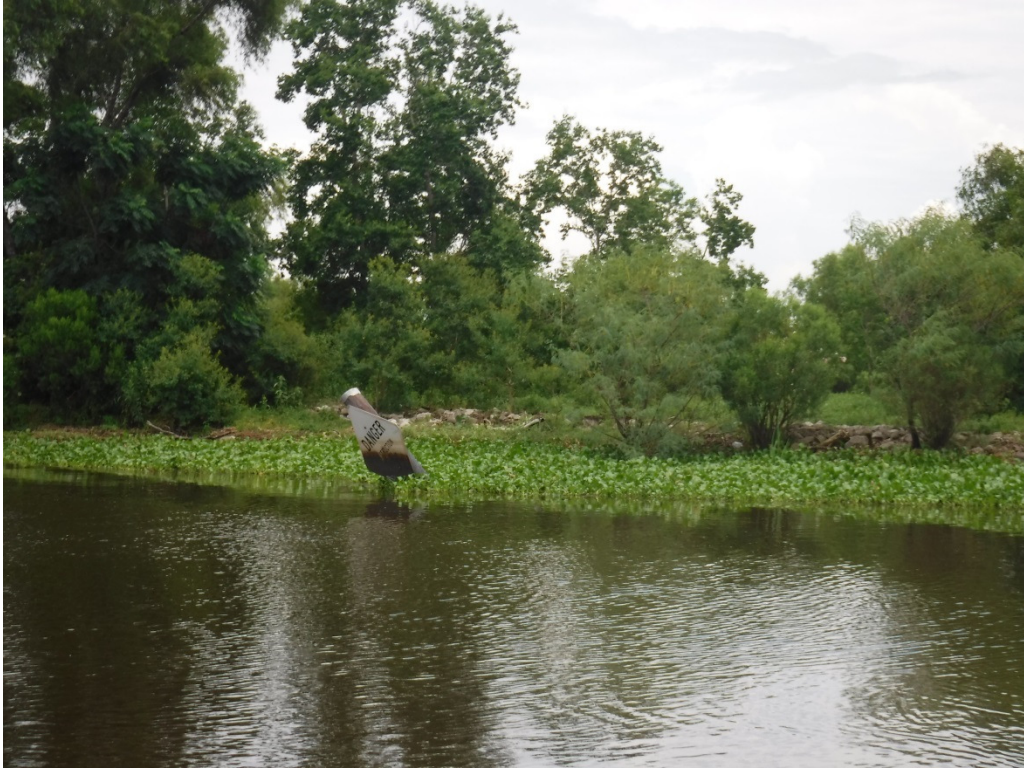
- J. Site/ Structure # 56** –There are large shrubs on about 20% of the rock dike. The water is slightly below the crest of the rock dike and there is no water exchange. One warning sign is still severely leaning and needs to be up righted and cleaned (Hurricane Katrina damage). (See Photos 20 & 21)

The warning sign on the west end of site #56 needs to be cleaned and the piling needs to be re-driven in an upright position.

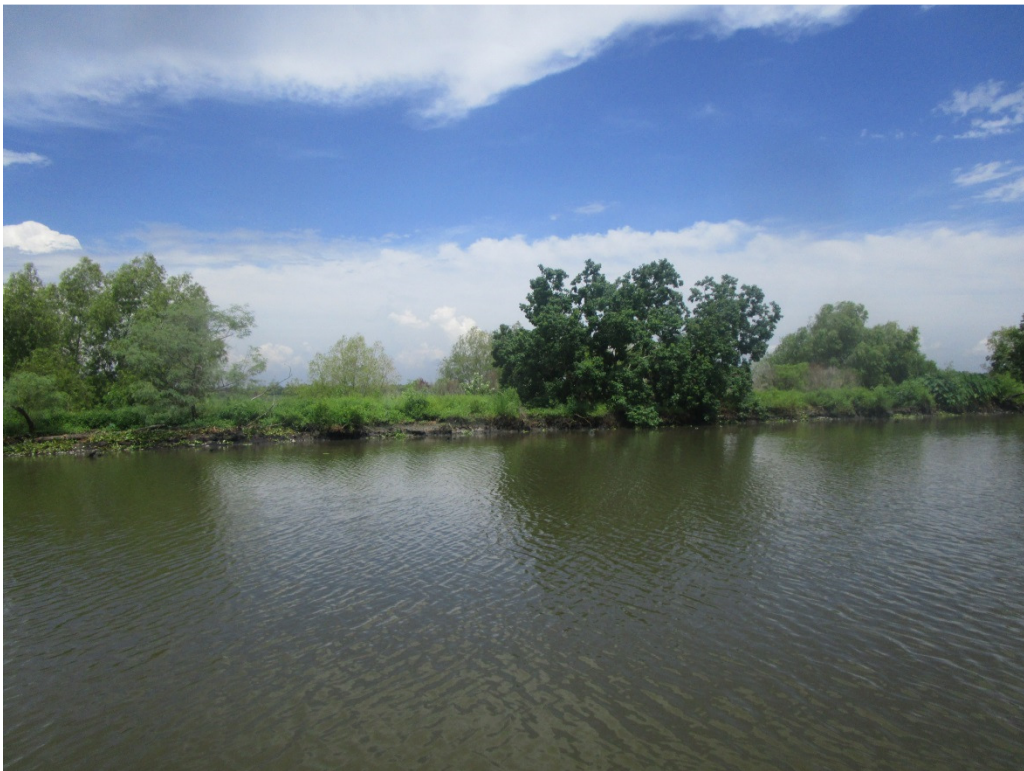
Photo No. 22, Site 58

- L. Site # 58** –The vegetation on the spoil bank along the sides of the Bayou Mandeville includes grasses, shrubs, and trees. No gaps were noticed, but there was one noticeable low spot, possibly from boats being pulled over at that point. Erosion was noticed along the spoil bank, likely caused by increased boat traffic. This has resulted in soil being washed off the roots of trees and the trees falling into the bayou. (See Photo 22)

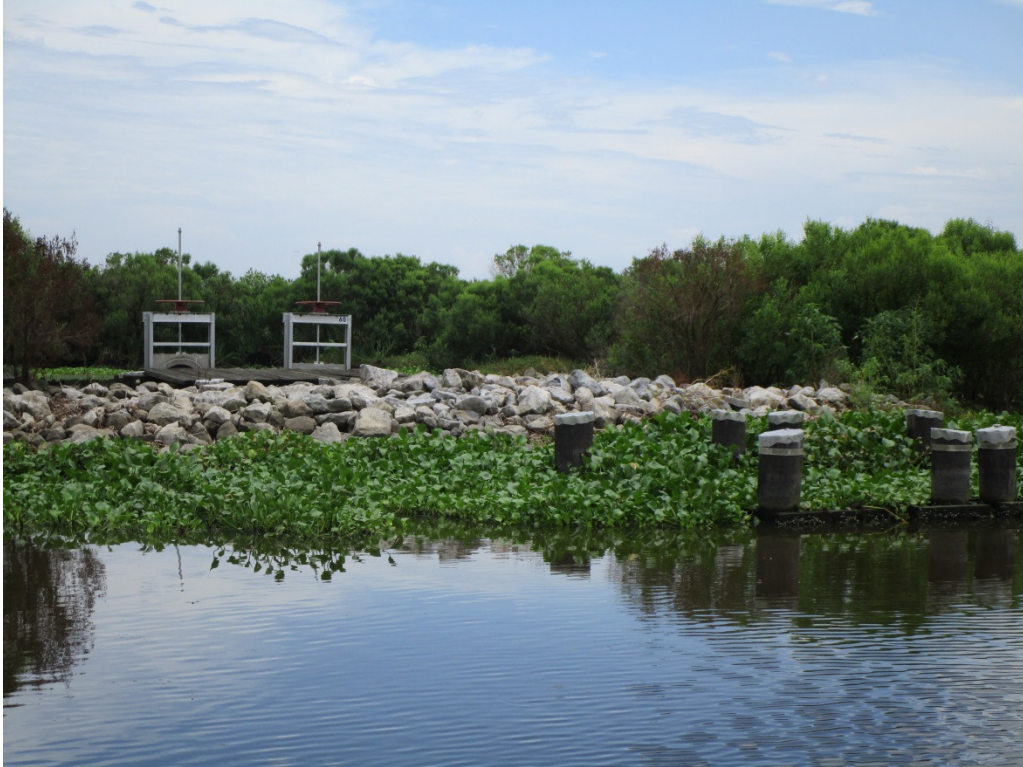
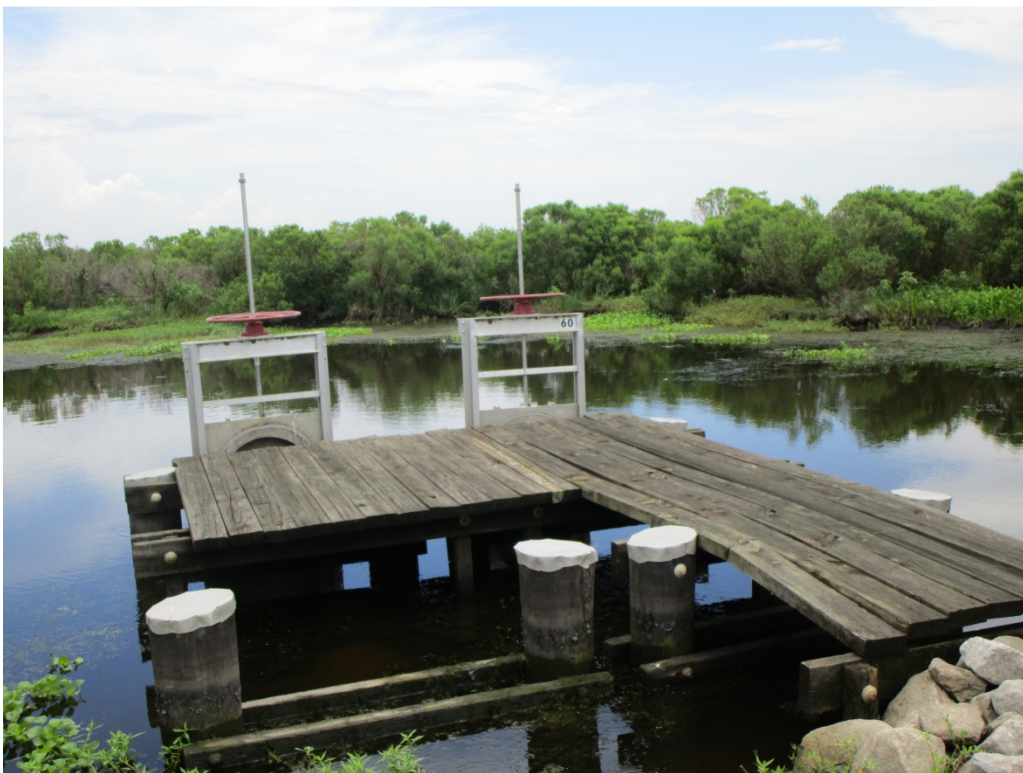
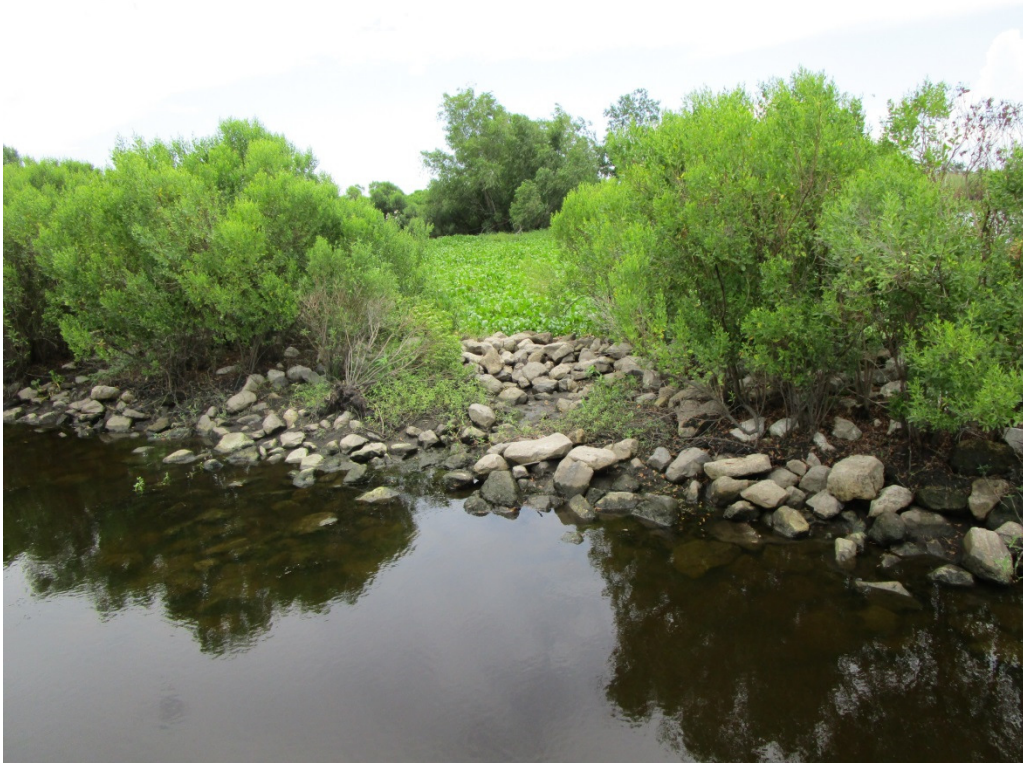
- M. Site/Structure # 60** – The two combination gates were in the up/open position. Overall condition of the structure is good. The small breach on the east side of the structure has been repaired using material from Site #32. There is a low area of rocks on the east side of the backside of the structure where it appears rocks have been moved from the dike into the adjacent water. (See Photos 23 - 25)
