**State of Louisiana  
Coastal Protection and Restoration Authority**

**2016 Annual Inspection Report**

**Fritchie Marsh Restoration**

State Project Number PO-06  
Priority Project List 2

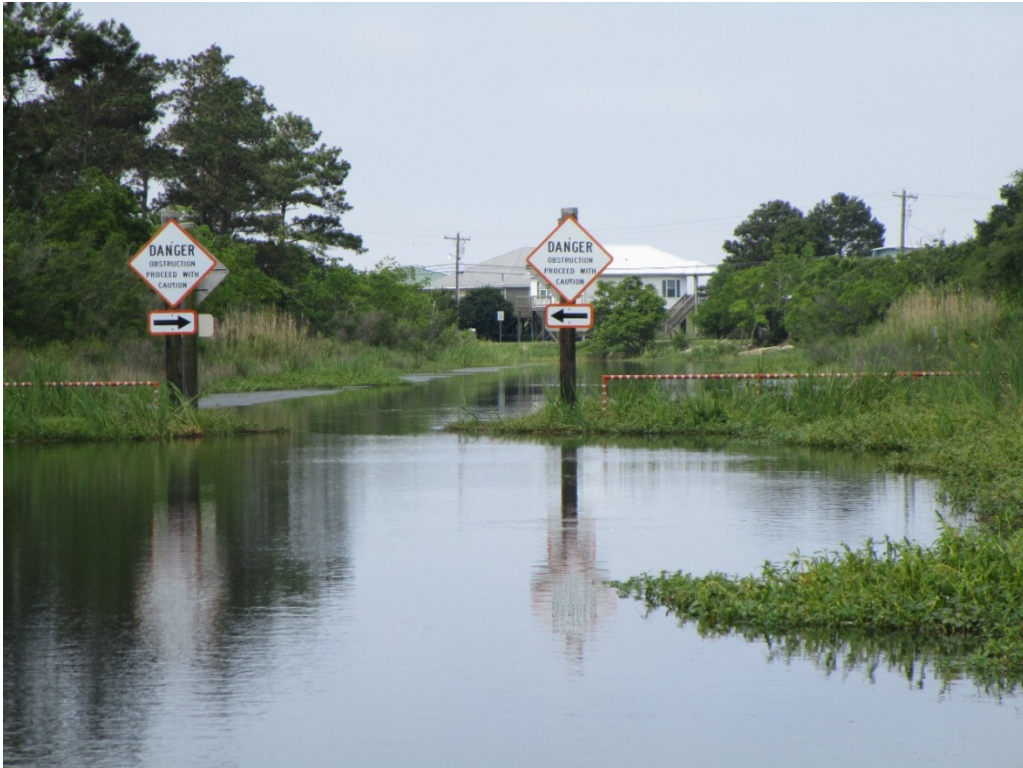
The weir structure was mostly surrounded by aquatic vegetation, but the boat bay was navigable. The visible portion of the handrails appeared to be in good condition. The new warning signs were in very good condition. No maintenance is required in this area at this time.

**Photo 1: W-14 Weir and Warning Signs**

Item	Condition	Physical Damage	Corrosion	Photo #	Observations and Remarks
Steel Bulkhead / Caps	Good	None	None	6	No significant defects noted.
Handrails, Grating, Hardware, etc.	Good	None	None	1	No significant defects noted.
Signage, Supports	Very Good	None	None	1	Signs and timber support piles appeared to be in very good condition.
RipRap channel lining	Good	None		4	Good condition. Rip-rap covered by concrete debris on South bank.
W-14 Weir structure	See remarks	See remarks		1	Structure was mostly hidden by emergent vegetation; strong flow was visible in channel.
W-14 diversion channel dredge	Good	None		2	Channel entrance is shallow but unobstructed. Emergent vegetation was present in outfall.
Salt Bayou dredging	See remarks	N/A		5	Salt Bayou was deep and unobstructed for about 4,500 feet downstream (marsh side) of culverts at US Hwy 90. Siltation was noted beginning at approx. Sta. 45+00 and continued southwest to Sta. 53+00.

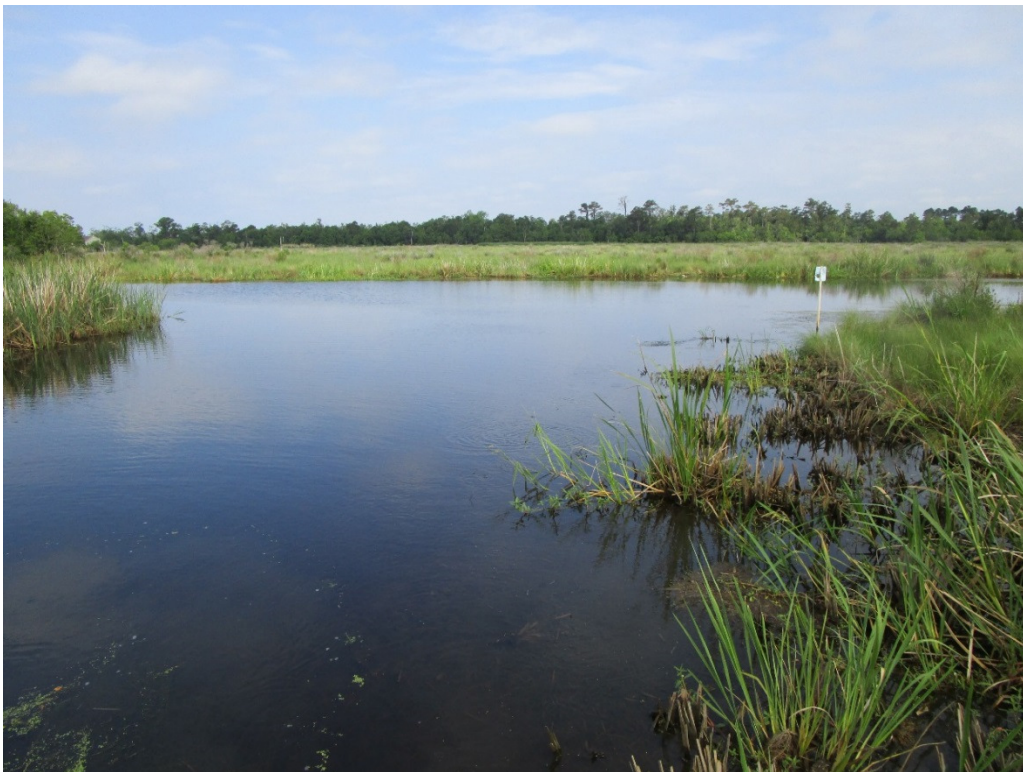
The channel inlet was shallow, but free of significant obstructions. Emergent aquatic vegetation was present in the channel outfall. The diversion channel appeared to be in generally good condition.

**Photo 2: W-14 Diversion Canal**

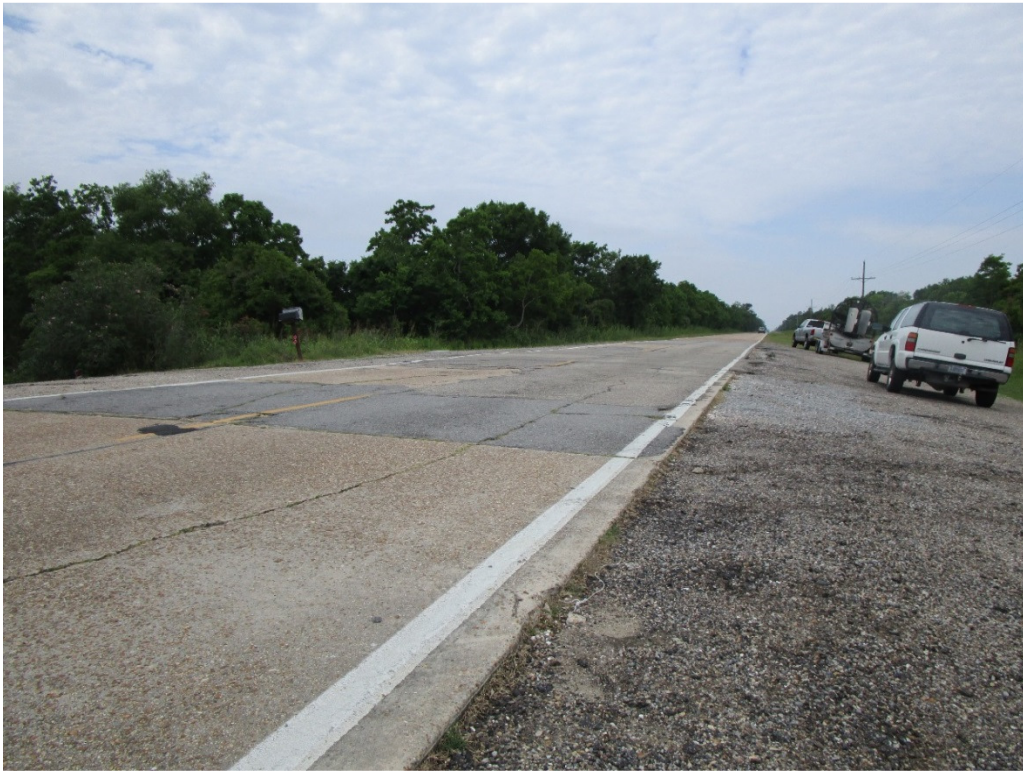
**Photo 3: Hwy. 90 Road Surface Above Culverts**

72" Diameter culvert	Good	None		4	No significant defects noted; water appeared to be flowing freely through culvert.
HWY 90 road surface	Good	None		3	No significant change since last inspection.

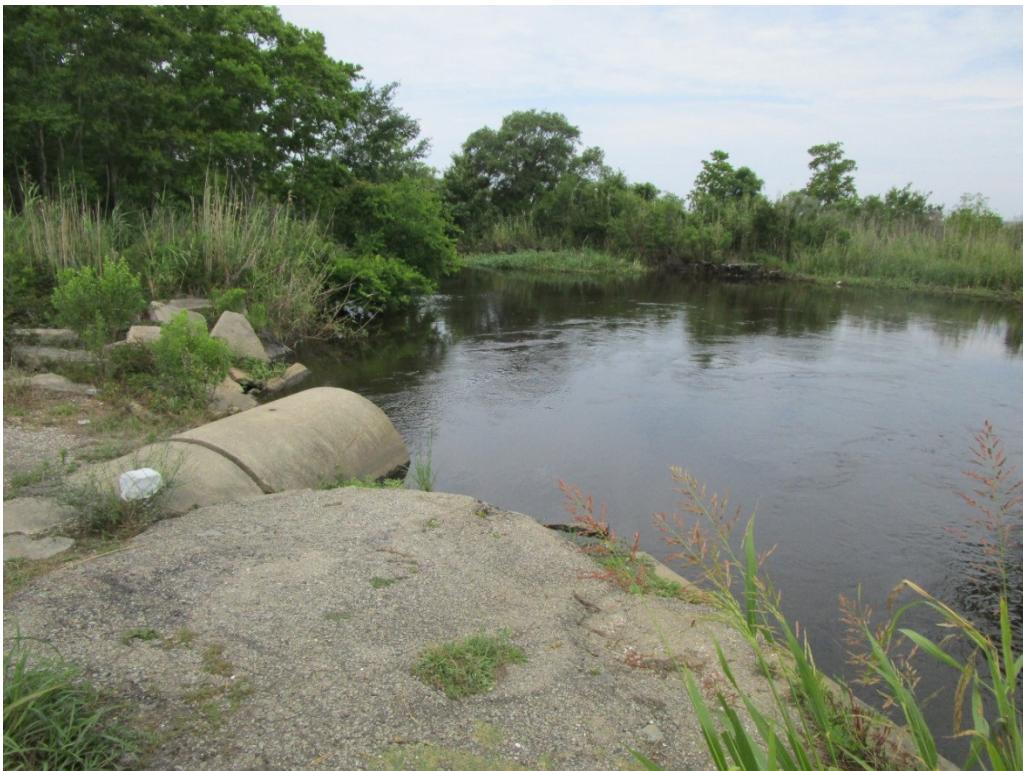
There is little change in this structure from the previous inspection. The bank scour reported in previous inspections appeared to have progressed very little, even with the extremely high water experienced during the Spring 2016 flooding. This area deserves continued observation during future inspections.

**Photo 4: Culverts Below Hwy. 90**

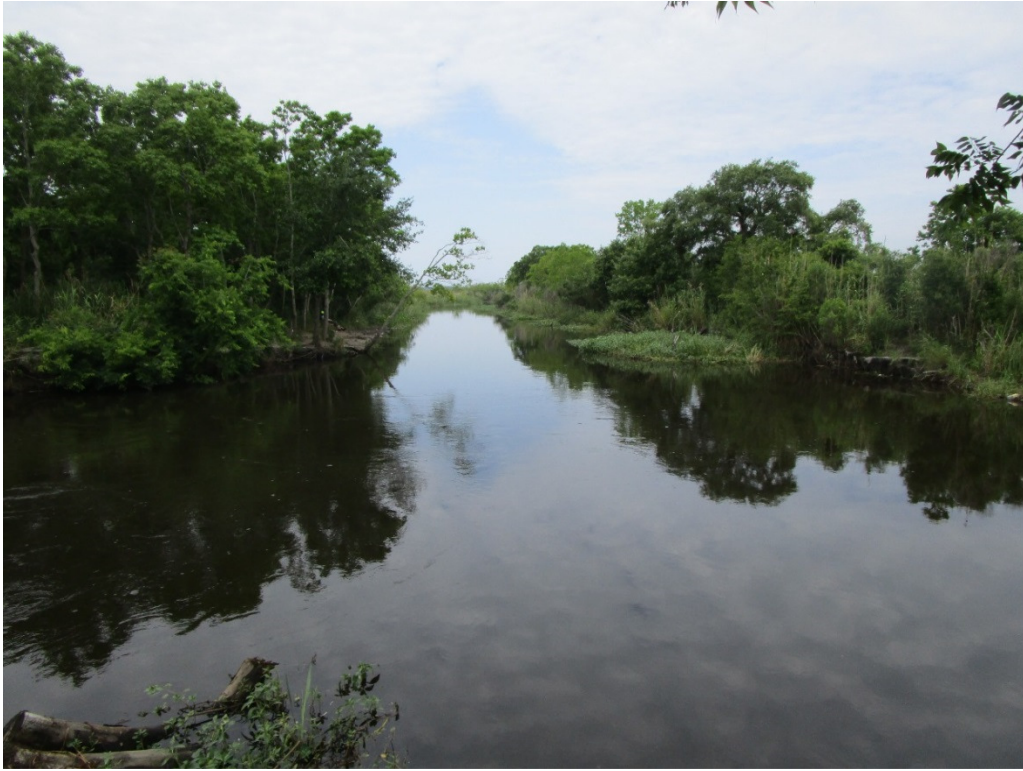
The inspection team travelled up Salt Bayou via airboat and noted that the bayou appeared to be in generally good condition for much of the CWPPRA-dredged length. An inspection in December 2015 determined that significant siltation of the bayou begins at approximately 4,500 feet downstream of the culvert and remains shallow for several thousand feet beyond the end of dredging at 5,300 feet downstream of the culvert. This condition appeared to be relatively unchanged. A steady flow of water was observed flowing into the project area.

**Photo 5: Salt Bayou Flowing into Project Area**

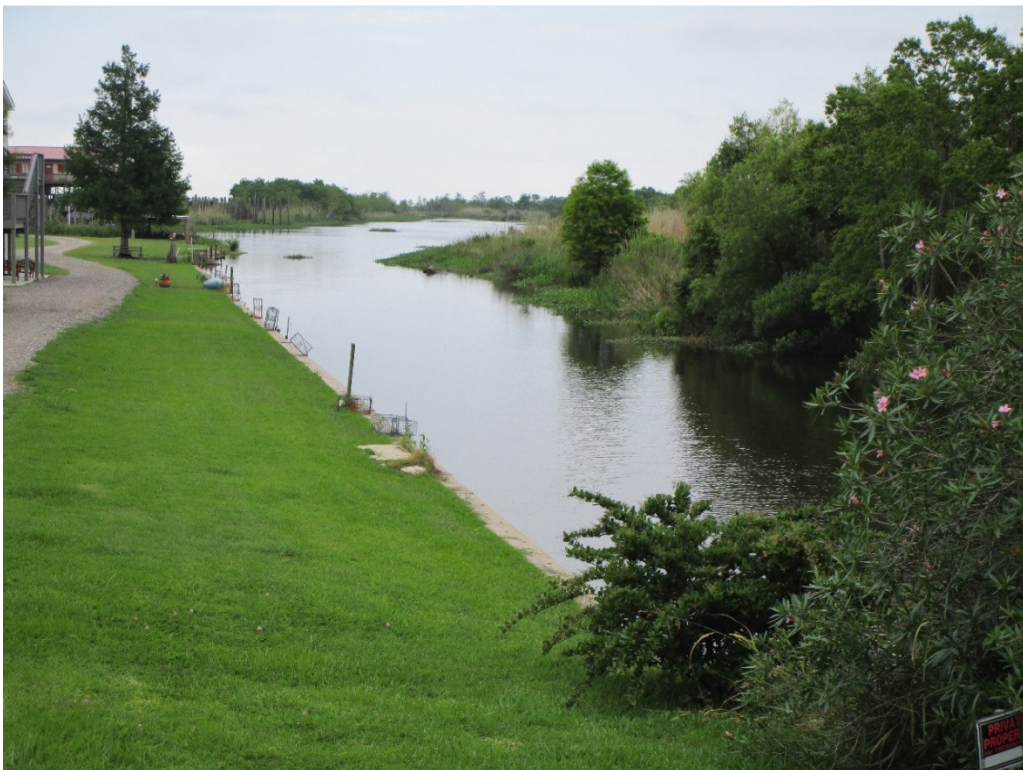
**Photo 6: Bulkhead on Southeast Side of Hwy. 90**
