**State of Louisiana  
Coastal Protection and Restoration Authority**

**2016 Annual Inspection Report**

**Mississippi Sediment Delivery System –  
Bayou Dupont**

State Project Number BA-39  
Priority Project List 12

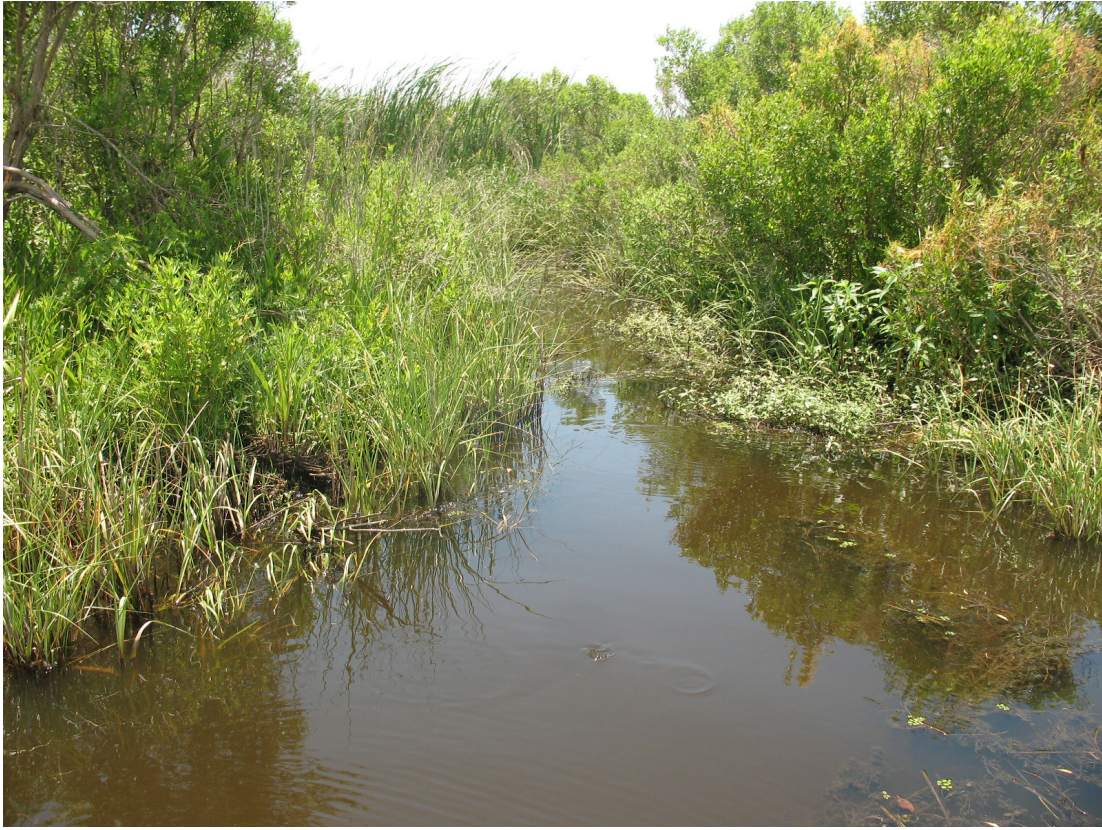
**Photo # 1 – Containment Dike Gap - Marsh Creation Area 2**

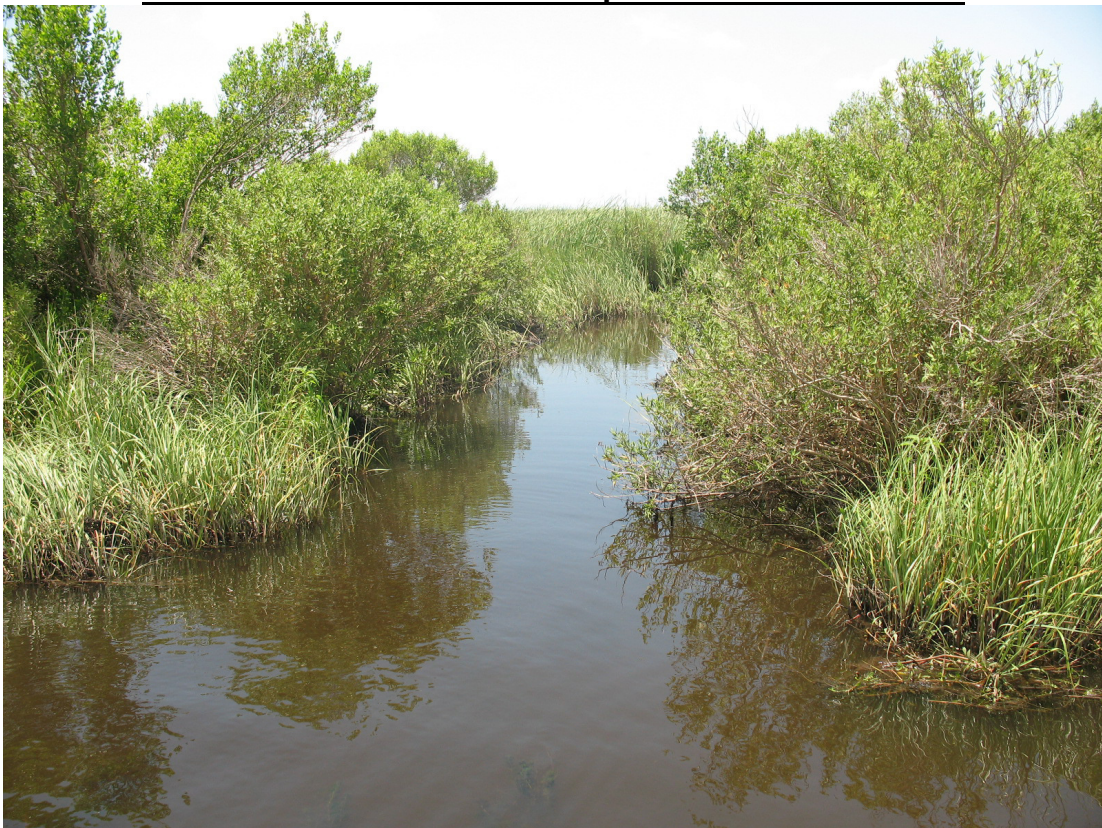
**Photo # 2 – Containment Dike Gap - Marsh Creation Area 1**

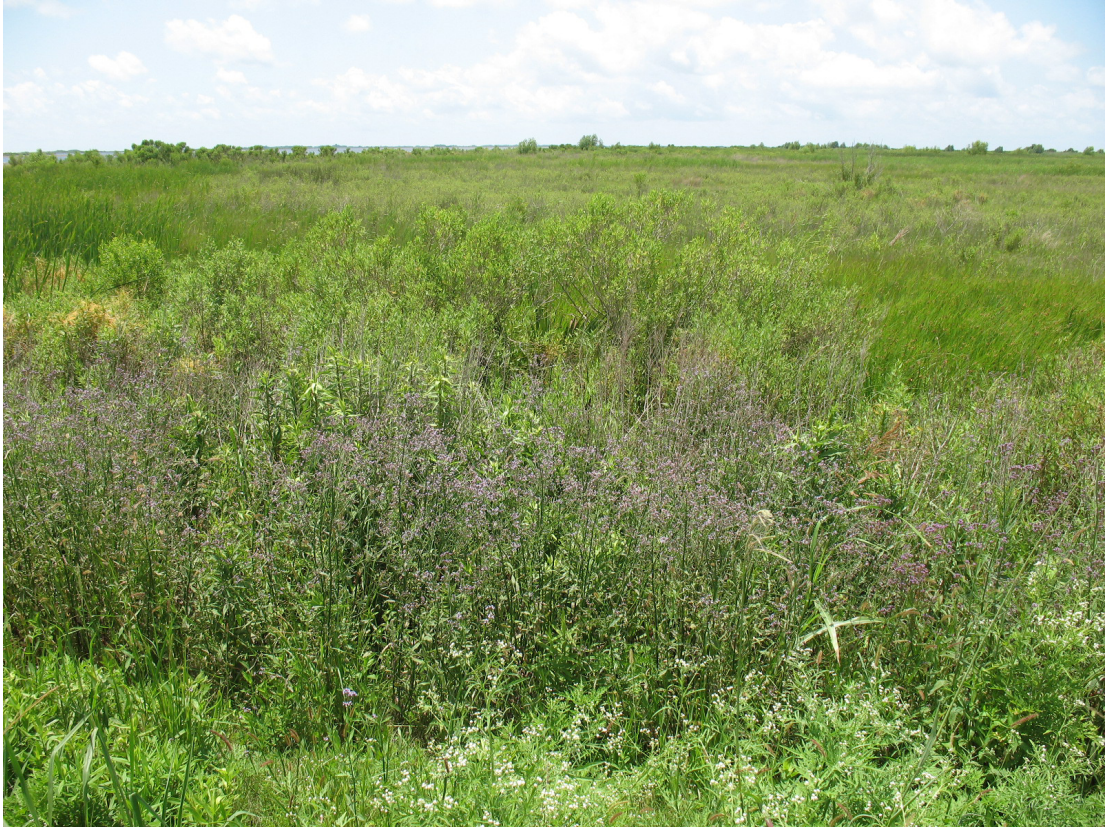
**Photo # 3 – Marsh Creation Area 1**

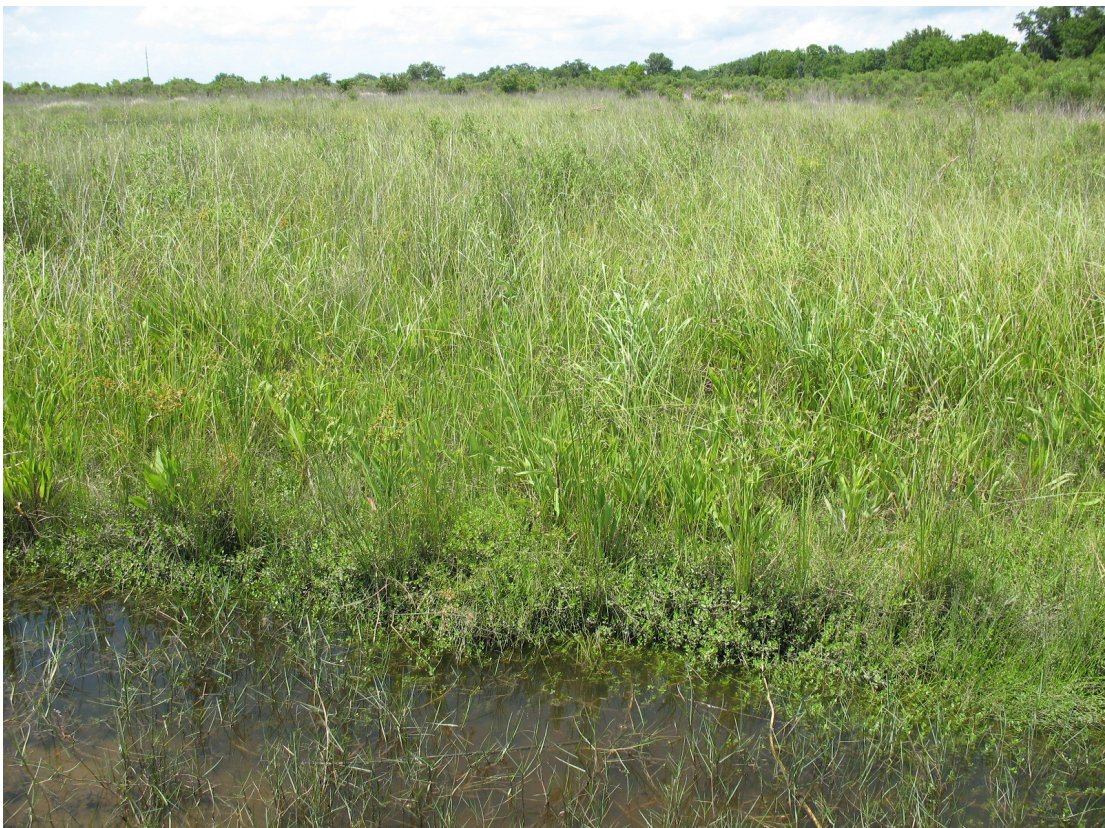
**Photo # 4 – Marsh Creation Area 2**
