**State of Louisiana
Coastal Protection and Restoration
Authority**

**2016 Operations, Maintenance,
and Monitoring Report**

**Caernarvon Diversion Outfall
Management (BS-03a)**

July 28, 2016
Plaquemines Parish

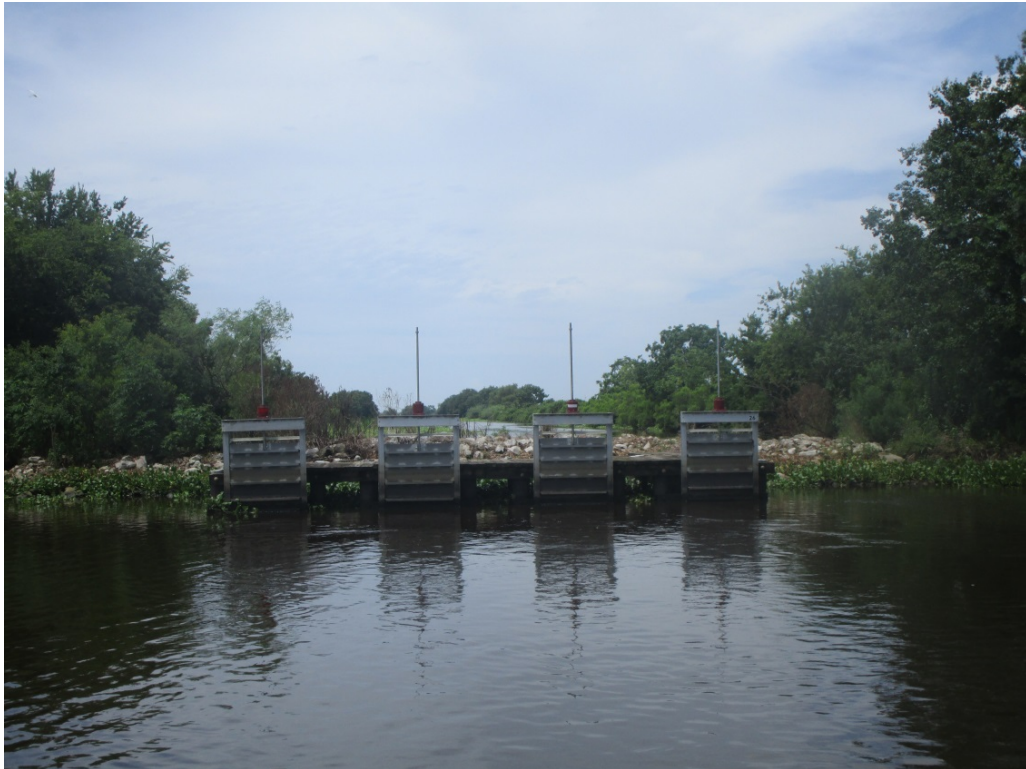
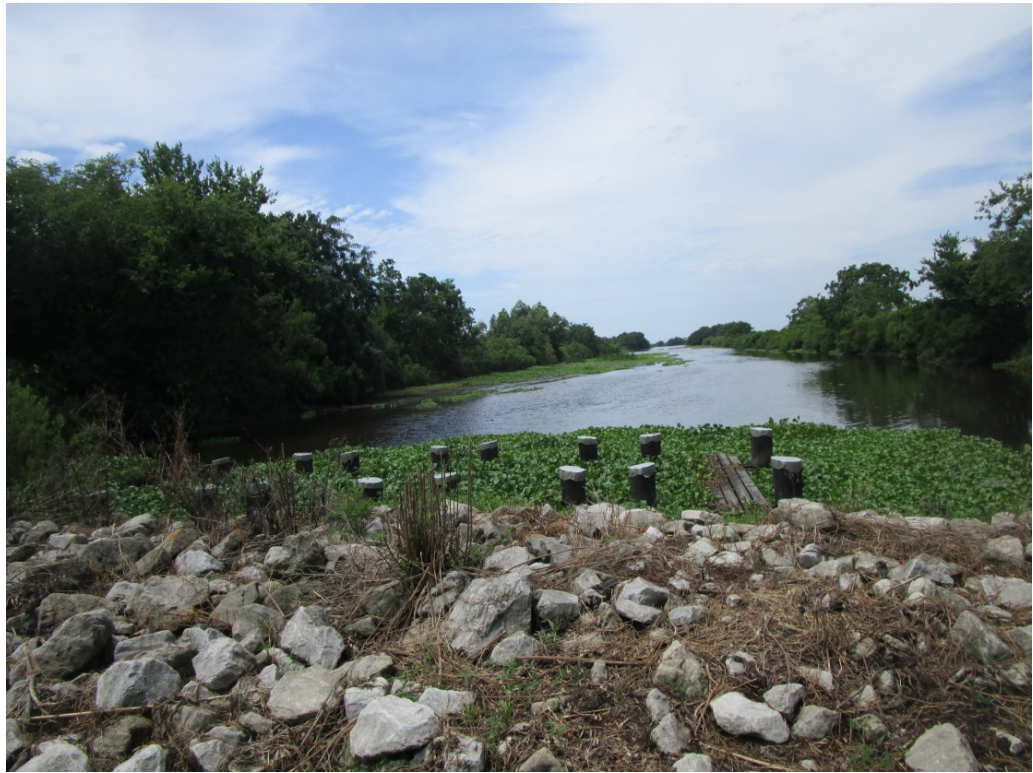
- B. Site/Structure # 25** – The inspection team did not attempt to inspect this feature as the site was inaccessible. (No Photo)
- C. Site/Structure # 26** – The gates were in the open position allowing water flow. There was vegetation covering approximately 30% of the earthen/rock closure, though some had been cleared since the last inspection. The structure and outfall appear to be in good condition. The boardwalk on the back side of the structure was partly covered with water hyacinth. (See Photos 4 & 5)

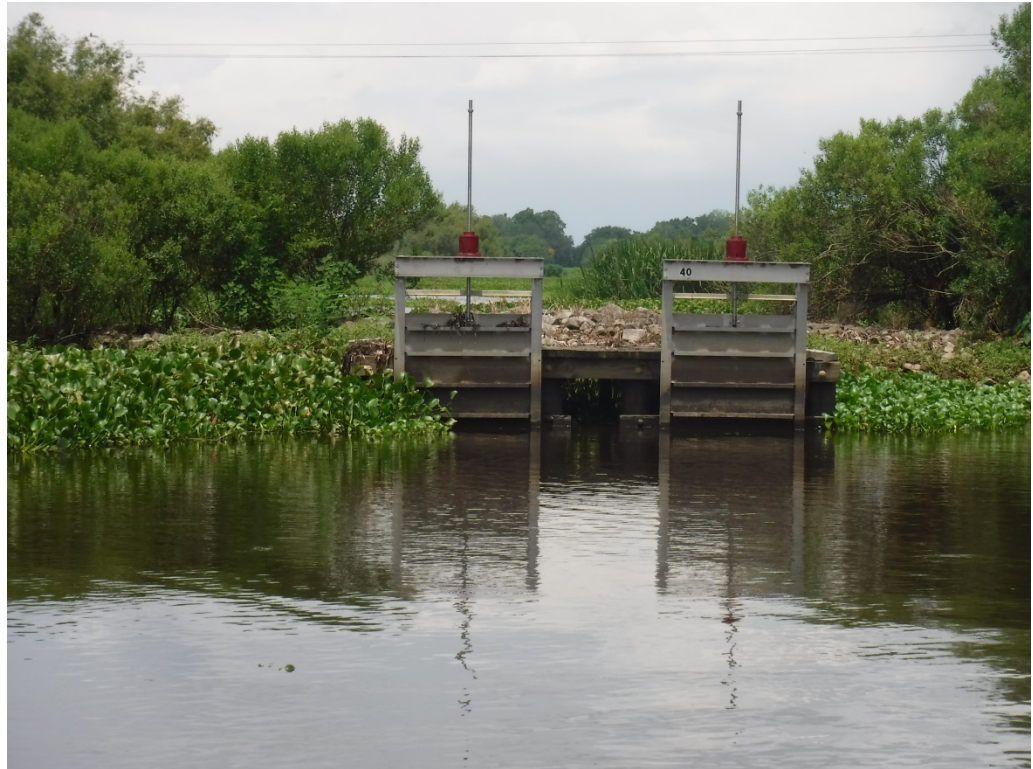
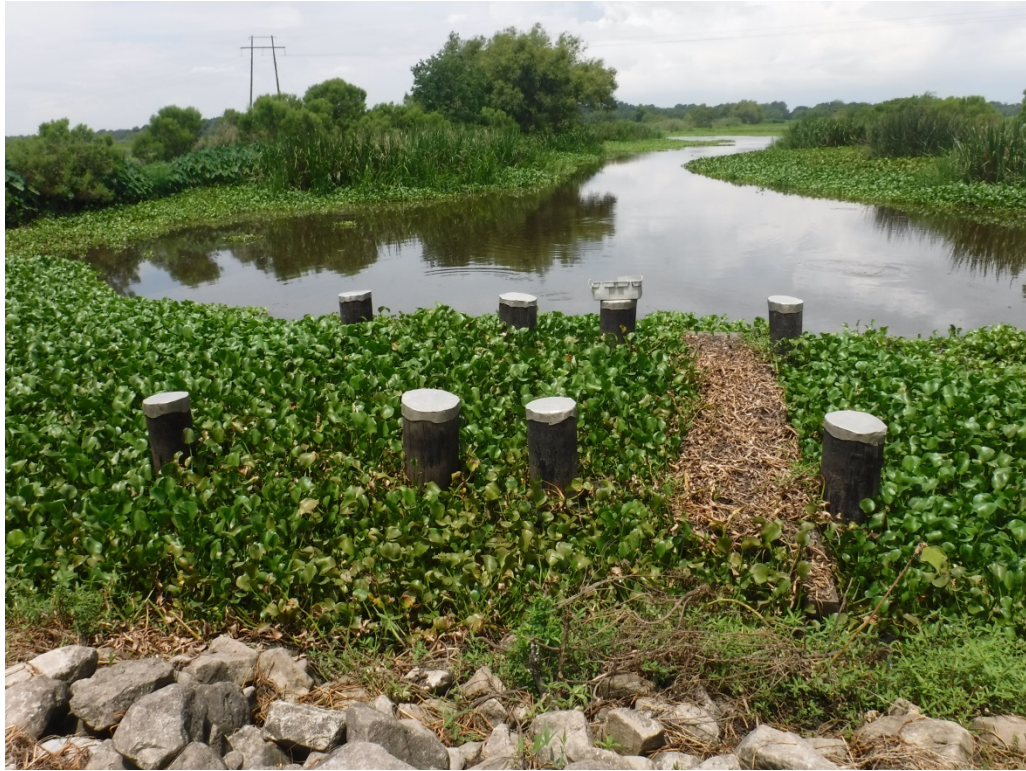
- E. Site/ Structure # 40** – The gates remained in the open position. The structure was in good condition. Dead water hyacinth covered the boardwalk on the back side of the structure. (See Photos 6 & 7)

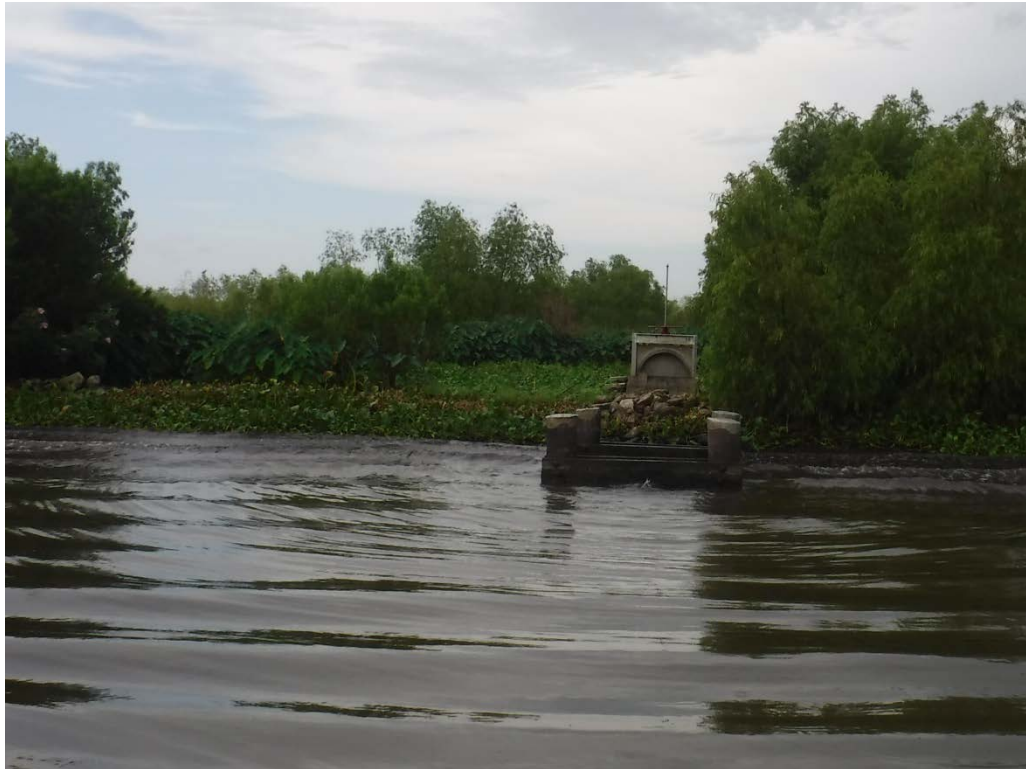
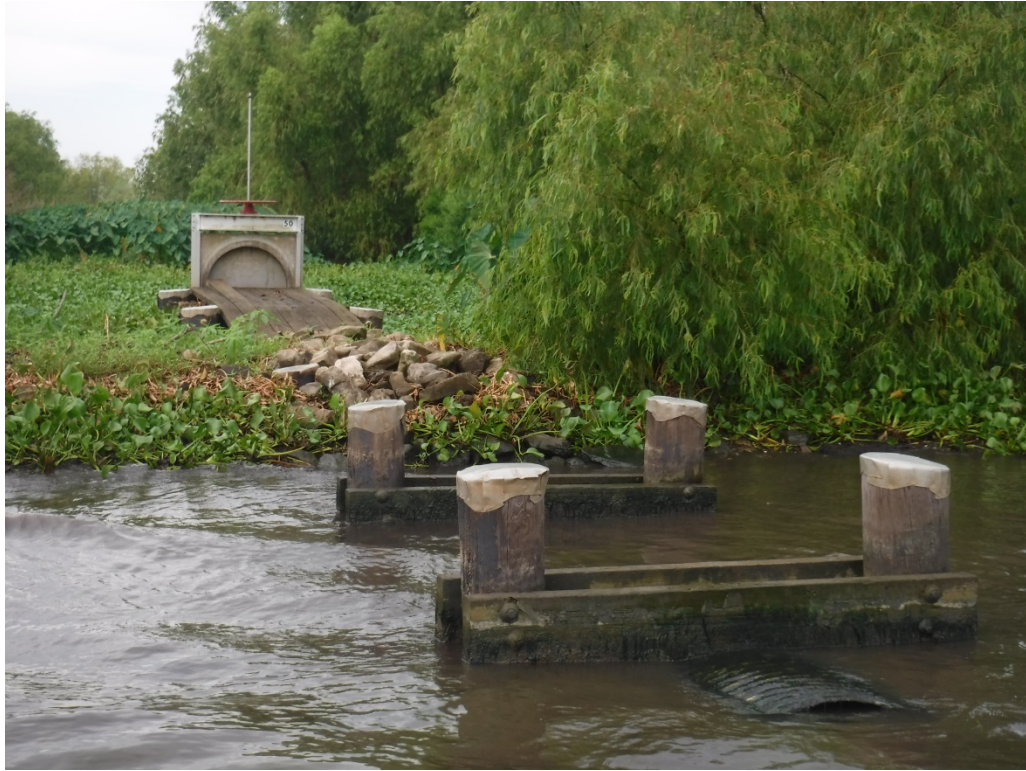
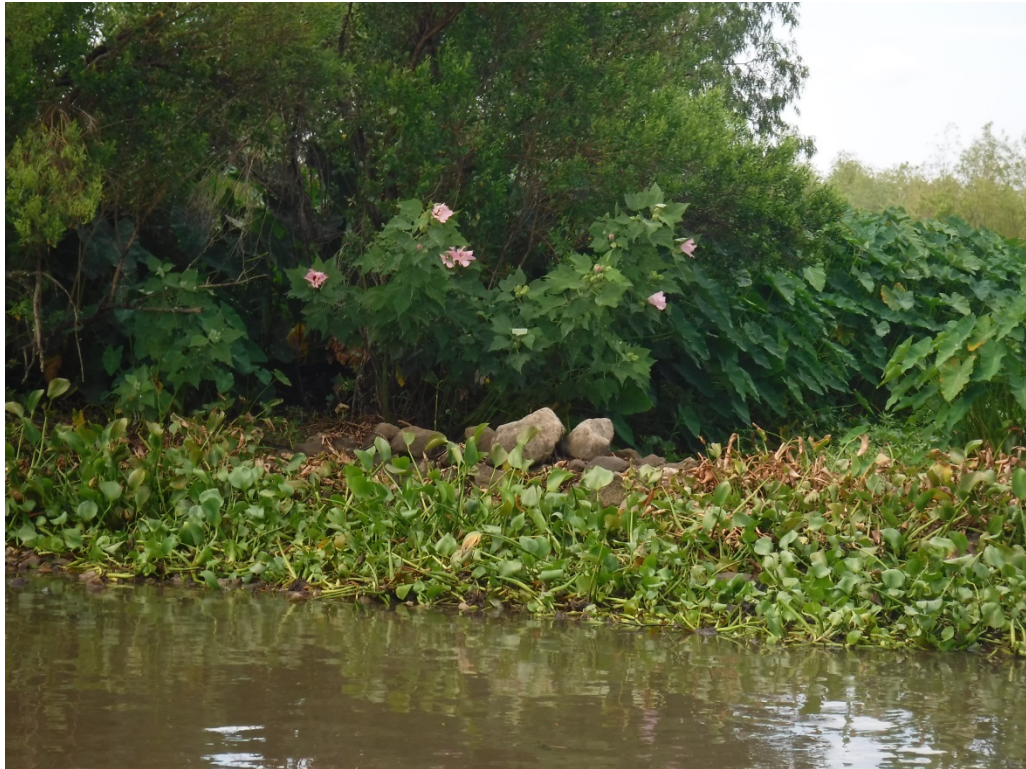
- F. Site/Structure # 50** – The combination gate was in the up/open position. The breach in the rock dike was repaired with material from Site #32 and remained intact. The boardwalk remained bowed with one plank that was not attached to the support beams. There was vegetation covering approximately 70% of the rock dike. (See Photos 8 - 10)

The CPRA recommends repair of the decks at structures #13 and #50. The deck at structure #13 is not attached to the supports at one end, and the deck at structure #50 is bowed with one plank detached.

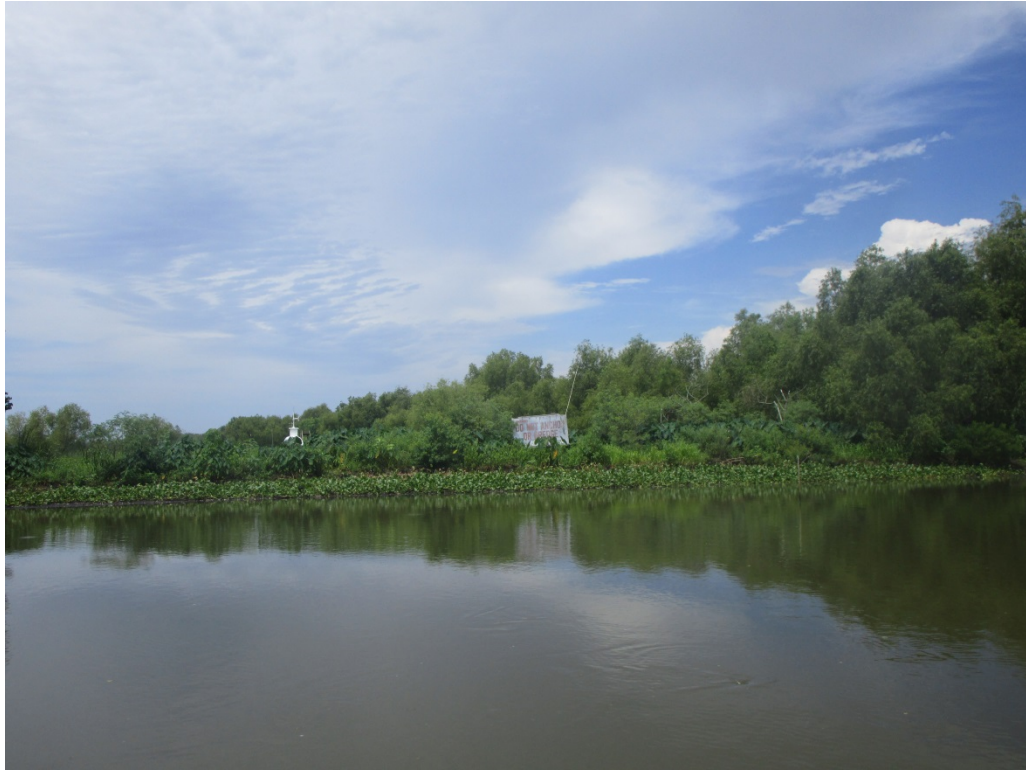
Photo No. 11, Site 51

- G. Site/Structure #51** – Plug was heavily vegetated and remained at proper elevation. (See Photo 11)
- H. Site/Structure #52** – The two combination gates were in the open position. A breach previously repaired by the dredging contractor had re-opened and was between 20-25 feet in width and estimated to be about 7 feet deep. The breach was allowing unimpeded flow between the channel and marsh. The boards were uneven when walked on and detached in some areas. (See Photos 12 - 14)

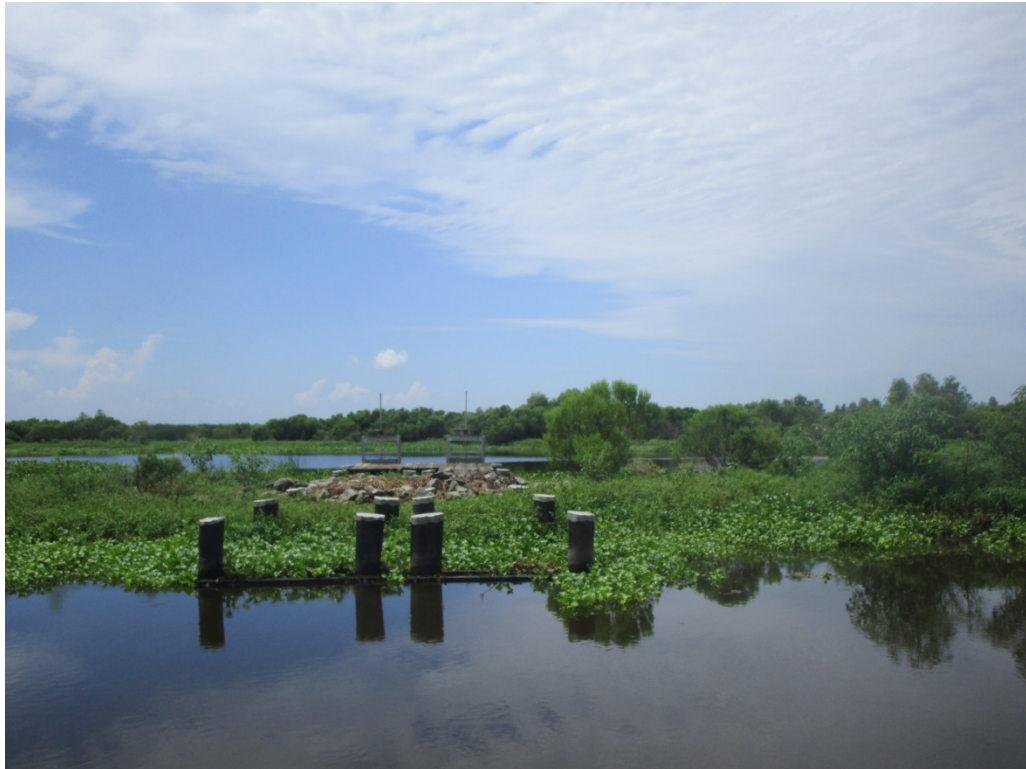
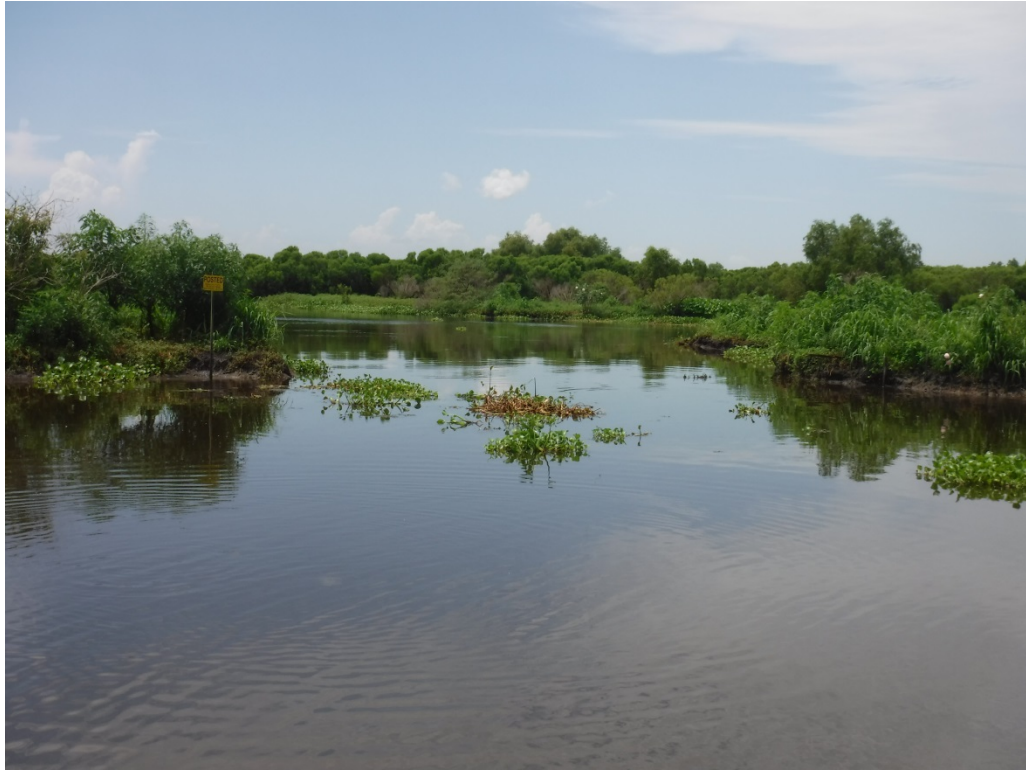
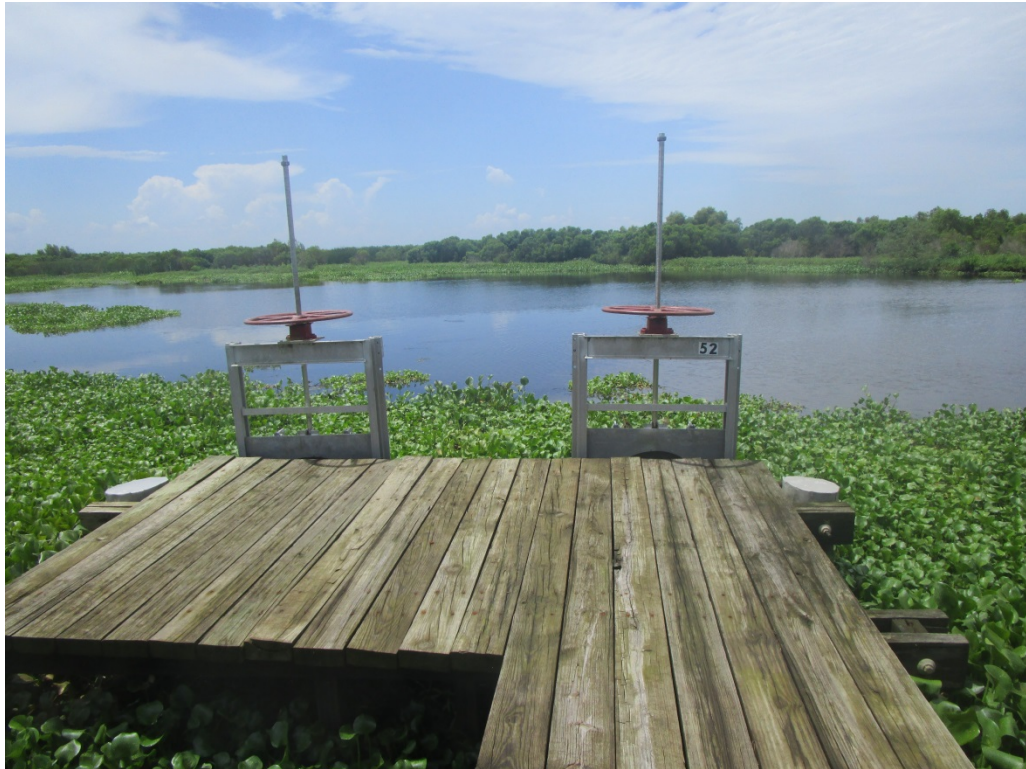
There is a gap at Site #52 which has been increasing in size over the past few years. It is estimated to be 20 to 25 feet in width and the depth of the water is estimated to be around 7 feet. CPRA and NRCS recommended using material from site #32, before it is covered, to plug the breach.

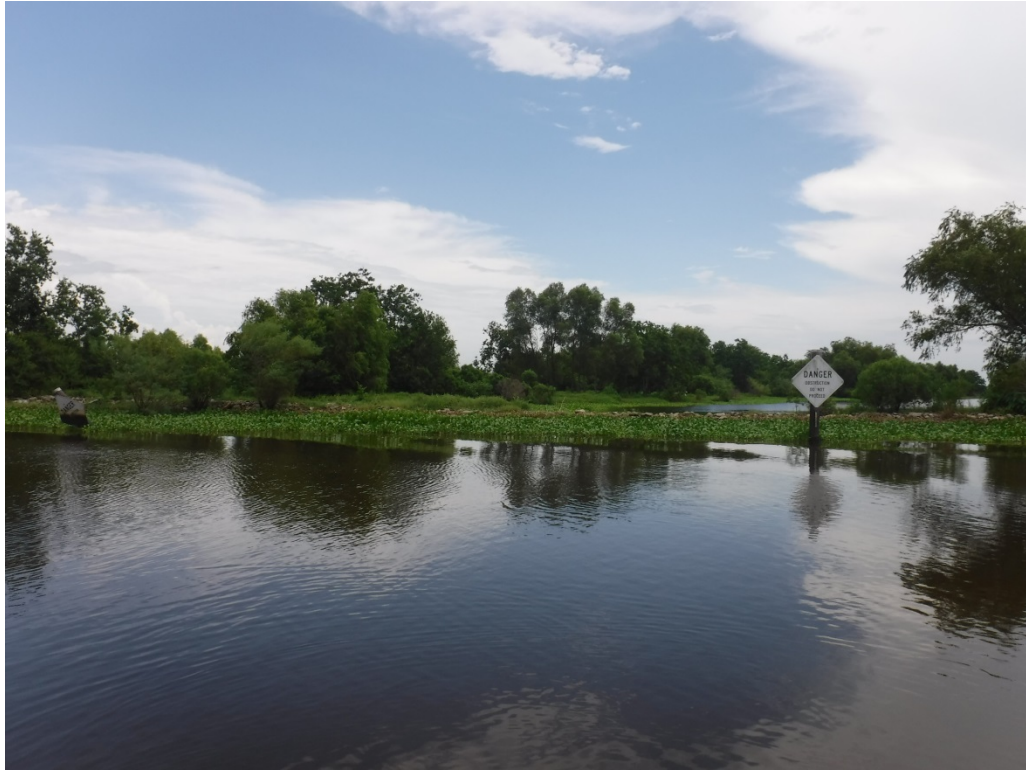
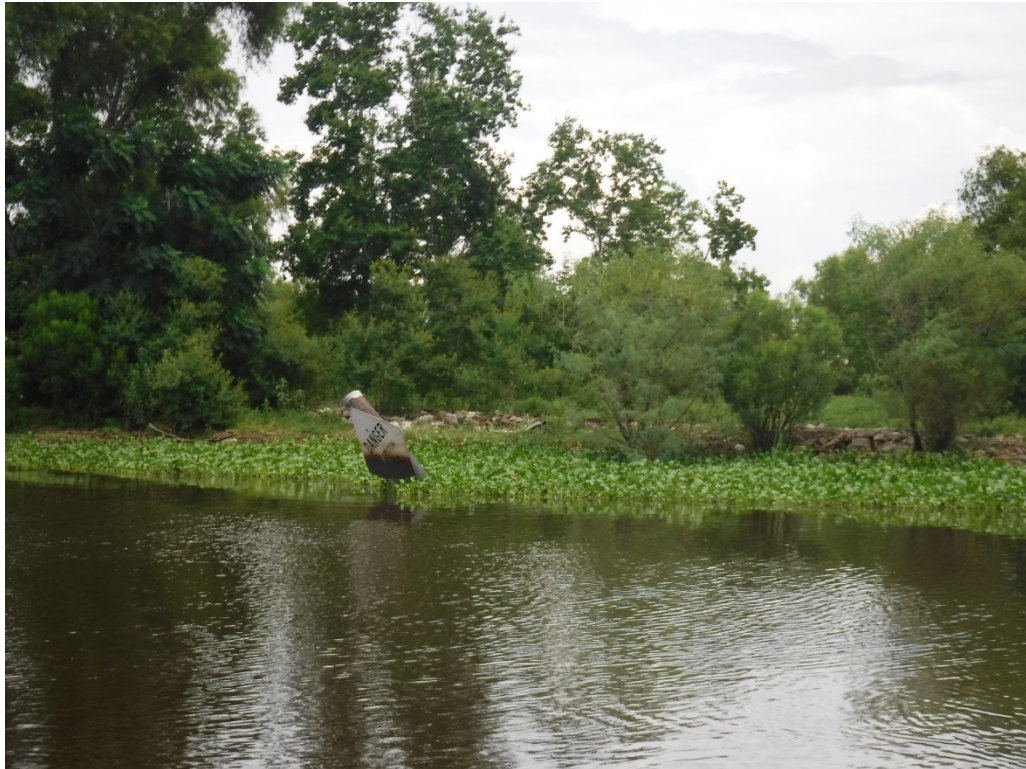
- J. Site/ Structure # 56** –There were large shrubs on approximately 20% of the rock dike. The water was slightly below the crest of the rock dike and there was no water exchange. One warning sign was still severely leaning and needs to be up-righted and cleaned (Hurricane Katrina damage). (See Photos 17 & 18)

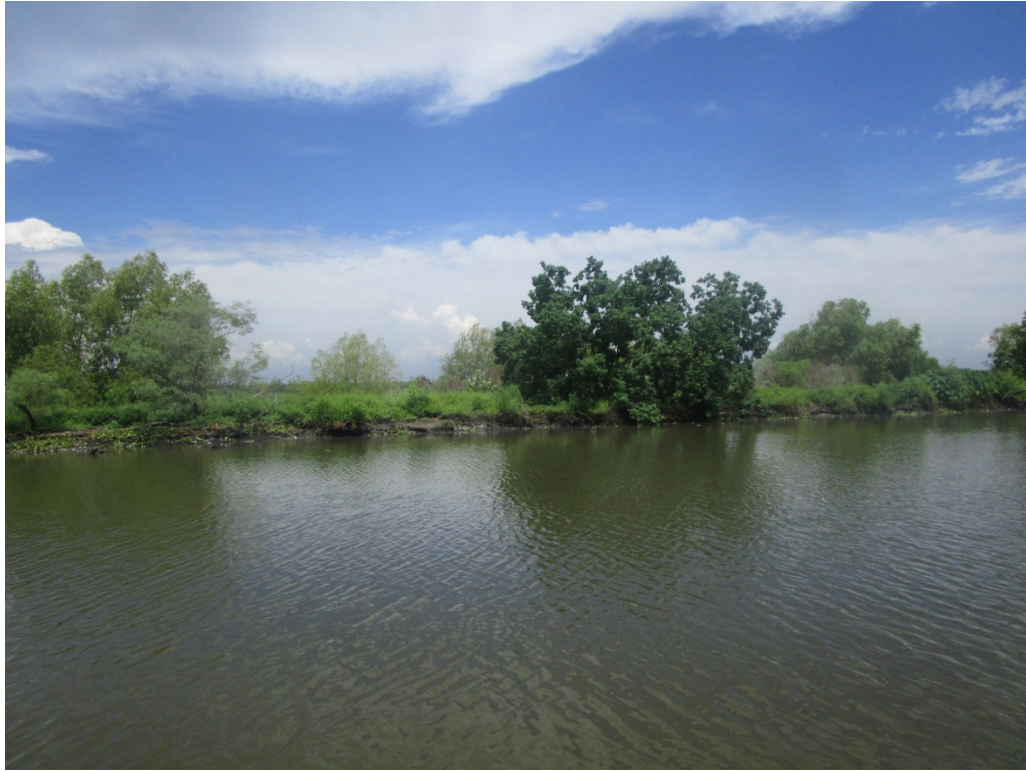
Photo No. 19, Site 58

- L. Site # 58** –The vegetation on the spoil bank along the sides of the Bayou Mandeville includes grasses, shrubs, and trees. No gaps were noted, but there was one noticeable low spot, possibly from boats being pulled over at that point. The spoil bank showed signs of recent erosion, likely caused by increased boat traffic. This has resulted in soil being washed off the roots of trees and the trees falling into the bayou. (See Photo 19)

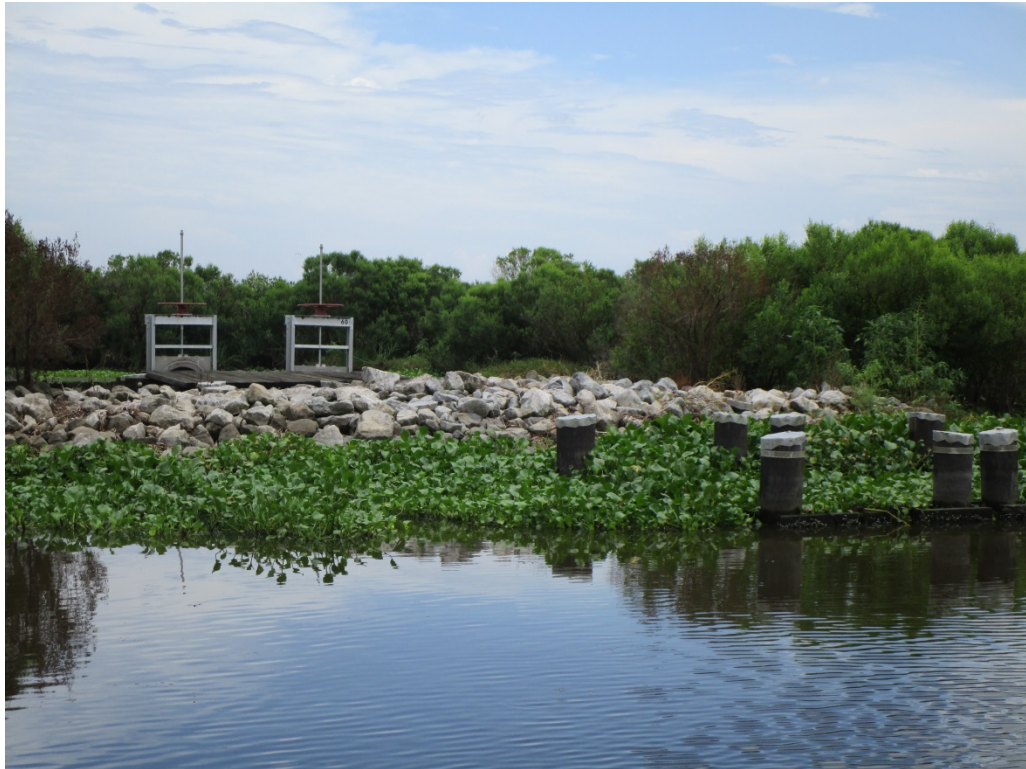
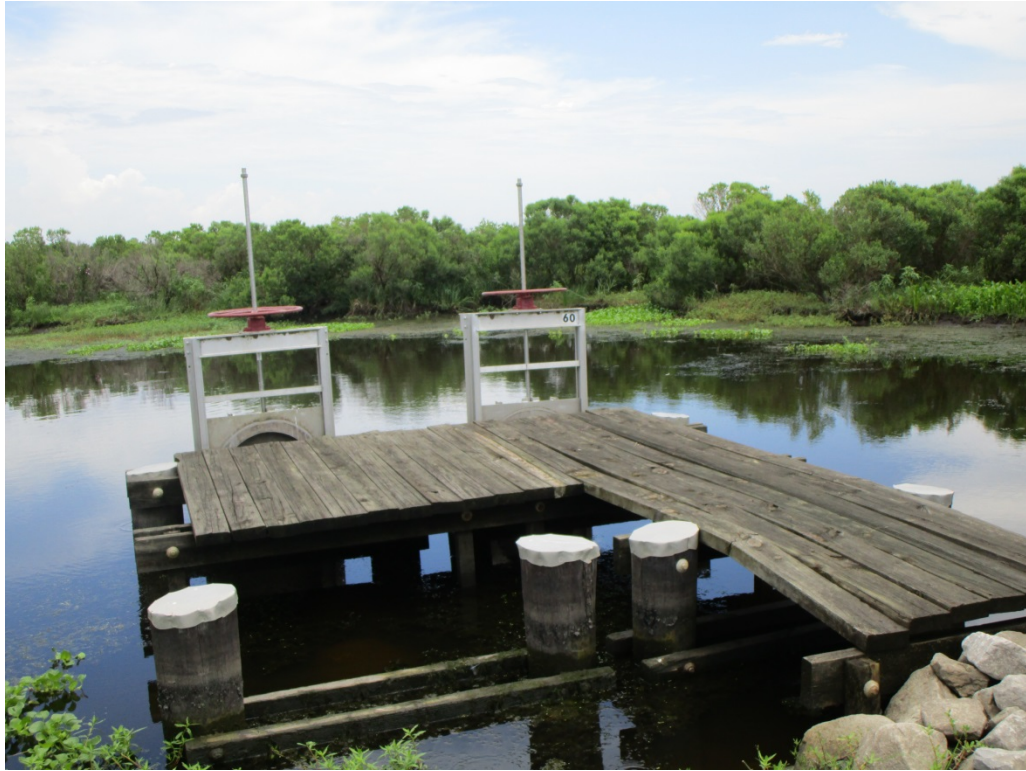
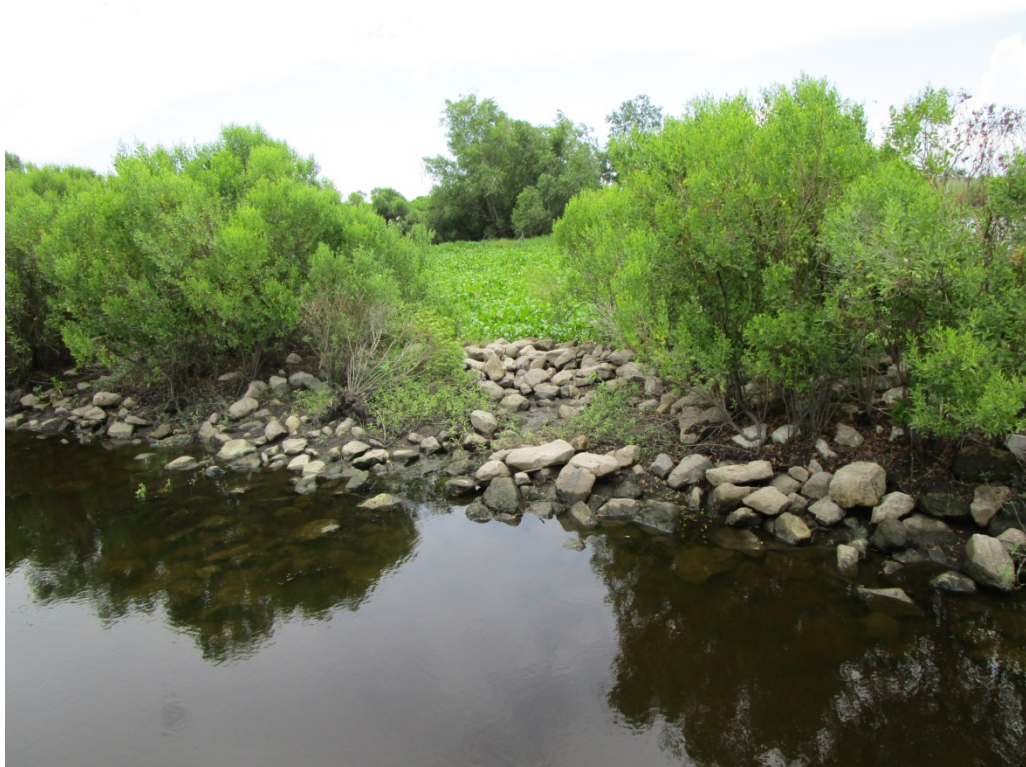
- M. Site/Structure # 60** – The two combination gates were in the up/open position. Overall condition of the structure was good. The small breach on the east side of the structure has been repaired using material from Site #32. There was a low area of rocks on the east side of the backside of the structure where it appears rocks have been moved from the dike into the adjacent water. (See Photos 20 – 22)
