2017 Annual Inspection Report

**Barataria Bay Waterway West
Shoreline Protection**

State Project Number BA-23
Priority Project List 4

November 7, 2017
Jefferson Parish

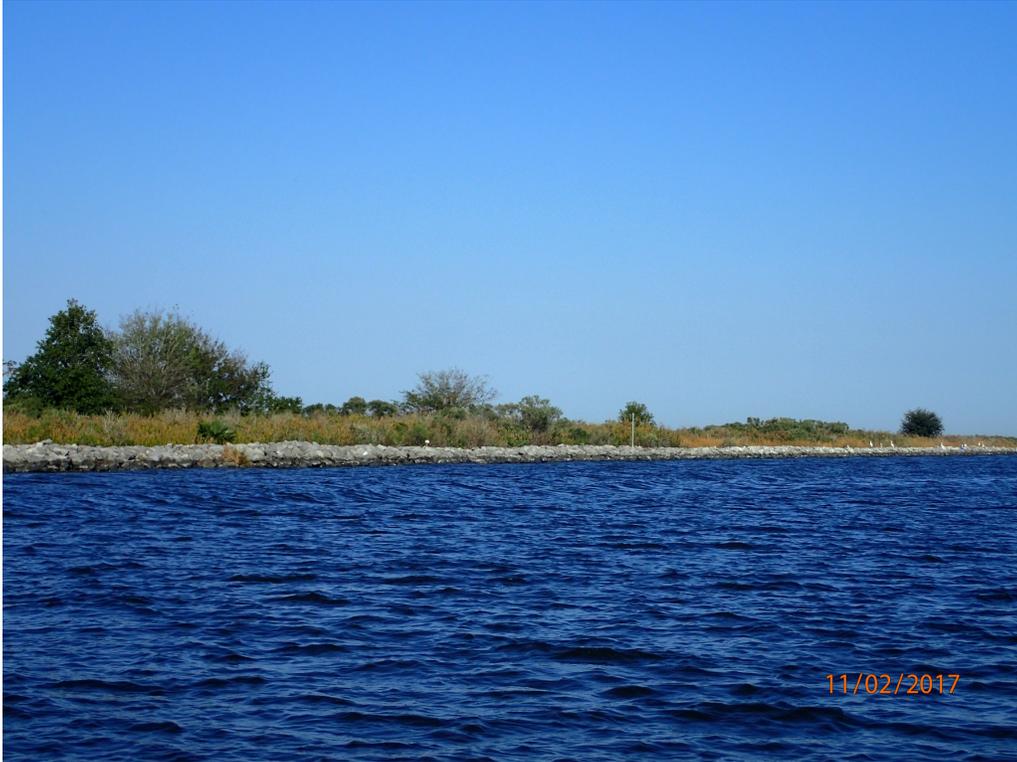
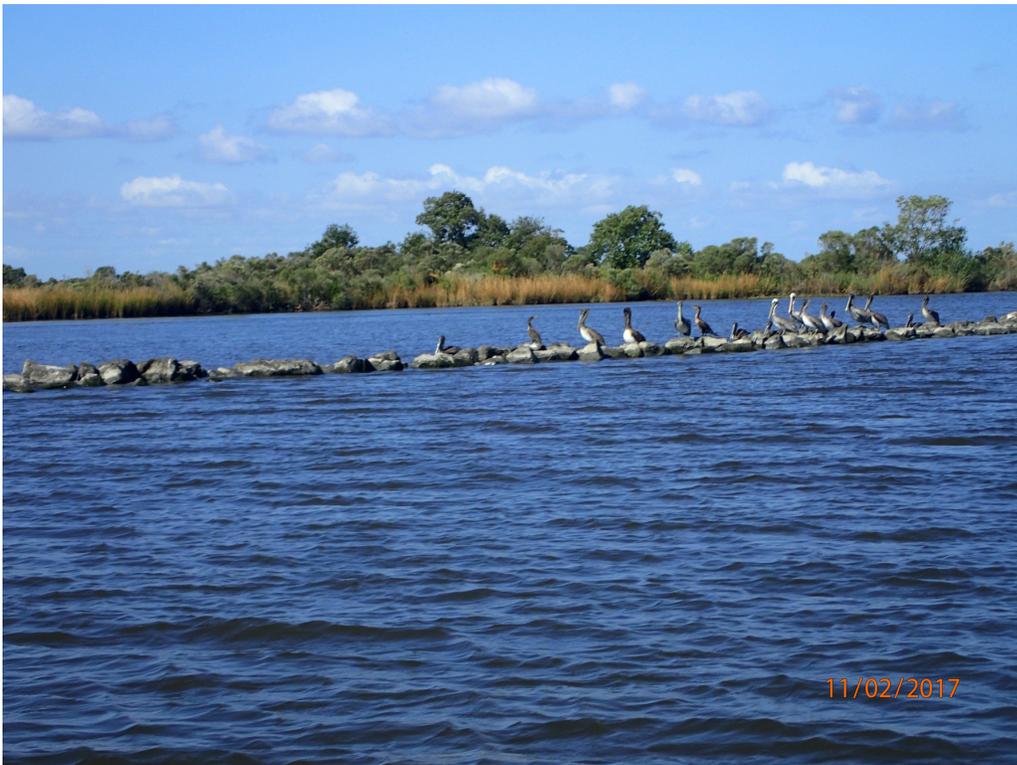
The rock structure appeared to be in good condition at the time of the inspection (Photos #1 & #2). There are some sections which have experienced settlement, but the structure is still functioning as designed. These sections will continue to be monitored for maintenance needs.

Photo #1 – Shoreline Protection

Photo #2 – Shoreline Protection

Item	Condition	Physical Damage	Corrosion	Photo #	Observations and Remarks
CMP culverts	Very Good	None	N/A		No significant defects noted.
Weir Bays - logs locks, hoist, supports	Good	None	Minor	#3, #4	A few stoplogs experienced deterioration and warping from extended submersion.
Handrails Grating Hardware etc.	Good	None	Minor	#3, #4	No significant defects noted.
Timber Piles	Good	None	N/A	#3, #4	No significant defects noted.
Timber Wales	Good	None	N/A		No significant defects noted.
Galv. Pile Caps	Fair	None	Moderate	#3, #4	Galvanized caps exhibited some weathering.
Signage /Supports	Good	None	None		No significant defects noted.
Riprap	Good	None	N/A	#3, #4	No significant defects noted.
Earthen Berm	Very Good	None	N/A		No significant defects noted.
Foreshore Rock Dike	Good	None	N/A	#1, #2	Good condition overall; some minor settlement was observed.

- Perform a survey of the rock dike to determine their status as we move toward the End of Project Life.

- Continue to check the WCS during operational procedures.
- Determine if WCS needs any minor maintenance before Project End of Life.
- Continue to observe rock structure for settlement.

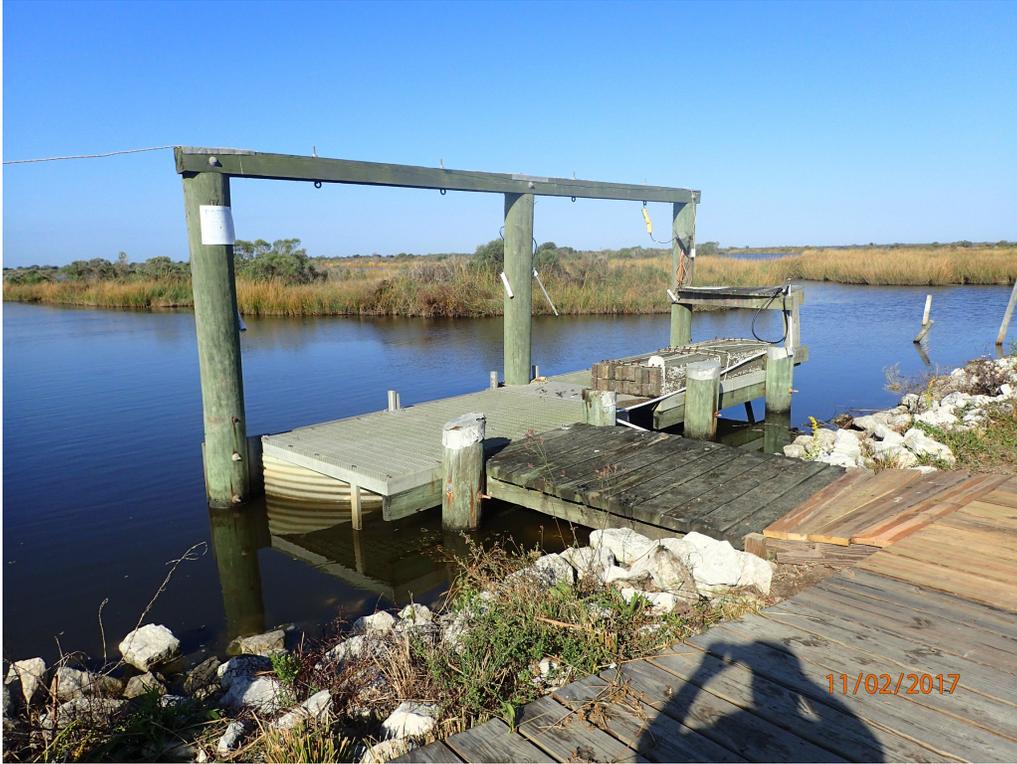
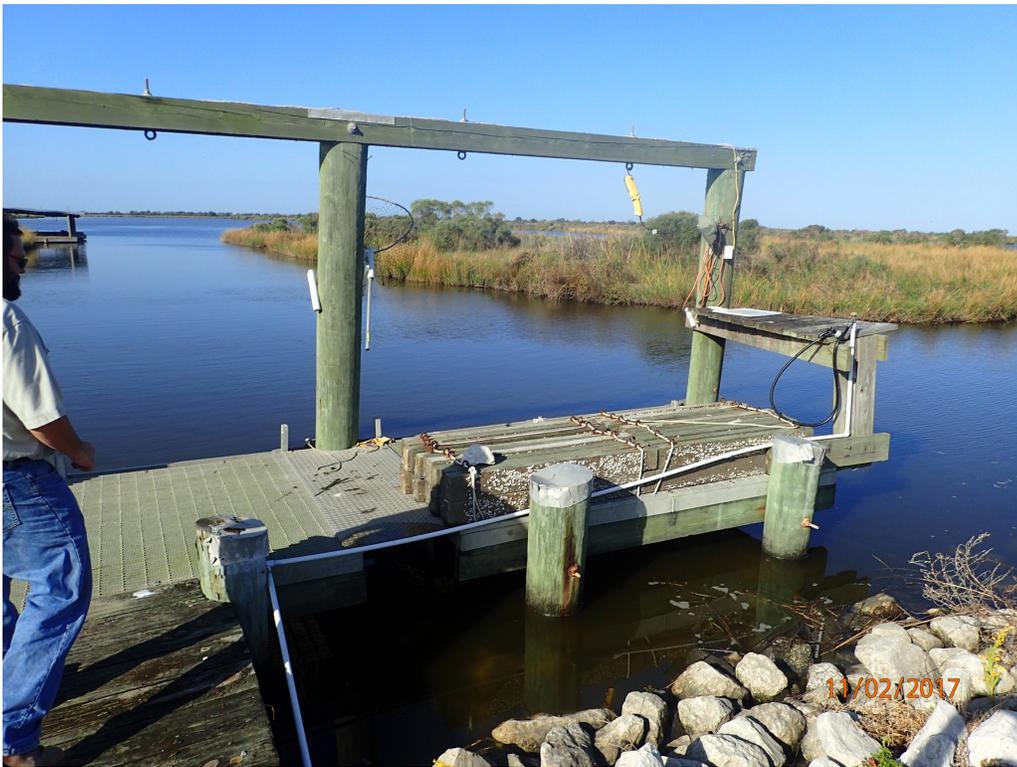
The WCS appeared to be in good condition (Photos #3 & #4). Some of the stoplogs are warped and deteriorating, and there is some minor to moderate corrosion of the steel members, however the structure is still functioning as designed.

Photo #3 – Water Control Structure

Photo #4 – Water Control Structure
