**State of Louisiana
Coastal Protection and Restoration Authority**

2017 Annual Inspection Report

**Bayou Sauvage Refuge Restoration
Phase I**

State Project Number PO-16
Priority Project List 1

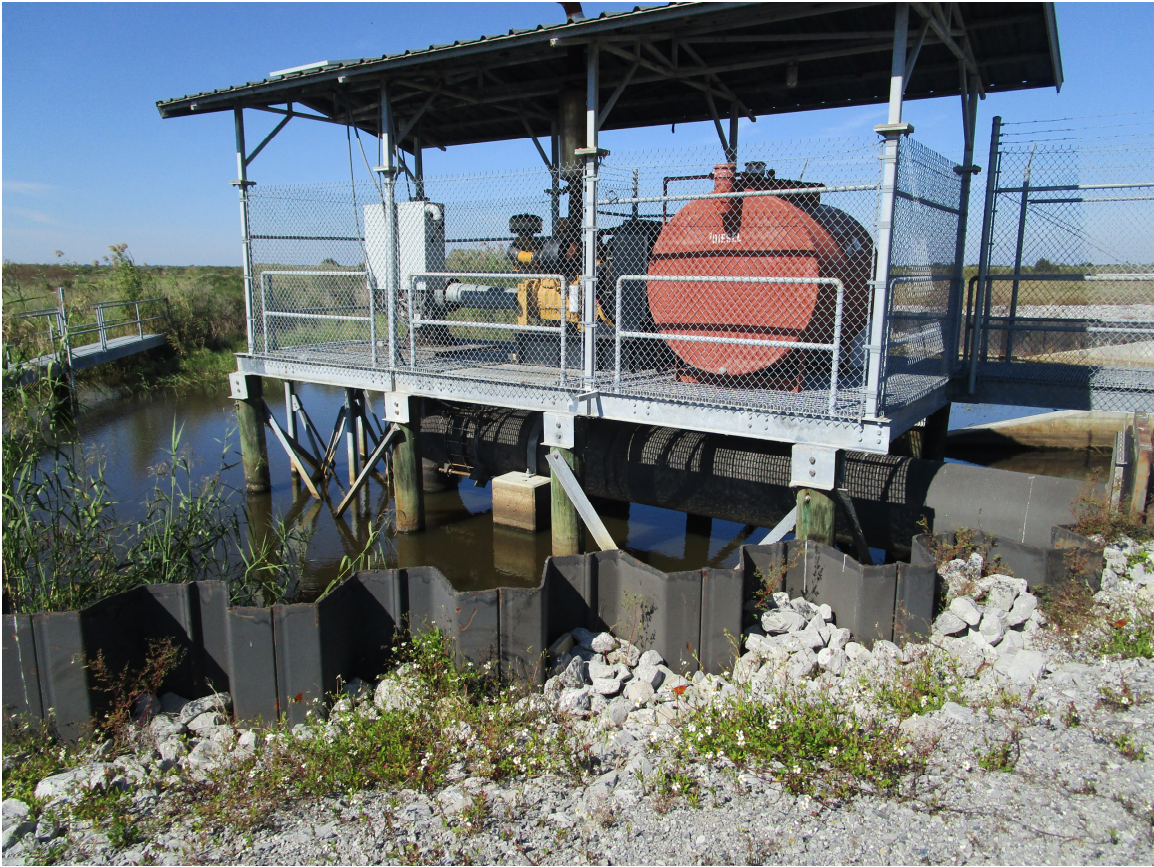
Photo #1 – Pump #5

Pump #5 is working as designed.

Item	Condition	Physical Damage	Corrosion	Photo #	Observations and Remarks
Platform	Good	None	Light	1	
Trash rack	Good	N/A	None Observed		
Fuel Tank	Good	None	None	1	
Pump Drive Engine	Good	None	Light	1	
Pump Gear Box	Good	None	None	1	
Piping	Good	None	None Observed		
Lake Pont. Inlet System	Good	None	None Observed

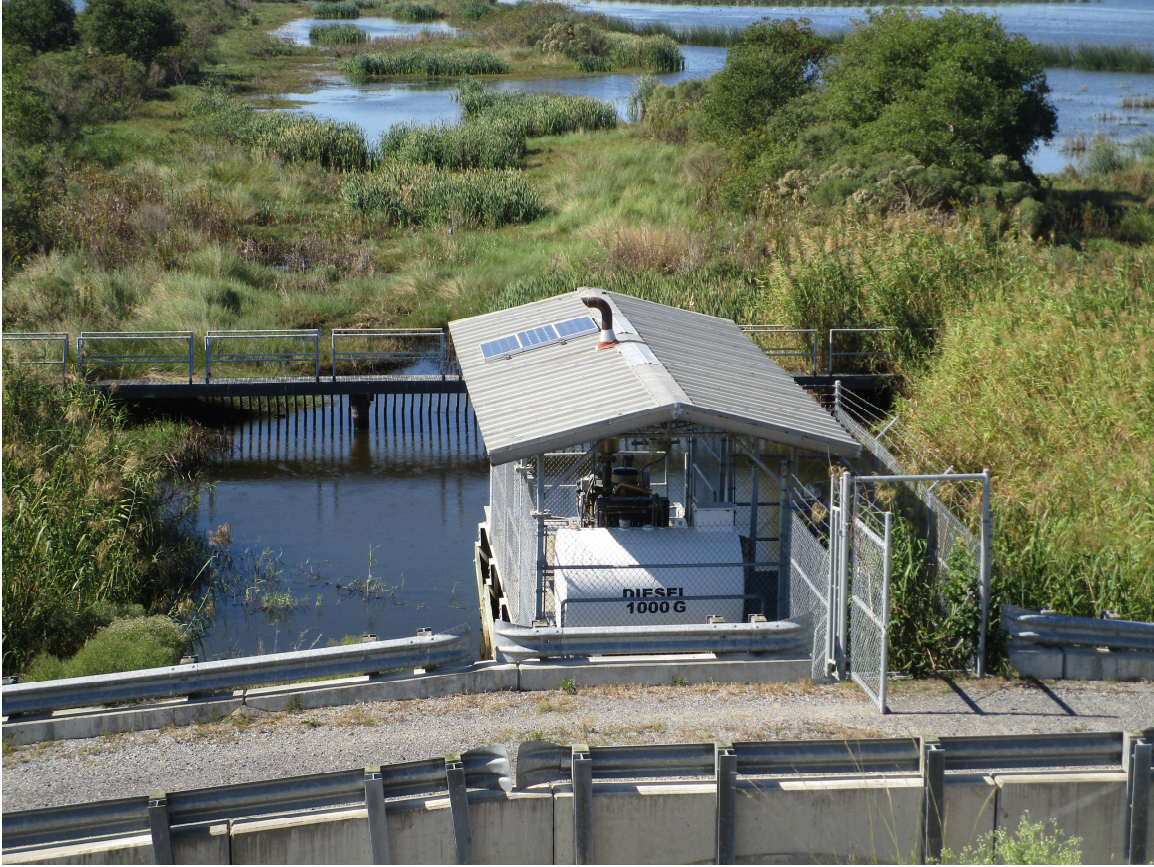
Photo #2 – Pump #6

Pump #6 is working as designed.

Item	Condition	Physical Damage	Corrosion	Photo #	Observations and Remarks
Platform	Good	None	Light	2	Vegetation almost blocking the walkway; needs clearing.
Trash rack	Good	N/A	None Observed	2	
Fuel Tank	Good	None	None	2	
Pump Drive Engine	Good	None	Light		
Pump Gear Box	Good	None	None		
Piping	Good	None	None Observed		
Lake Pont. Inlet System	Good	None	None Observed
