**State of Louisiana
Coastal Protection and Restoration Authority**

2017 Annual Inspection Report

**CAERNARVON OUTFALL
MANAGEMENT
(BS-03a)**

State Project Number BS-03a
Priority Project List 2

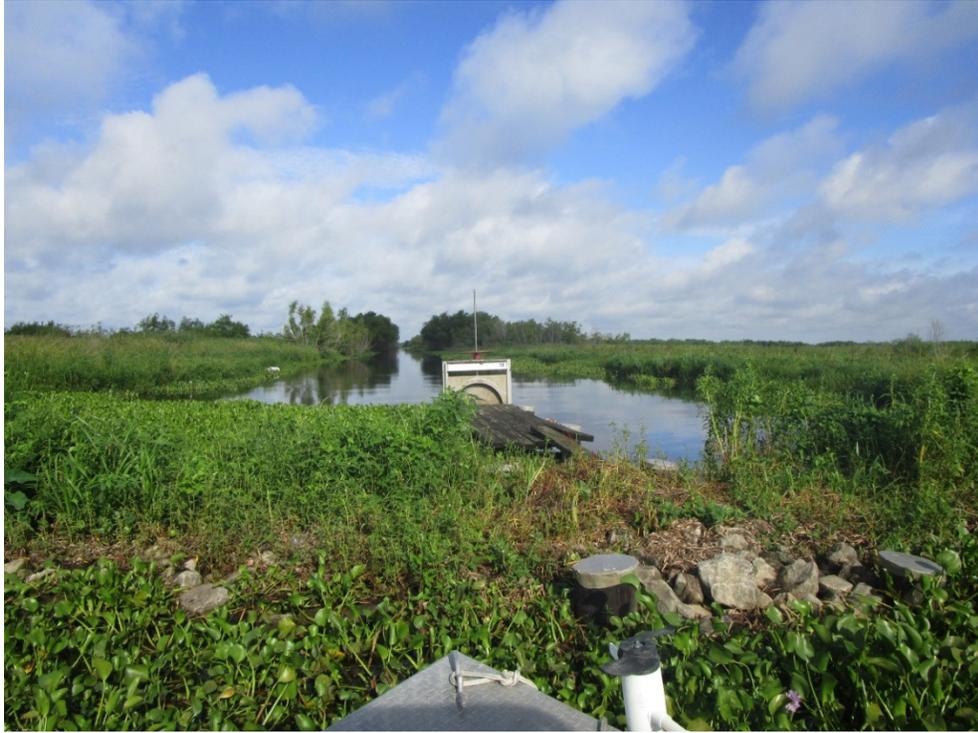
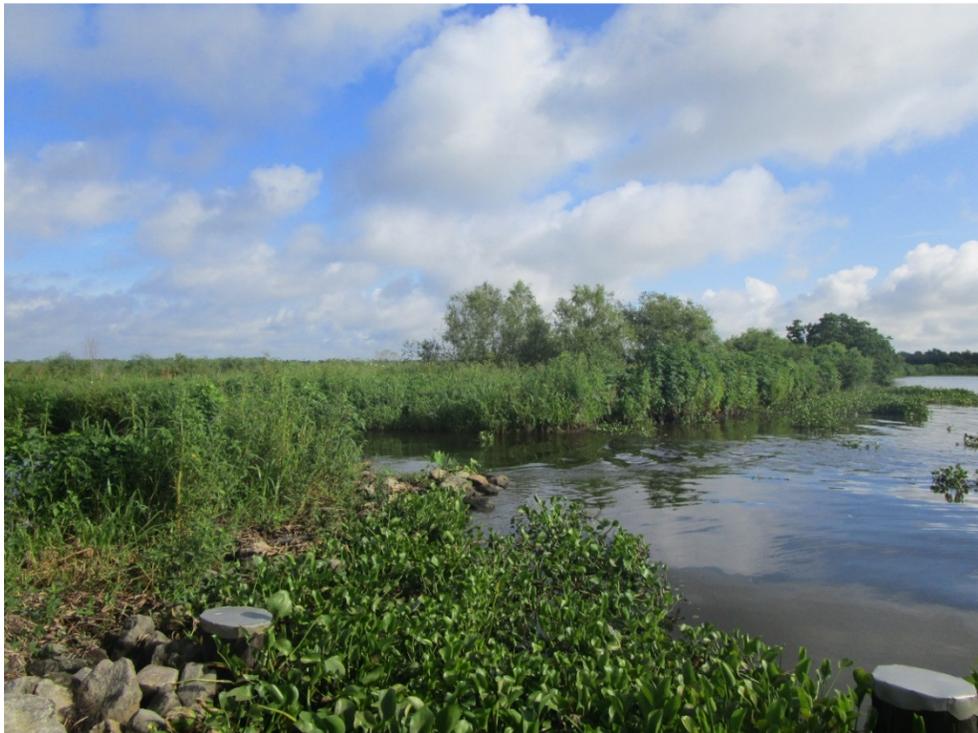
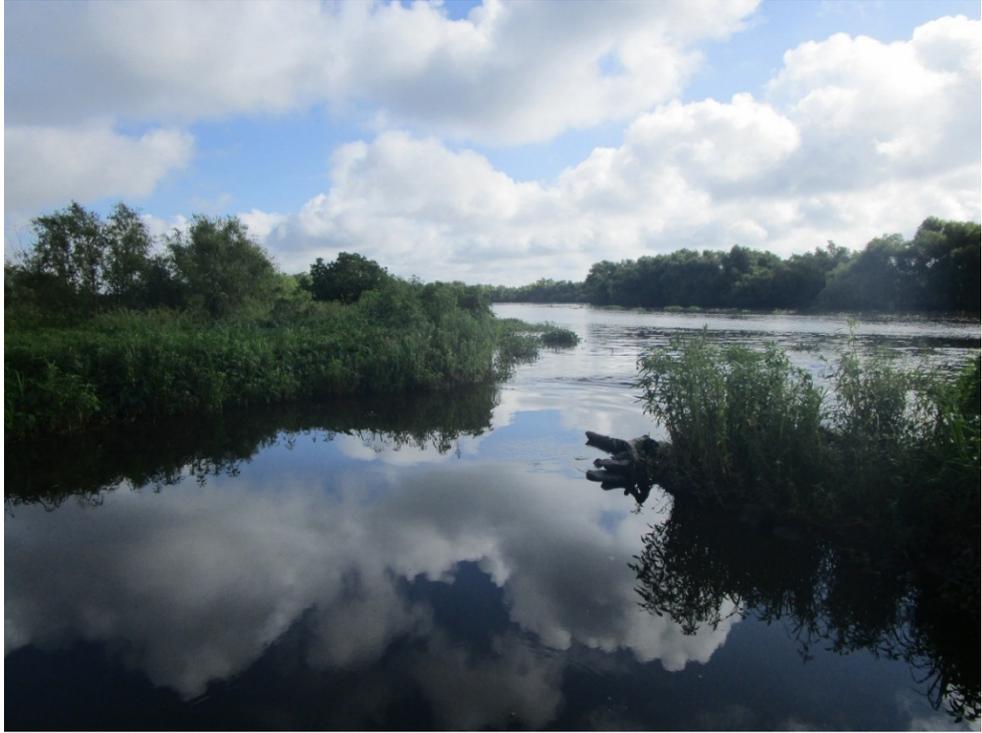
- A. Site/Structure # 13** –The combination gate was in the up/open operating position to allow maximum uninterrupted tidal exchange into the marsh. The gate has a slight tilt, but it was not affecting the function. The timber walkway still lays separated from its support beam at one end and the boards are uneven. There was a wood plank in place to connect the timber walkway to the rock dike. The rock from Site #32 used to plug the breach has settled and the breach has reopened. (See Photo Nos. 1 - 3)

Another recommendation is to repair the decks at structures #13 and #50. The deck at structure #13 is not attached to the supports at one end, and the deck at structure #50 is bowed with one plank detached.

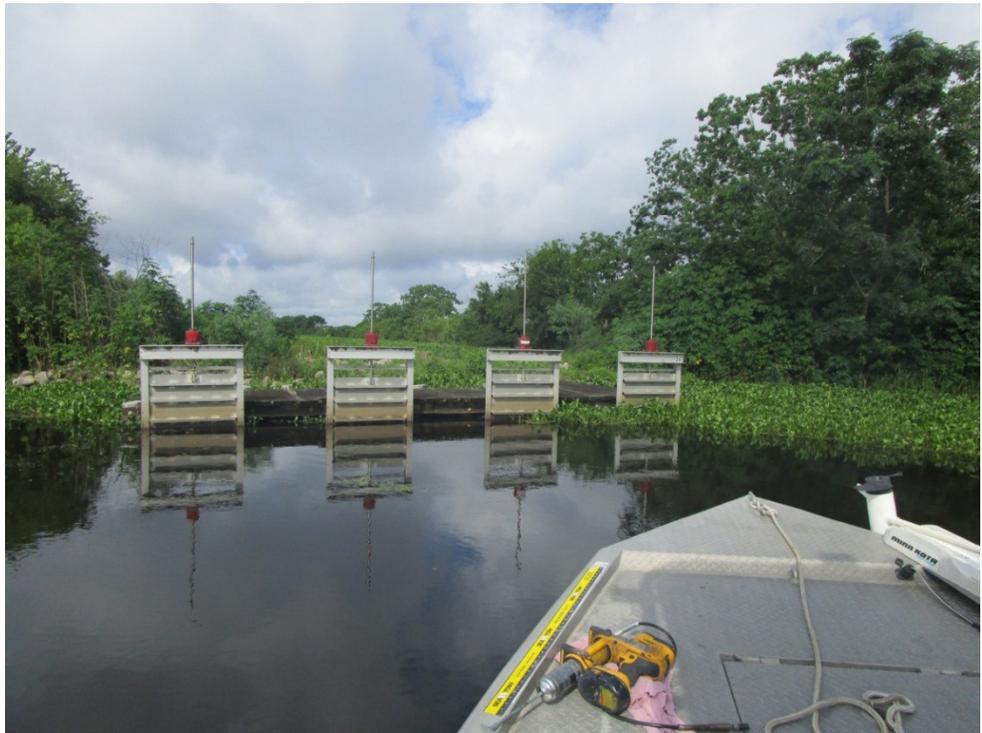
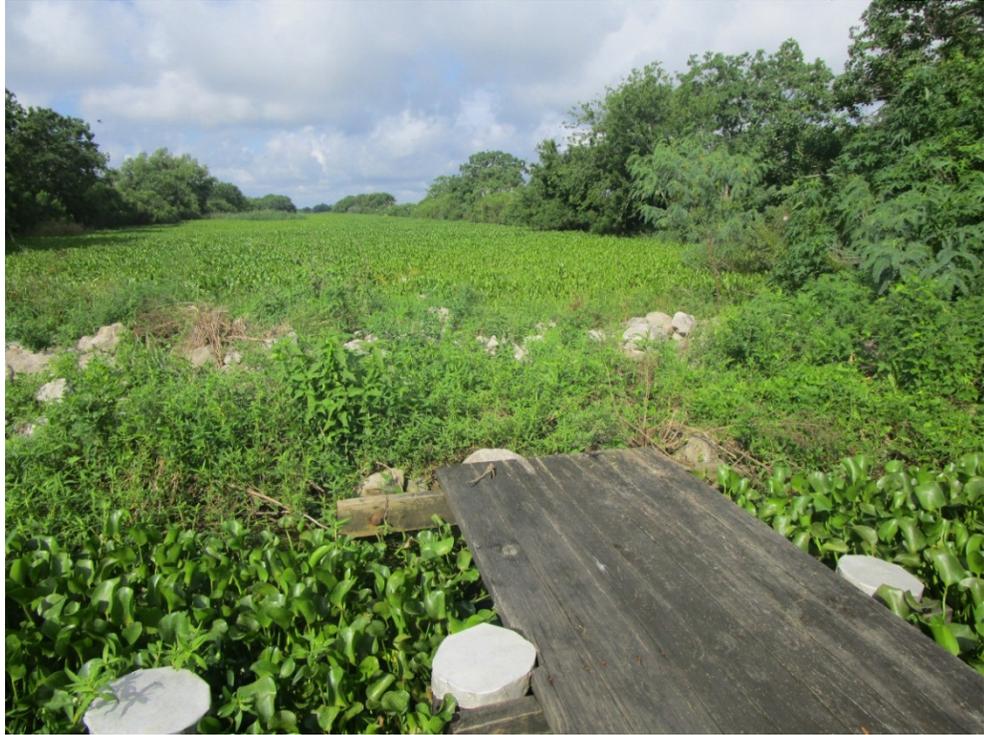
- B. Site/Structure # 25** – The inspection team did not attempt to inspect this feature as the site was inaccessible. (No Photo)
- C. Site/Structure # 26** – The gates were in the open position allowing water flow. There is vegetation covering about 50% of the earthen/rock closure, some has been cleared since the last inspection. The flow meter at this site was damaged during Isaac in September 2012. The decision was made to no longer monitor flow at this gate. The structure and outfall appear to be in good condition. The boardwalk on the back side of the structure is partly covered with water hyacinth. (See Photo Nos. 4 & 5)

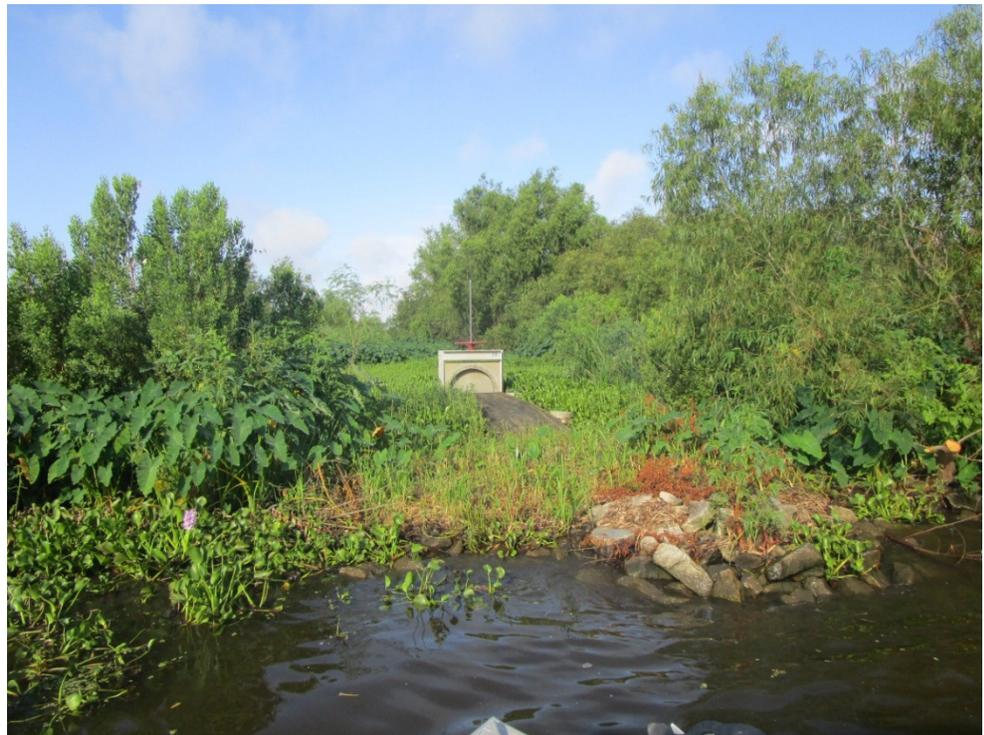
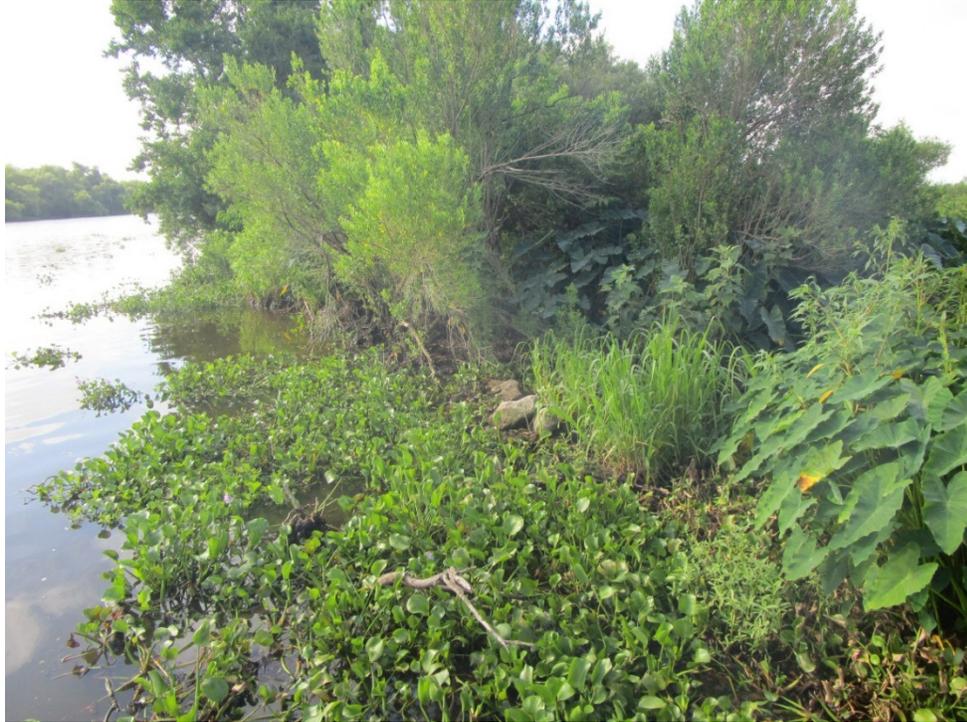
- E. Site/ Structure # 40** – The inspection team did not attempt to inspect this feature as the site was inaccessible. (No Photo)
- F. Site/Structure # 50** – The combination gate was in the up/open position. The breach in the rock dike was repaired with material from Site #32 and remained intact. The boardwalk remained bowed with one plank that was not attached to the support beams. There was vegetation covering approximately 70% of the rock dike. (See Photo Nos. 6 & 7)

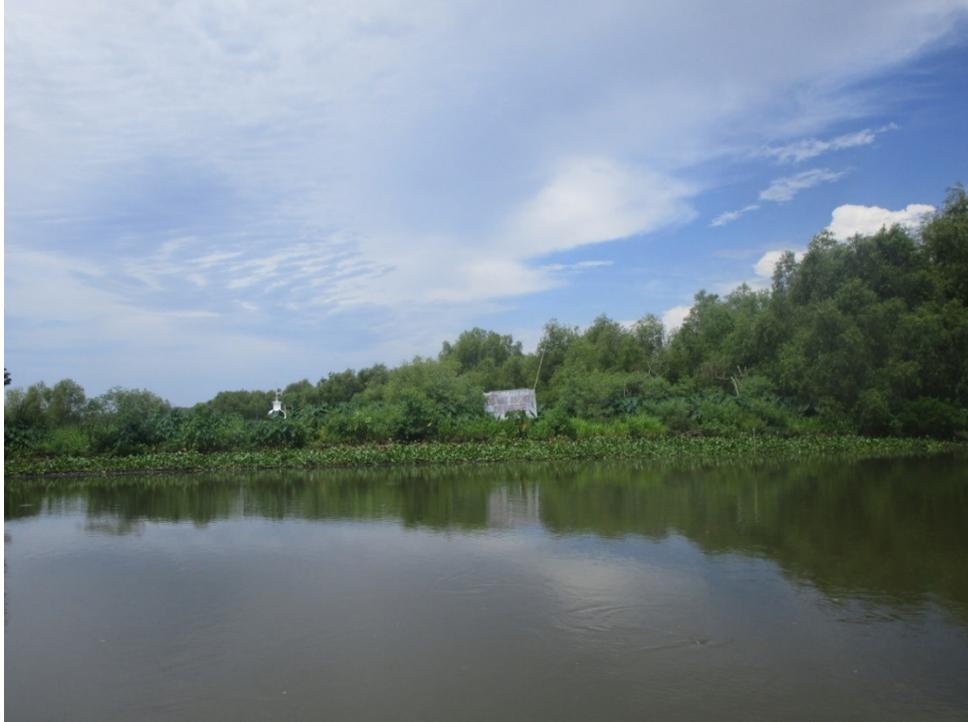
Photo No. 8, Site 51 (07-05-2016)

- G. Site/Structure #51** – The inspection teams did not attempt to inspect this feature. (See Photo No. 8 from a site visit in 2016)
- H. Site/Structure #52** – The two combination gates were in the open position. A breach previously repaired by the dredging contractor had re-opened and was between 20-25 feet in width and estimated to be about 7 feet deep. The breach was allowing unimpeded flow between the channel and marsh. The boards were uneven when walked on and detached in some areas. (See Photo Nos. 9 - 11)

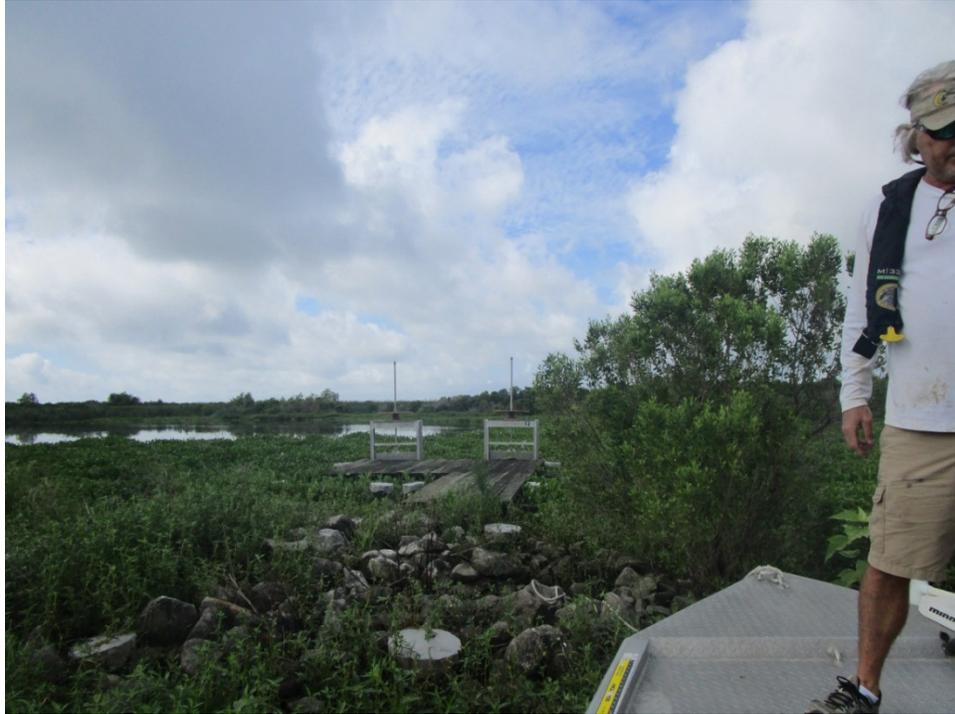
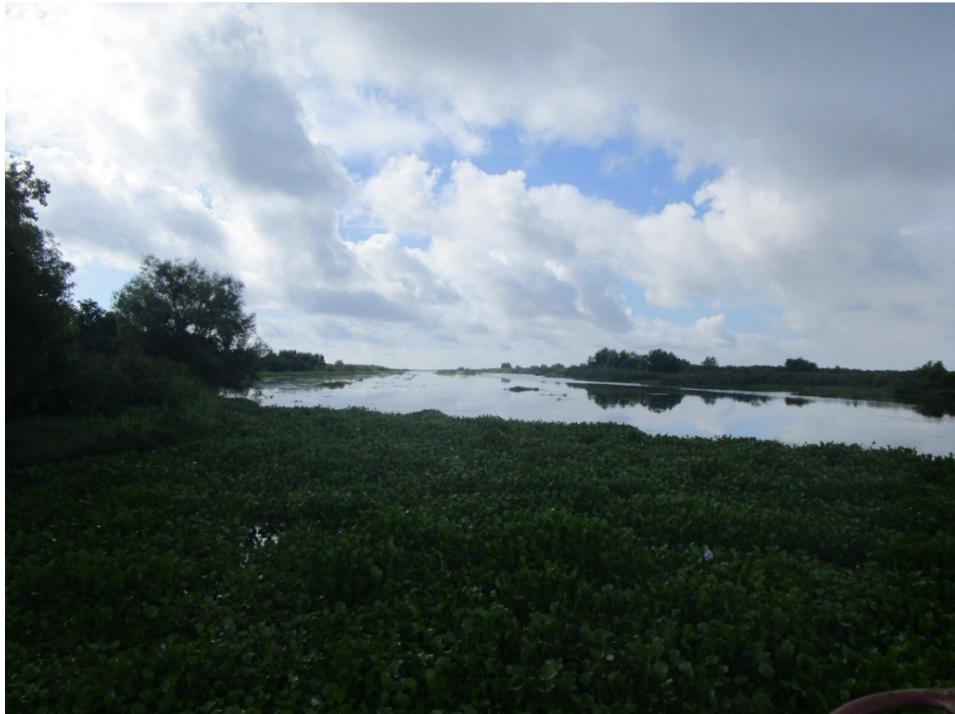
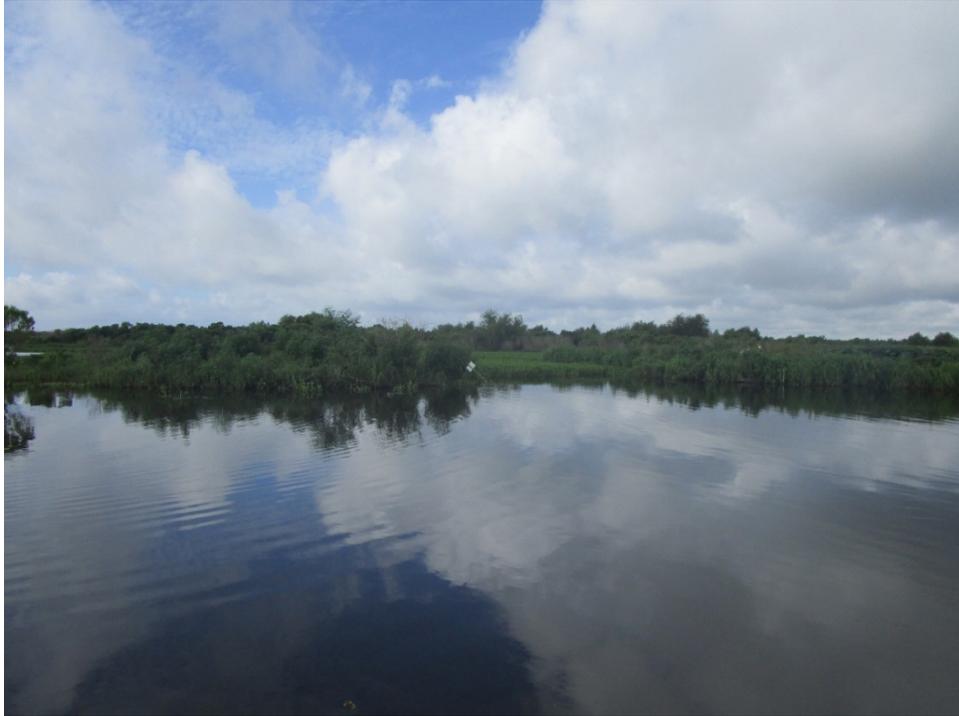
There is a gap at Site #52 which has been growing in size over the past few years. It is estimated to be 20 to 25 feet in width and the depth of the water is estimated to be around 7 feet. CPRA and NRCS discussed with the contractor the possibility of using material from site #32 to plug the breach.

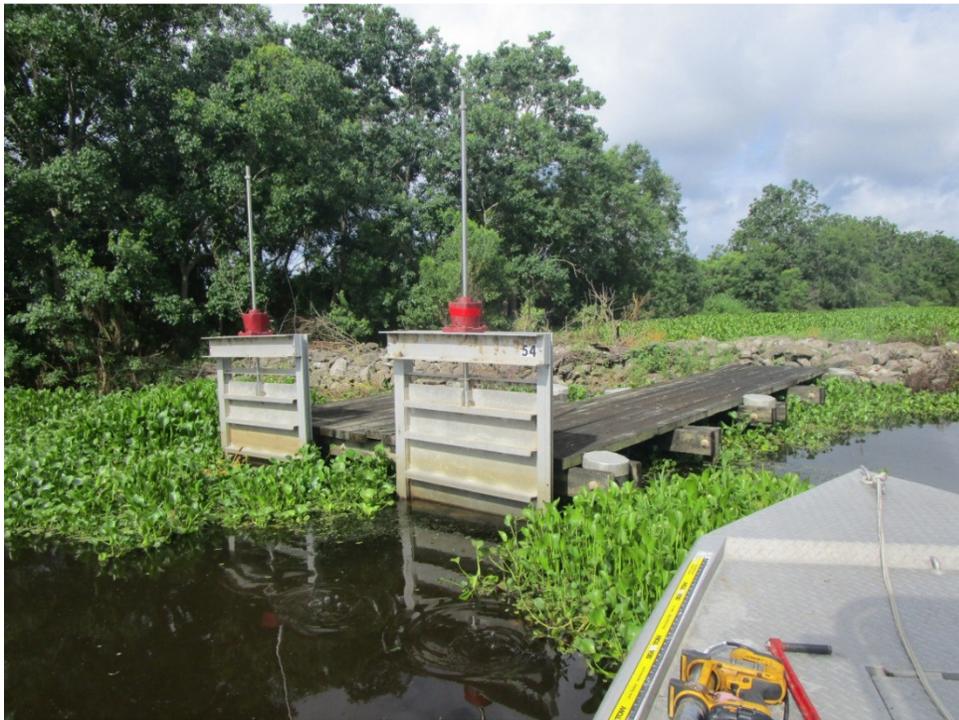
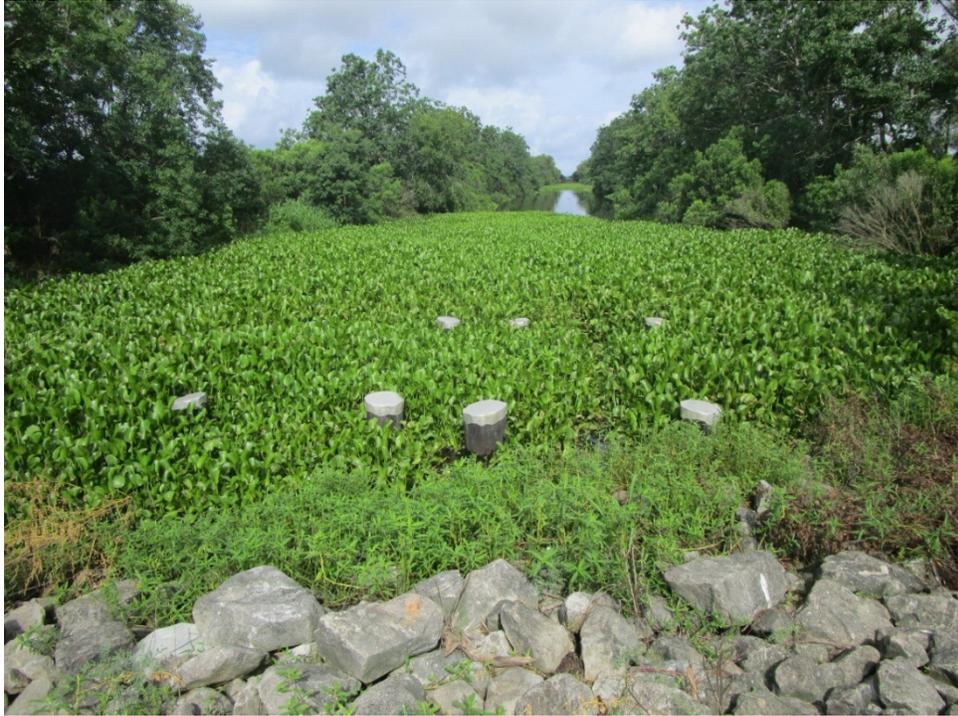
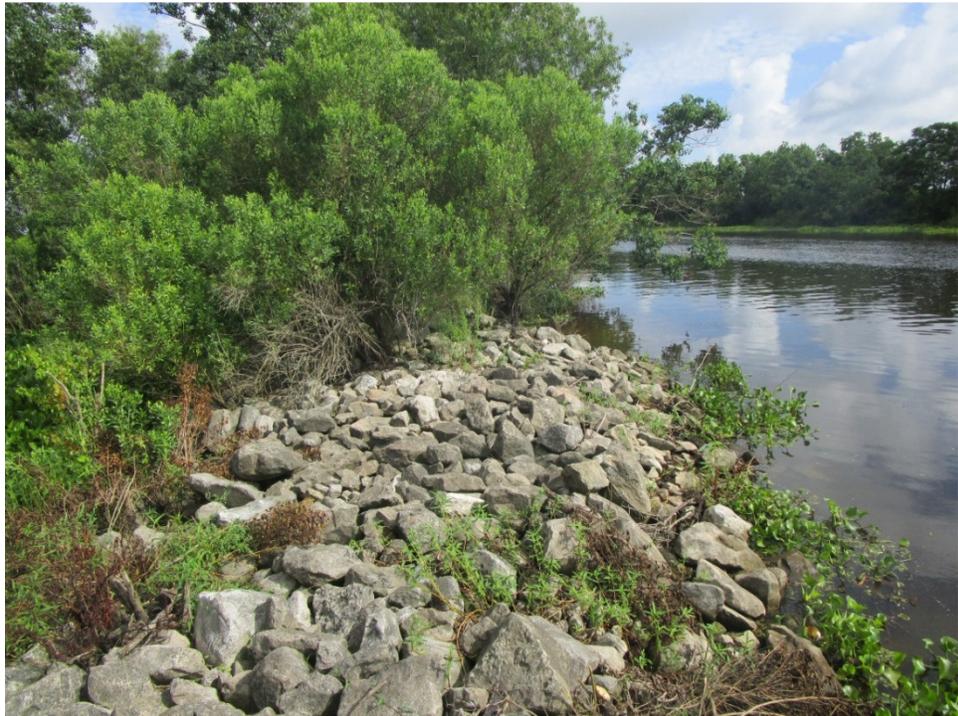
- I. Site/Structure # 54** – The gates remain in the open position. No flow was visible through the culverts. The flow meter at this site was removed in December 2014 based on the decision to discontinue flow monitoring at this structure. The rocks have been cleared of most vegetation, although water hyacinths were abundant around the structure. (See Photo Nos. 12 - 14)

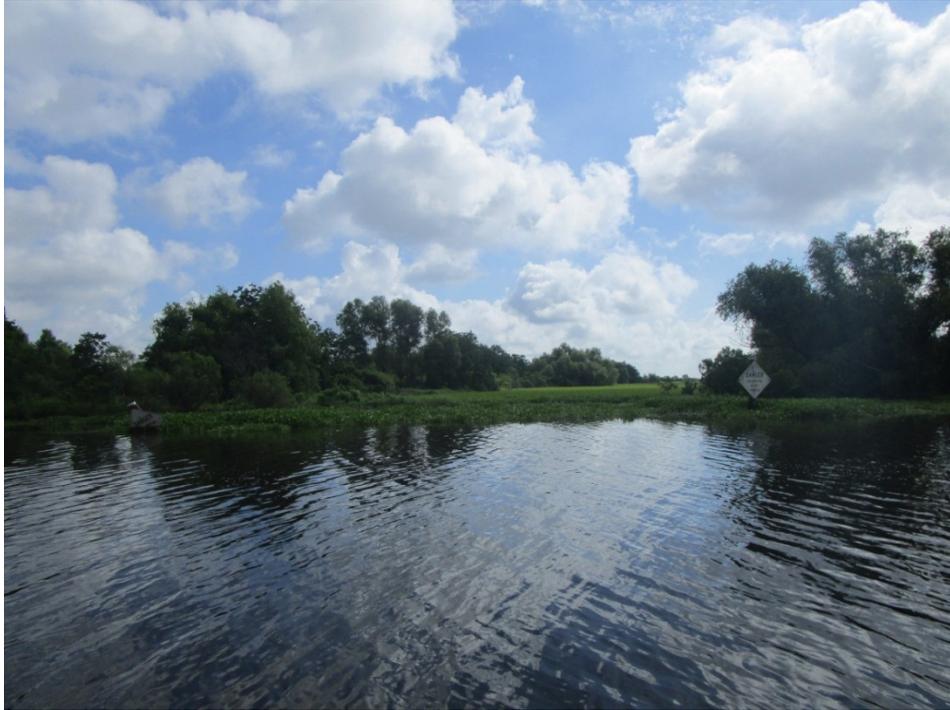
Photo No. 15, Site 56

- J. Site/ Structure # 56** –There were large shrubs on approximately 50% of the rock dike. The water was at the crest of the rock dike and no flow was visible. One warning sign was still severely leaning and needs to be up-righted and cleaned (Hurricane Katrina damage). (See Photo No. 15)

The warning sign at site #56 needs to be cleaned and have the piling re-driven in an upright position.

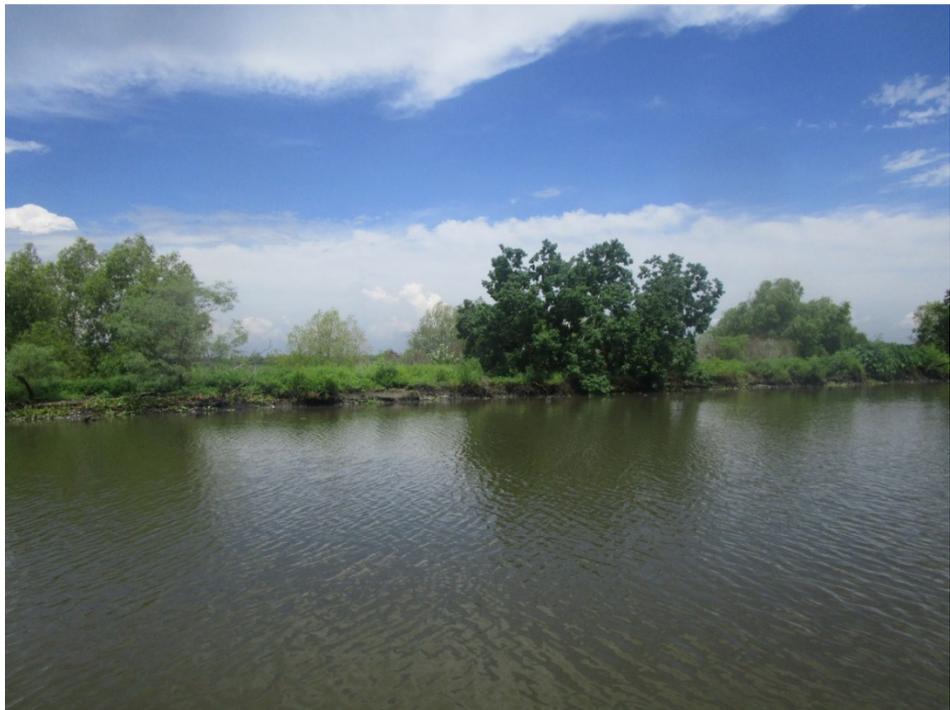
Photo No. 16, Site 58 (07-05-2016)

- L. Site # 58** – The inspection teams did not attempt to inspect this feature. (See Photo No. 16 from a site visit in 2016)
- M. Site/Structure # 60** – The two combination gates were in the up/open position. Overall condition of the structure was good. The small breach on the east side of the structure has been repaired using material from Site #32. There was a low area of rocks on the east side of the backside of the structure where it appears rocks have been moved from the dike into the adjacent water. (See Photo Nos. 17 - 19)
