**State of Louisiana
Coastal Protection and Restoration Authority**

2017 Annual Inspection Report

Hopedale Hydrologic Restoration

State Project Number PO-24
Priority Project List 8

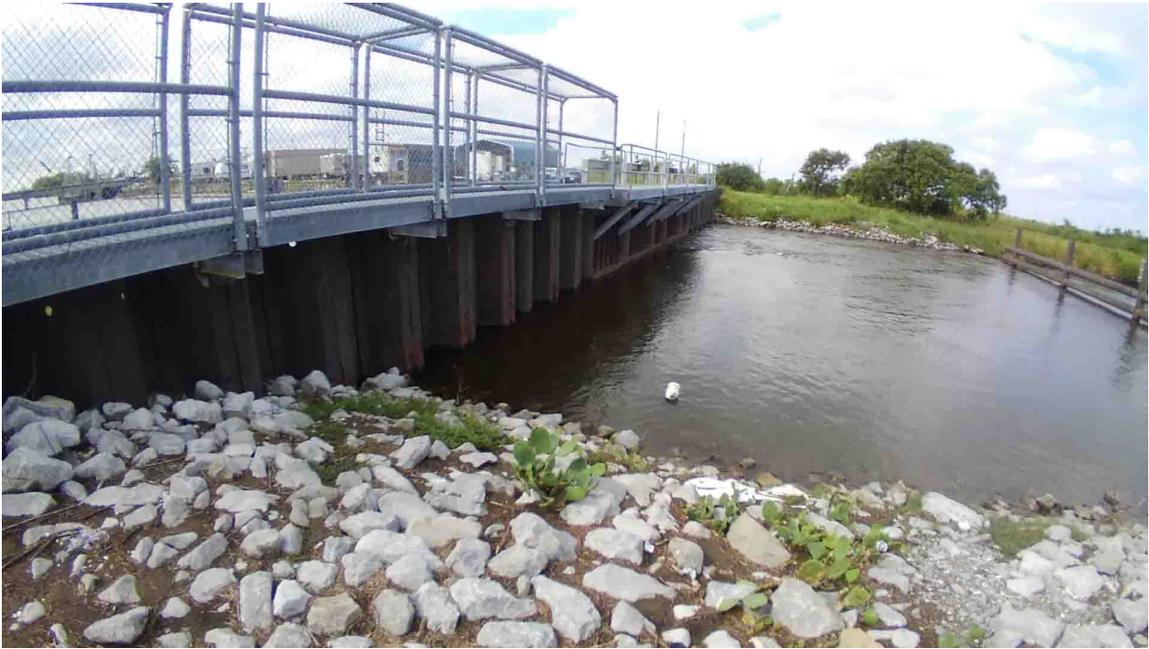
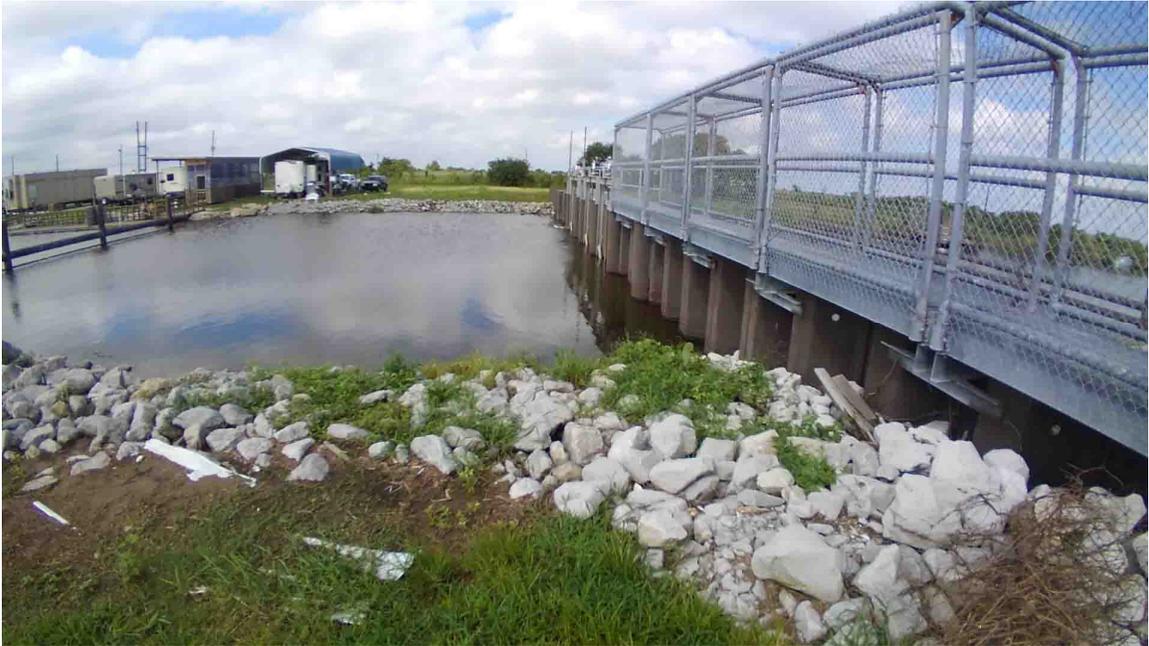
Hurricane Isaac passed through Southeast Louisiana on August 28, 2012. The only damage noted on this structure was a damaged stem cover on one of the Fish Gates.

Item	Condition	Physical Damage	Corrosion	Photo #	Observations and Remarks
Swing Gates 84" D	Good	None	None	1,2	
Fish Gates 24" x 84"	Good	None	None	1,2	One stem cover damaged in Hurricane Isaac.
Handrails Grating Hardware etc.	Good	None	None	1,2	
Galv. Pile Caps	Good	None	None		
Signage /Supports	Good	None	None		
Riprap	Good	None	None	1,2	
Silt/Fill	Good	None	None

- Replace one vinyl gate stem cover.
