**State of Louisiana
Coastal Protection and Restoration Authority**

2017 Annual Inspection Report

**Lake Borgne Shoreline Protection
Project**

State Project Number PO-30
Priority Project List 10

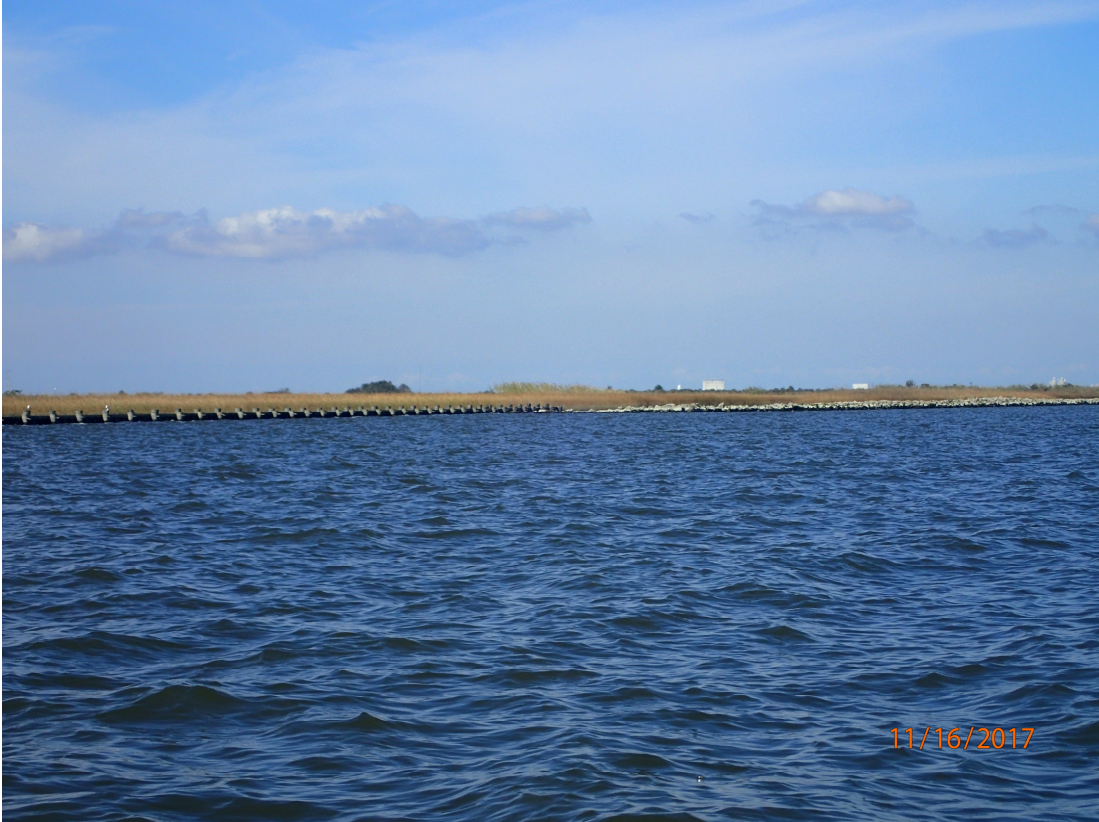
Photo 1: Reach 1

Reach 1 – Shortly after construction and the passage of Hurricanes Ike and Gustav the rock breakwater settled below the mudline for much of its length. The 2013 maintenance project placed a rock lift in reach 1 and installed a composite sheetpile wall in the areas where rock had settled below the mudline. There is significant deterioration of this feature for which a follow up trip will be conducted with the project engineer to determine how to repair.

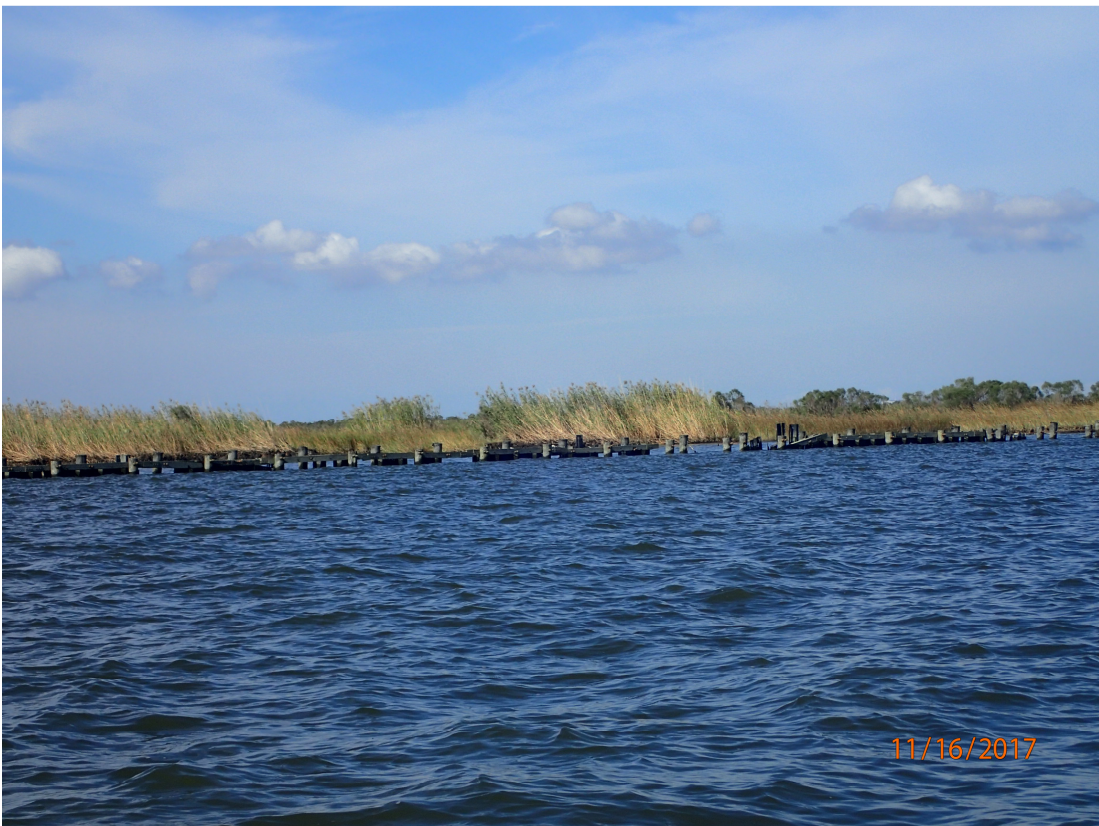
Photo 2: Reach 1 - Damaged Sheetpile Wall

Item	Condition	Physical Damage	Corrosion	Photo #	Observations and Remarks
Reach 1 Rock Breakwater	Good	None	N/A	1	
Reach 1 Composite Sheetpile Const. 2013	Poor	Deteriorating Sheetpile Wall	N/A	1,2	Significant damage noted. A maintenance event is being planned to repair this.
Reach 2 Rock Breakwater	Good	None	N/A	3	
Reach 3 Rock Breakwater	Good	None	N/A		
Reach 3 Composite Sheetpile Const. 2013	Good	None	N/A		Approx. 770' of composite sheetpile wall was installed in two segments during 2013 maintenance project. no damage was observed.
Reach 4 Rock Breakwater	Good	none	N/A		
Reaches 1 & 2 Double Sheet-pile	Good	None	light		
Reaches 1 & 2 Warning Signs	Good	None	N/A

- A maintenance project is scheduled to address the damaged composite sheetpile wall.

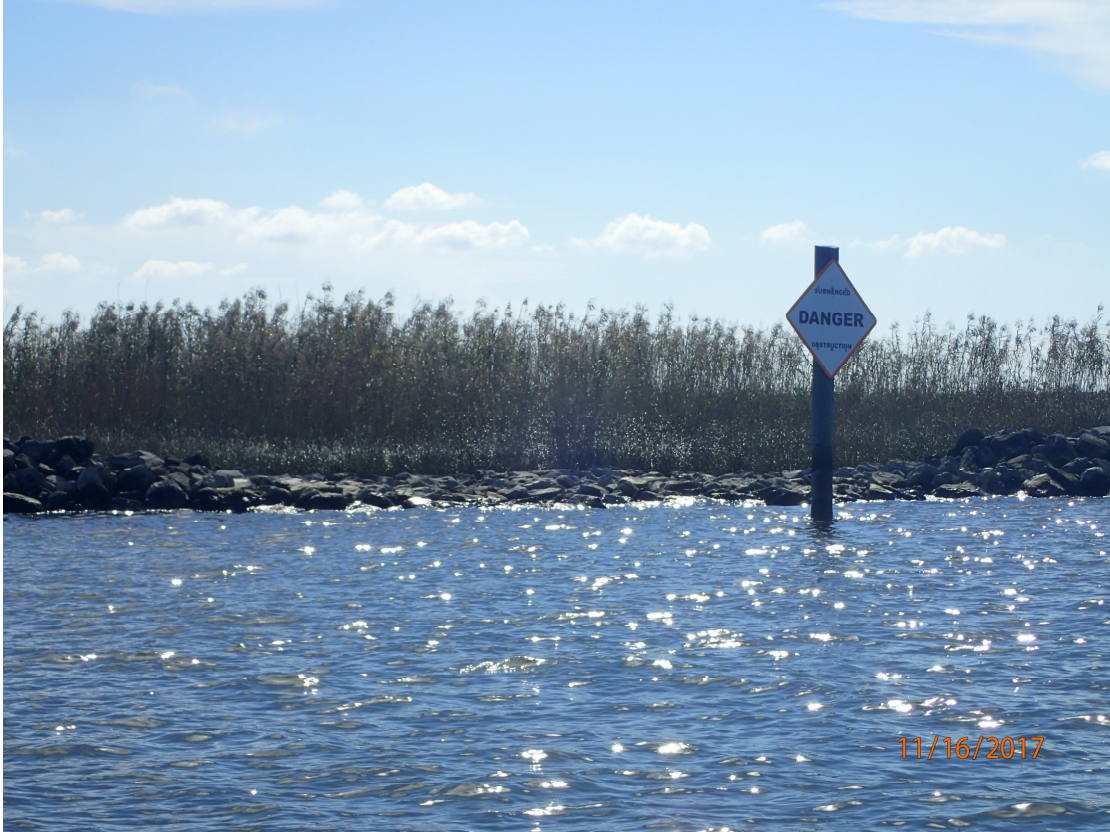
Reaches 2, & 3(strong) - The breakwater reaches appear to be in good condition, except for limited areas that have settled and should be monitored for possible future action.

Photo 3: Reach 2 – Fish Dip

- Continue to monitor the condition of the breakwaters.
