2017 Annual Inspection Report

**Mississippi Sediment Delivery System –
Bayou Dupont**

State Project Number BA-39
Priority Project List 12

August 8, 2017
Jefferson Parish &
Plaquemines Parish

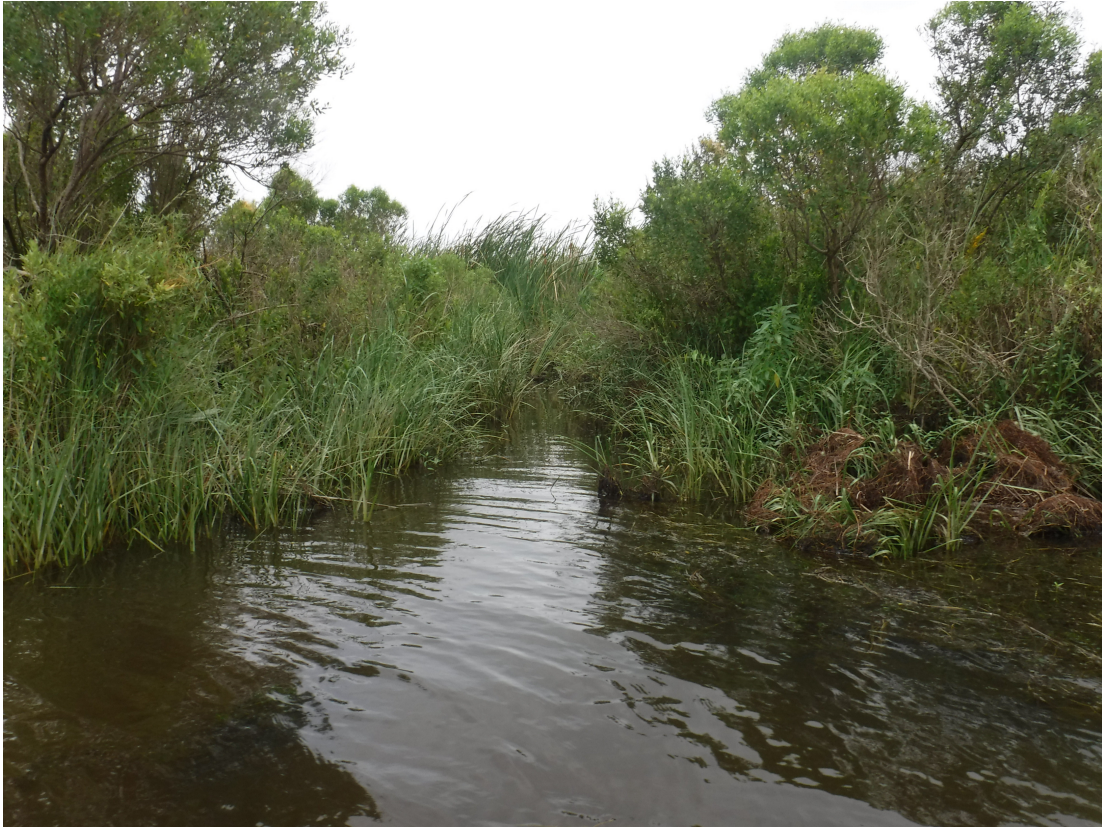
Photo # 1 – Containment Dike Gap - Marsh Creation Area 2

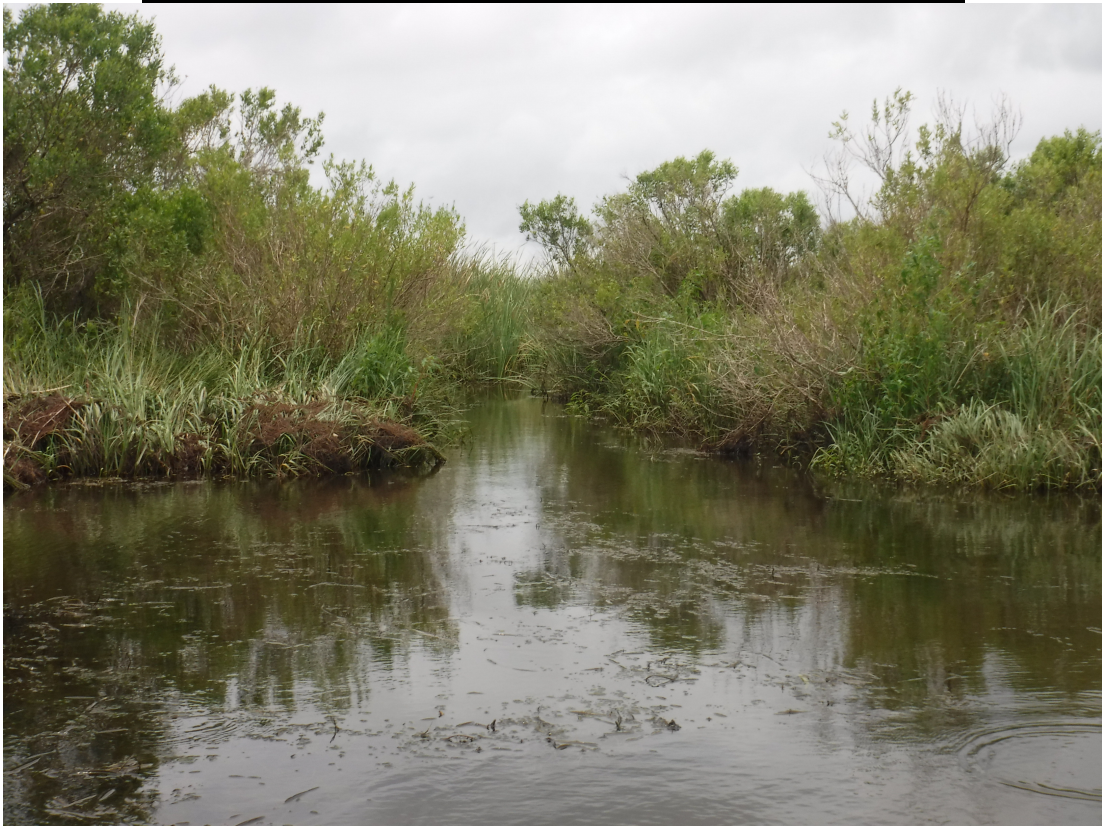
Photo # 2 – Containment Dike Gap - Marsh Creation Area 1

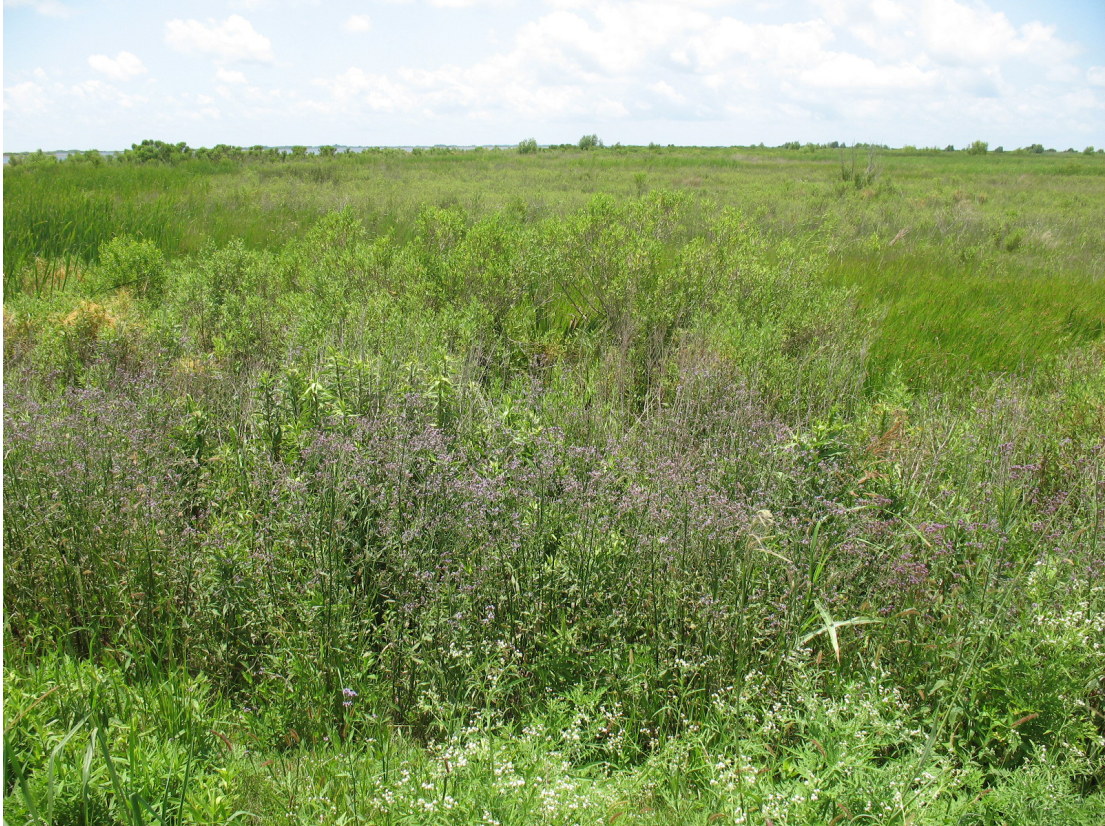
Photo # 3 – Marsh Creation Area 1

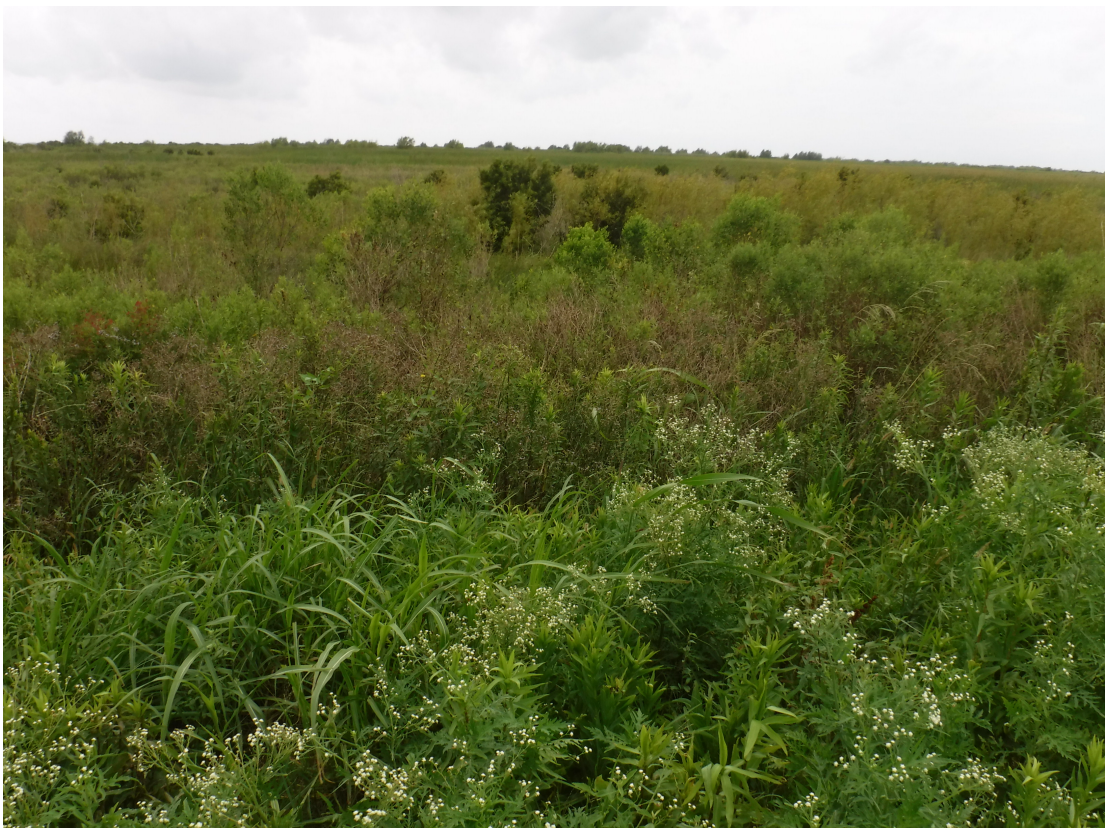
Photo # 4 – Marsh Creation Area 2
