2017 Annual Inspection Report

**South Shore of The Pen Shoreline
Protection and Marsh Creation**

State Project Number BA-41
Priority Project List 14

November 15, 2017
Jefferson Parish

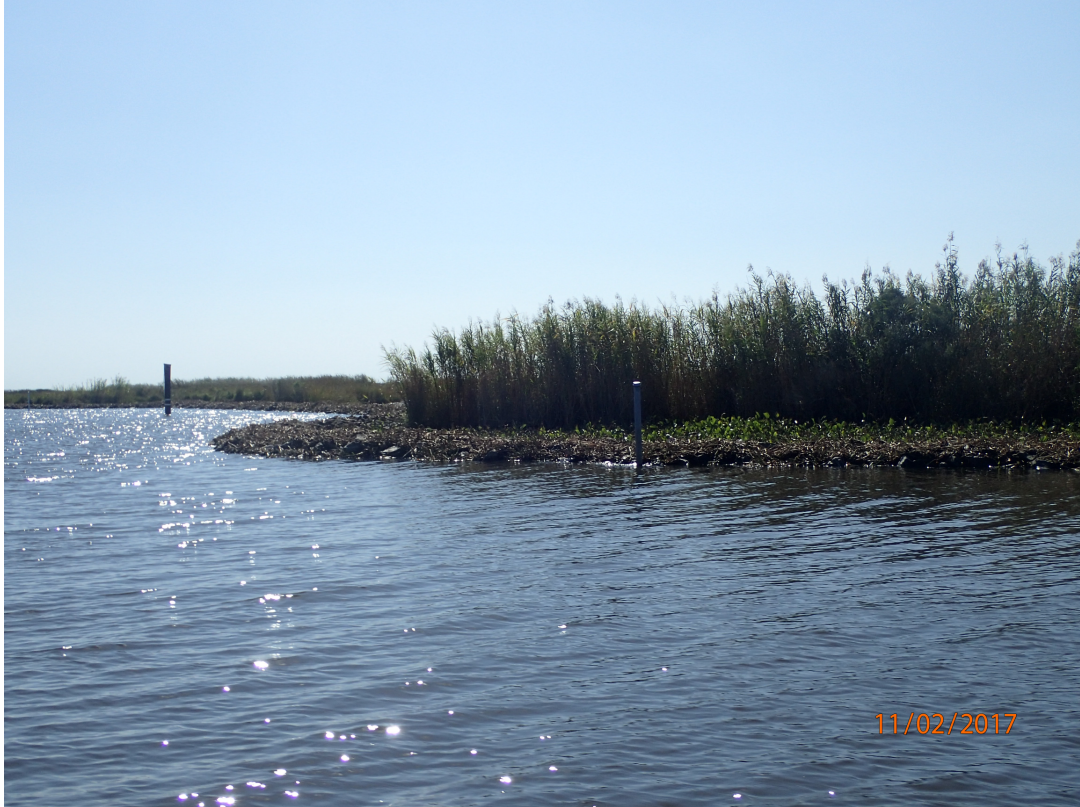
Photo #1 – Shoreline Protection, West Reach

The West project reach was observed to be in generally good condition and was performing the project goal of protecting the marsh to the south (Photo # 1). However, portions of the rock structure along the Central and East reaches, which received a maintenance rock lift in 2015, have already experienced significant settlement (Photos #2-4).

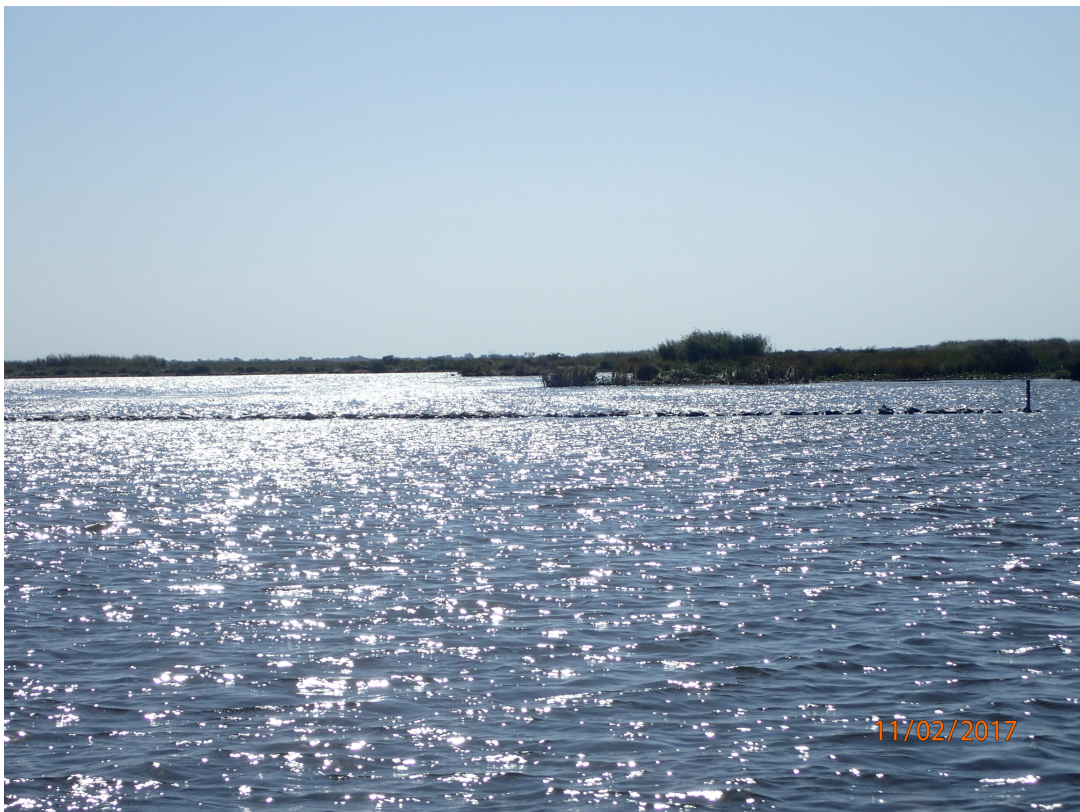
Photo #2 – Shoreline Protection, Central Reach

The majority of the project recently received a rock lift to bring it back to design elevation. There are many sections that appear to have resettled below this elevation. Some investigation and thought are needed before the next scheduled rock lift in 2026 to ensure better success. In the meantime the situation will continue to be monitored and proper warning signage will be maintained or upgraded to ensure public safety.

- Continue to observe rock structure for settlement.

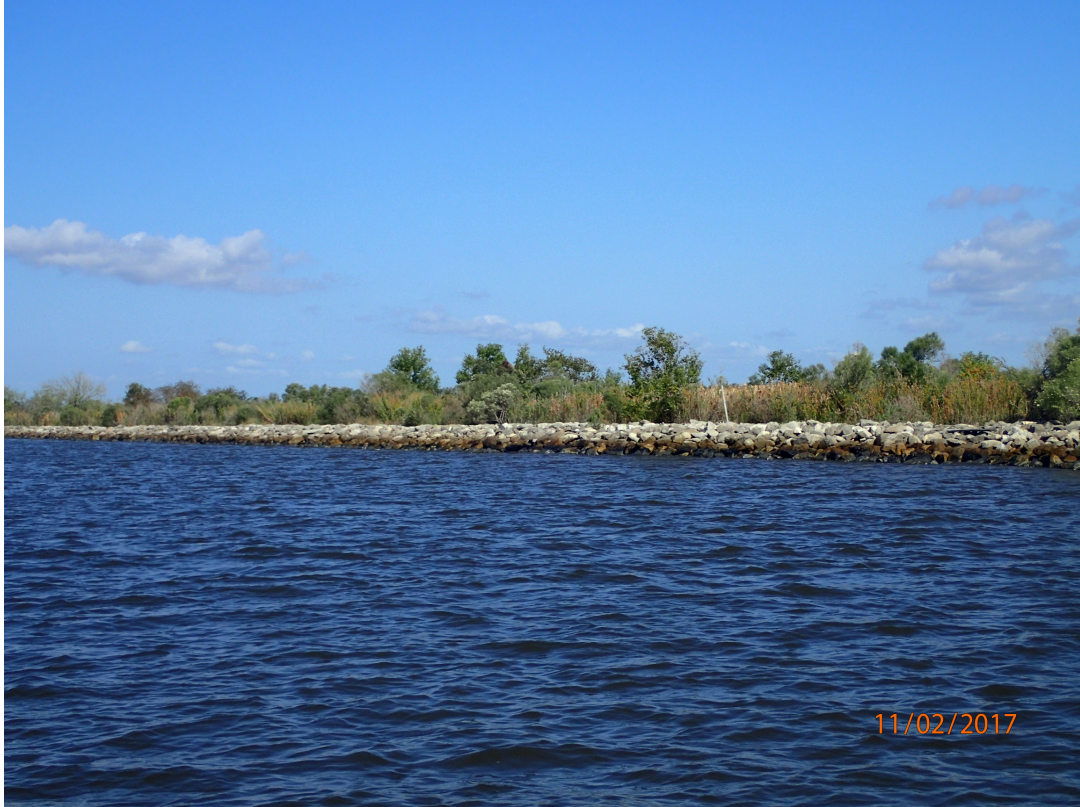
Photo #5 – Marsh Creation Area Viewed from Barataria Waterway

Inspection of this feature was performed visually from the Barataria Bay Waterway due to lack of access over the rock shoreline protection structure and shallow depths encountered outside of established waterways. The marsh creation area appeared well-vegetated with healthy marsh grass and Roseau cane (Photos #5 & #6). No maintenance needs were identified for this area.
