### **2025/2026 Annual Inspection Report**

### **BLACK BAYOU CULVERTS HYDROLOGIC RESTORATION PROJECT (CS-29)**

State Project Number CS-29  
Priority Project List 9

January 27<sup>th</sup>, 2026  
Calcasieu and Cameron Parishes

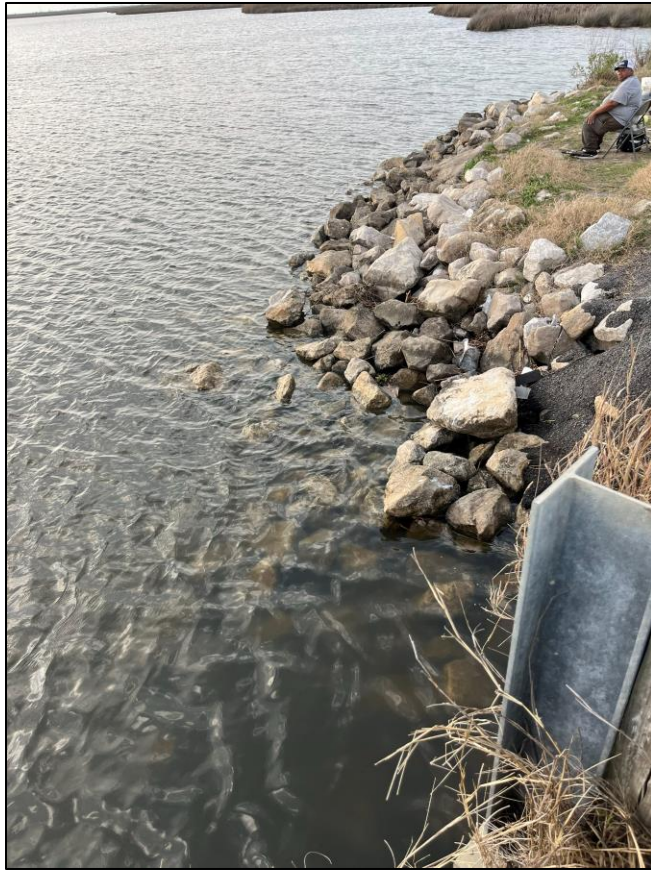
**B3. West Side of Structure – North Riprap**

The visible rock rip rap was in good condition. (Photos: Appendix B)

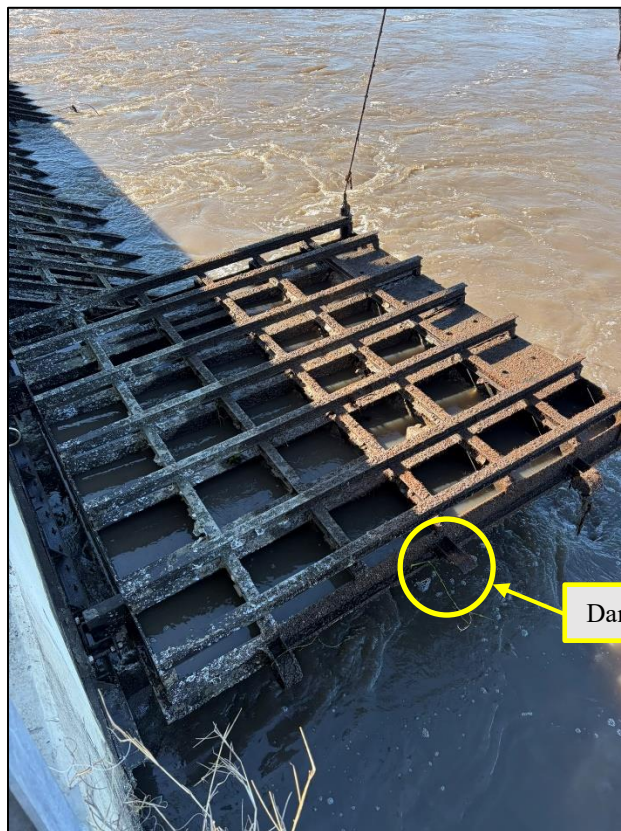
Damaged Locking Ring

**1b. Gate No. 1 – North side of Gate**

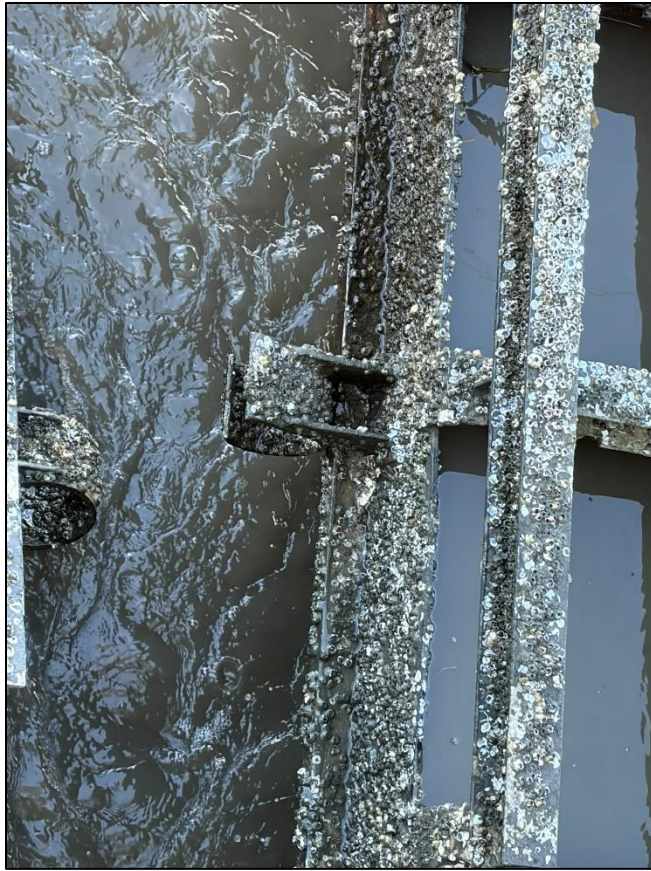
Feature No.	Description	Intact	Damaged	Comments
<b>Flap Gate Features</b>				
1	Hinge Assembly (Left)	X		
2	Hinge Assembly (Right)	X		
3	Flap Gate Lock Ring, Upper (Rt.)		X	Approximately 1/3 of the outer portion of this ring is missing. However the portion remaining should serve to help hold the locking pin in place if deployed.
4	Flap Gate Lock Ring, Middle(Rt.)	X		
5	Flap Gate Lock Ring, Lower (Rt.)	X		
6	Flap Gate Lock Ring, Lower (Lt.)	X		
7	Flap Gate Lock Ring, Middle (Lt.)	X		
8	Flap Gate Lock Ring, Upper (Lt.)		X	This ring except for the portion welded to the gate frame is missing. As such, it will not provide any support should the locking pins need to be installed.
9a	Aluminum Plate for Retaining Styrofoam Floatation Block	X		
9b	Styrofoam Floatation Block	X		
10a	Aluminum Plate for Retaining Styrofoam Floatation Block	X		
10b	Styrofoam Floatation Block	X		
11a	Aluminum Plate for Retaining Styrofoam Floatation Block	X

**3e. Gate No. 3 – South side of Gate - Damaged Upper Locking Ring**

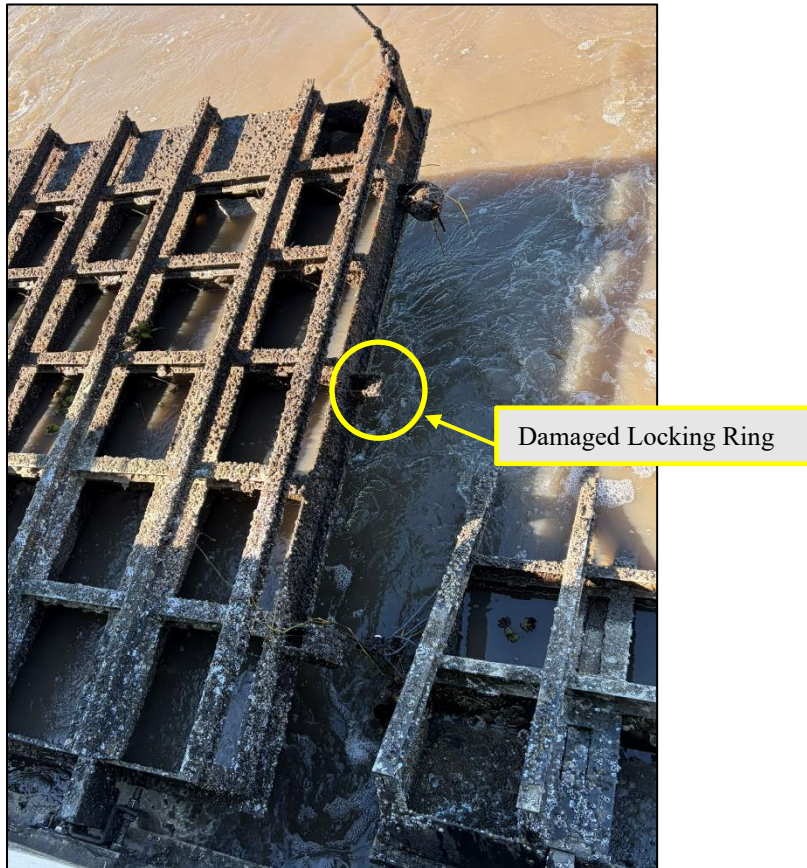
Damaged Locking Ring

**6b. Gate No. 6 – North side of Gate**

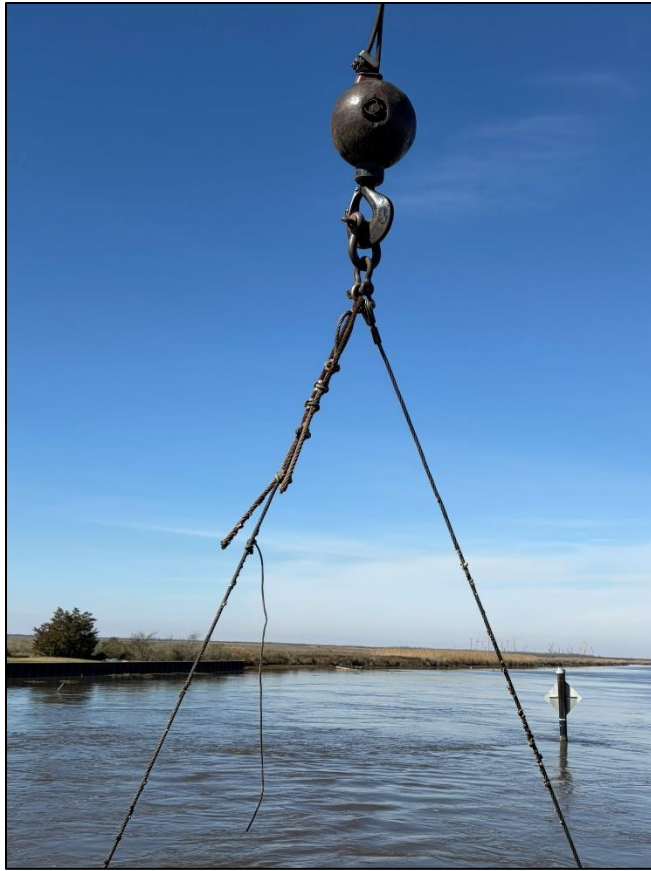
During the inspection, the south lifting cable on Gate No. 6 and the north lifting cable on Gate No. 7 were replaced. In addition, the south lifting cable pin on Gate No. 10 was replaced.

**6e. Gate No. 6 – Old, Damaged Lifting cable. (South Cable)**

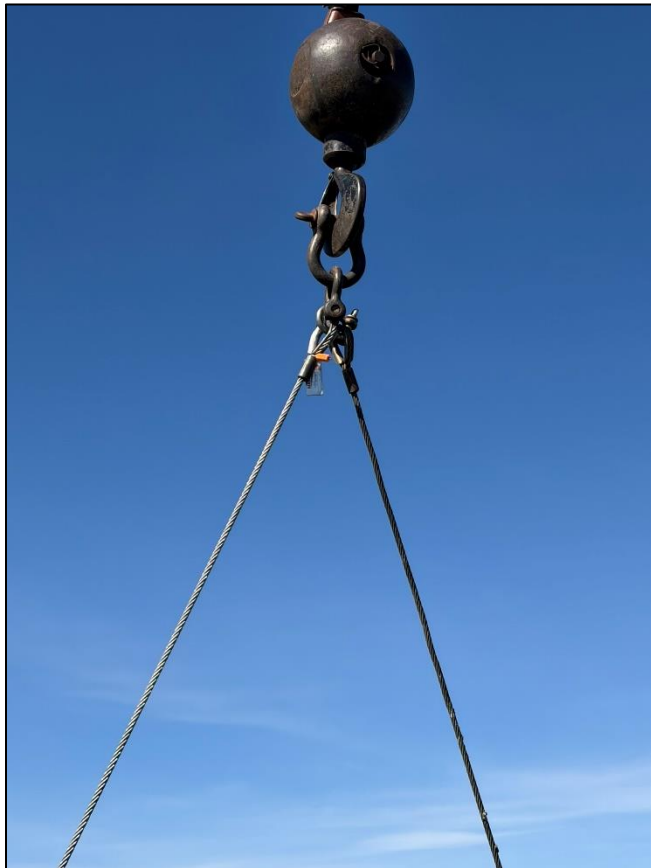
**6f. Gate No. 6 – New Lifting cable. (South Cable)**

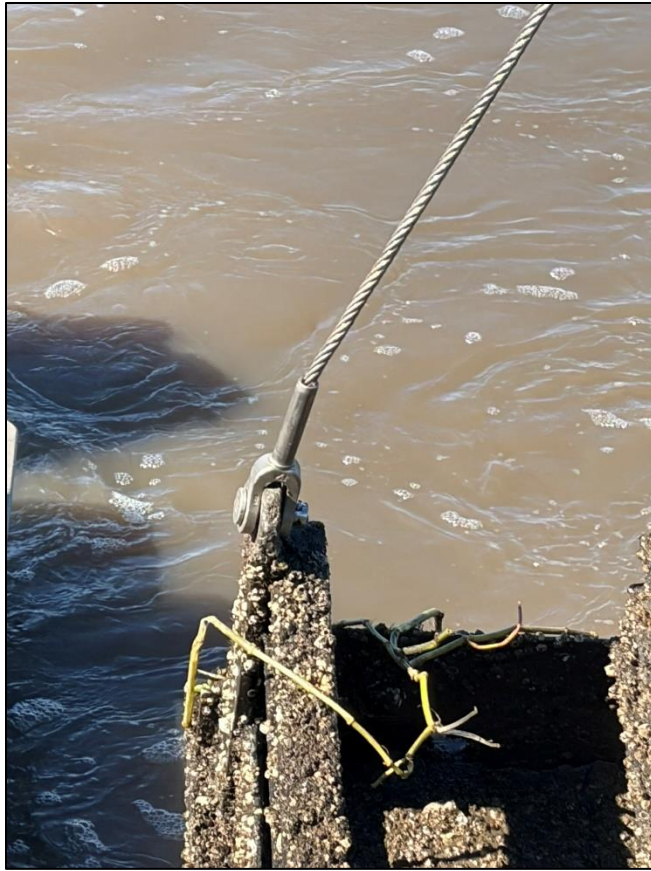
**6g. Gate No. 6 – New Lifting eye, shackle and cable - South side of Gate**

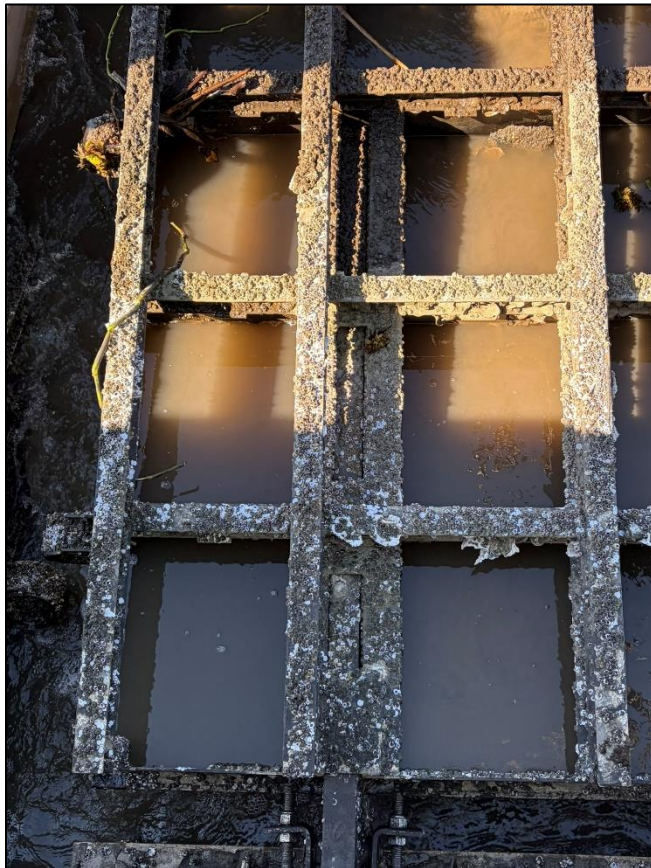
**6h. Gate No. 6 – Hinge Assembly and Stop Plate – South Side**

Feature No.	Description	Intact	Damaged	Comments
<b>Flap Gate Features</b>				
1	Hinge Assembly (Left)	X		
2	Hinge Assembly (Right)	X		
3	Flap Gate Lock Ring, Upper (Rt.)	X		
4	Flap Gate Lock Ring, Middle(Rt.)	X		
5	Flap Gate Lock Ring, Lower (Rt.)	X		
6	Flap Gate Lock Ring, Lower (Lt.)	X		
7	Flap Gate Lock Ring, Middle (Lt.)		X	All but the welded connection to the gate portion of this lock ring is missing.
8	Flap Gate Lock Ring, Upper (Lt.)	X		
9a	Aluminum Plate for Retaining Styrofoam Floatation Block	X		
9b	Styrofoam Floatation Block	X		
10a	Aluminum Plate for Retaining Styrofoam Floatation Block	X		
10b	Styrofoam Floatation Block	X		
11a	Aluminum Plate for Retaining Styrofoam Floatation Block	X		
11b	Styrofoam Floatation Block	X		
12a	Aluminum Plate for Retaining Styrofoam Floatation Block	X		
12b	Styrofoam Floatation Block	X		
13	Aluminum Angle (Lt.)	X		
14	Aluminum Angle (Rt.)	X		
15	Stop Plate (Left)		X	Cracked weld

16	Stop Plate (Right)		X	Cracked weld
17	Lifting Cables	X		Installed New South Lifting Cable
<b>Additional Comments</b>				
A	Water levels in the channel did not allow for visual inspection of the locking rings attached to the gate frames.			
B	With all but one locking ring on the gate intact, barring issues with the rings on the receiver gate frame, there should be no problems locking the gate in the closed position. Note that the operations Contractor had trouble locking the gate in the closed position in March of 2022. The locking pin could not be inserted to its full length through the locking rings on the north side of the gate. It's believed that an underwater obstruction may have prevented the proper installation of the locking pin. Repair/replacement is not recommended at this time.			
C	Due to the south lifting cable being damaged, a new lifting cable was installed during the inspection.

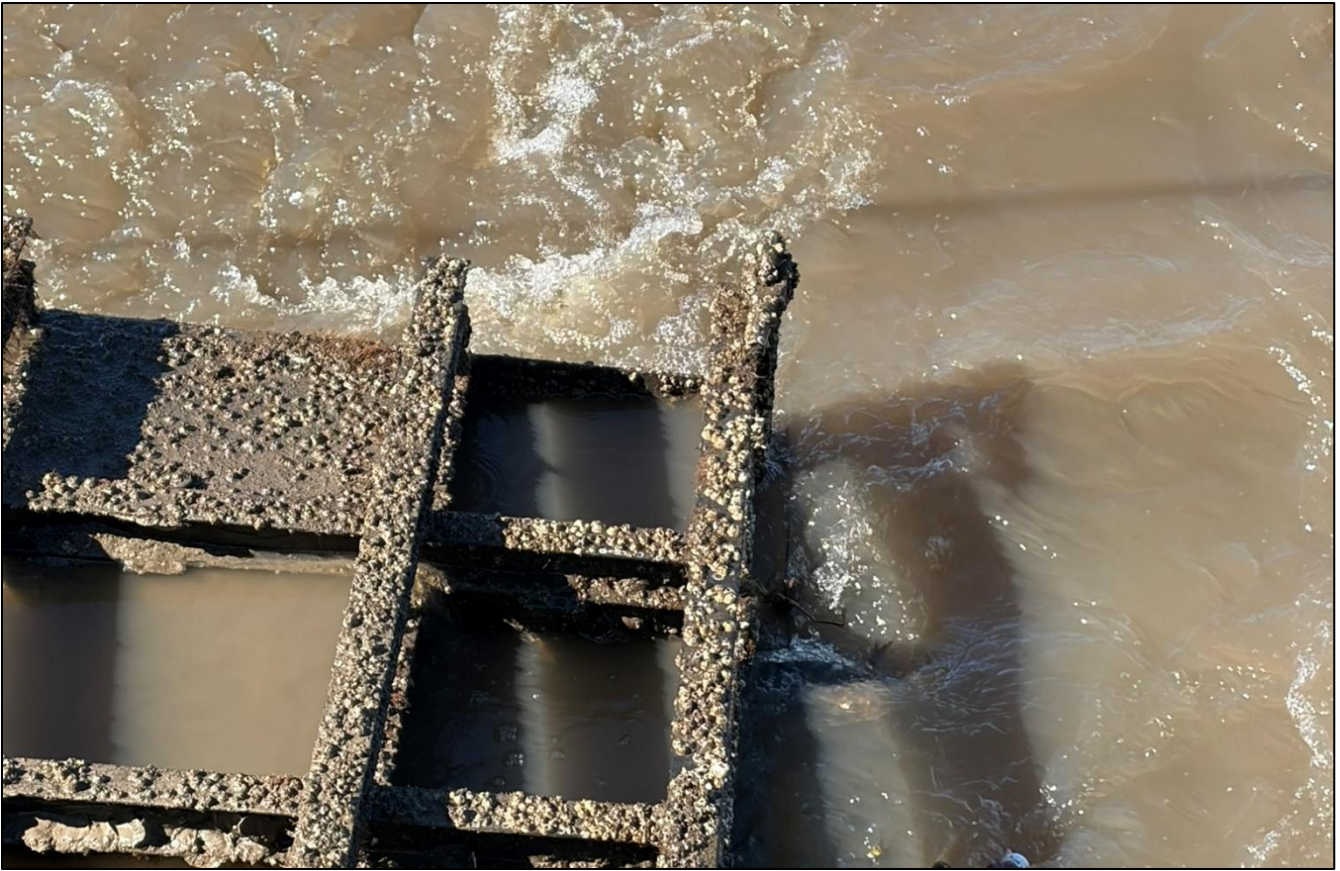
**7c. Gate No. 7 – Lifting eye, shackle and cable - North side of Gate. Broken Cable**

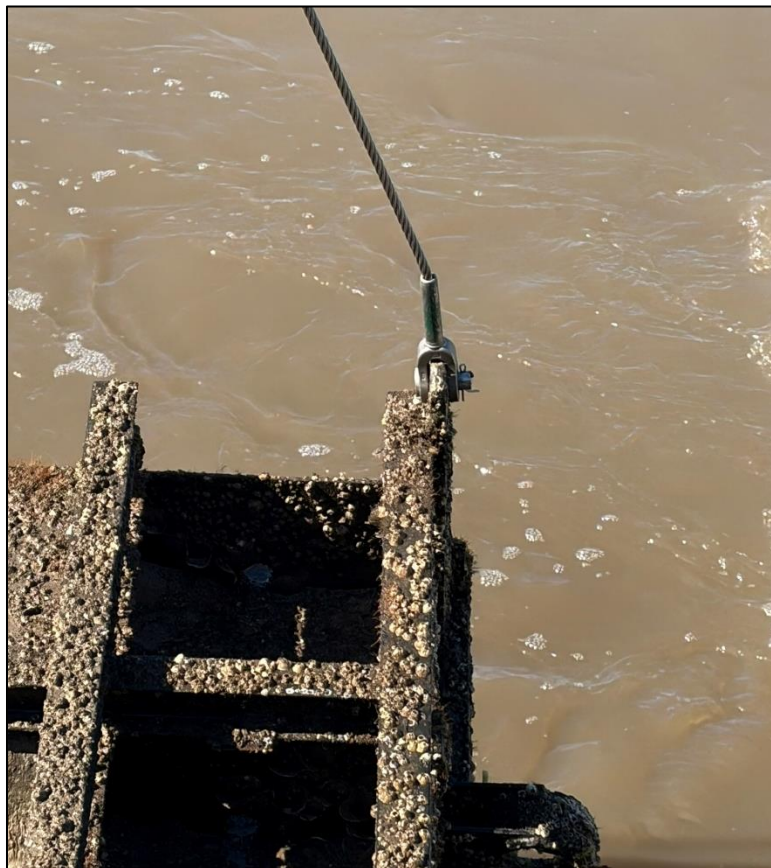
**7d. Gate No. 7 – New Cable Installed**

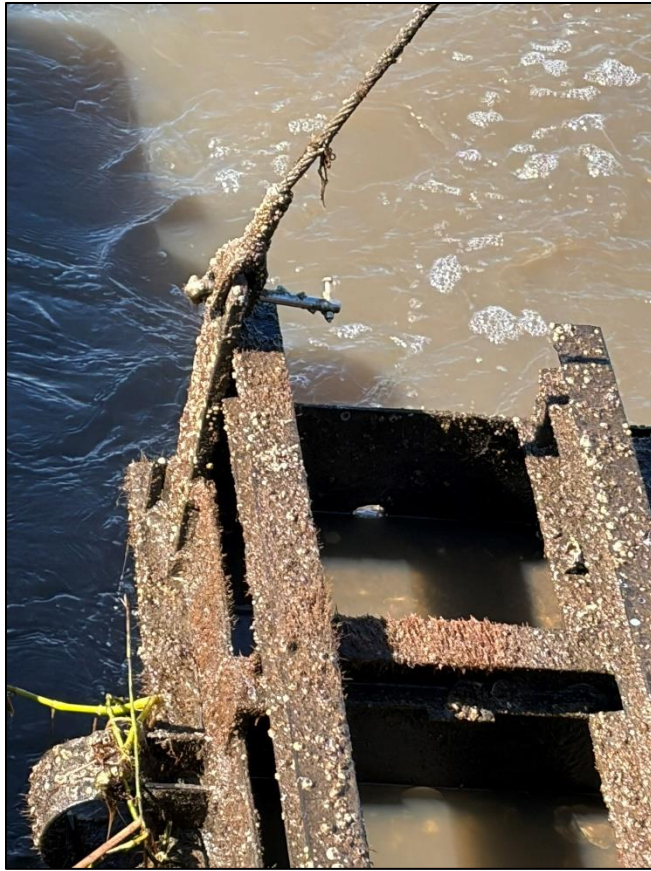
**10e. Gate No. 10 – Lifting eye, shackle and cable - South side. Old Pin**
