PROJECT COMPLETION REPORT

PROJECT NAME: **Brady Canal Breach Repair Project (2003)**

CWPPRA/STATE PROJECT NO. **TE-28 – Maintenance Project**

REPORT DATE: **August 12, 2003**

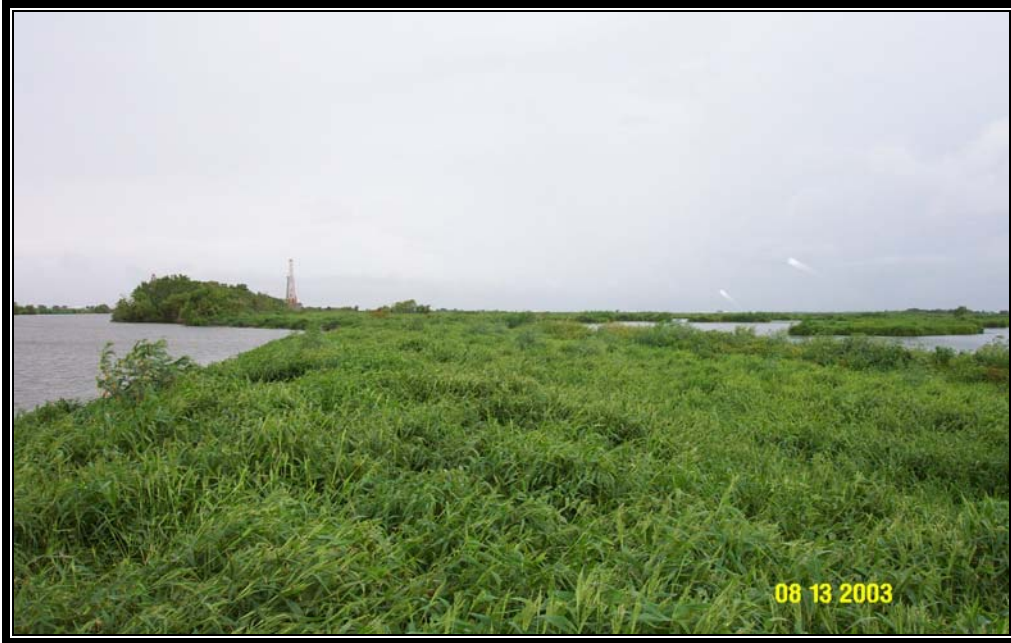
Breach 5 & 6 – Photo of breach repair along Turtle Bayou looking south.

Breach 5&6 – 1,500 linear feet of earthen embankment construction located along Turtle Bayou.

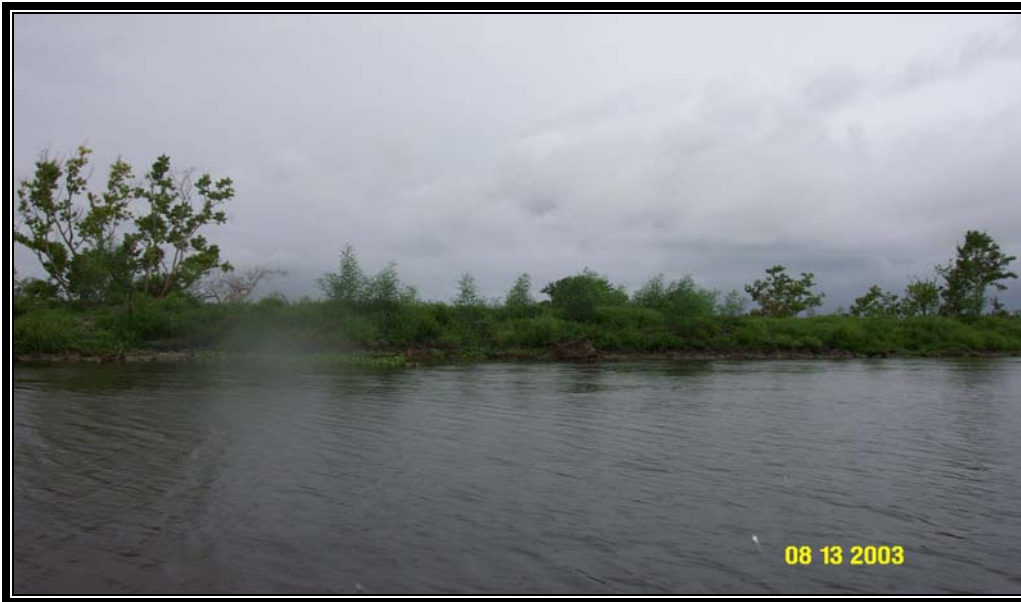
Breach 9 – Photo of breach repair along Superior Canal looking south.

Breach 9 – 200 linear feet of earthen embankment construction located along Superior Canal.

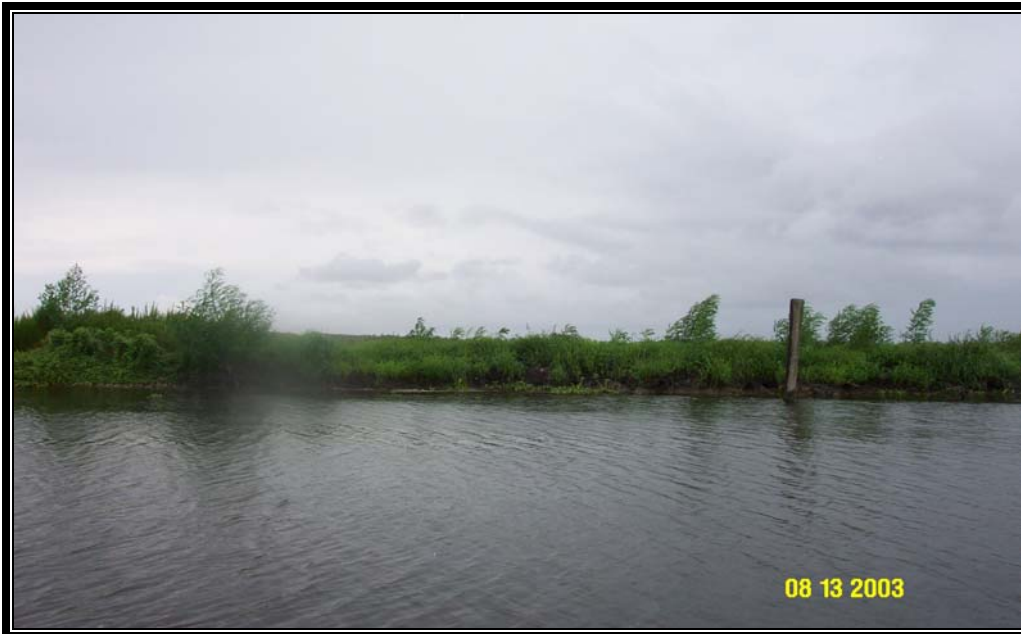
Breach 8 – Photo of levee repair along Superior Canal looking south.

Breach 8 – 200 linear feet of earthen embankment construction located Superior Canal.

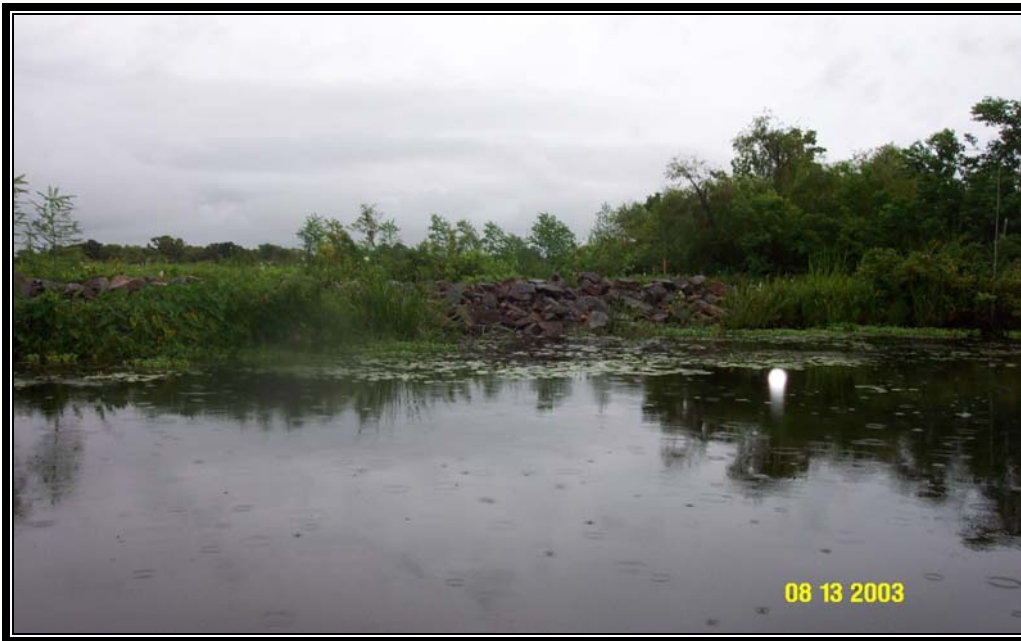
Breach 7 – Photo of rip-rap breach repair along oil field canal looking north.

Breach 7 – 261 linear feet of broken stone rip-rap dike above geotextile fabric located along an existing oil field canal off of Superior Canal.

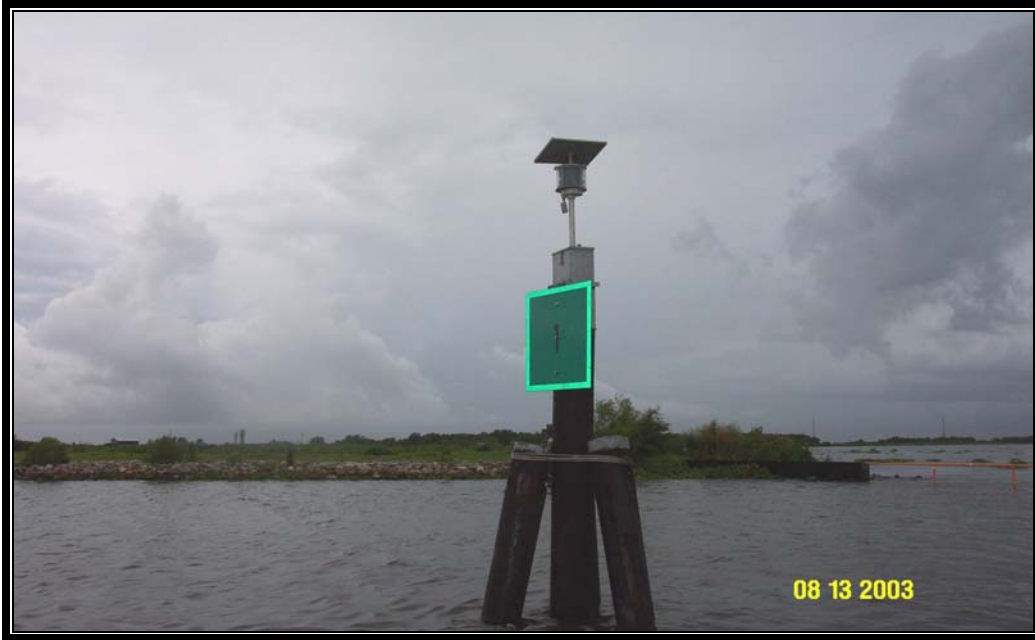
Photo of timber pile repair at Structure No.6 along Bayou Decade.

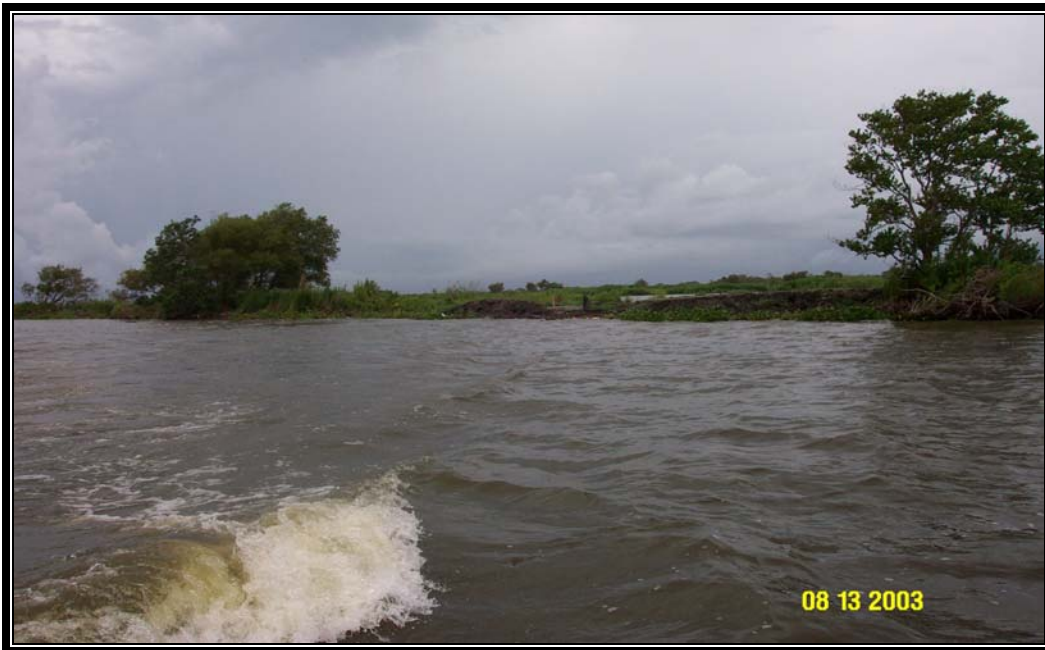
- B. The construction contract required the repair of an existing breach adjacent to a culvert flap gate along the west bank of Jug Lake. This breach was repaired as required by the contract. Not long after the repairs were made, over-wash from Tropical Storm Bill re-opened the breach. Through discussions with NRCS, LDNR and the landowners, a consensus was established that this structure should be removed to prevent future deterioration of the levee bank. LDNR is pursuing the removal of this structure.

Breach 10 – photo of breach repair along the west bank of Jug Lake.

Breach 10 – 90 linear feet of earthen embankment construction located along the west bank of Jug Lake near an existing culver/flap gated structure.

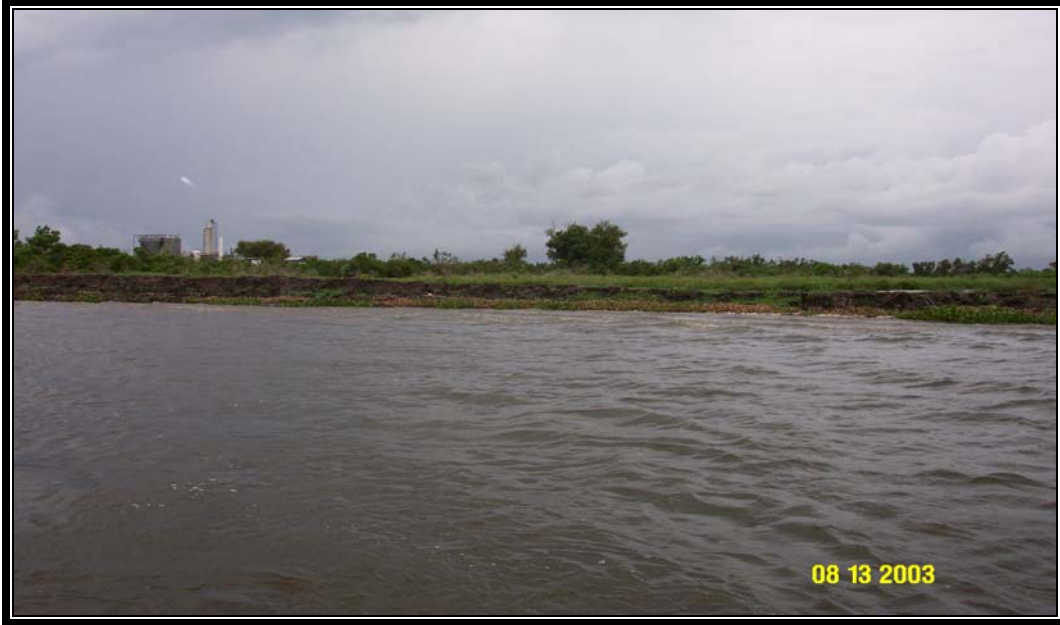
Breach 11 – photo of breach repair along the west bank of Jug Lake.

Breach 11 – 300 linear feet of earthen embankment construction located along the west bank of Jug Lake north of Breach 10.

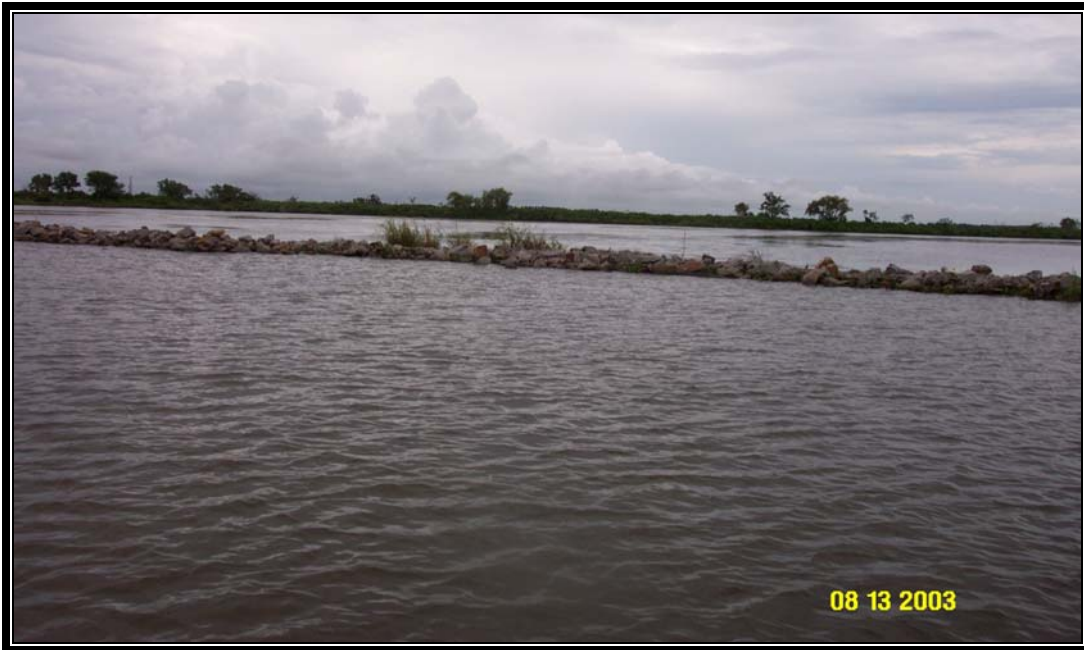
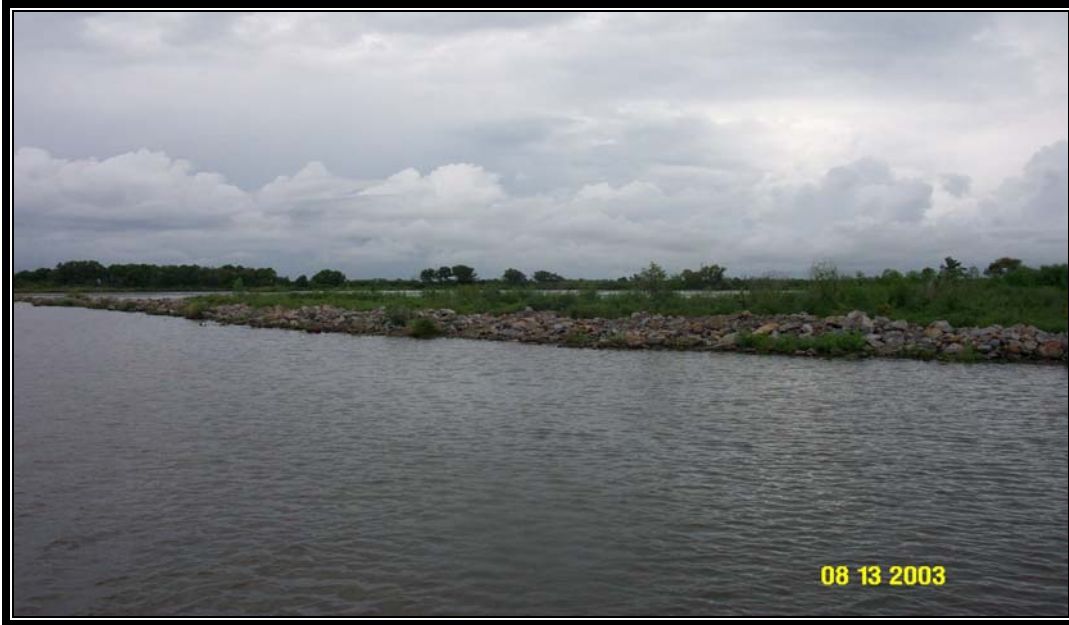
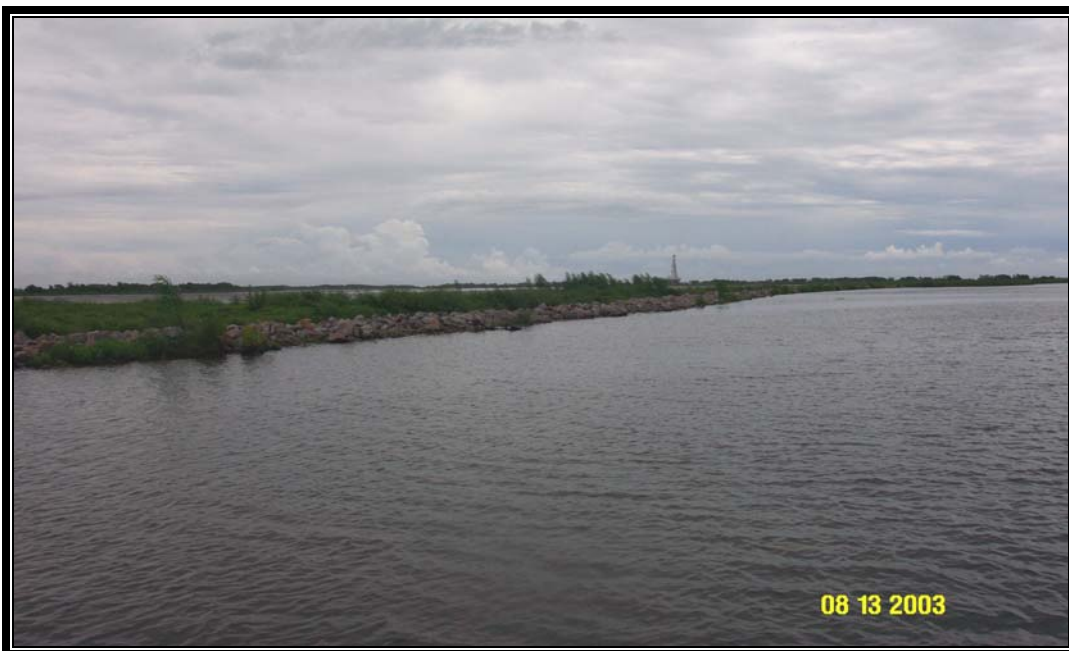
Breach 1 thru 4 – rock dike along Bayou Decade looking north.

Breach 1 – 660 linear feet of broken stone rip-rap dike above geotextile fabric located along the northern bank of Bayou Decade near Jug Lake.

Breach 2&3 – 1,130 linear feet of broken stone rip-rap dike above geotextile fabric located along the northern bank of Bayou Decade.

Breach 4 – 160 linear feet of broken stone rip-rap dike above geotextile fabric located along the northern bank of Bayou Decade.

- 1,700 linear feet of rip-rap dike along Bayou Decade between breach 1 and 2.
- 400 linear feet of rip-rap dike along Bayou Decade beginning at the end of breach 3 and the beginning of breach 4.
