**State of Louisiana  
Department of Natural Resources  
Coastal Restoration Division and  
Coastal Engineering Division**

**2004 Operations, Maintenance,  
and Monitoring Report**

**Cameron Prairie Refuge Protection**

State Project Number ME-09  
Priority Project List 1

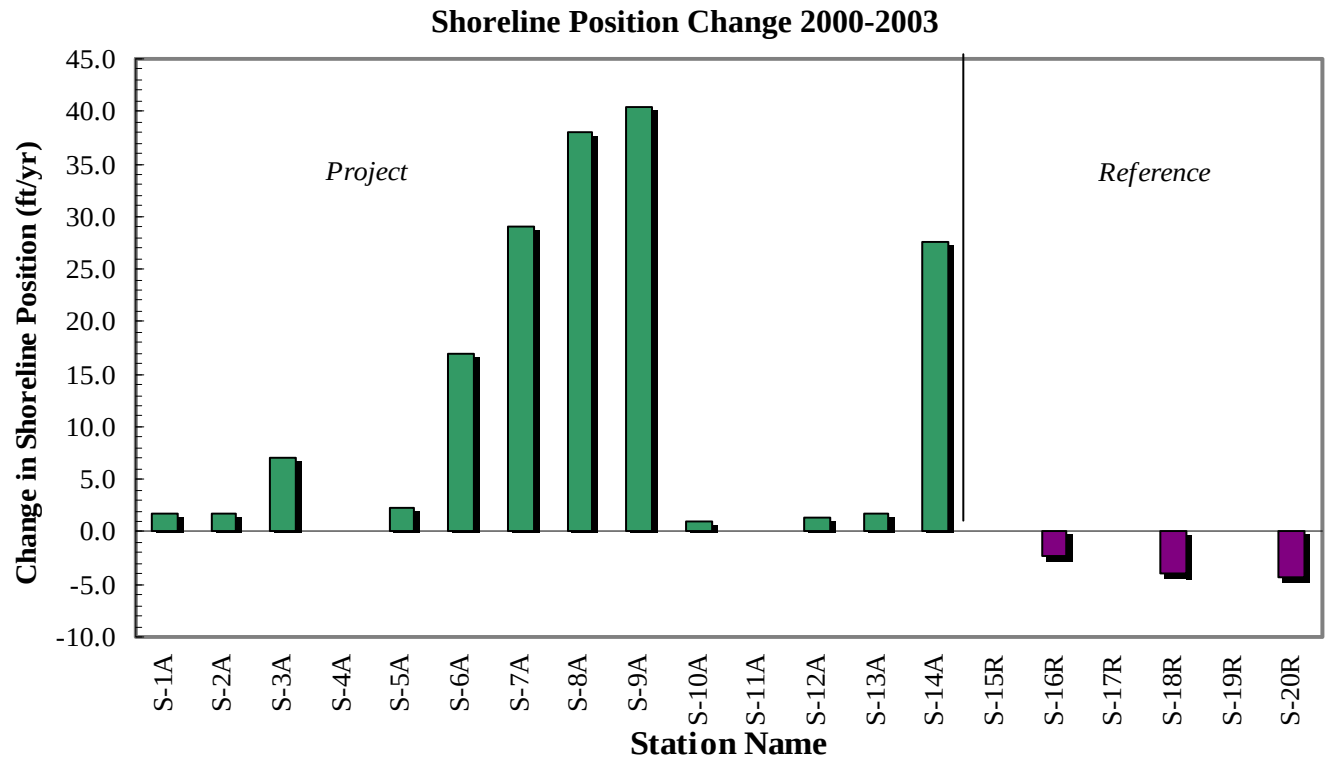
Shoreline change data were collected in 1995, 1997, 2000 and 2003. Presented here is the comparison between the 2000 and 2003 surveys (figures 4-8, table 1). Mean shoreline change rate was calculated to be 13 +/- 15.4 ft/yr (4 +/- 4.7 m/yr) and -2.1 +/- 2.1 ft/yr (-0.6 +/- 0.6 m/yr) for the project and reference areas, respectively. The data indicate that the project has continued to be effective in preventing erosion at all project area stations. Shoreline position at the reference sites continued to retreat.

**Figure 5.** Shoreline position change within the Cameron Prairie (ME-09) project and reference areas for 2000-2003 in feet/year.

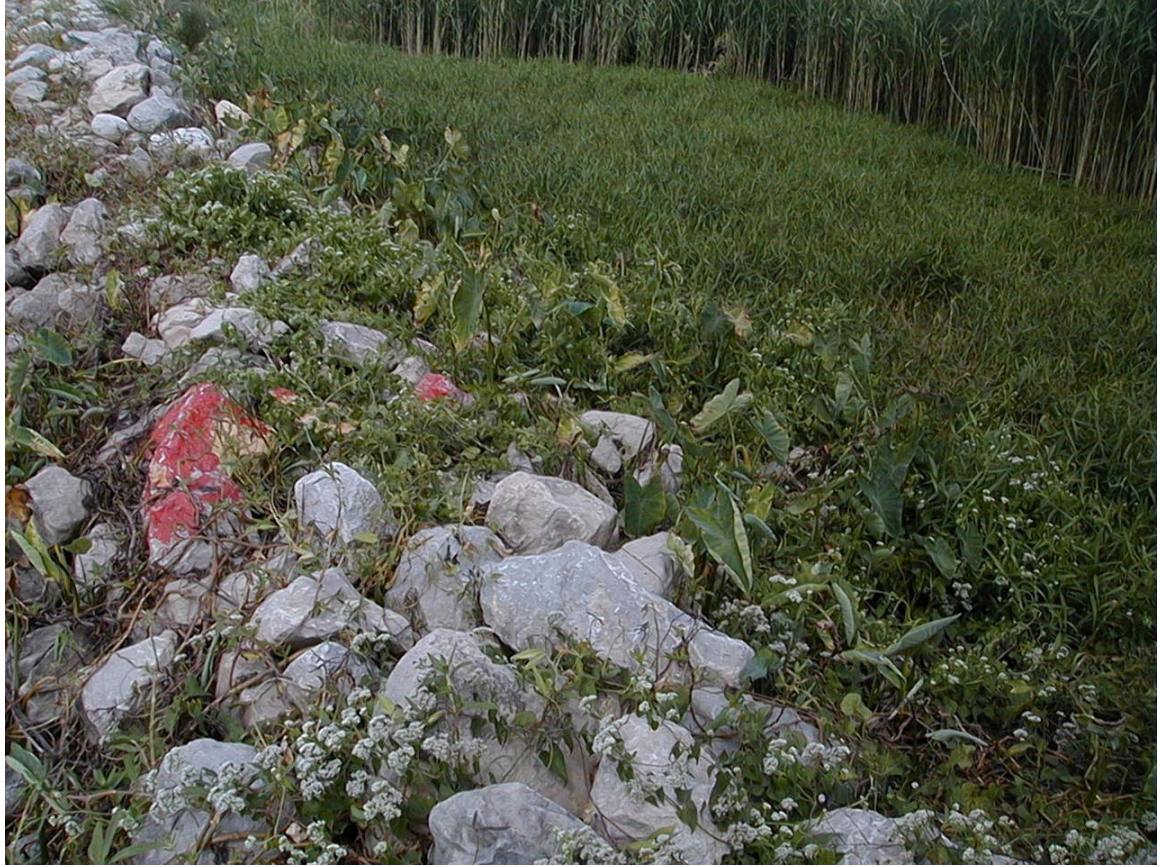
**Figure 8.** View of the Cameron Prairie rock dike showing naturalized vegetation colonizing the dike itself and the accreted marsh behind the dike. The red paint was used to mark the location of the shoreline marker for the DGPS survey.

The project has been effective at preventing shoreline erosion at all project area stations, while the shoreline in the reference area stations continued to retreat. Visual observation indicates vertical accretion of the wetland area at many locations between the foreshore rock dike and the shoreline.
