**2004 Operations, Maintenance,  
And Monitoring Report**

**Freshwater Bayou Canal Bank  
Stabilization**

State Project Number ME-13  
Priority Project List 5

May 2004  
Vermilion Parish

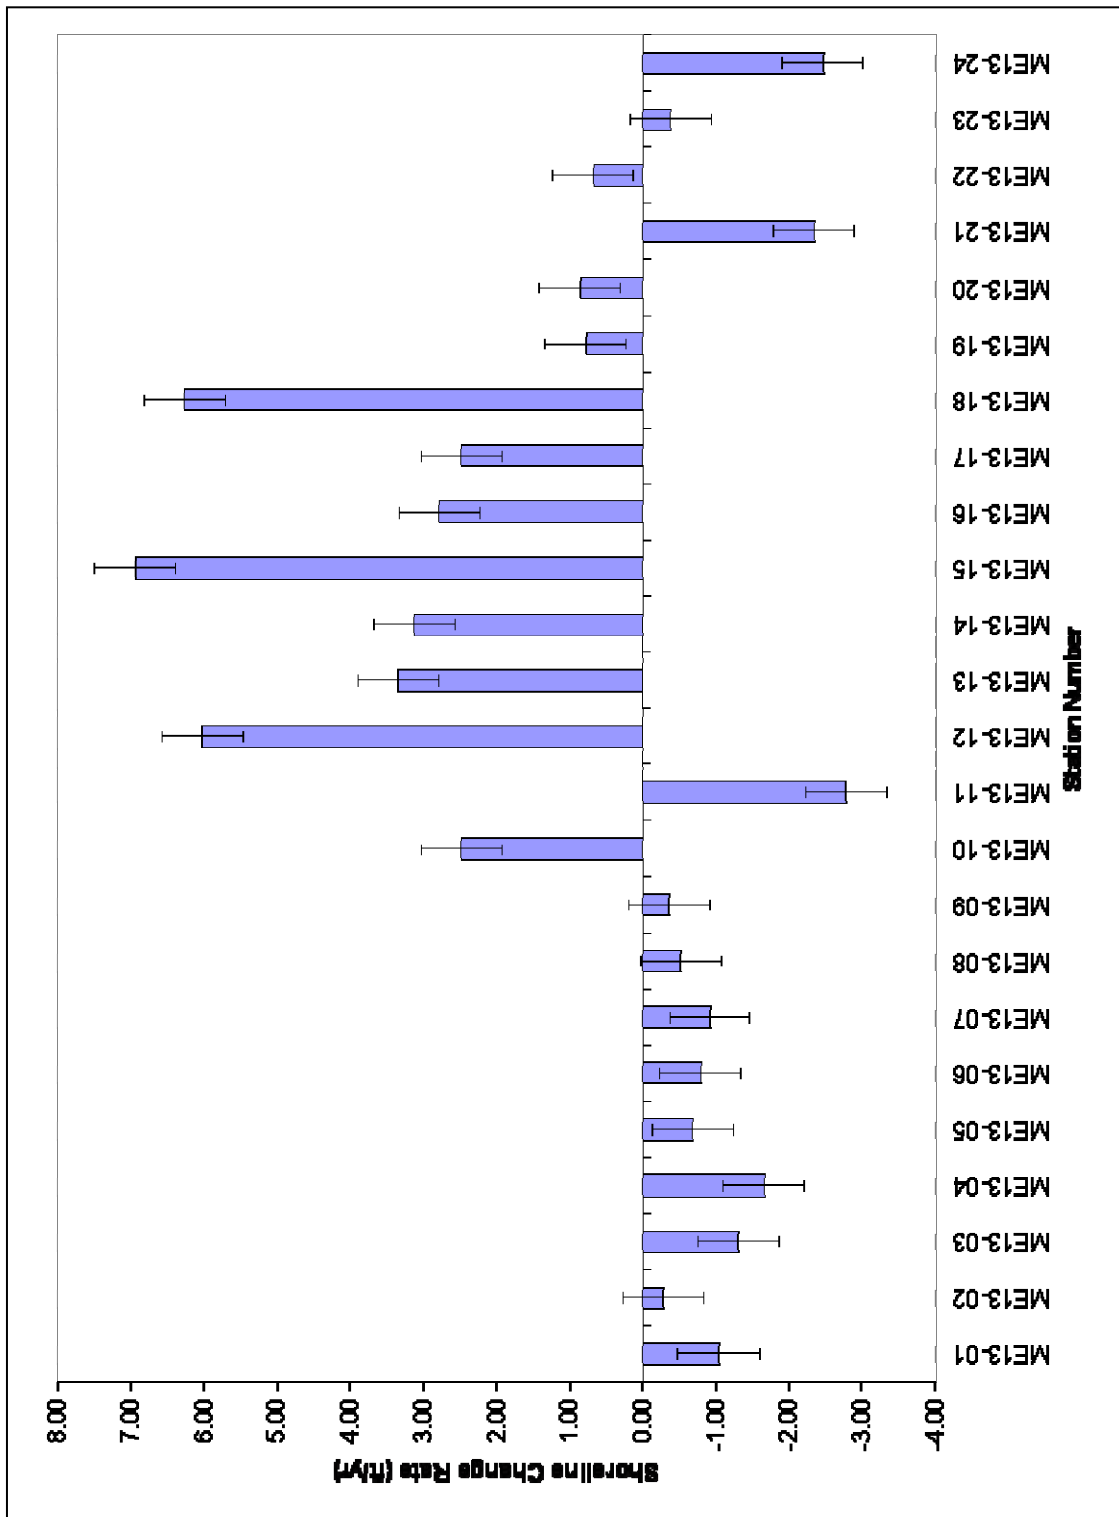
- The project area shoreline prograded at an average rate of 0.84 ft/yr (0.26 m/yr) (figure 4, table 1) and the reference area shorelines eroded at an average rate of -11.94 ft/yr (-3.64 m/yr) (figure 5, table 2) indicating that the ME-13 project rock dike has significantly reduced wave erosion of the protected segment of canal bank for the past five years.

**Figure 4:** Shoreline change rate (ft/yr) along Freshwater Bayou Canal at the ME-13 project area stations for the July 23, 1998 – July 21, 2003 time period. Error bars represent  $\pm 1$  standard error of the mean of all stations.

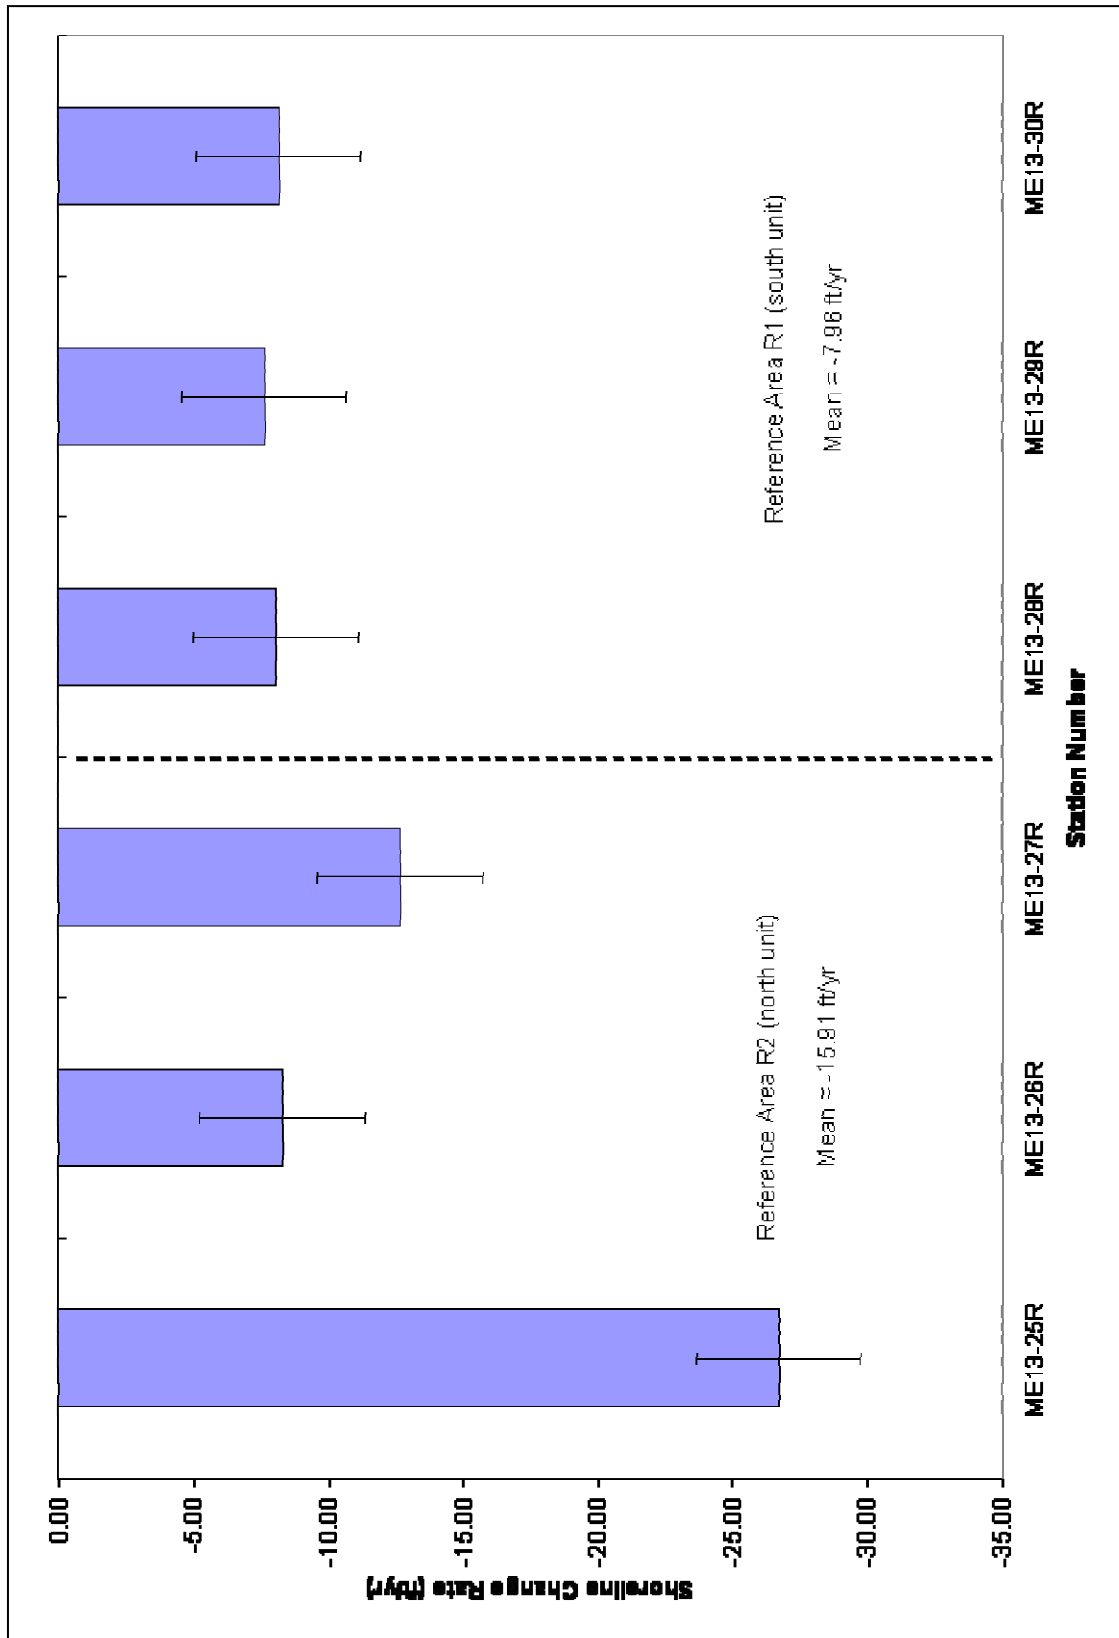
**Figure 5:** Shoreline change rate (ft/yr) along Freshwater Bayou Canal at the ME-13 reference area monitoring stations for the 23 July 1998 – 21 July 2003 time period. Error bars represent  $\pm 1$  standard error of the mean of all 6.

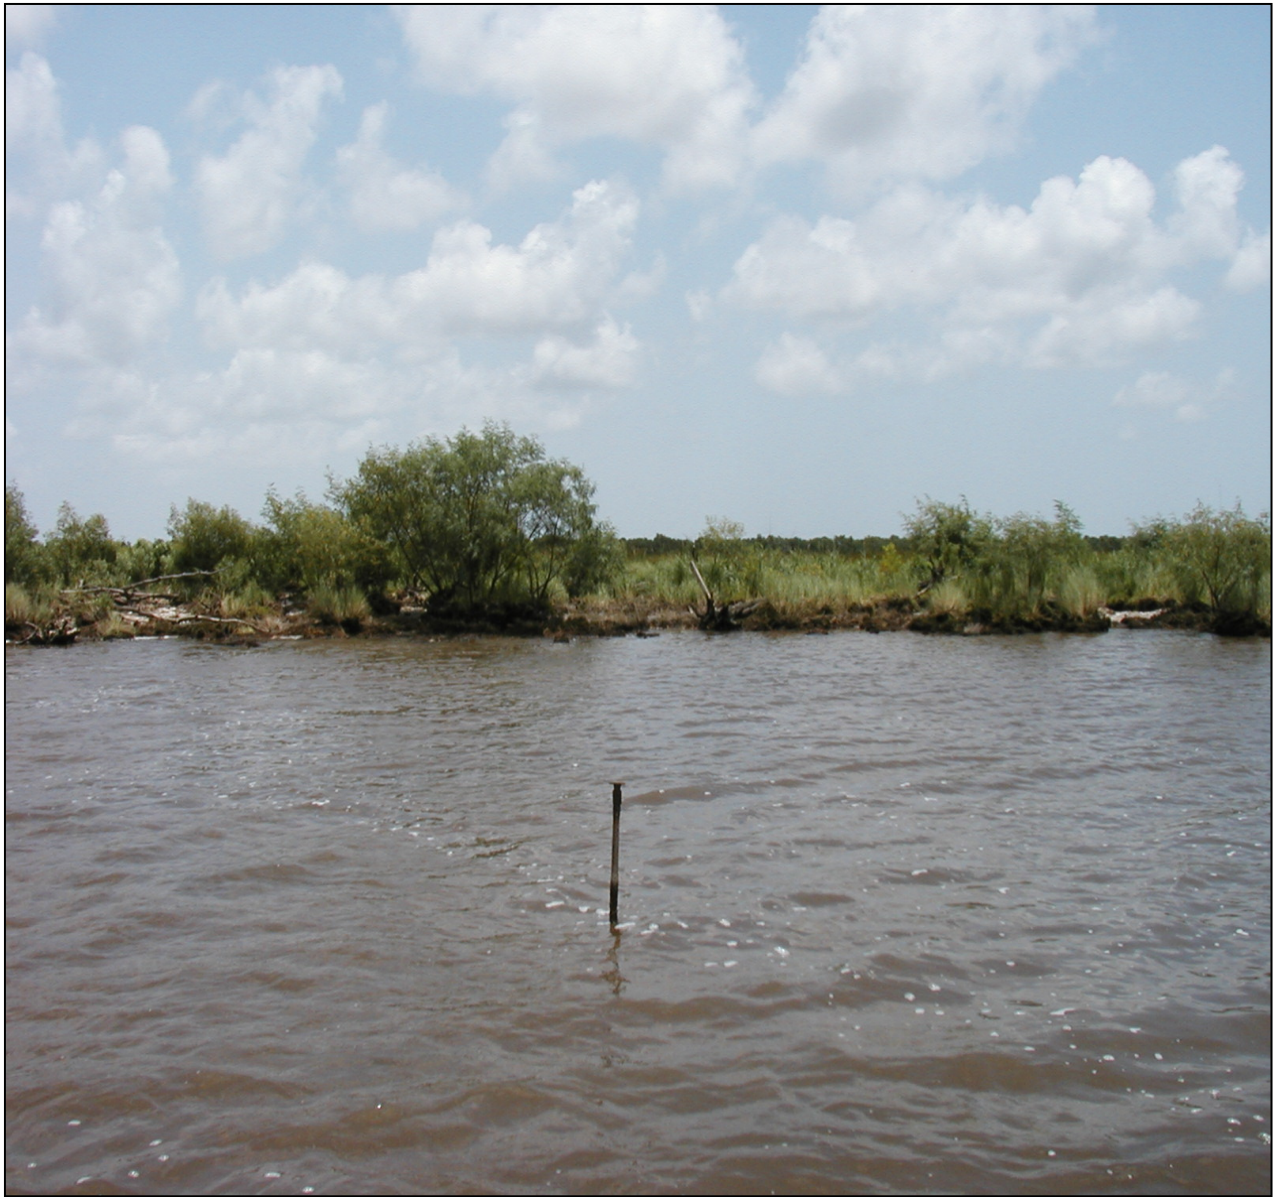
- The highest rate of shoreline retreat occurred at the north end of reference areas R2 (north unit) at station ME13-25R, where the shoreline retreated 89.0 ft (27.1 m) between July 23, 1998 and July 21, 2003 (figure 6).

**Figure 6:** View of the Freshwater Bayou Canal shoreline at reference area R2 (north unit) monitoring station ME13-25R taken on July 21, 2003. Note the current shoreline position which is 89.0 ft (27.1 m) inland from the survey hub in open water in the foreground. The hub was placed 44.7 feet (13.6 m) inland from the shoreline when it was installed in 1998.

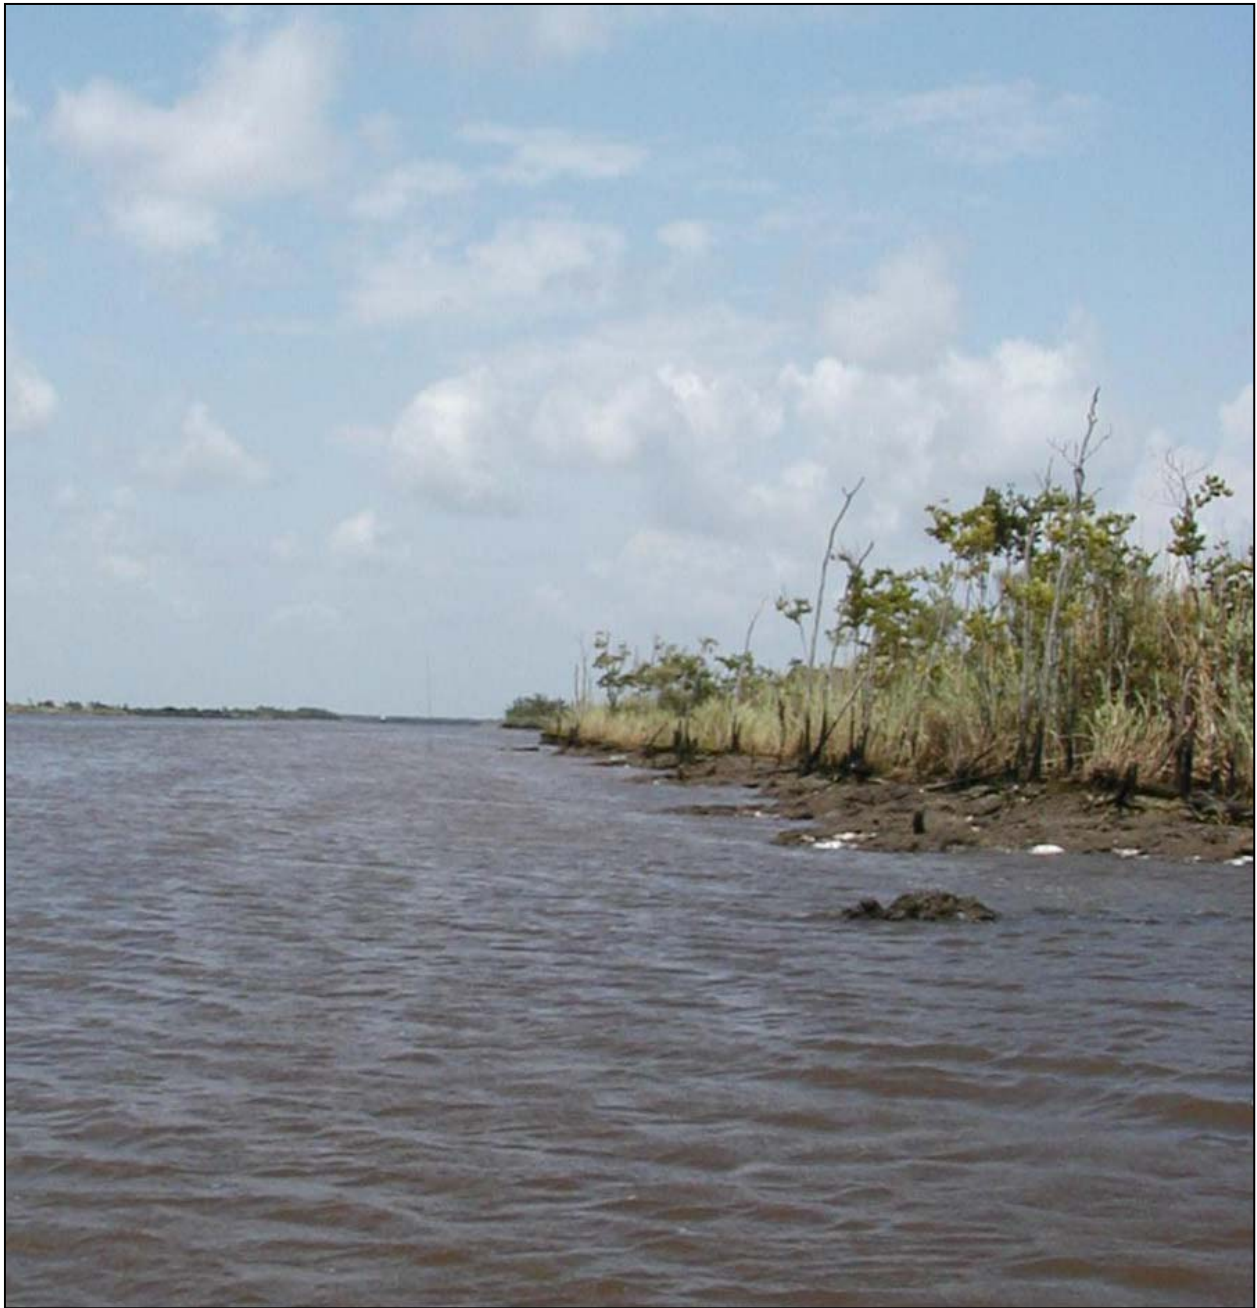
- Vegetation along unprotected shorelines of Freshwater Bayou Canal is subject to repeated battering from rack that accumulates along the unprotected shorelines, particularly where fallen trees are present. As a result, unprotected shoreline vegetation appears to be more stressed and in poorer health than shoreline vegetation protected by a rock dike.

**Figure 7:** View of the Freshwater Bayou Canal shoreline along reference area R1 (south unit) taken on July 21, 2003. Note the scalloped shoreline profile characterized by small coves and headlands. Fallen trees in this area are repeatedly rammed against the remaining live trees along the shoreline by boat wake-induced wave action.

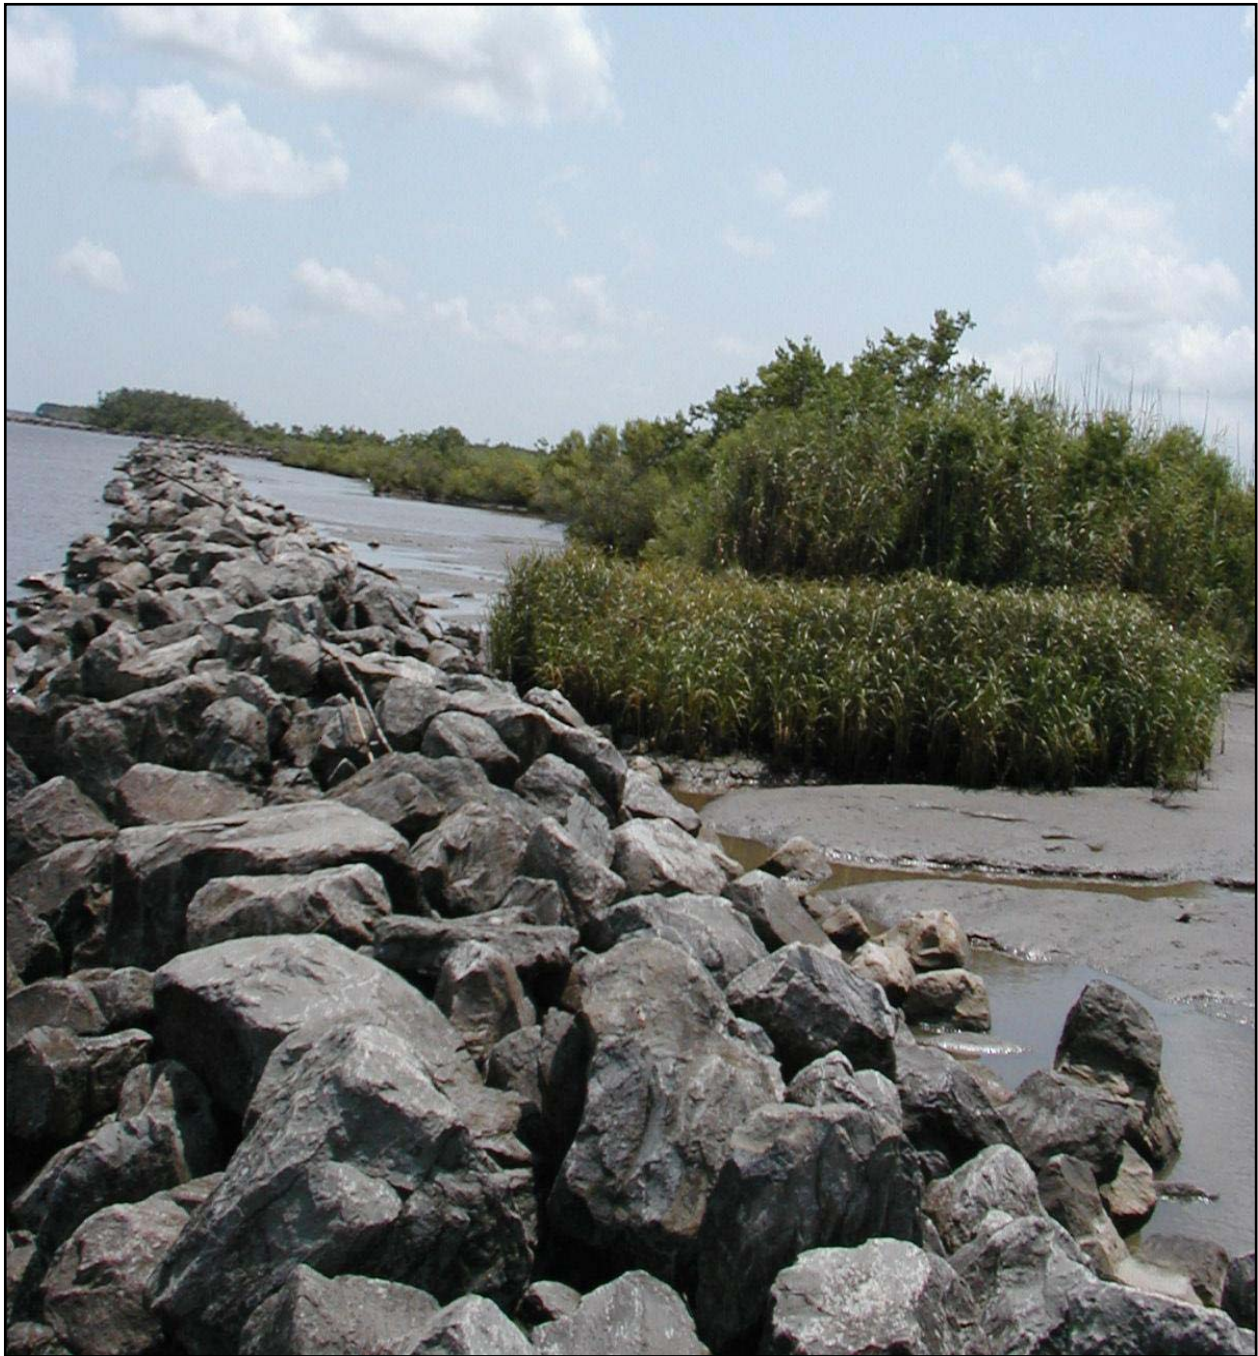
- Variation in the shoreline retreat rate along the project and reference area shorelines may be related to the erodibility of the substrate. Additionally, variability in the project area may also be related to crown height of the rock dike, which may require periodic additions of rock to be maintained. Marsh soils erode more rapidly than spoil bank soils, which erode more rapidly than shell ridges. In unprotected areas, variation in substrate erodibility produces a scalloped shoreline profile with small coves and headlands (figure 7). In protected areas, sediment accumulates along shorelines behind rock dikes, which tend to prograde towards the rock dike, and can even meet the rock dike with accumulated sediment which can revegetate naturally (figure 8).

**Figure 8:** View of the Freshwater Bayou Canal shoreline behind the ME-13 rock dike, looking south from monitoring station ME13-01, as observed on July 21, 2003. Note the healthy condition of the native vegetation along the shoreline and colonizing the shelf of sediment accumulating between the shoreline and rock dike.
