2004 Operations, Maintenance and Monitoring Report

FRITCHIE MARSH RESTORATION

State Project Number PO-06 Priority Project List 2

May 2004 St. Tammany Parish

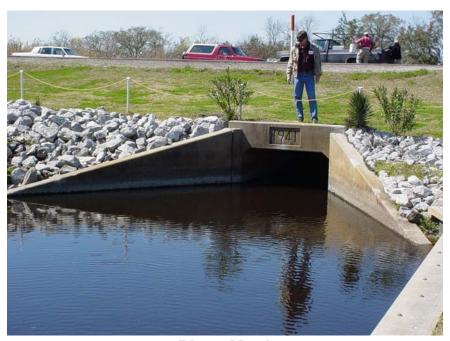
Slight erosion where the left descending bank meets the riprap lining for the Hwy 90 culvert was noted at the final inspection in March 2001, but does not show signs of increasing (Photos 1-4). The 72" x 136 L.F. RCP culvert beneath State Hwy 90 showed no apparent problems. No settlement or blockage of flow was noted. In addition, there were no signs of scour at the pipe ends (Photos 2-4). Some reflective cracking was noted in the asphalt riding surface on Hwy 90; and the aggregate shoulders need regrading in the vicinity of the pipe to remove the drop off between the pavement and shoulder (Photos 5). However, no evidence of settlement of the pipe or roadway has been noted since initial construction was completed in March 2001.

Photo No. 1
Pre-existing concrete box culvert under Hwy. 90 with adjacent stone riprap erosion protection placed in 2001.

- Re-grade the shoulders to remove the elevation difference the pavement and shoulder material.
- Monitor the reflective cracking in the asphalt in the vicinity of the RCP culvert.
- Monitor the erosion at the end of the stone riprap on the left descending bank of Salt Bayou.
- Install a staff gauge on the outside of the culvert and tie into network.

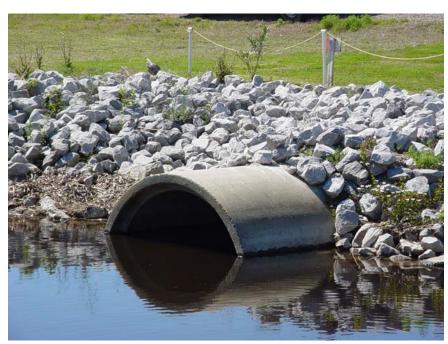
Photo No. 2 Round 72" concrete culvert under Hwy. 90 with stone erosion protection was completed in 2001.

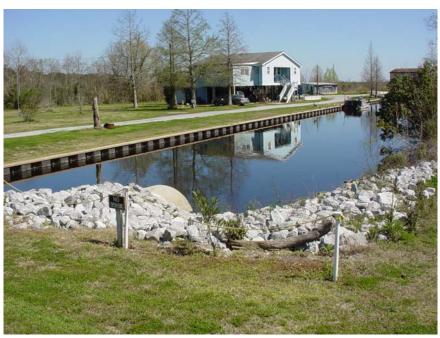
Photo No. 3
Steel sheet pile bulkhead and stone riprap erosion protection located adjacent to 72" concrete culvert on south side of Hwy 90.

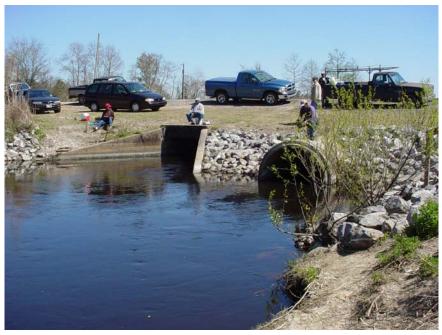
Photo No. 4 Riprap stone erosion protection placed on bank on both sides of culverts on the north side of Hwy 90.

- **b.** Monitor the reflective cracking in the asphalt in the vicinity of the RCP culvert.
 - **c.** Monitor the erosion at the end of the stone riprap on the left descending bank of Salt Bayou.

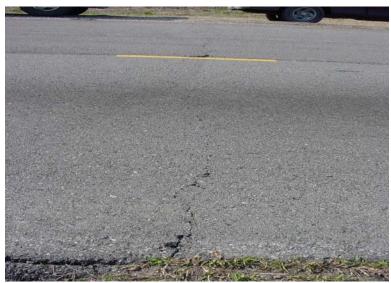
Photo No. 5 Newly placed asphalt surface at culvert crossing on Hwy 90 shows some slight cracking with little separation.

Overall, the constructed features of the Fritchie Marsh Restoration Project are in good to excellent physical condition with only minor maintenance problems noted. Slight reflective cracking was noted in the asphalt pavement of Hwy 90 directly above the RCP culvert and some settlement of the shoulder material was observed. Slight erosion at the end of the stone riprap was noted on an earlier inspection but has not increased.

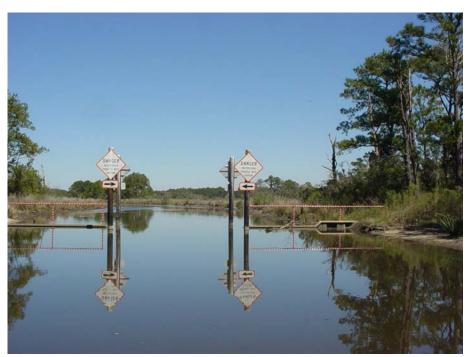
Structure is in excellent condition (Photo 6). All permanent signage was undamaged and in excellent condition. Hand rails were well marked with reflective tape and were undamaged. All

hardware was un-corroded. Tie-ins to the bank were well vegetated and showed no signs of erosion.

Spoil areas supported stable vegetation with no signs of significant settlement or erosion (Photo 6). Channel cross sections were not checked quantitatively as the dredging was recently completed.

Photo No. 6 W-14 Weir Structure looking east

- **3.** <u>Structural Assessment.</u> In order to evaluate weir settlement, stability of the structure, toe scour, any vertical accretion of the structure, and in-fill of the dredging efforts on Salt Bayou, a structural assessment survey performed by a licensed engineering/land surveying firm is recommended within the first 5 years of construction. The date of the assessment survey is to be agreed upon by the state and federal sponsor at the annual maintenance inspection.
