**2004 Operations, Maintenance,  
and Monitoring Report**

**LAKE CHAPEAU SEDIMENT  
INPUT AND HYDROLOGIC  
RESTORATION, POINT AU FER  
ISLAND**

State Project Number TE-26  
Priority Project List 3

May 2004  
Terrebonne Parish

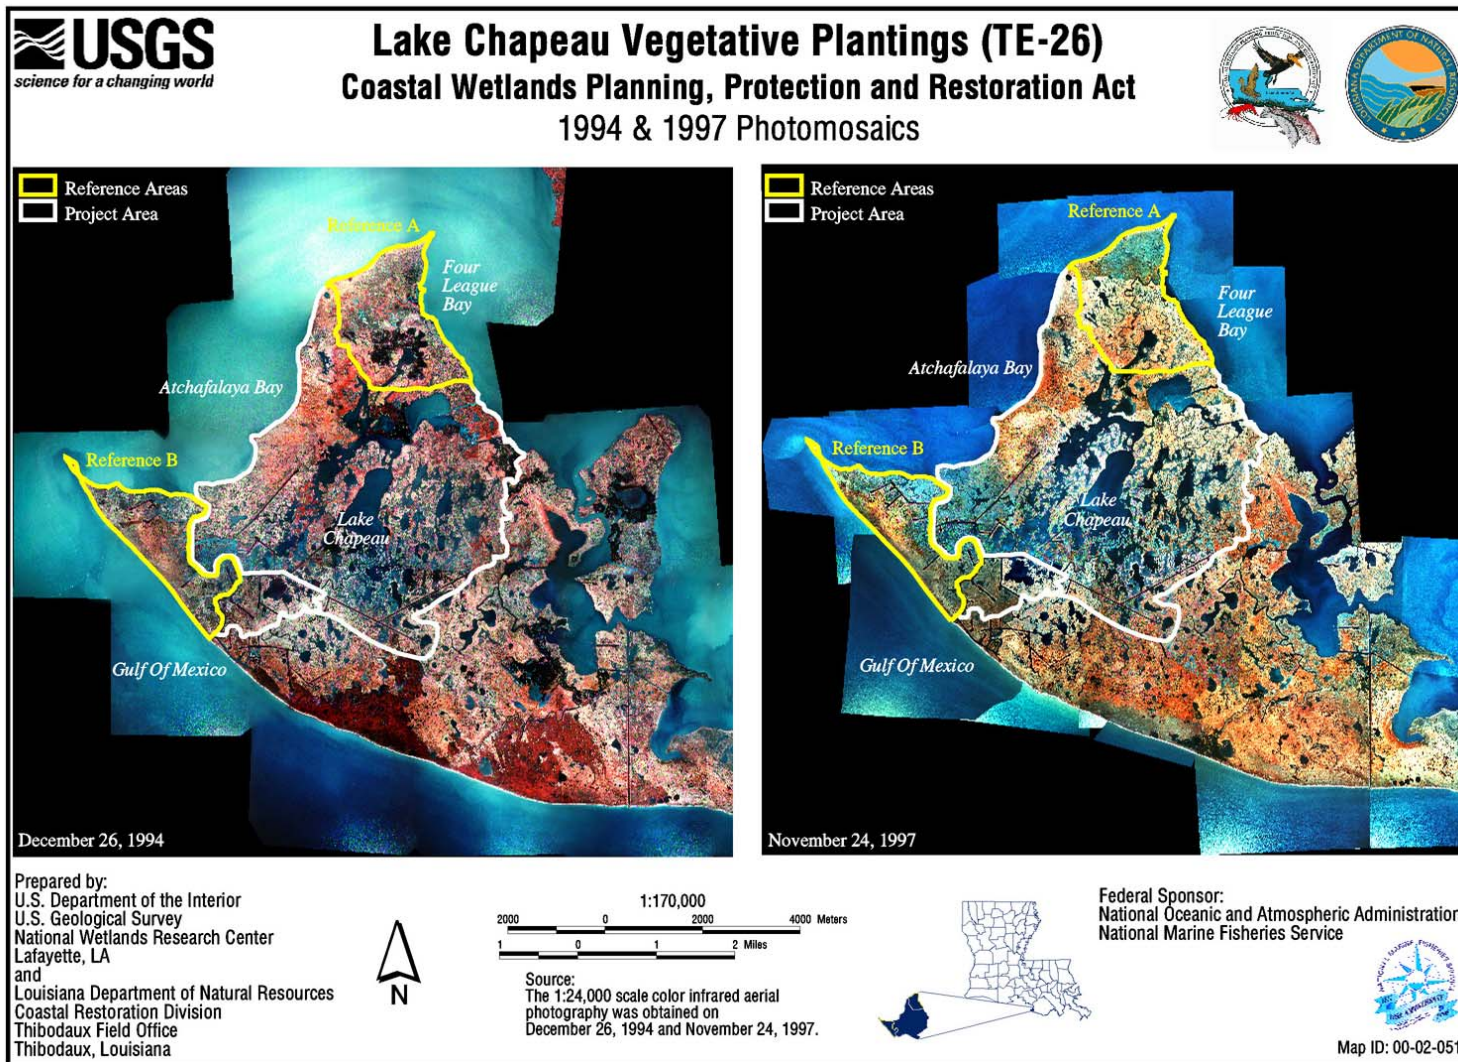
**Figure 2. 1994 and 1997 photomosaics for the Lake Chauvenet Sediment Input and Hydrologic Restoration, (TE-26) Point Au Fer Island project.**

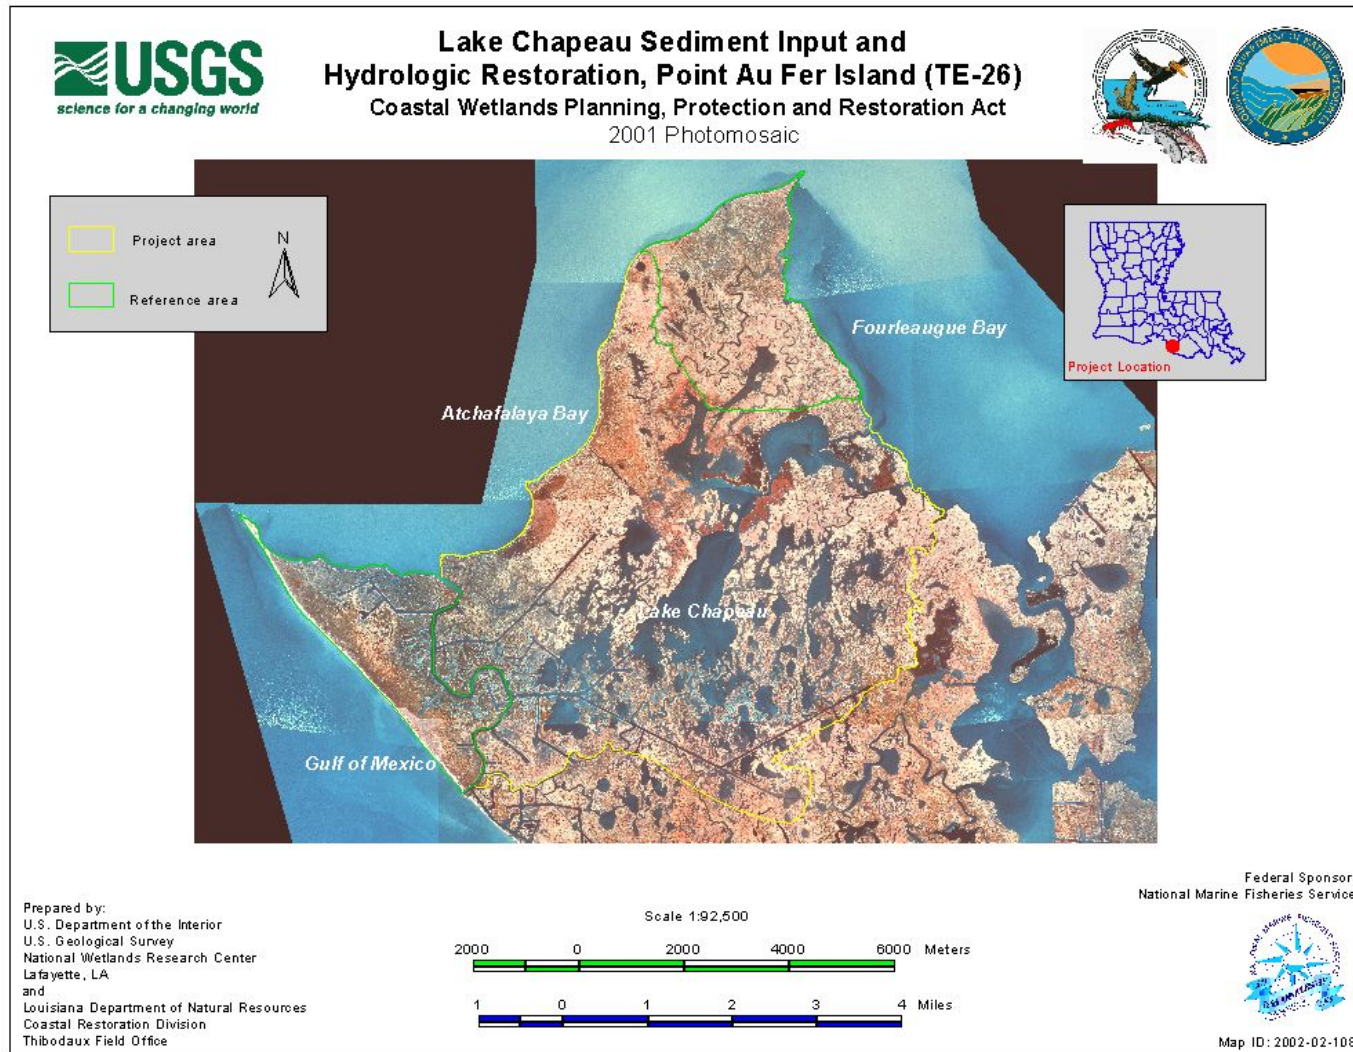
**Figure 3. 2001 photomosaic for the Lake Chapeau Sediment Input and Hydrologic Restoration, (TE-26) Point Au Fer Island project.**

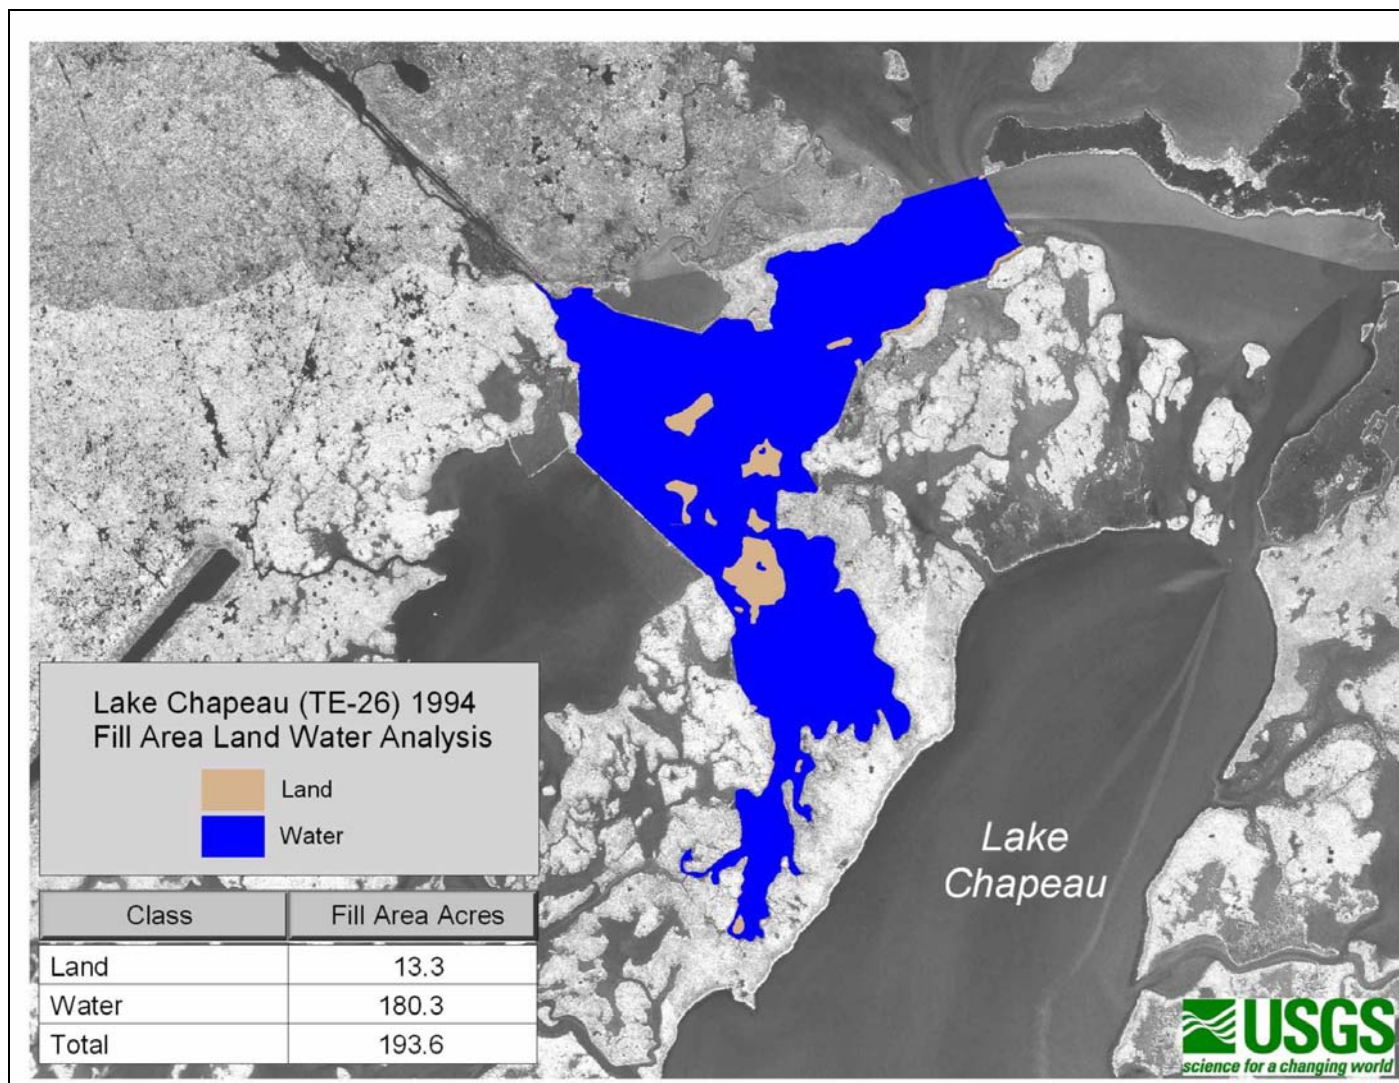
**Figure 4. 1994 fill area land-water analysis for the Lake Chapeau Sediment Input and Hydrologic Restoration, (TE-26) Point Au Fer project.**

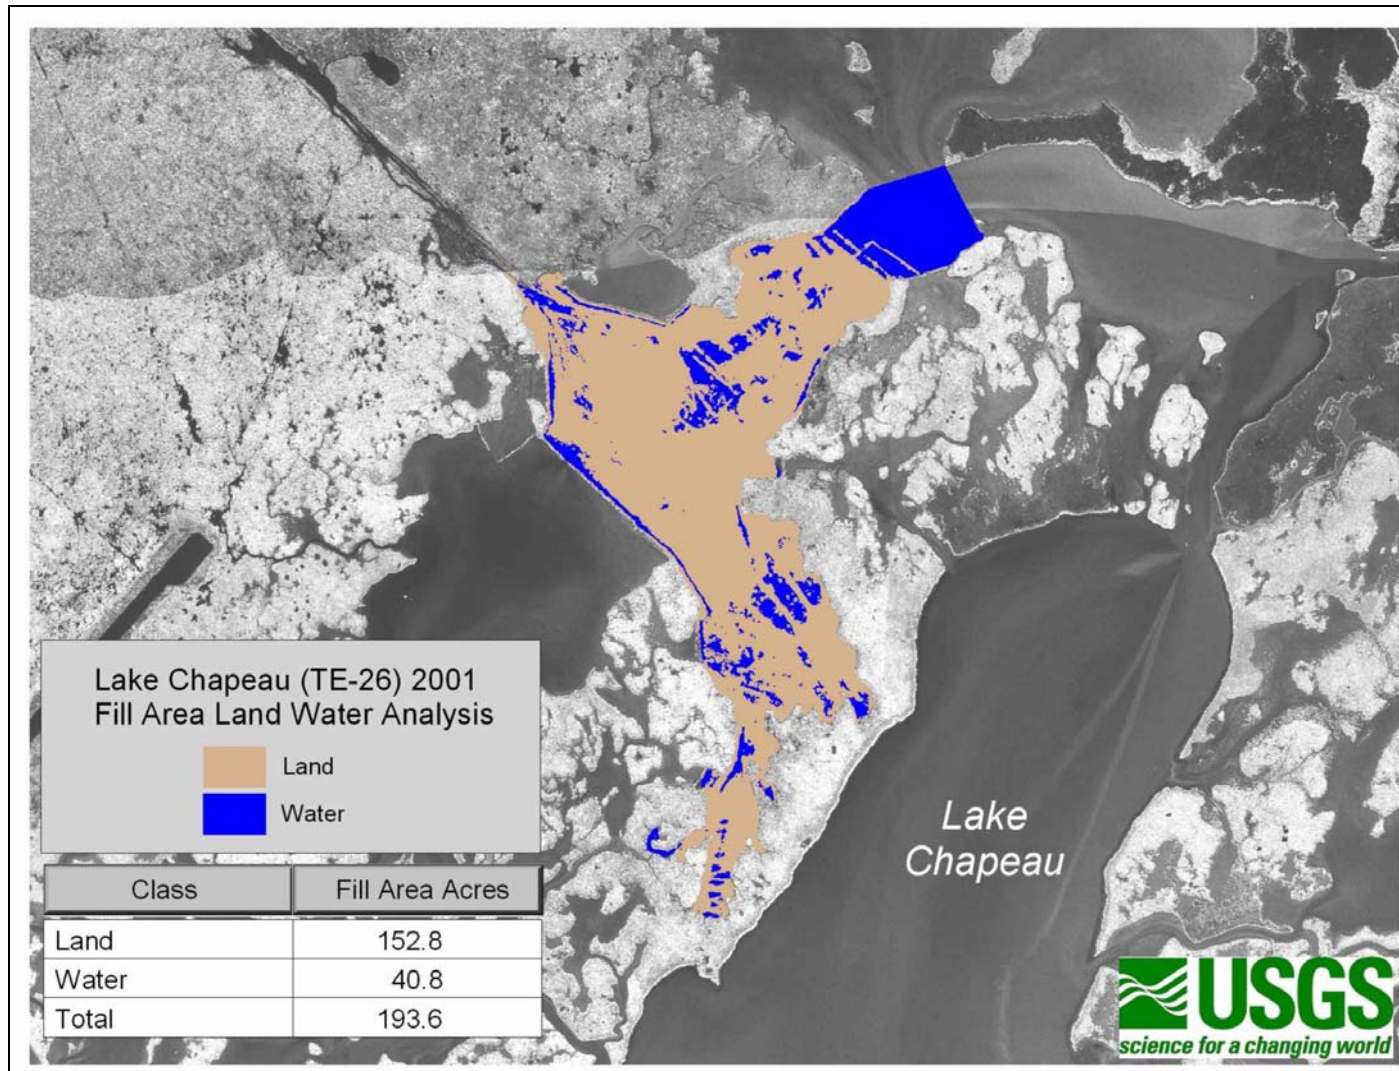
**Figure 5. 2001 fill area land-water analysis for the Lake Chapeau Sediment Input and Hydrologic Restoration, (TE-26) Point Au Fer Island project**

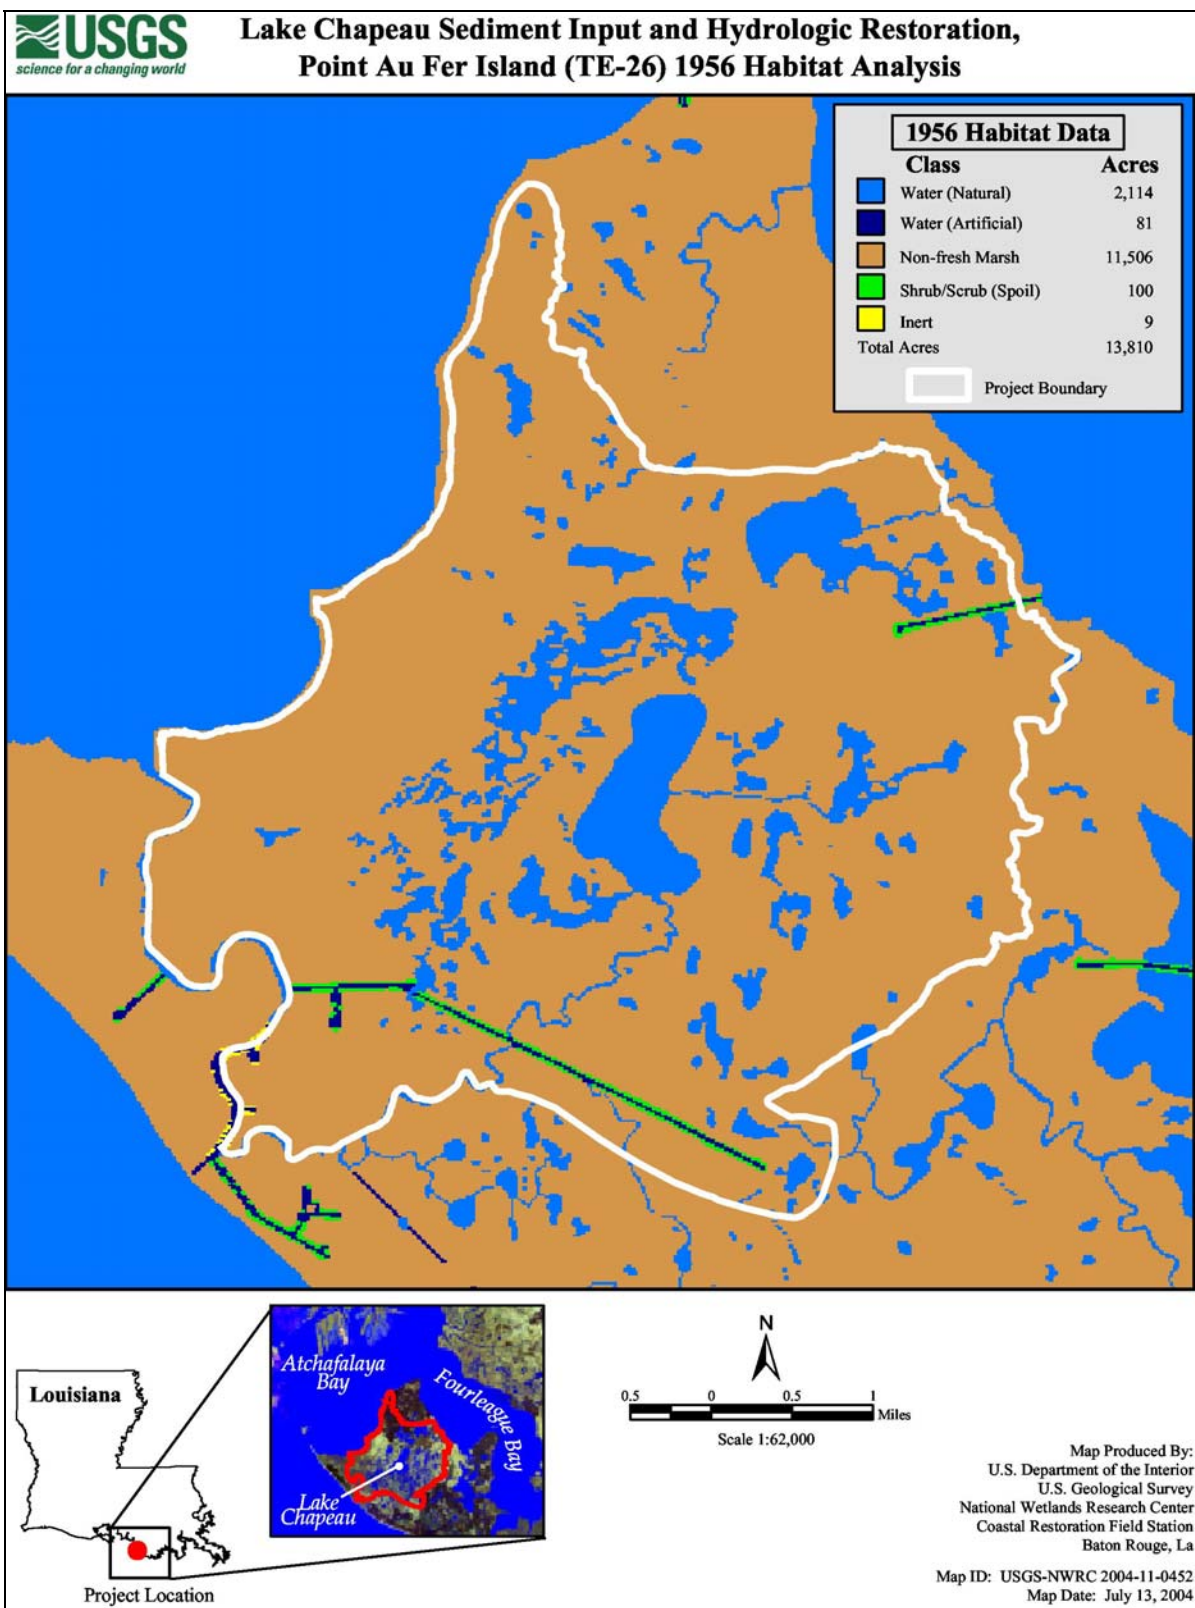
**Figure 6. 1956 habitat analysis of the Lake Chapeau Sediment input and Hydrologic Restoration (TE-26), Point Au Fer Island project area.**

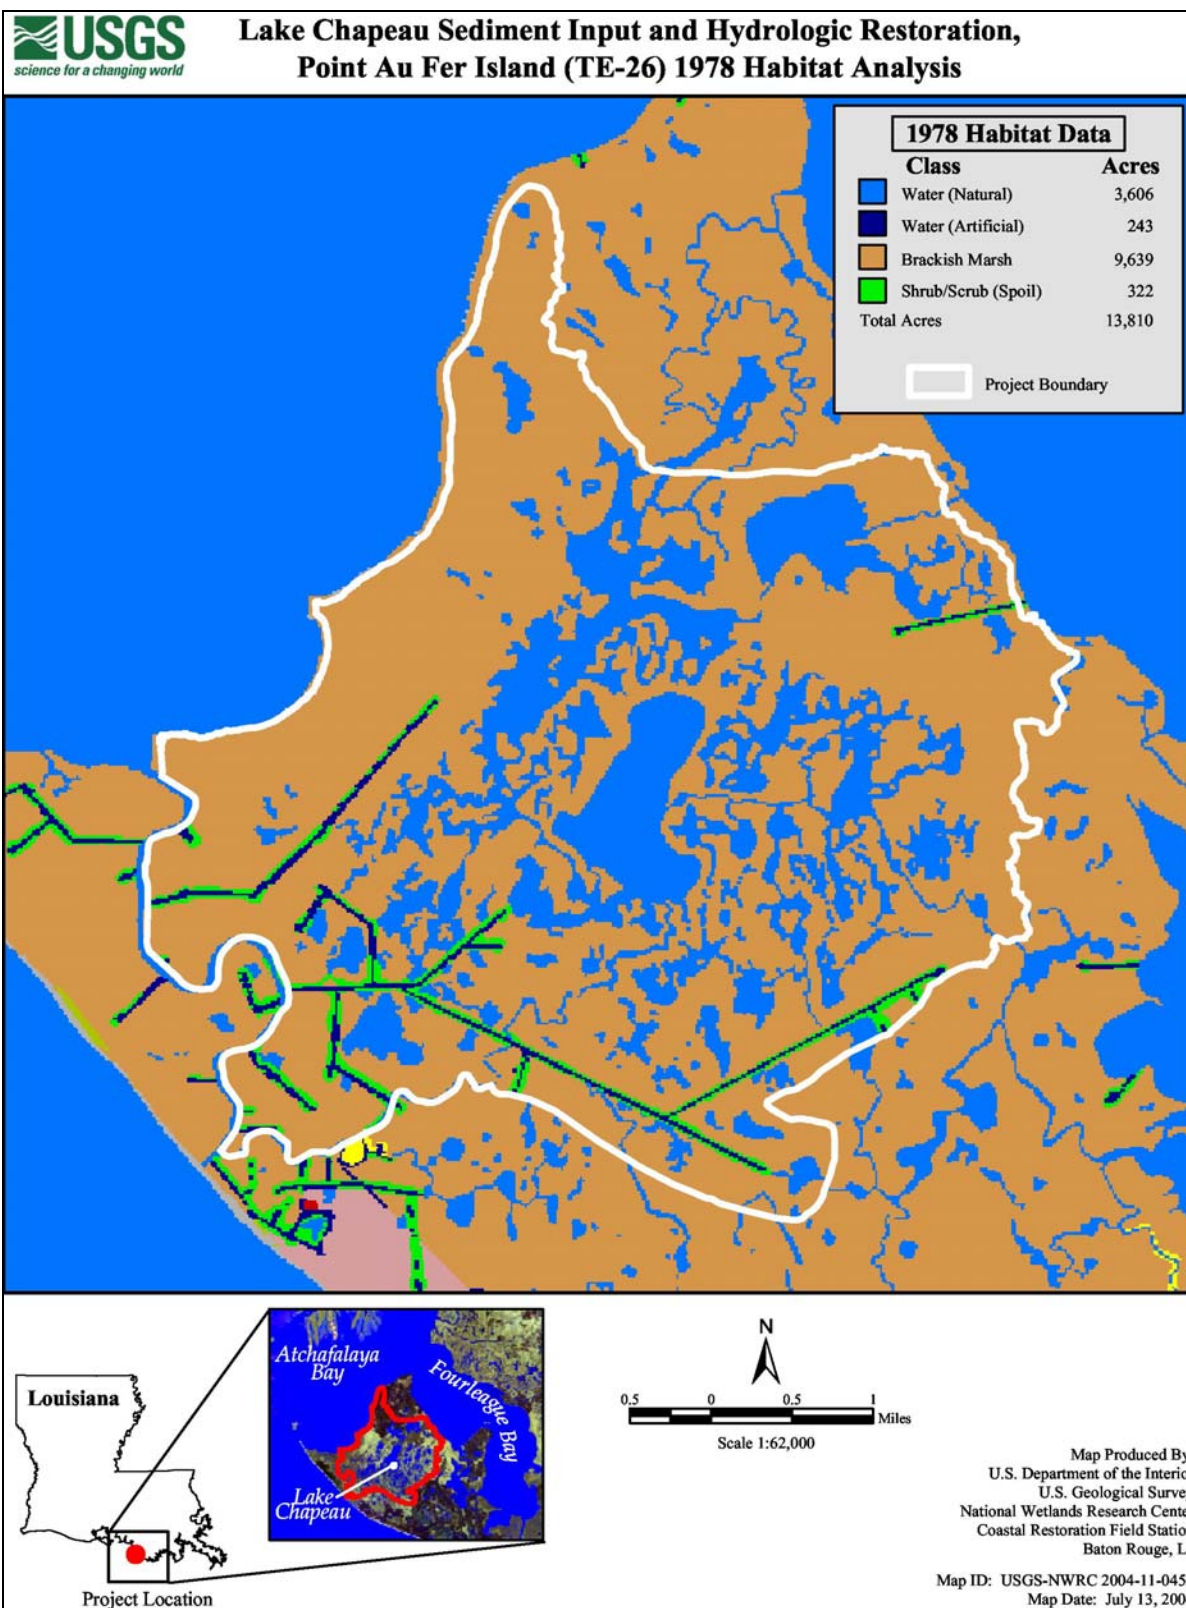
**Figure 7. 1978 habitat analysis map of the Lake Chapeau Sediment Input and Hydrologic Restoration (TE-26), Point Au Fer Island project area.**

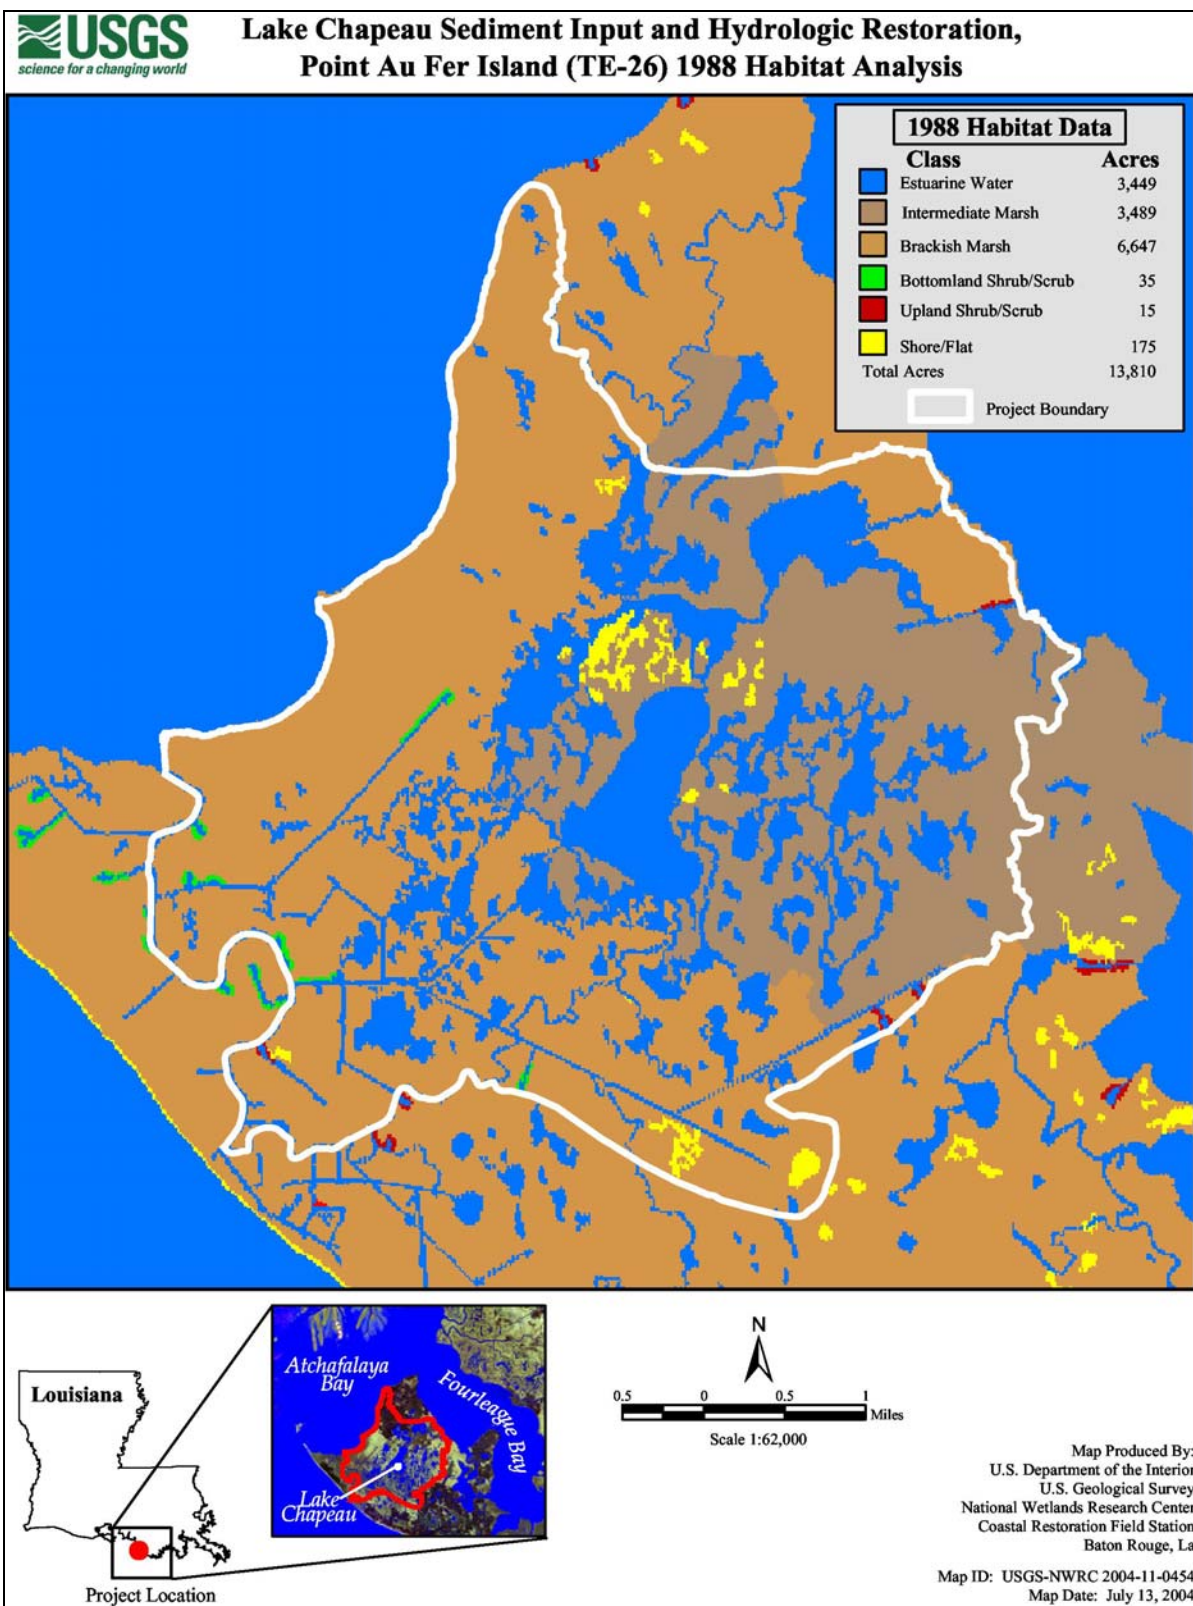
**Figure 8. 1988 habitat analysis of the Lake Chapeau Sediment Input and Hydrologic Restoration (TE-26), Point Au Fer Island project area.**

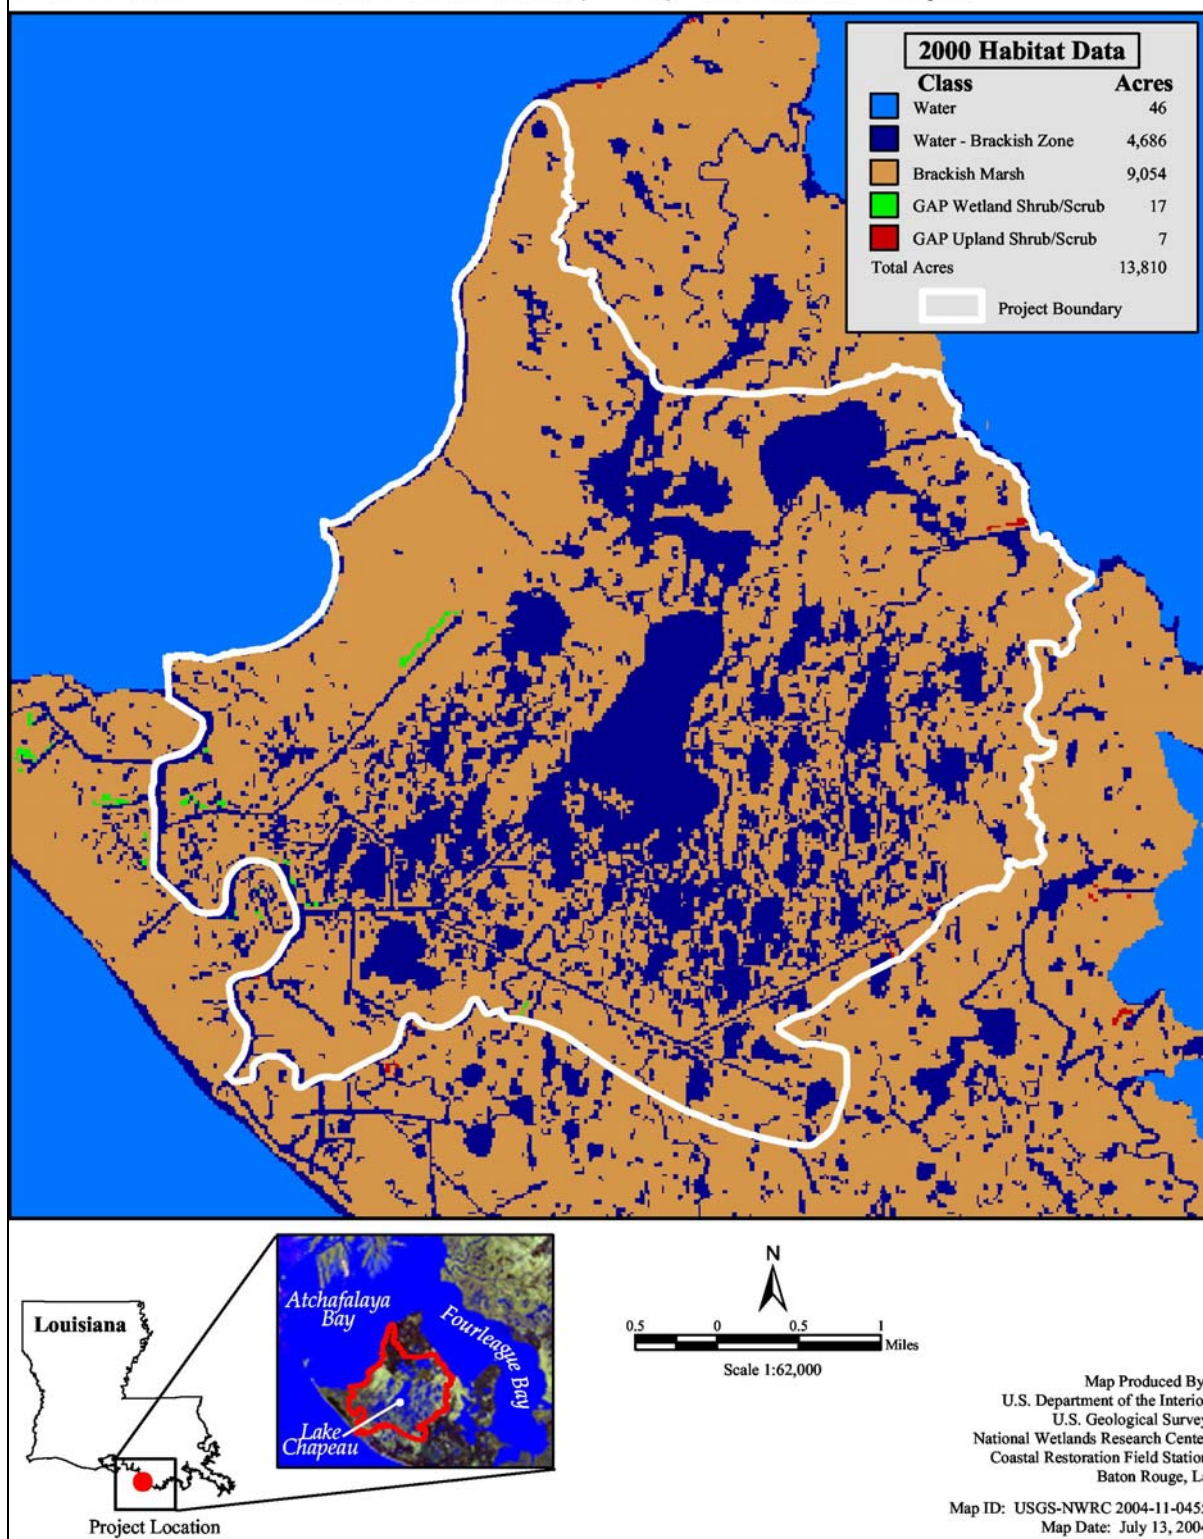
**Figure 9. 2000 habitat analysis of the Lake Chapeau Sediment Input and Hydrologic Restoration (TE-26), Point Au Fer Island project area.**

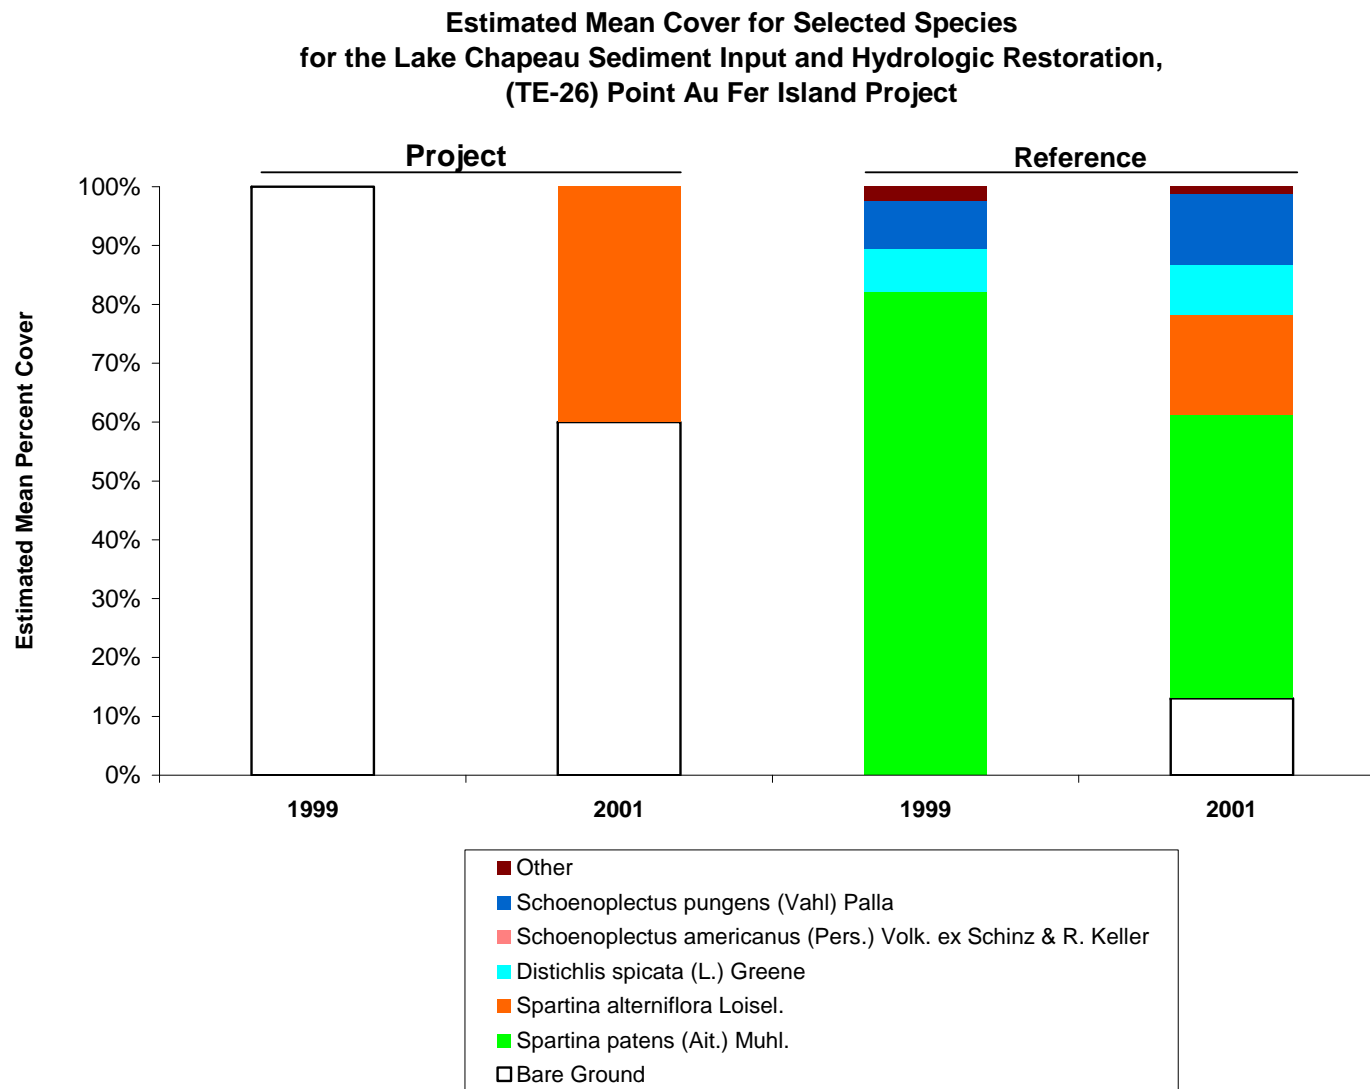
**Figure 12. Estimated Mean cover of selected emergent vegetation species for the fall 1999 and fall 2001 at the Lake Chapeau Sediment Input and Hydrologic Restoration (TE-26), Point Au Fer Island project.**

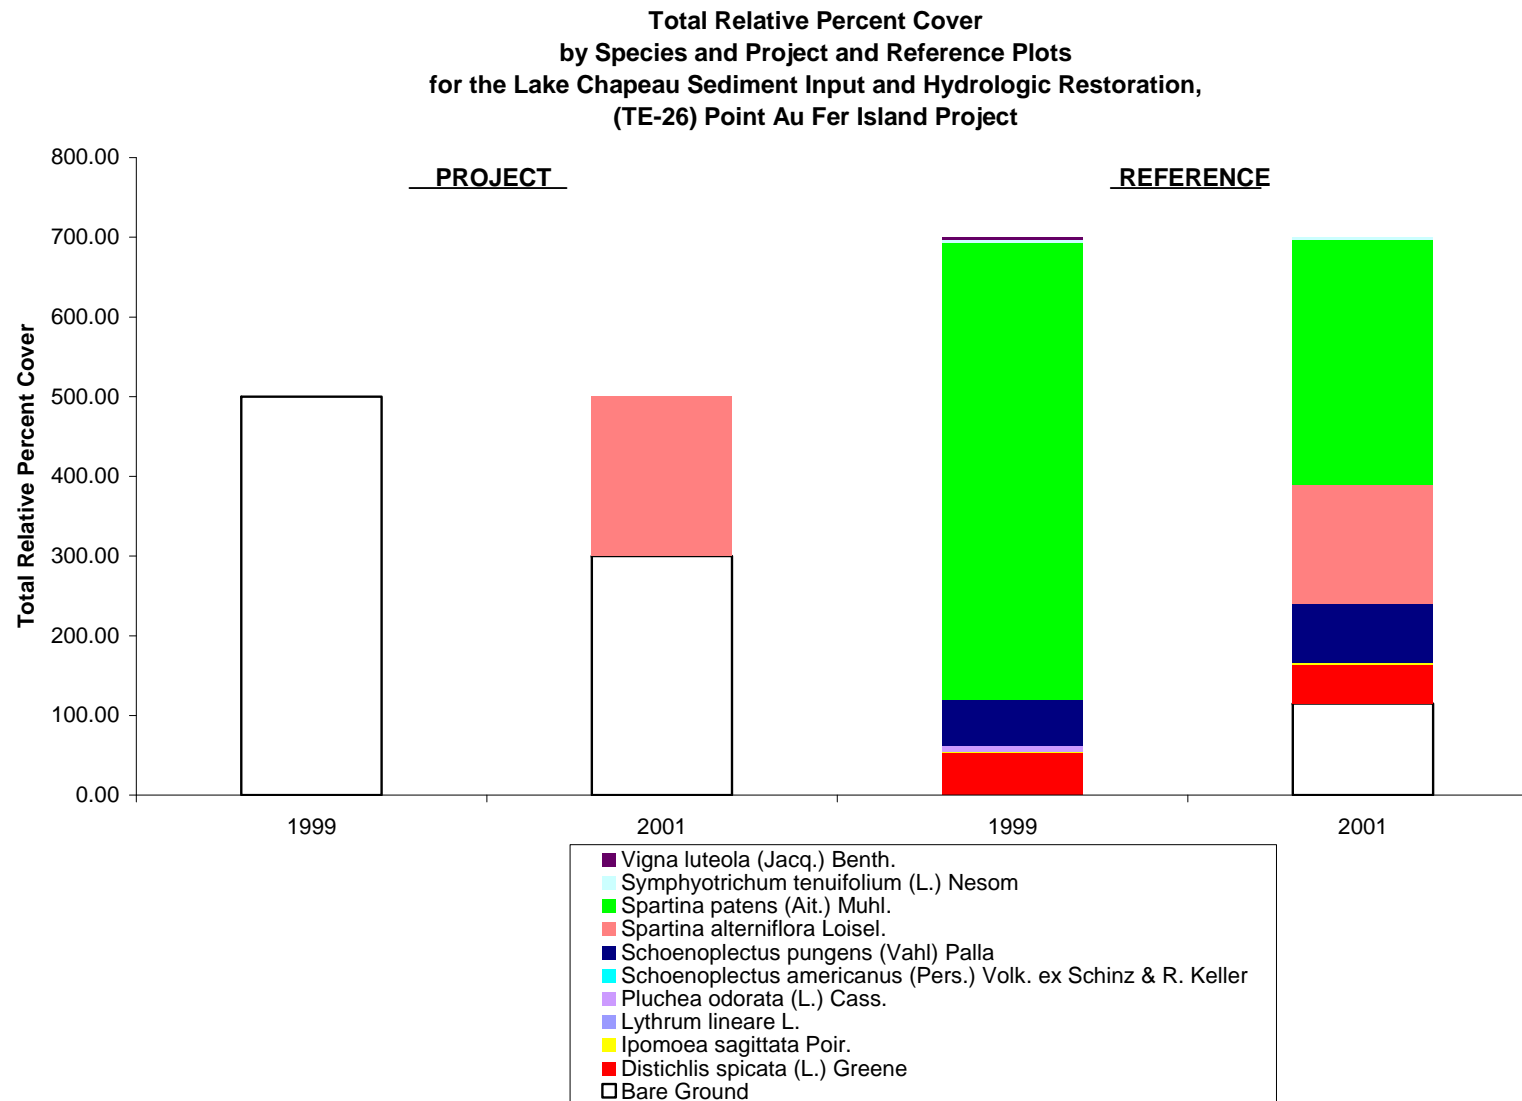
**Figure 13. Total relative percent cover by species and project and reference plots for the Lake Chapeau Sediment Input and Hydrologic Restoration (TE-26), Point Au Fer Island project.**

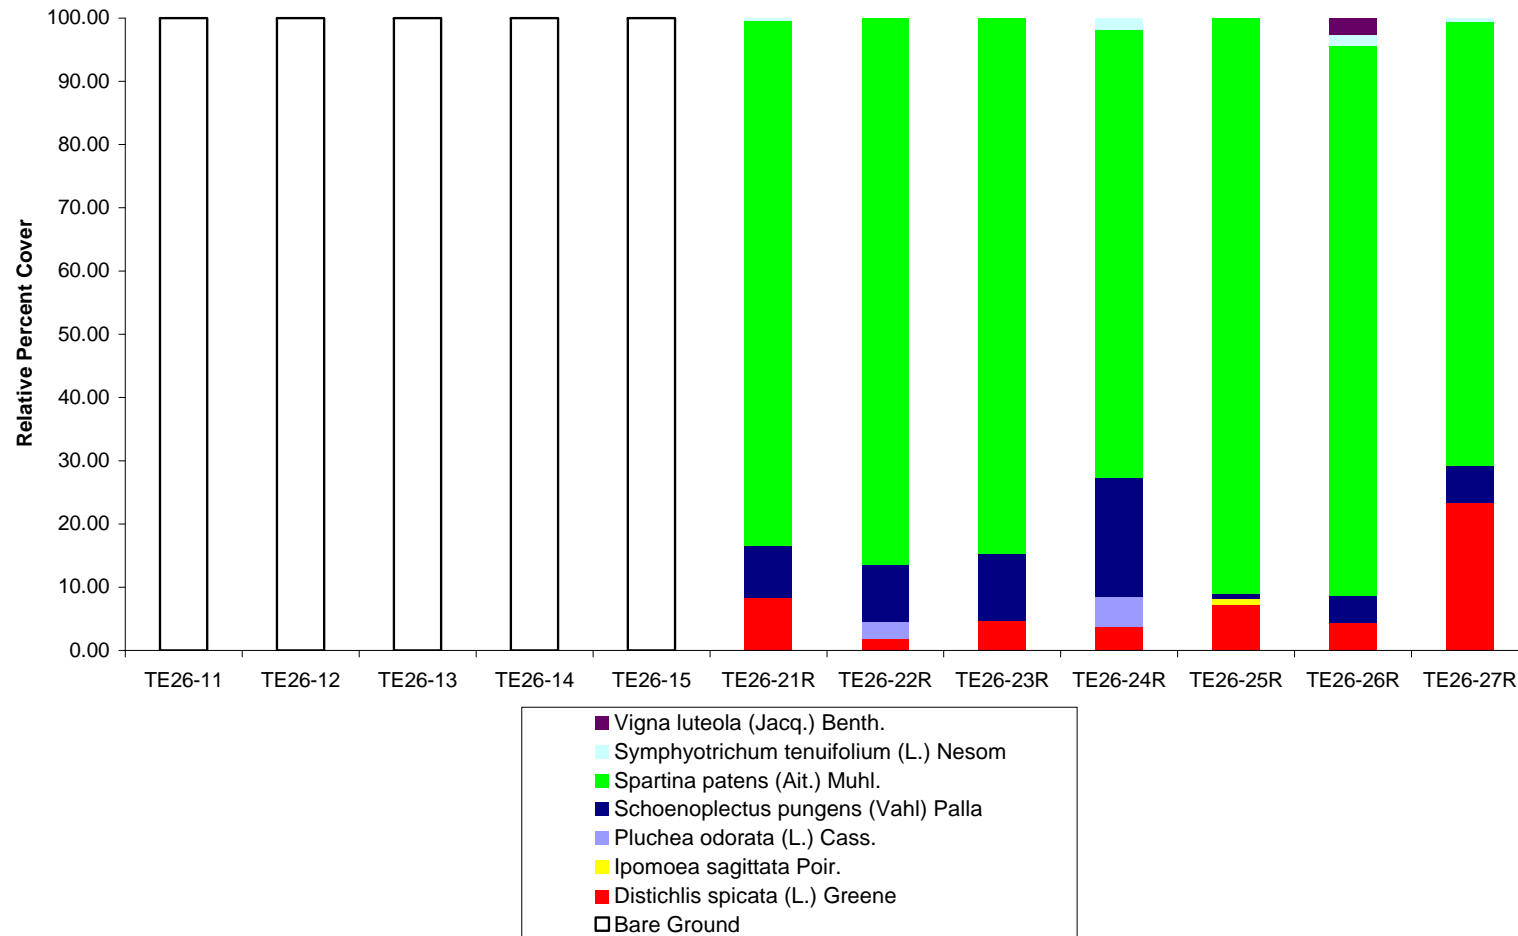
**Figure 14. Estimated relative cover of all species in 1999 for the Lake Chapeau Sediment Input and Hydrologic Restoration (TE-26), Point Au Fer Island project.**

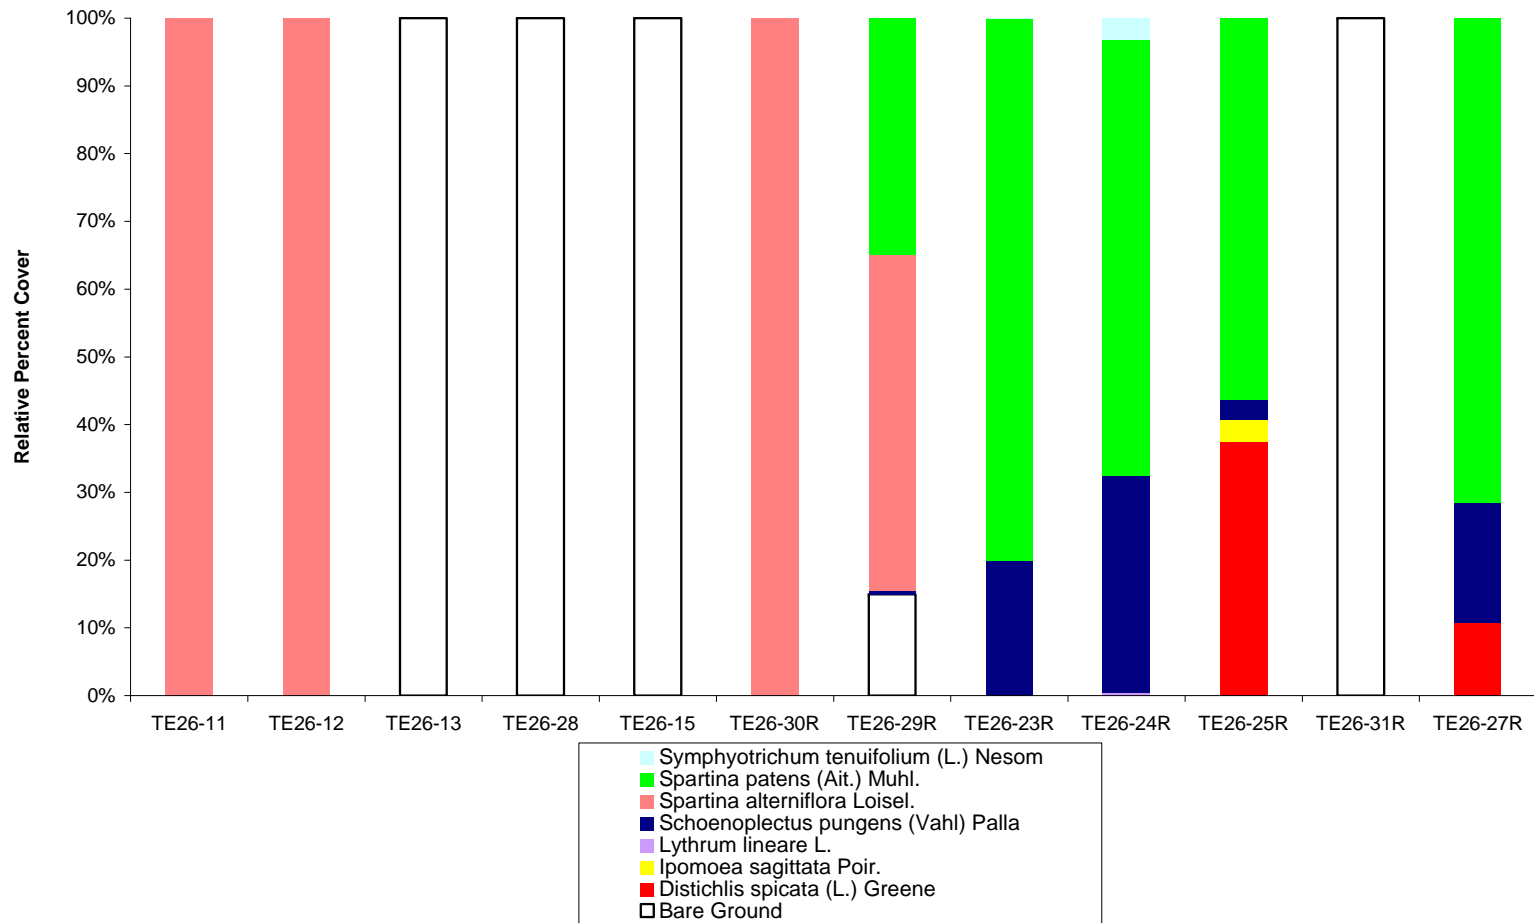
**Figure 15. Estimated relative cover of all species in 2001 for the Lake Chapeau Sediment Input and Hydrologic Restoration (TE-26) Point Au Fer Island project.**
