**2004 Operations, Maintenance,
and Monitoring Report**

**Boston Canal/ Vermilion Bay
Shoreline Stabilization**

State Project Number TV-09
Priority Project List 2

May 2004
Vermilion Parish

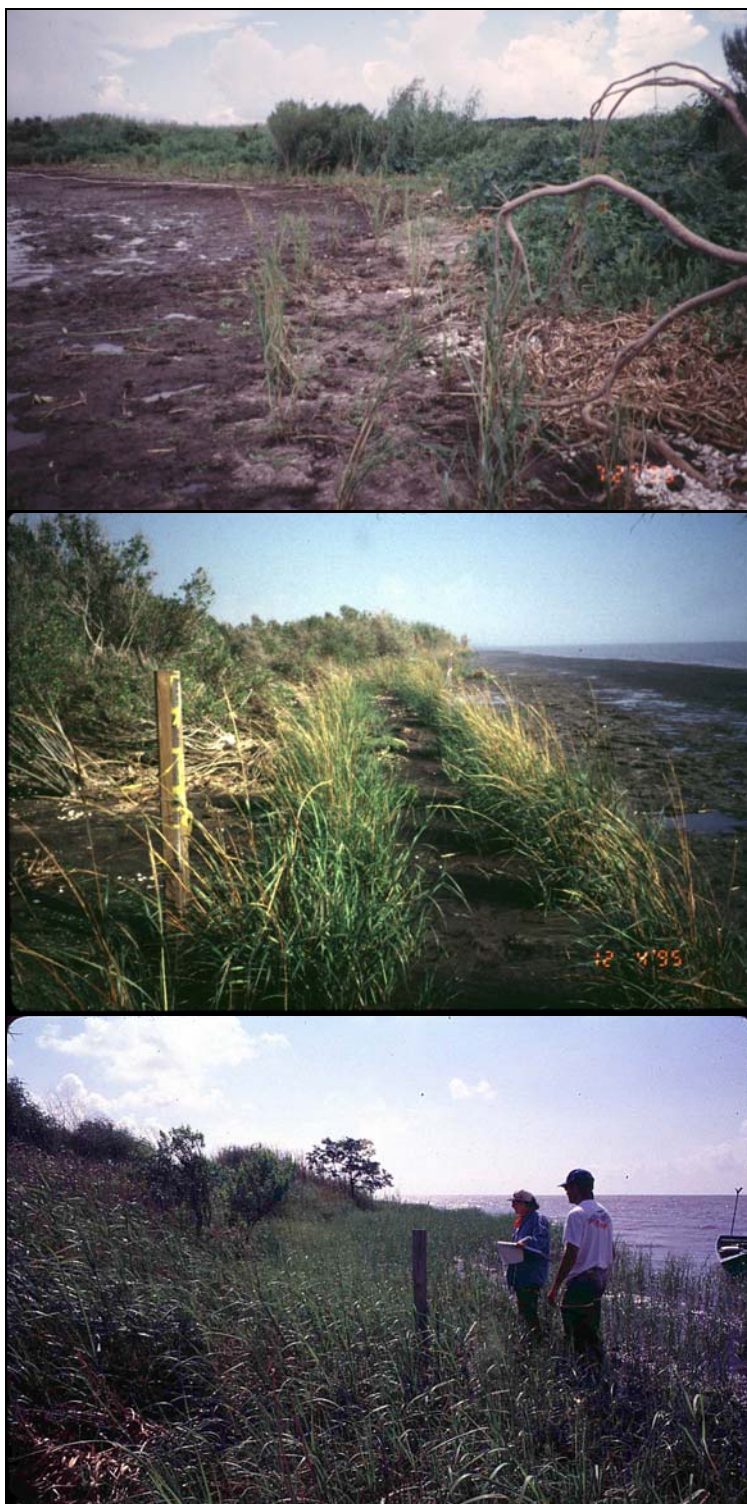
Percent survival of *S. alterniflora* at the 36 month post-planting averaged 90.6 % among all land types. Percent survival of *S. alterniflora* at the 36 month post-planting in the high, medium and low *P. australis* coverage was 12.5 %, 62.5 %, and 89.1 %, respectively. Percent cover of *S. alterniflora* at the 36 month post-planting in high, medium, and low *P. australis* coverage was 5.6 %, 56.9 %, and 75.9 %, respectively. The high average percent survival and percent cover of the *S. alterniflora* on the shoreline indicate that the plants have become established. However, the data indicate that survivorship and percent cover of *S. alterniflora* was lessened in established stands of *P. australis*. Data collection on vegetation is complete as per the 1999 vegetation survey because individual plants in the plots were indistinguishable (figures 5-6).

Figure 7. *Spartina alterniflora* planting at the 6 (upper), 12 (center) and 36 (lower) mo post-planting monitoring.

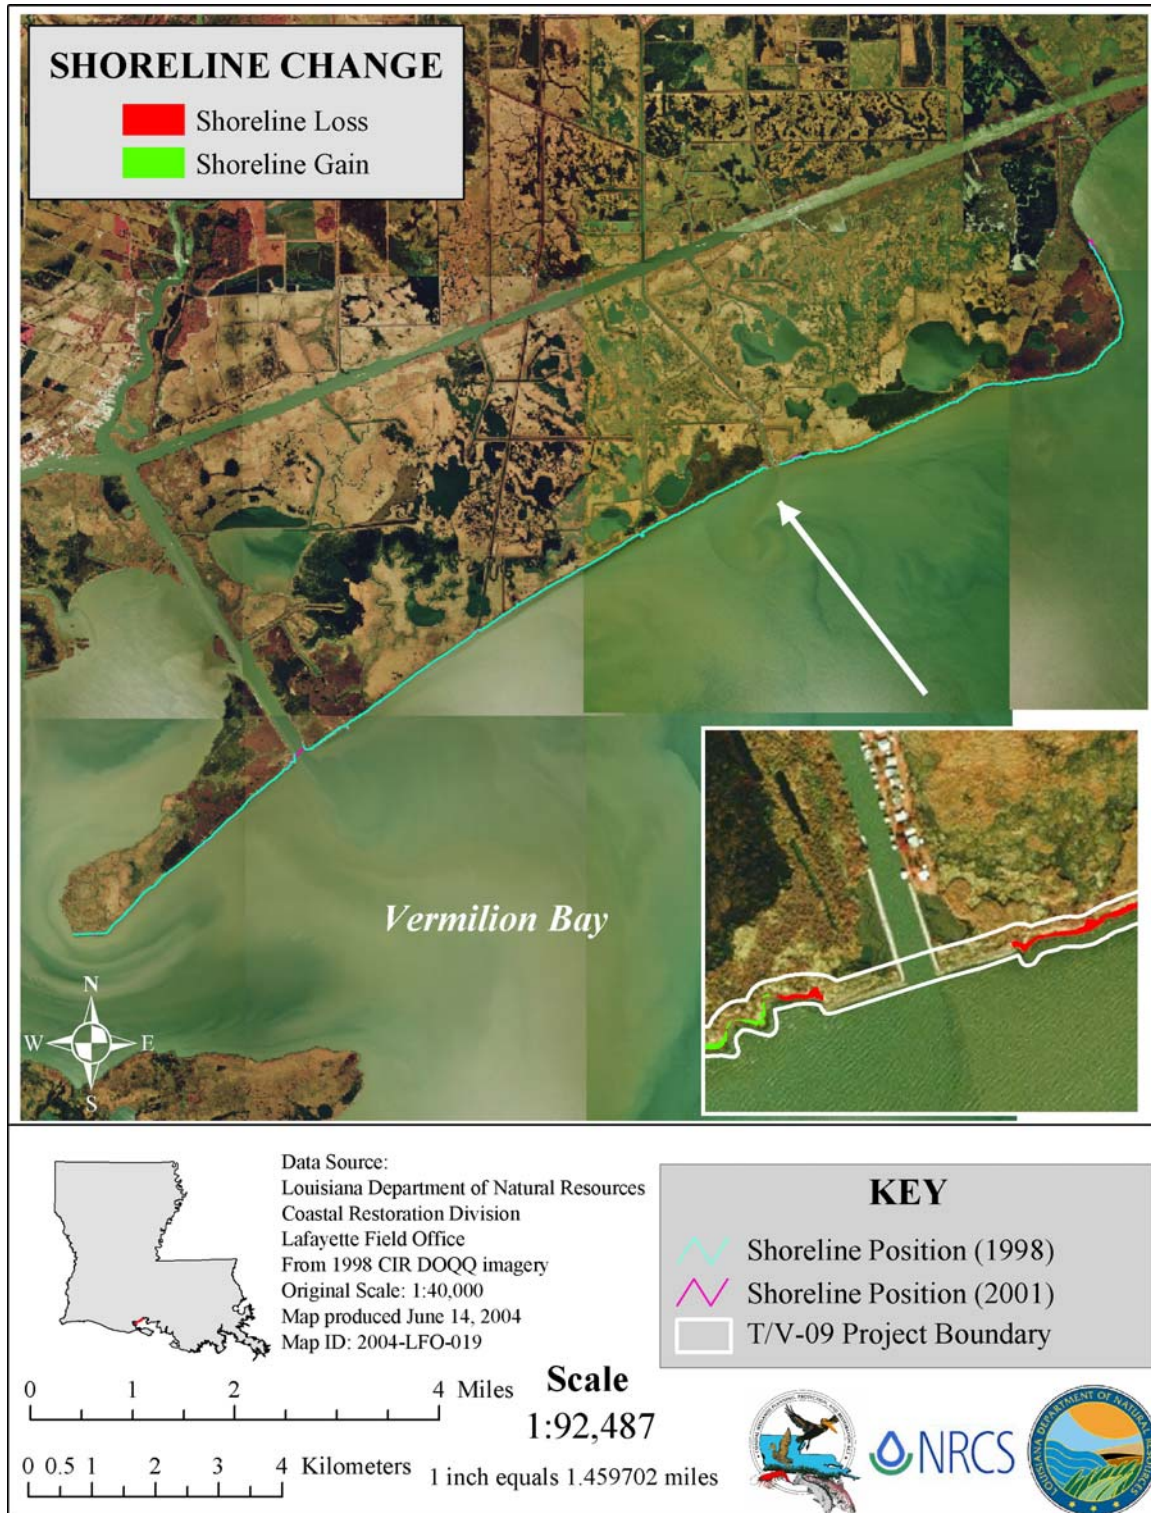
The overall shoreline change for the Boston Canal Shoreline Stabilization (TV-09) project area from 1998-2001 is 21.44 acres. The majority of that change is considered gain with only 6.40 acres of loss (figure 7). Data collection in the reference area was discontinued in 2000 as a result of the Oaks/Avery Shoreline Protection (TV-13a) project boundary incorporating the Boston Canal reference area within it. Shoreline GPS from the Boston Canal 1998 monitoring and pre-construction GPS from the Oaks/Avery 2000 monitoring were used to calculate shoreline change. The overall change for the reference area for Boston Canal from 1998-2000 is 2.87 acres, of which less than half was loss (1.06 acres; figure 8).

Figure 8. Shoreline position change for Boston Canal Shoreline Stabilization (TV-09) project using 1998 to 2001 differential global positioning system.

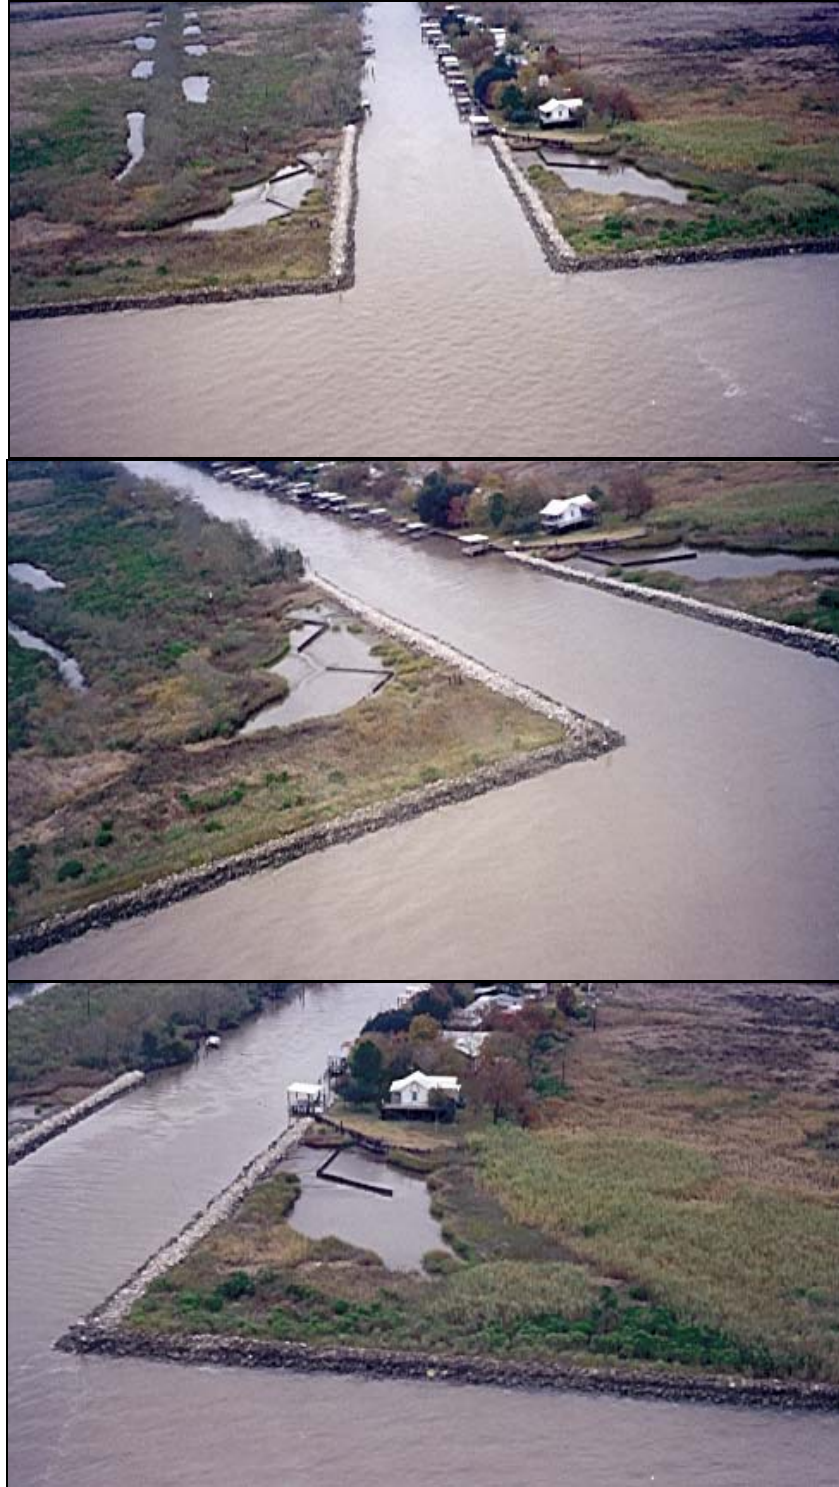
For the most part, the breakwaters are in excellent post construction condition. There is no apparent toe-scour or rock displacement. Some shoreline retreat has occurred on the eastern and western ends of the rock dike. These areas will be closely monitored, and should the situation significantly worsen, steps will be taken to close/stabilize these areas. Signage and associated pilings are stable and functioning.

The sediment fencing was modified in March, 2002. Modifications of the fences involved cutting geotextile panels from the top of the fence down to approximately 6 inches below the mudline and removing each panel. The sediment fences were preventing sediment from filling the entire marsh area behind the dikes. Since removal of the fences, sediment has been more evenly distributed.

Figure 10. Boston Canal/Vermilion Bay Shoreline Stabilization (TV-09) rock breakwaters and sediment fences at the mouth of Boston Canal (January 2001).

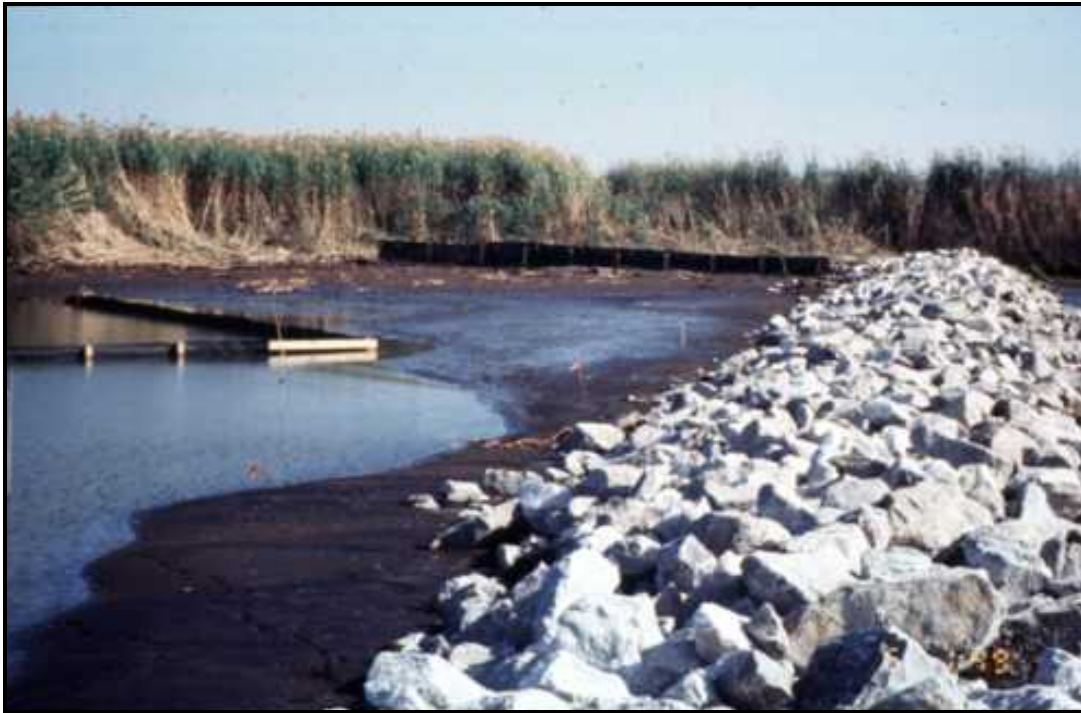
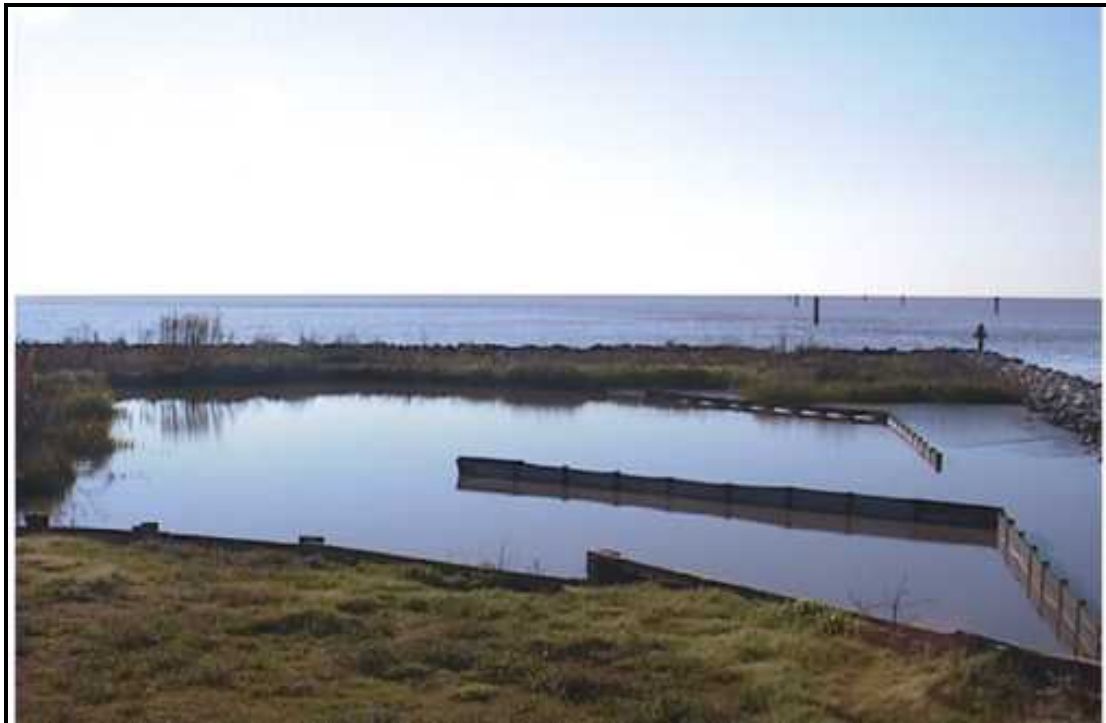
Figure 11. Boston Canal/Vermilion Bay Shoreline Stabilization (TV-09) photographs: (A) sedimentation behind the breakwaters December 1994: (B) vegetation growing behind the breakwaters in February 1998.

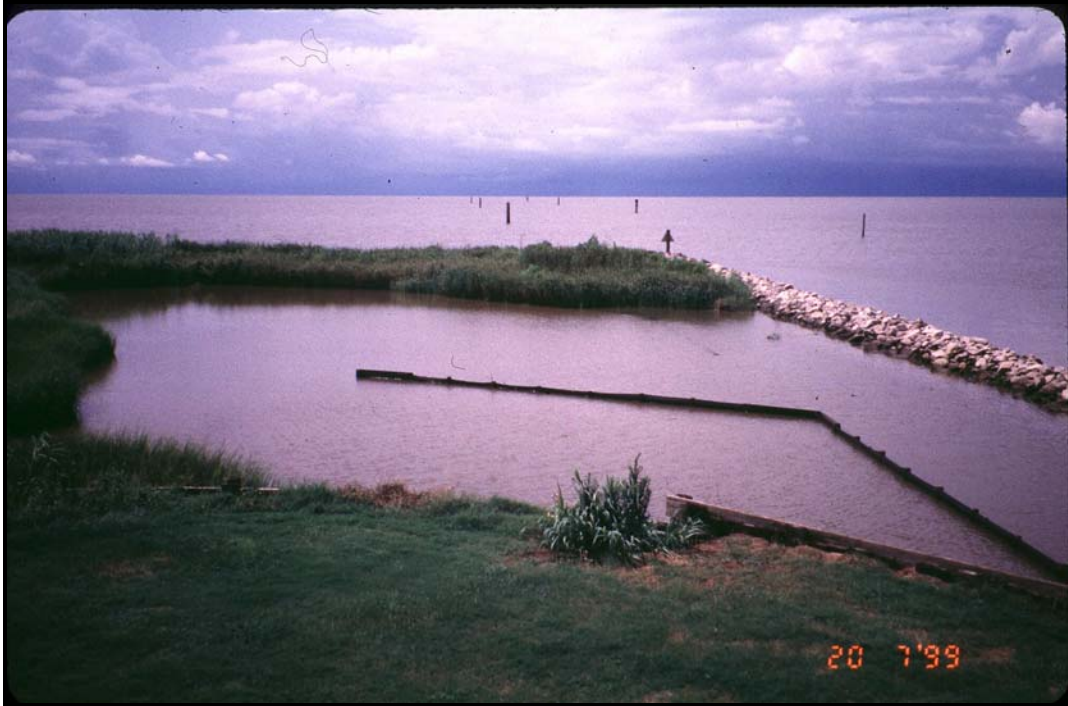
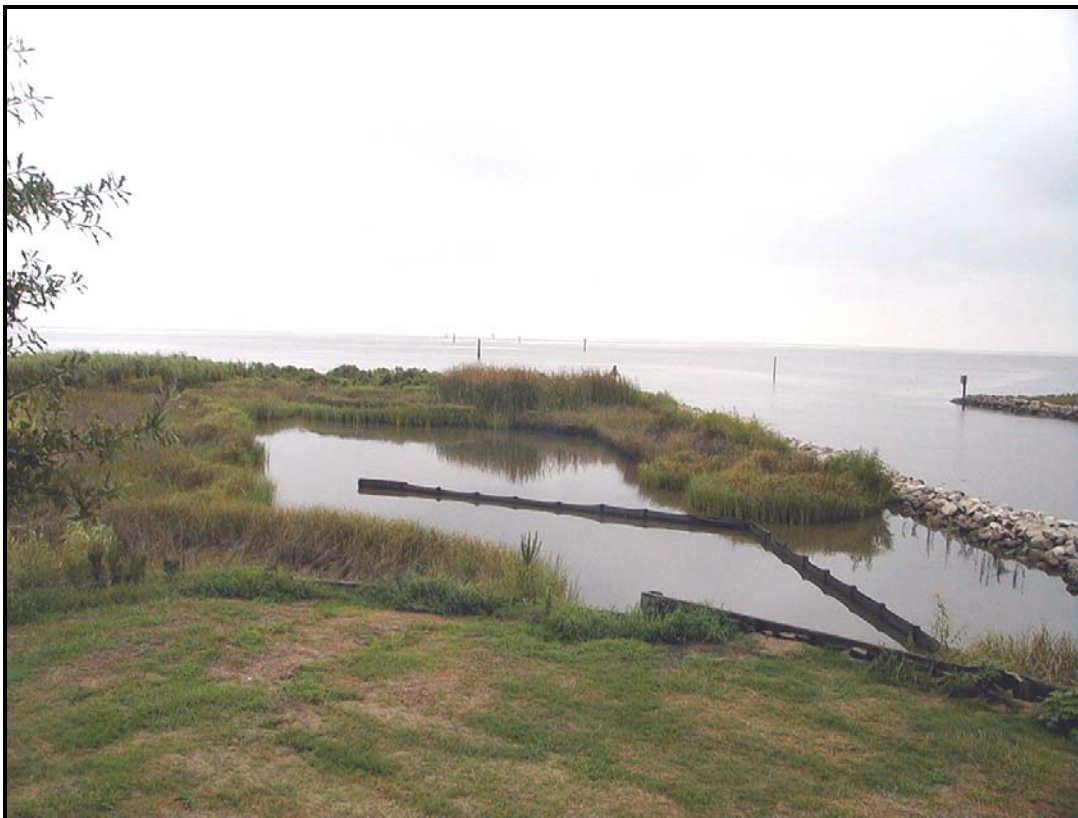
Figure 12. Boston Canal/Vermilion Bay Shoreline Stabilization (TV-09) photographs: (Upper) vegetation behind the breakwaters July 1997: (Lower) vegetation behind the breakwaters in October 2001.

Survivorship and percent cover of *S. alterniflora* was lessened in established stands of *P. australis*. Planting *S. alterniflora* in dense stands of *P. australis* should be avoided. Sediment fences inhibited even distribution of sediment behind the rock breakwaters. In March 2002, wire on the sediment fences were removed by NRCS personnel to allow the sediment to be more evenly distributed into the open water areas behind the fences closest to the shore (see figure 12). The use of sediment fences may not be necessary behind rock breakwaters.
