**State of Louisiana
Department of Natural Resources
Coastal Restoration Division and
Coastal Engineering Division**

**2004 Operations, Maintenance,
and Monitoring Report**

**Little Vermilion Bay Sediment
Trapping**

State Project Number TV-12
Priority Project List 5

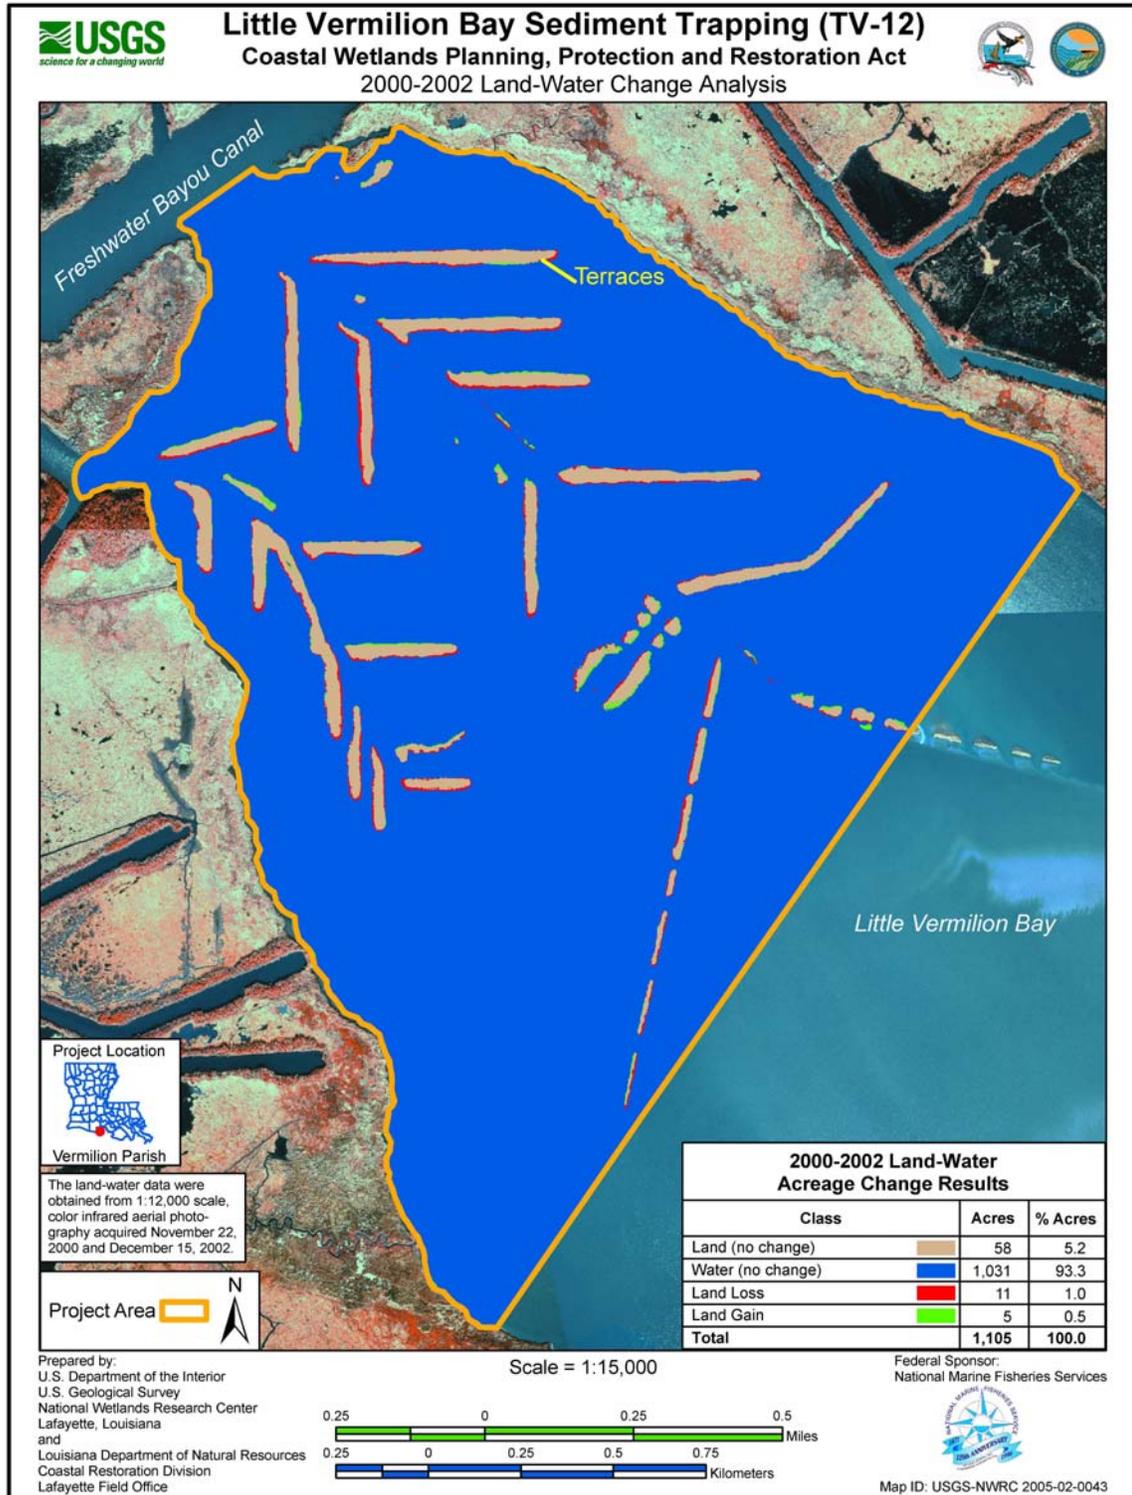
According to the year 2000 photography analysis, the project area consisted of 68 ac (27.5 ha) of land and the reference area had 74 ac (29.9 ha) (figure 4). Of the total land in the project area, 56.2 ac (22.7 ha) were constructed terraces (figure 5). The 2002 land-water analysis determined that the land portion of the project area consisted of 62.7 ac (25.4 ha) and the reference area had 73.5 ac (29.7 ha) of land (figure 6). The change from the 2000 amounts is a loss of 5.3 ac (2.1 ha) of land in the project area and a loss of 0.5 ac (0.2 ha) in the reference area. The project area was further analyzed to identify areas of loss and gain (figure 7). There was no pattern, but gains were limited to a few terraces, whereas losses were distributed among the edges of all terraces. In addition to the land and water classes, a mud flat class was added to describe areas of very shallow water mostly in between terraces and in some places in the reference area. In 2002, the project area had 199.5 ac (80.7 ha) of mud flat area and the reference area had 111.6 ac (45.1 ha) of mud flat. The periodically exposed mudflats are apparently building up from sediment deposition and may eventually become permanently subaerial and contribute to the land component of the analysis. It is interesting to note that mudflat developed around natural features in the reference area, yet in the project area, all sediment deposition appears to be near the project features, indicating the utility of the terraces.

Figure 7. Map showing specific areas of land loss / gain in the project area from 2000 to 2002.

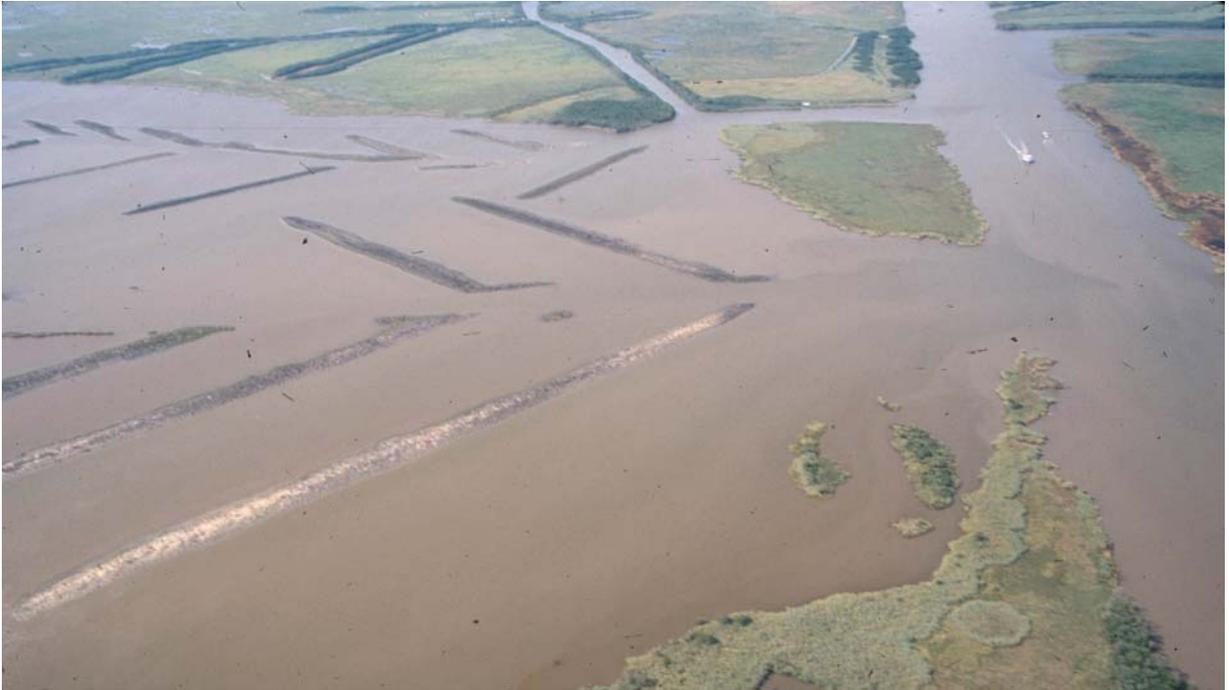
In 1999 immediately after construction, the terraces were obviously bare except for the *Spartina alterniflora* plantings (figures 8 and 9). By 2000, the *Spartina alterniflora* plantings covered much of the edges of the terraces with thick, tall vegetation (figure 10). Planted and natural vegetation cover increased and completely covered parts of some terraces by 2001 (figure 11). In summer 2002, the emergent vegetation on the terraces was sampled. *S. alterniflora* plantings grew well, and on most terraces they remained dominant on the edges. Many other species have colonized and covered the terraces (figure 12). Of the approximately 42 species found, 22 are obligate wetland, 15 are facultative wetland, 4 are facultative, and 1 is facultative upland (table 1). These plants and the plantings have covered all but the highest elevations in the middle of a few terraces where some bare ground remains. One hundred percent of the total 488 segments with some vegetation have an average prevalence index value of 1, 2, or 3, which corresponds to the wetland classifications obligate wetland, facultative wetland, and facultative respectively. Also, 98% of all the segments had average index values that were 2 or less, indicating that the vast majority of vegetation on the terraces is ideally suited for emergent marsh habitat.

Figure 8. Aerial photo 9/30/99 immediately post construction. Freshwater Bayou is to the right.

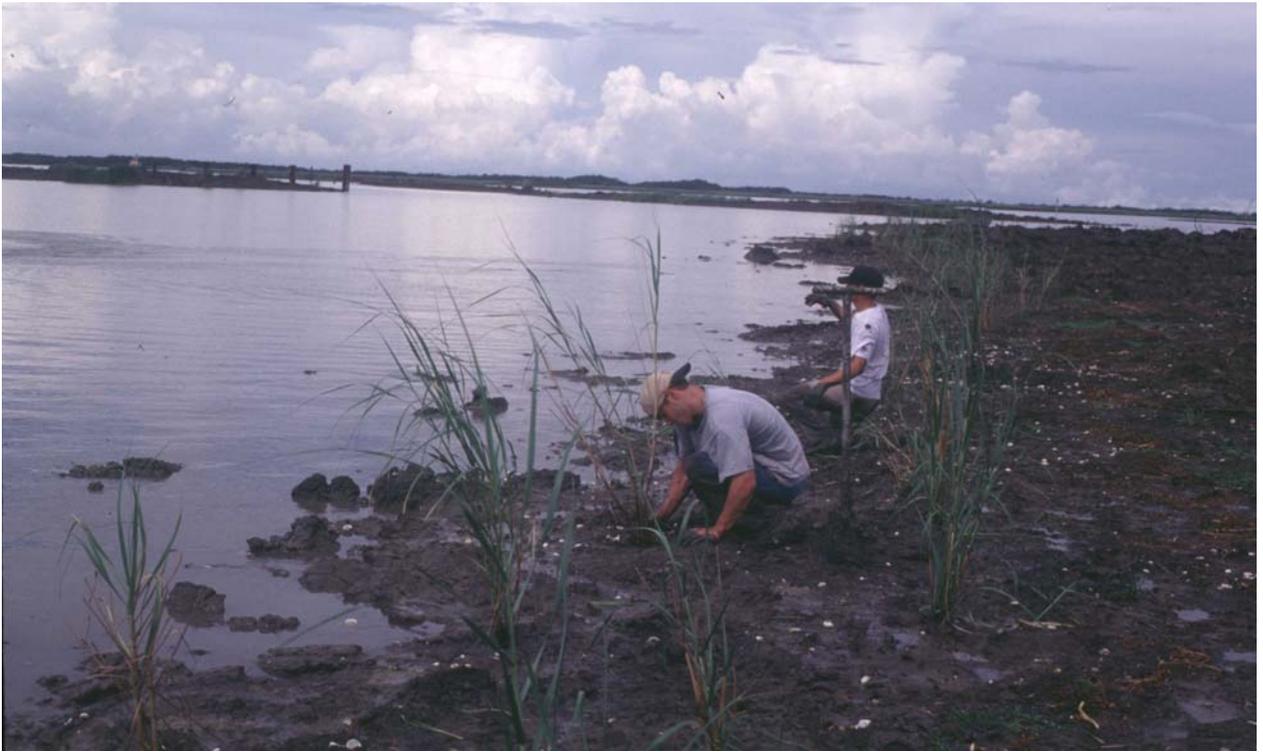
Figure 9. Newly constructed terrace being planted in summer 1999.

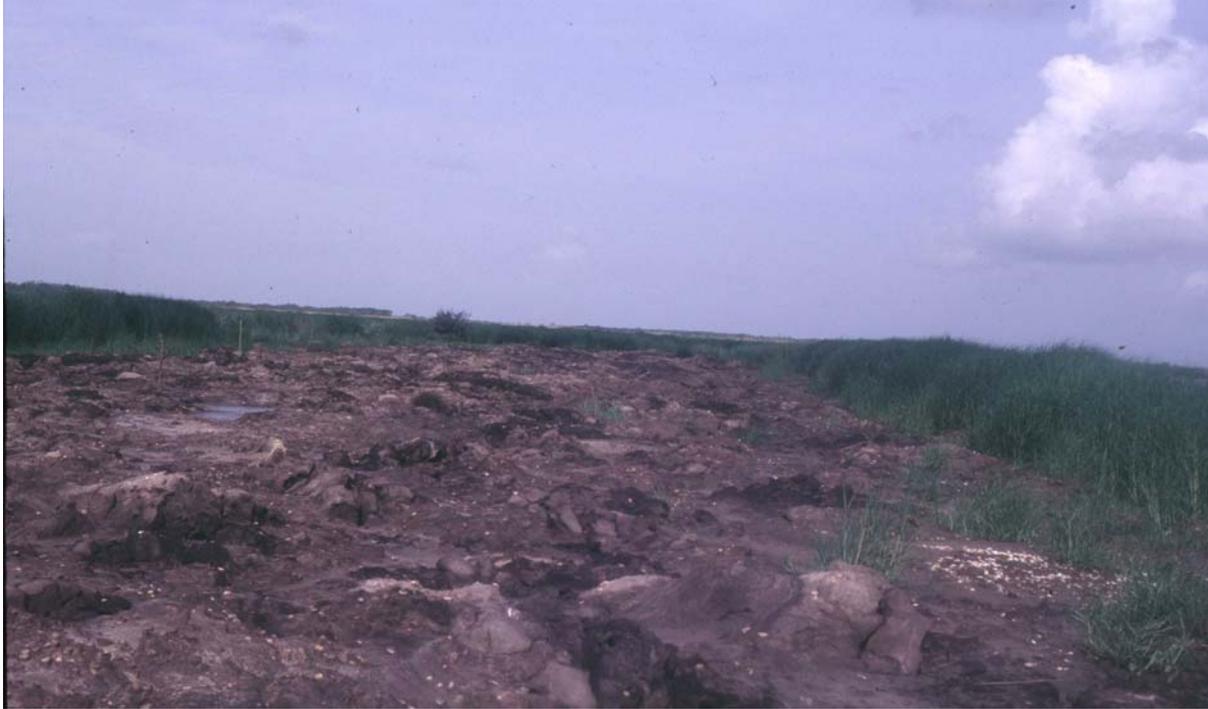
Figure 10. View from middle of a terrace in June 2000 one year after construction and planting, showing growth of planted *Spartina alterniflora* on either side.

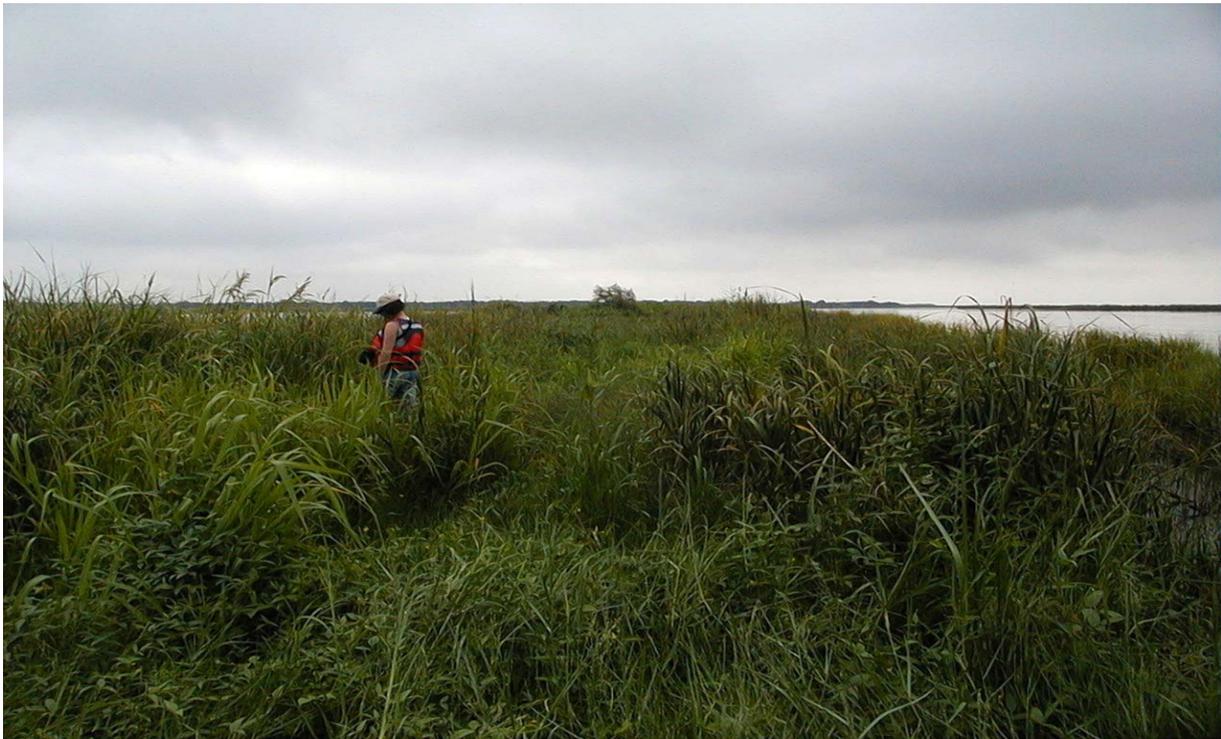
Figure 11. Planted and natural vegetation growth on a terrace in August 2001.

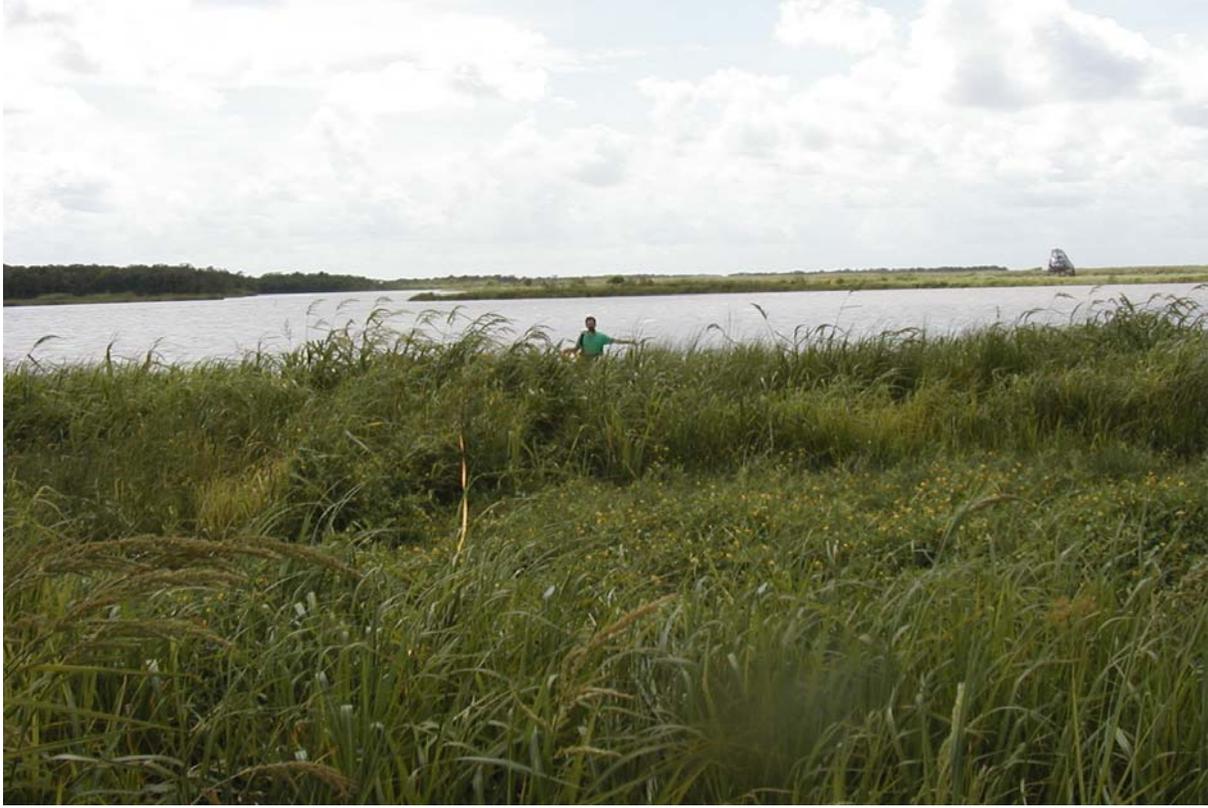
Figure 12. Vegetation on a terrace photographed during emergent vegetation survey in August 2002.

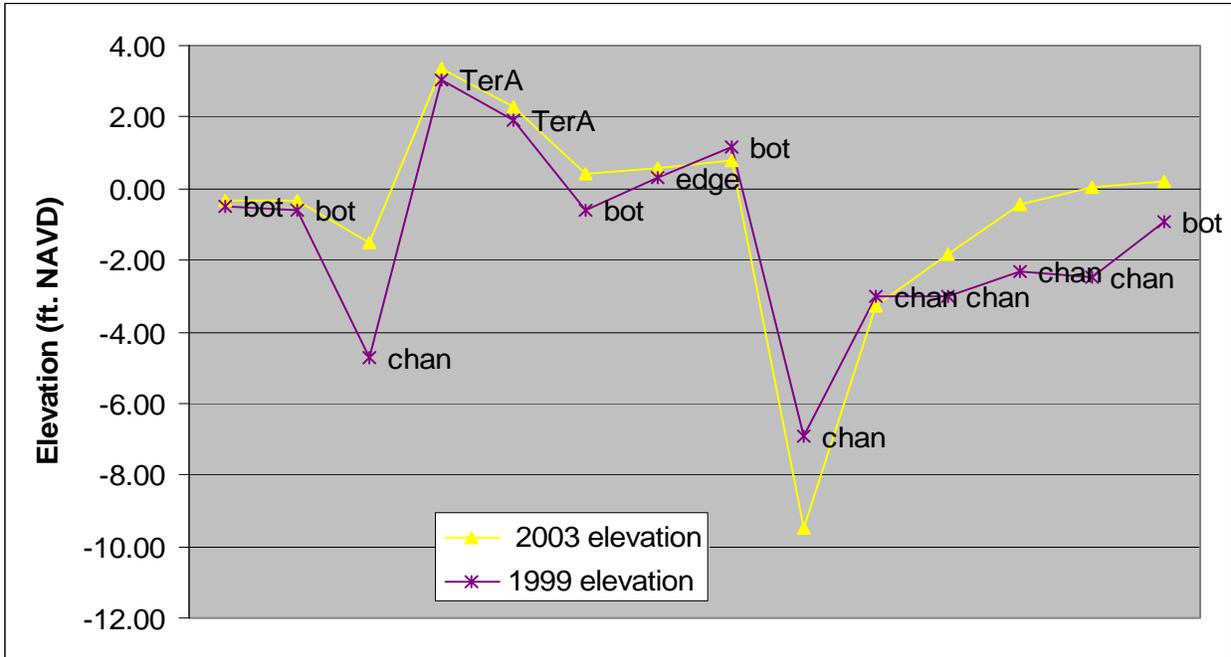
An elevation survey was conducted immediately after construction in September 1999. A postconstruction elevation survey of a subset of the original transects was completed in August 2003. It appears that there has been substantial sediment deposition. The mean channel bottom elevation in 2003 was 1.37 ft higher than in 1999 (figure 14). Bay bottom in the vicinity of the terraces, had a mean elevation increase of 0.5 ft. During the same period, the average terrace elevation loss was only 0.018 ft. All cross sections showed some elevation increases on bottoms or in channels (figures 15 – 20). Most channels filled in more by 2003, but a few apparently were scoured to a greater depth since 1999 (figures 15, 17, and 20).

Figure 15. Elevations of selected paired points along cross section 3 from the 1999 and 2003 surveys. Bot = Bay Bottom, Ter = terrace, chan = channel, and edge = edges between terraces, channels, and bottoms. Points are equidistant along the x axis on the chart and the distance between them does not reflect the true physical distance.

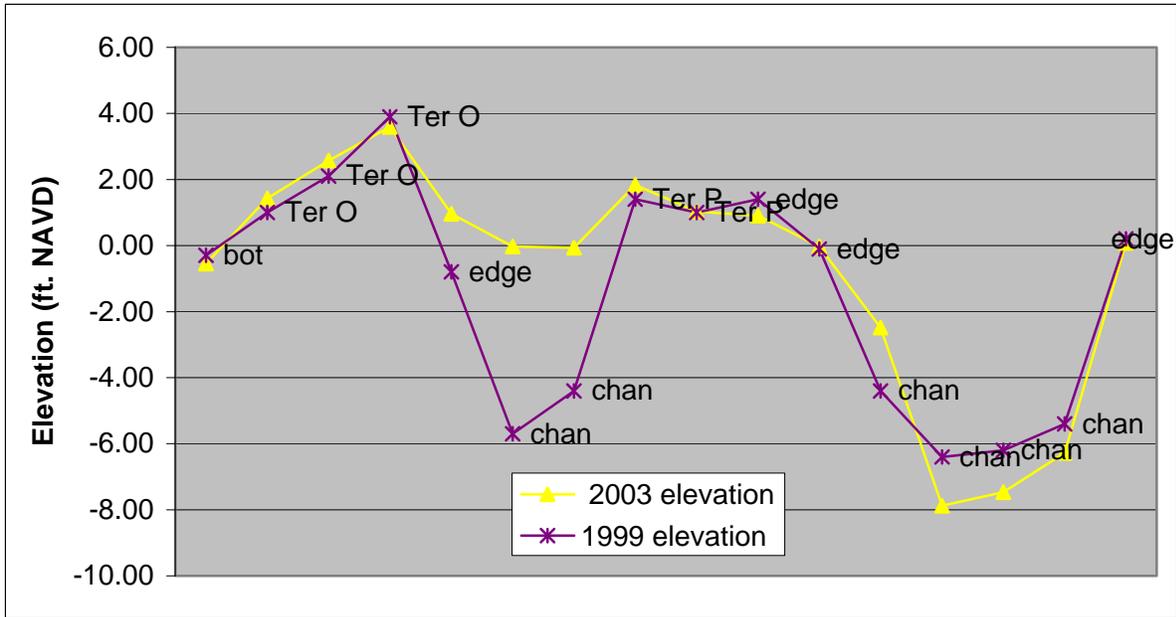
Figure 17. Elevations of selected paired points along cross section 16 from the 1999 and 2003 surveys. Bot = Bay Bottom, Ter = terrace, chan = channel, and edge = edges between terraces, channels, and bottoms. Points are equidistant along the x axis on the chart and the distance between them does not reflect the true physical distance.

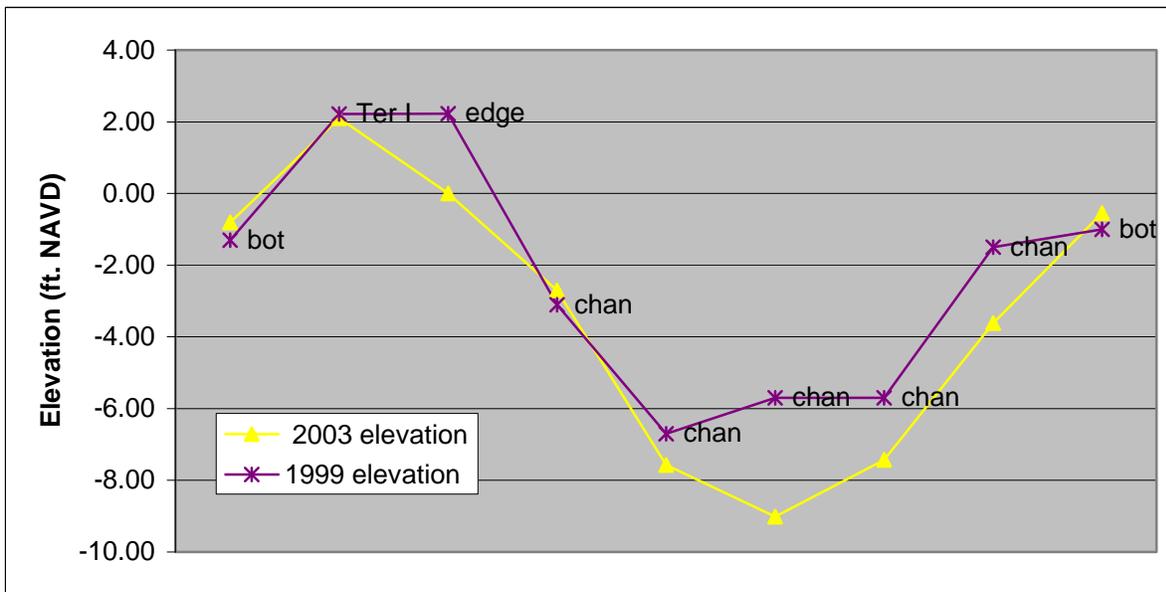
Figure 20. Elevations of selected paired points along cross section 31 from the 1999 and 2003 surveys. Bot = Bay Bottom, Ter = terrace, chan = channel, and edge = edges between terraces, channels, and bottoms. Points are equidistant along the x axis on the chart and the distance between them does not reflect the true physical distance.

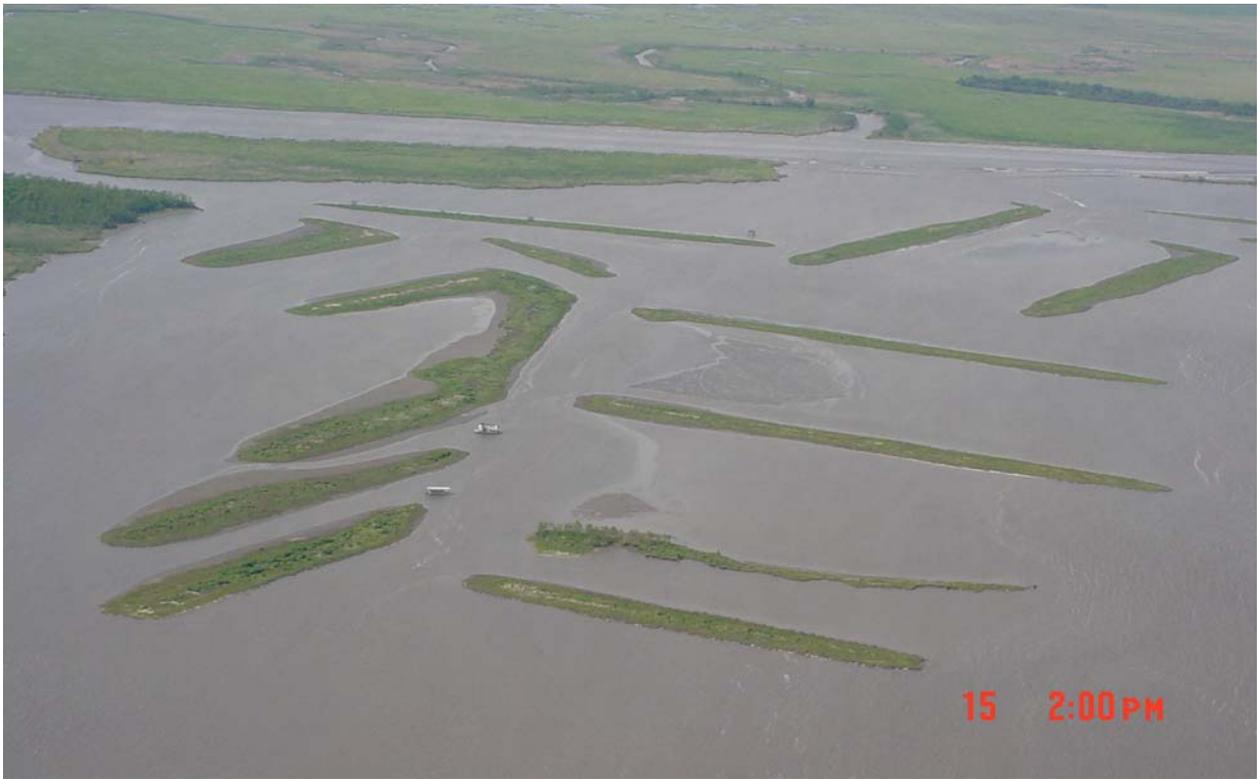
Aerial photography (figure 21) and the presence of mudflats with sprouting vegetation between terraces (figure 22) offer additional proof that sediment deposition has begun. The source of the sediments may be from Freshwater Bayou, regularly resuspended bay bottom, Hurricane Lili, sloughed terrace material, or some combination of all four. It seems unlikely that all the sedimentation could be from only shed terrace materials. The other three are naturally occurring and expected to continue, so we anticipate further substantial sediment deposition.

Figure 21. Aerial photograph of TV-12 project area taken in April 2003 showing exposed mudflat areas.

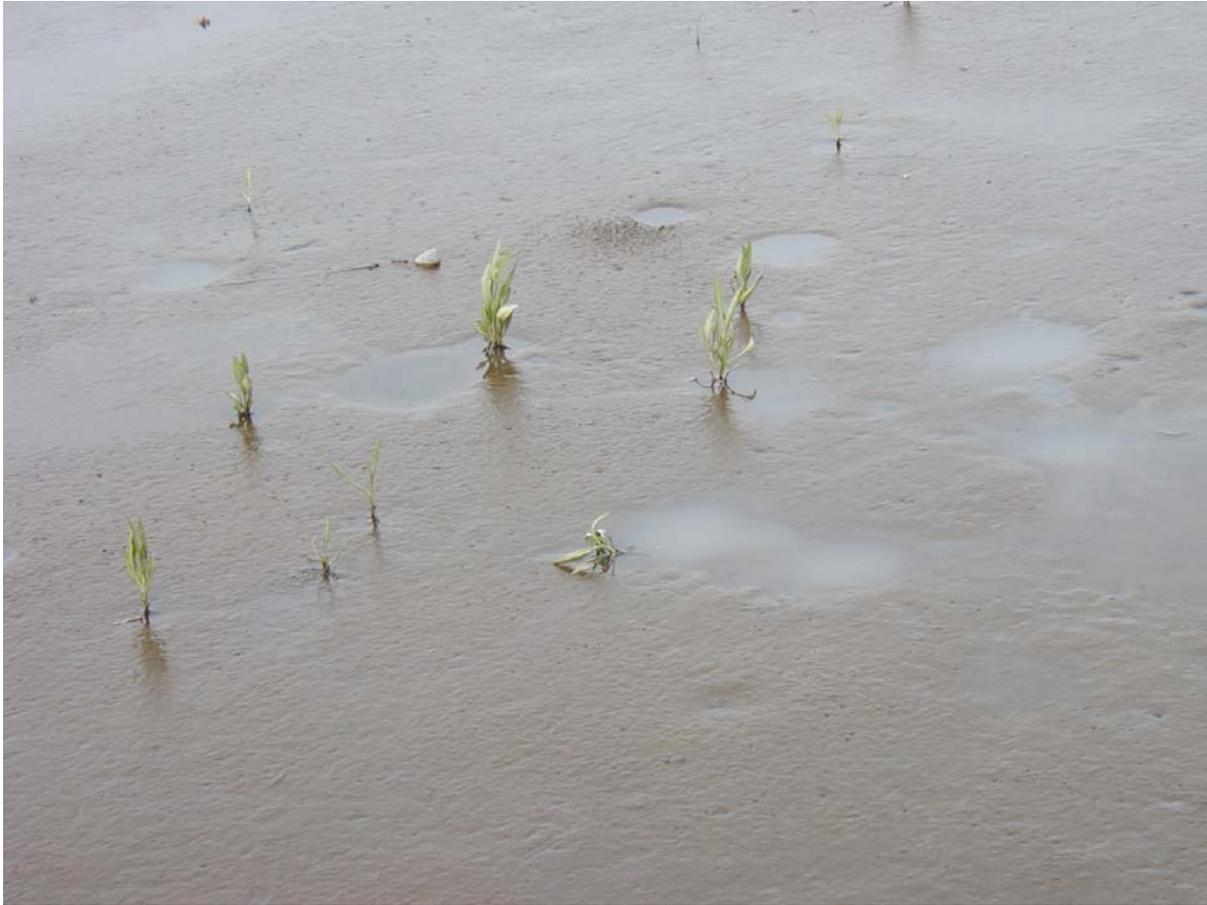
Figure 22. Close up view of a mudflat between terraces of the TV-12 project with sprouting vegetation.
