**2004 Operations, Maintenance,  
and Monitoring Report**

**Marsh Island Hydrologic  
Restoration**

State Project Number TV-14  
Priority Project List 6

May 2004  
Iberia Parish

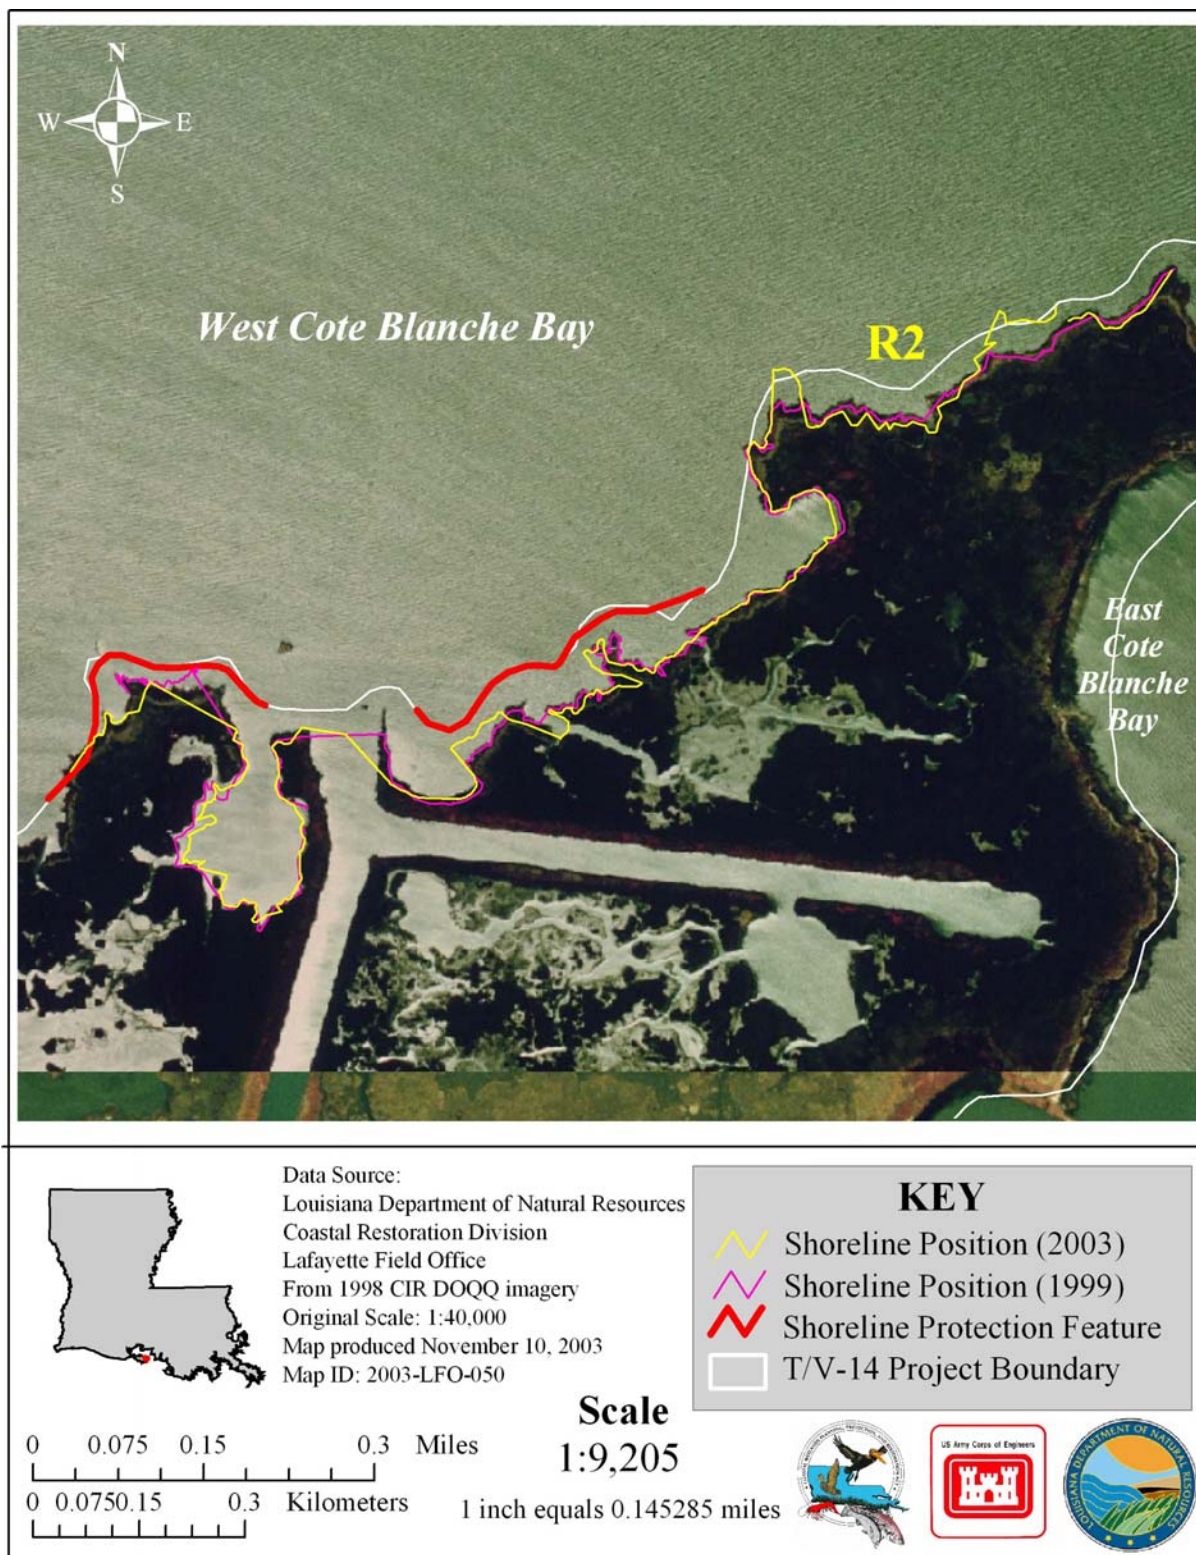
**Figure 8.** Comparison of shoreline position in 1999 and 2003 for the TV-14 project and reference areas.

The 2003 data were processed and compared to the preconstruction dataset to determine changes in shoreline position and configuration (figure 8). GIS analysis of the shoreline datasets indicated a loss of 2.07 acres (0.84 ha) and a gain of 1.85 acres (0.75 ha) for a net loss of 0.22 acres (0.09 ha) in the project area between 1999 and 2003. In the reference area, a net loss of 0.05 (0.02 ha) acres was documented. However, since the preconstruction shoreline position was documented more than 3 years prior to project construction, this loss may not necessarily be attributable to project features. There is also some degree of error due to limitations in the GPS technology used for the surveys, as well as temporal variations in water level which may affect data accuracy. This amount of loss is not considered to be ecologically significant.
