**Coastal Protection and Restoration
Authority of Louisiana**

**2008/2009 Annual Inspection
Report**

**EAST MUD LAKE MARSH
MANAGEMENT PROJECT
(CS-20)**

State Project Number CS-20
Priority Project List 2

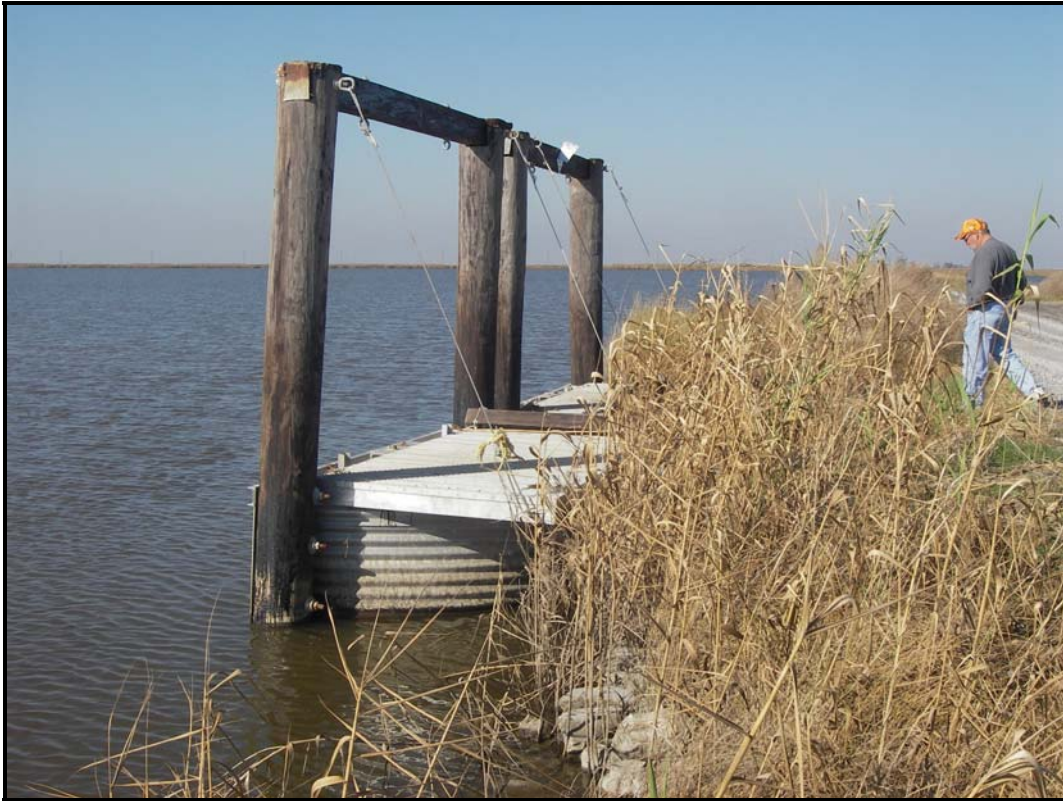
Photo No.1 Structure No. 6

The overall condition of Structure No. 6 appears to be very good and does not appear to have suffered any damage from Hurricane Ike. Water level gauges weren't available near the structure. Water was flowing out of the project at the time of the inspection. The timber piles, stop logs, grating, etc. are in good condition, however the metal pile caps are rusting out. Rock placed around the outlet side of the structure has held up well and stabilized the shoreline. Erosion is occurring on the bank line adjacent to the inlet side of the structure. The ends of the outlet pipes are clogged with marsh and other debris. The padlocks on the stop log locking devices have rusted and cannot be operated. As a result of the inspection of Structure No. 6, OCPR and NRCS agree that approximately 114 tons of stone needs to be added on the cut bank lines adjacent to the access roadway, replace padlocks, replace lock pins, replace metal pile caps, and clean out ends of both outfall pipes of marsh debris. (Photos: Appendix B, Photo 1).

Item	Condition	Physical Damage	Corrosion	Photo #	Observations and Remarks
Steel Bulkhead / Caps	N/A				
Steel Grating	Good				
Stop Logs	Good				
Hardware	Poor		Yes	1	Corrosion on padlocks, need to be replaced.
Timber Piles	Good				
Timber Wales	Good				
Galv. Pile Caps	Poor		Yes	1	Need to be replaced.
Cables	Good				
Signage / Supports	Fair				General Note: There are no staff gages at this structure.
Outlet Pipes	Fair				The ends of both outlet pipes are clogged with marsh debris.
Earthen Embankment	Fair			1	Rock armor needed on bank line adjacent to inlet structure.

- ES-6 – rock rip rap for bank erosion, replace padlocks and metal pile caps, clean out culverts.
- ES-7 – rock rip rap for bank erosion, replace padlocks and metal pile caps, check elevation of staff gages, replace missing inside staff gage, clean out culverts.

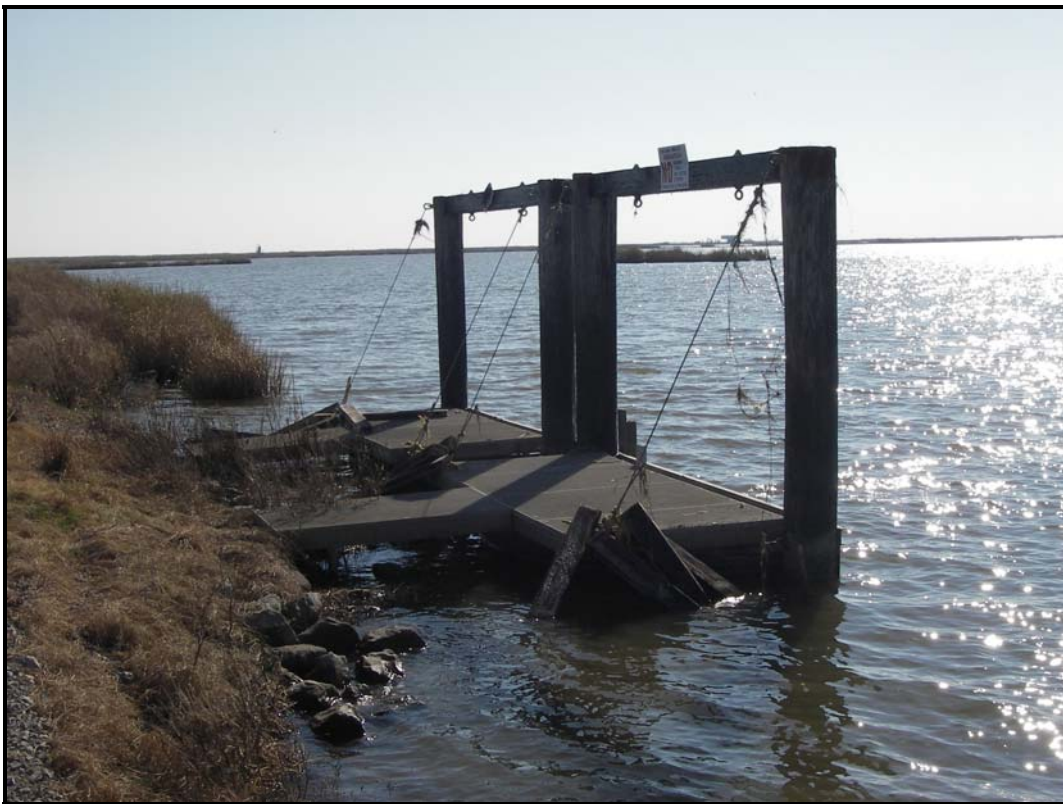
Photo No. 2 Structure No. 7

Structure No. 7 appears to be in very good condition and does not appear to have suffered any damage from Hurricane Ike. Water level gage on the outside was slightly above +2.0 NAVD88. (Note: these staff gages were recently replaced through the CRMS program). Both ends of this structure are clogged with marsh debris and have silted up. Erosion is occurring on the bank line adjacent to the inlet side of the structure. The padlocks on the stop log locking devices have rusted and cannot be operated. As a result of the inspection of Structure No. 7, OCPR and NRCS agree that approximately 66 tons of stone needs to be added on the cut bank lines adjacent to the access roadway, replace padlocks, replace lock pins, replace metal pile caps, check elevation of staff gages on inlet and outlet side of the structure, and clean out ends of both outfall pipes of marsh debris. (Photos: Appendix B, Photo 2).

Item	Condition	Physical Damage	Corrosion	Photo #	Observations and Remarks
Steel Bulkhead / Caps	N/A				
Steel Grating	Good				
Stop Logs	Good				
Hardware	Poor		Yes	2	Corrosion on padlocks, need to be replaced.
Timber Piles	Good				
Timber Wales	Good				
Galv. Pile Caps	Poor		Yes	2	Need to be replaced.
Cables	Good				
Signage / Supports	Good				
Staff Gages	Fair				Need to check elevation of staff gage outside and replace staff gage inside.
Inlet/Outlet Pipe	Fair				Inlet and outlet pipes are clogged with marsh debris.
Earthen Embankment	Fair			2	Rock armor needed on bank line adjacent to inlet structure.

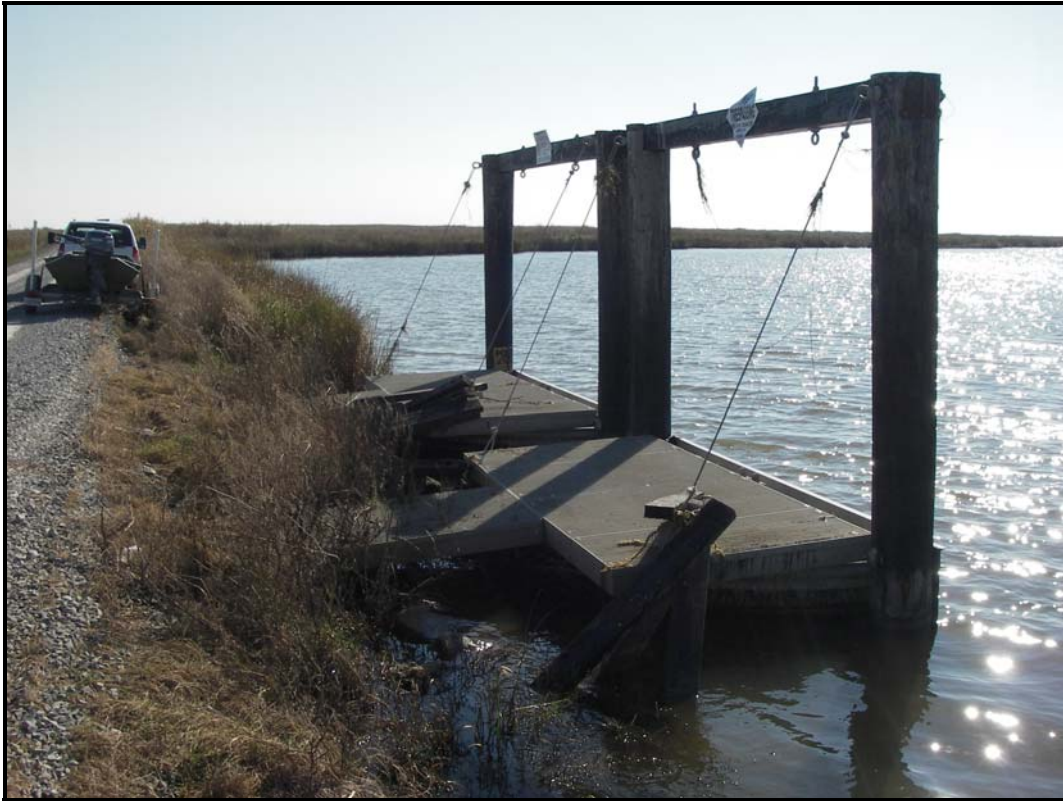
Photo No. 3, Structure No. 8

Structure No. 8 appears to be in very good condition and does not appear to have suffered any damage from Hurricane Ike. Water level gauges were unavailable. Both ends of this structure are clogged with marsh debris and have silted up. It appears very little flow is going through the pipes due to washover of the access road rock material into the water. Erosion is occurring on the bank line adjacent to the inlet side of the structure. The padlocks on the stop log locking devices have rusted and cannot be operated. OCPR and NRCS agree that this structure requires clean out of the ends of outlet pipes, placement of approximately 66 tons of rock along cut bank lines adjacent to the structure, replace padlocks, replace lock pins, and replace metal pile caps. (Photos: Appendix B, Photo 3).

Item	Condition	Physical Damage	Corrosion	Photo #	Observations and Remarks
Steel Bulkhead / Caps	N/A				
Steel Grating	Good				
Stop Logs	Good				
Hardware	Poor		Yes	3	Corrosion on padlocks, need to be replaced.
Timber Piles	Good				
Timber Wales	Good				
Galv. Pile Caps	Poor		Yes	3	Need to be replaced.
Cables	Good				
Signage / Supports / Staff Gages	Good				Note: There are no staff gages inside and outside of this structure.
Inlet/Outlet Pipe	Fair				
Earthen Embankment	Fair			3	Rock armor needed along bank line adjacent to inlet structure.

- ES-8 – rock rip rap for bank erosion, replace padlocks and metal pile caps.
- ES-9a – replace metal pile caps, clean out culvert, check elevation of staff gages, replace missing inside staff gage, replace padlocks and repair flapgate handle.

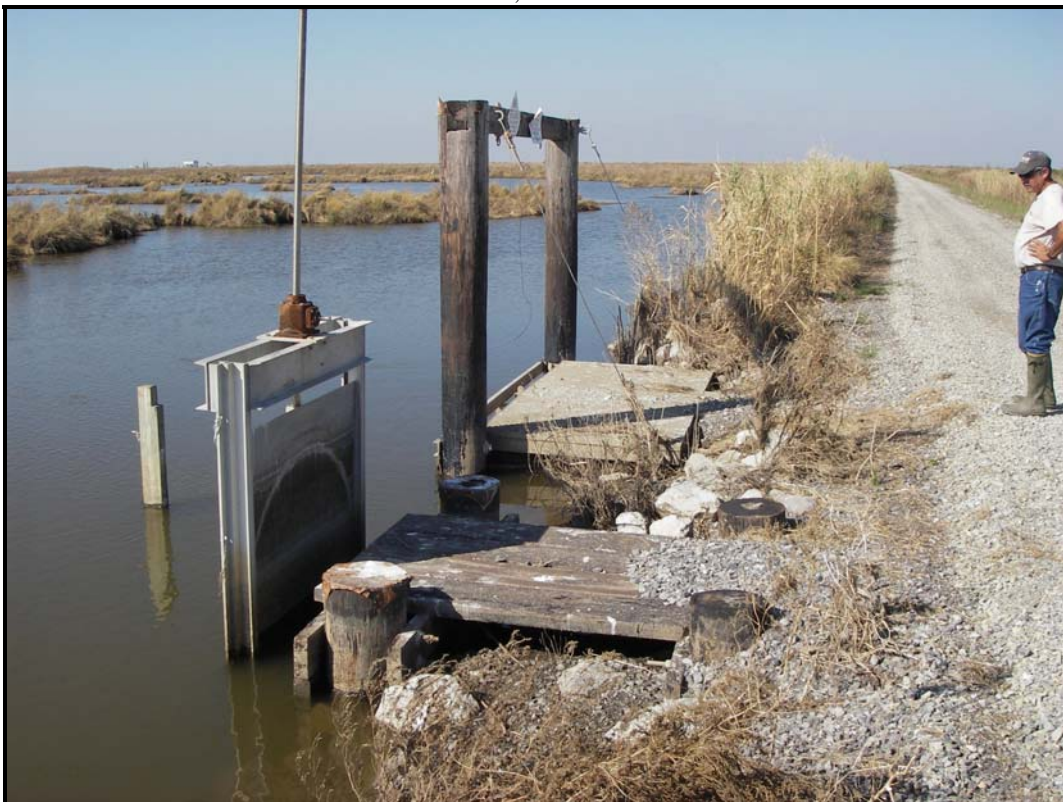
Photo No. 4, Structure No. 9a & 9b

Structure No. 9a is in good condition and does not appear to have suffered any damage from Hurricane Ike. The staff gage on the outside was +2.0 NAVD88. (Note: these staff gages were recently replaced through the CRMS program). Both ends of this structure are clogged with marsh debris and have silted up. The handle on the outlet pipe flapgate has been broken off. The metal pile caps on the pilings have rusted out. The padlocks on the stop log locking devices have rusted and cannot be operated. OCPR and NRCS agree that this structure requires replacement of the metal pile caps, clean out of the ends of outlet pipes, check elevation of staff gages inside and out, replace padlocks, replace lock pins and repair of the flapgate handle. (Photos: Appendix B, Photo 4).

Structure No. 9b is in good condition and does not appear to have suffered any damage from Hurricane Ike. Both ends of this structure are clogged with marsh debris and have silted up. The staff gage on the outside was +2.0 NAVD88. (Note: these staff gages were recently replaced through the CRMS program). Water was flowing into the project area. The handle on the outlet pipe flapgate has been broken off. The gear box on the sluice gate is showing signs of rust and the stem cover is missing. Apache personnel have reported that it, so far, is not a problem; however it will probably need to be addressed. Metal pile cap covers have rusted out. The seat flange on the flap gate is broken and has come apart from the pipe barrel. OCPR and NRCS agree that this structure is in operable condition and maintenance will be required to refurbish the gear box and replace stem cover, replace seat flange on flap gate, clean out of the ends of outlet pipes, replace padlocks, replace metal pile caps and repair flapgate handle. (Photos: Appendix B, Photo 4).

Item	Condition	Physical Damage	Corrosion	Photo #	Observations and Remarks
Steel Bulkhead / Caps	N/A				
Steel Grating	Good				
Stop Logs	Good				
Hardware Sluice Gate	Fair Poor		Yes Yes	4	Corrosion on padlocks, handles on outlet pipe flap gates are broken. Gear box corroded and needs to be refurbished, stem cover missing, needs to be replaced.
Timber Piles	Good				
Timber Wales	Good				
Galv. Pile Caps	Poor		Yes	4	Need to be replaced.
Cables	Good				
Signage / Supports	Good				
Staff Gages	Good				Check elevation of staff gage outside and replace inside gage.
Rip Rap (fill)	Good				
Earthen Embankment	Good

- ES-9b – refurbish gear box and replace stem cover, replace seat flange on flapgate, clean out culvert, replace padlocks and metal pile cap covers, repair flapgate handle.

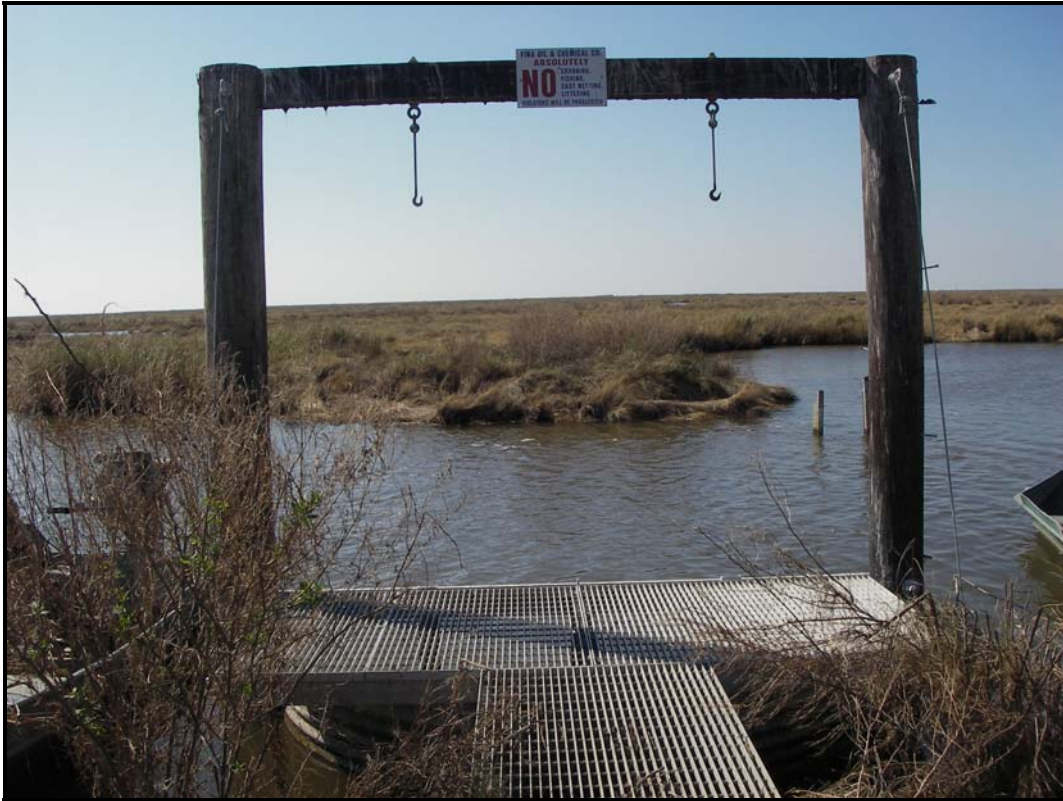
Photo No. 5, Structure No. 11

The structure is in good condition and does not appear to have suffered any damage from Hurricane Ike. Water level on the outside staff gage was +1.9 NAVD88 and the gage on the inside was +1.9 NAVD88. (Note: these staff gages were recently replaced through the CRMS program). There is some erosion of the bank on both the inlet and discharge sides of the structure. Approximately 228 tons of man size rip rap will be required to reinforce the bank around the structure. The bank line near the outlet flap gate has eroded and the boardwalk is not accessible. The metal pile cap covers have rusted out. The padlocks on the stop log locking devices have rusted and cannot be operated. OCPR and NRCS agree that maintenance work is required to add rip rap on both sides of the structure, extend wooden boardwalk, replace metal pile caps, replace padlocks, replaced lock pins and check elevations of replace staff gages inside and out. (Photos: Appendix B, Photo 5).

Item	Condition	Physical Damage	Corrosion	Photo #	Observations and Remarks
Steel Bulkhead / Caps	N/A				
Steel Grating	Good				
Stop Logs	Good				
Hardware	Poor		Yes		Corrosion on padlocks, need to be replaced.
Timber Piles	Good				
Timber Walkway	Poor				Wooden boardwalk needs to be extended.
Timber Wales	Good				
Galv. Pile Caps	Good				
Cables	Good				
Signage / Supports	Fair				
Staff Gages	Good				Check elevation of staff gages inside and out.
Rip Rap (fill)	N/A				
Earthen Embankment	Fair	Yes		5	Rock armor needed on both sides of the structure.

- ES-11 – rock rip rap for bank erosion, extend boardwalk, replace metal pile cap covers and padlocks, check elevation of staff gages.
- ES-5 – rock rip rap for bank erosion, replace metal pile cap covers, replace padlocks, replace boardwalk, and inside and outside staff gages.

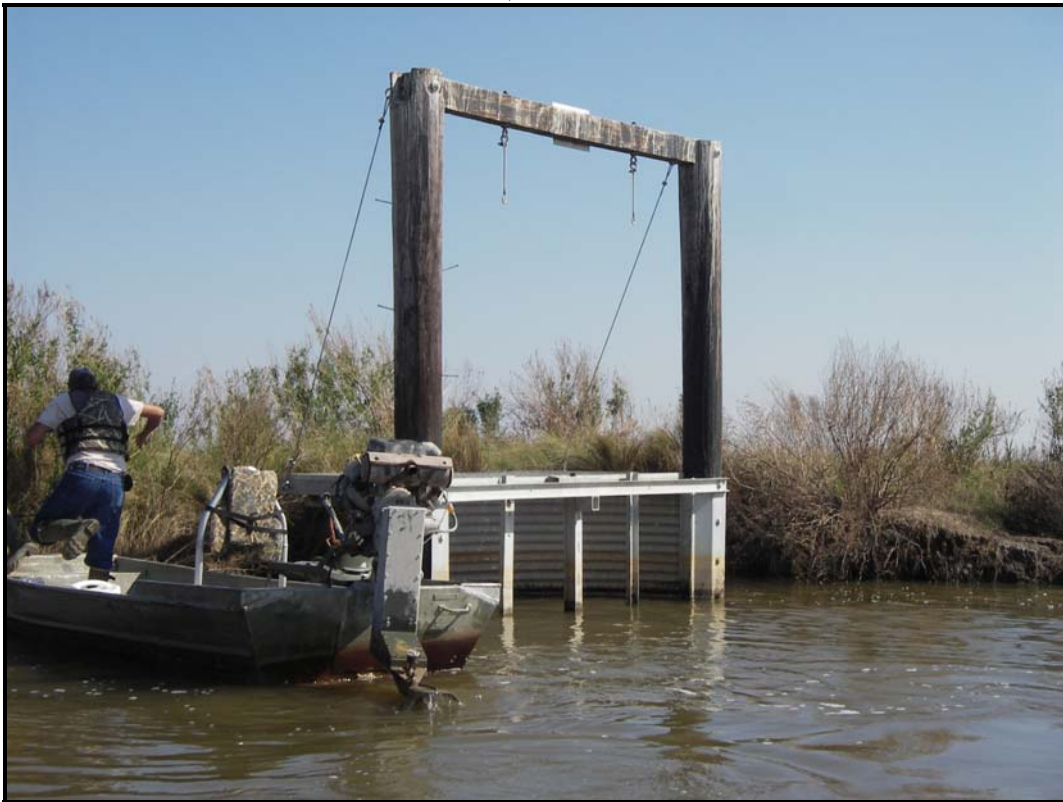
Photo No. 6, Structure No. 5

The structure itself is in good condition and does not appear to have suffered any damage from Hurricane Ike. Erosion was noted along the bank on both the inlet and discharge sides of the structure. Approximately 342 tons of rock will be needed to reinforce the bank around this

structure. The boardwalk at the outlet pipe flap gate is missing. The metal pile cap covers have rusted out. The padlocks on the stop log locking devices have rusted and cannot be operated. OCPR and NRCS agree that maintenance work is required to add rip rap, replace metal pile caps, replace padlocks, replace lock pins, replace wooden boardwalk, and check elevation of staff gages inside and out. (Photos: Appendix B, Photo 6).

Item	Condition	Physical Damage	Corrosion	Photo #	Observations and Remarks
Steel Bulkhead / Caps	N/A				
Steel Grating	Good				
Stop Logs	Good				
Hardware	Poor		Yes	6	Corrosion on padlocks, need to be replaced.
Timber Piles	Good				
Timber Walkway	Poor				Replace missing boardwalk.
Timber Wales	Good				
Galv. Pile Caps	Poor		Yes	6	Need to be replaced.
Cables	Good				
Signage / Supports	Good				
Staff Gages	Poor				Replace staff gages.
Rip Rap (fill)	N/A				
Earthen Embankment	Fair	Yes			Rock armor needed on both sides of structure.

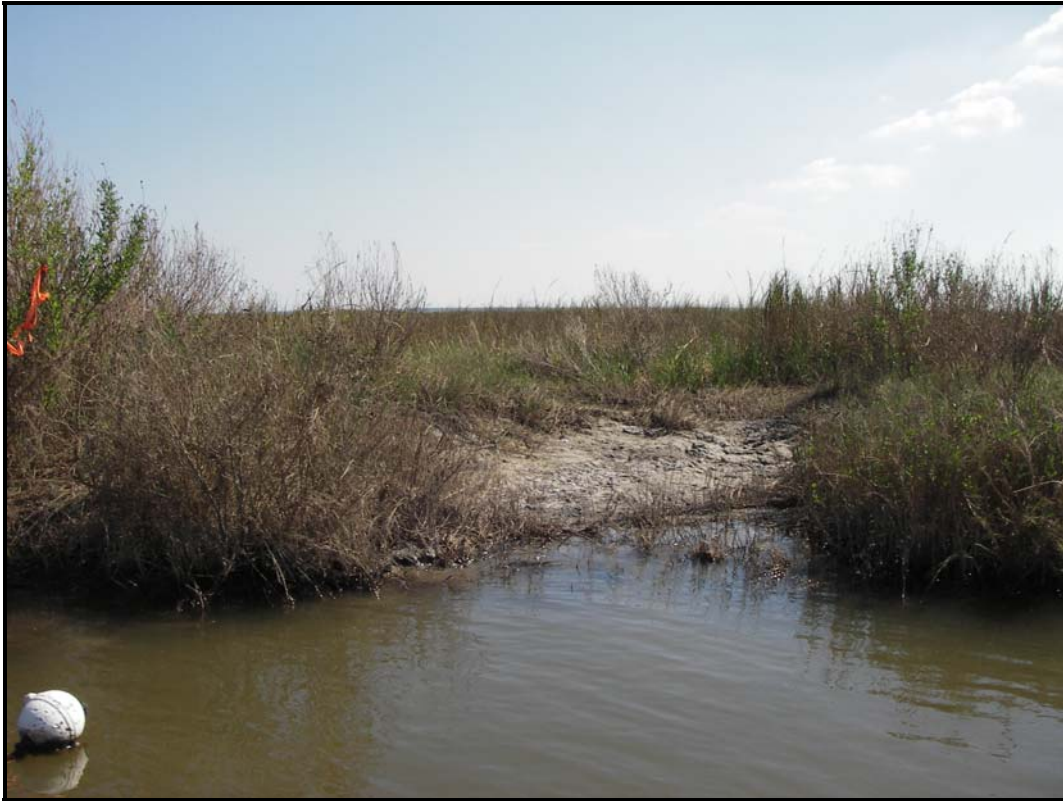
Photo No. 7, Typical levee erosion on eastern levee along Step Canal

The inspection of the earthen levee consisted of a visual inspection of the entire length of levee along the Step Canal. In addition to the erosion noted above, the storm surge has eroded portions of the levee in various locations. In addition the storm surge has placed large amounts of marsh and other debris into the east-west sections of the Step Canal. In these areas of the canal, the water depth was very shallow. The north-south sections appear to be relatively free of any obstructions. OCPR and NRCS agree that maintenance is required to repair the levees and remove trash from the canal. (Photos: Appendix B, Photo 7).

- Levee/Step canal – repair levees and remove trash/debris and silt from canal.

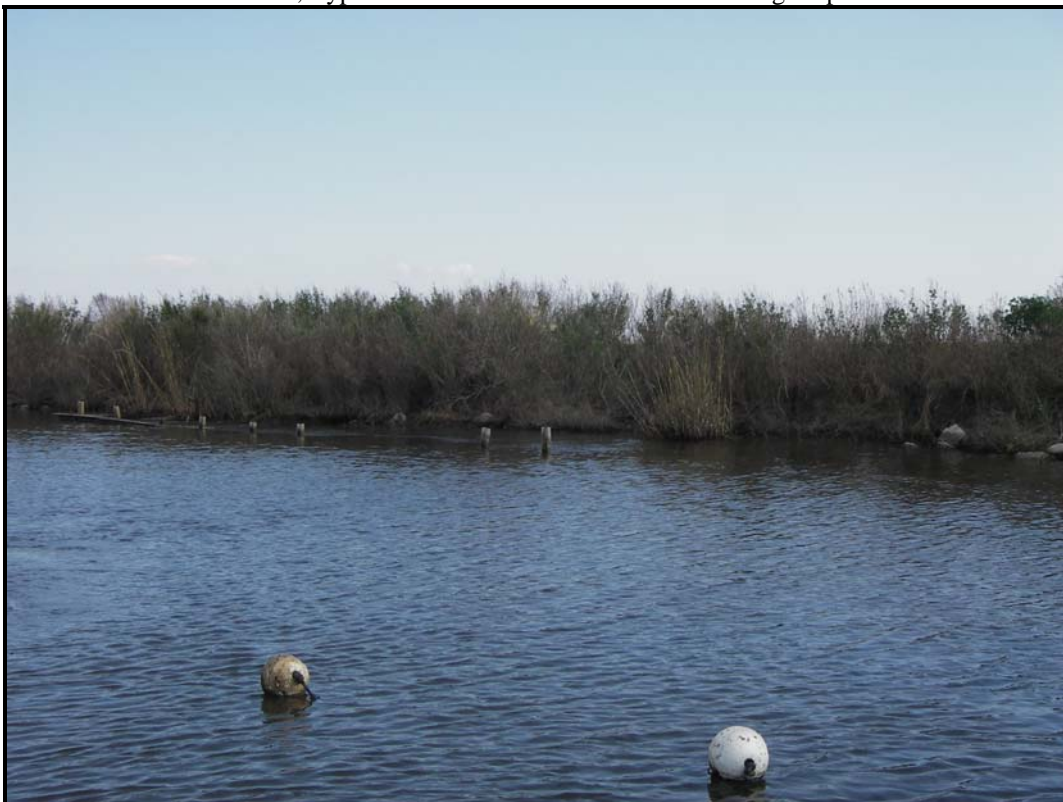
Photo No. 8, Structure No. 4

This structure is a pre-existing structure that was incorporated into the CS-20 Project. It is in disrepair and needs to be replaced. A new structure was let out for bids on February 10, 2005, however it was over budget and the bid was rejected. This structure will be replaced with a structure similar to ES-13, and the existing structure will be abandoned in place. Staff gauge readings were not available. (Photos: Appendix B, Photo 8).

Item	Condition	Physical Damage	Corrosion	Photo #	Observations and Remarks
Steel Bulkhead / Caps	N/A			8	GENERAL NOTE: Due to severe settlement of the overall structure, it is beyond repair and needs to be abandoned in place, and a new structure built along side.
Steel Grating	Poor				
Stop Logs	Fair				
Hardware	Fair				
Timber Piles	Poor				
Timber Wales	Poor				
Galv. Pile Caps	Good				
Cables	N/A				
Signage / Supports	Good				
Rip Rap (fill)	Fair				
Earthen Embankment	Fair	Yes

- ES-4 – replace structure, abandon existing structure in place.
- ES-3 – rock rip rap for bank erosion, clean out culvert, replace boardwalks, replace padlocks and check elevation of staff gages.

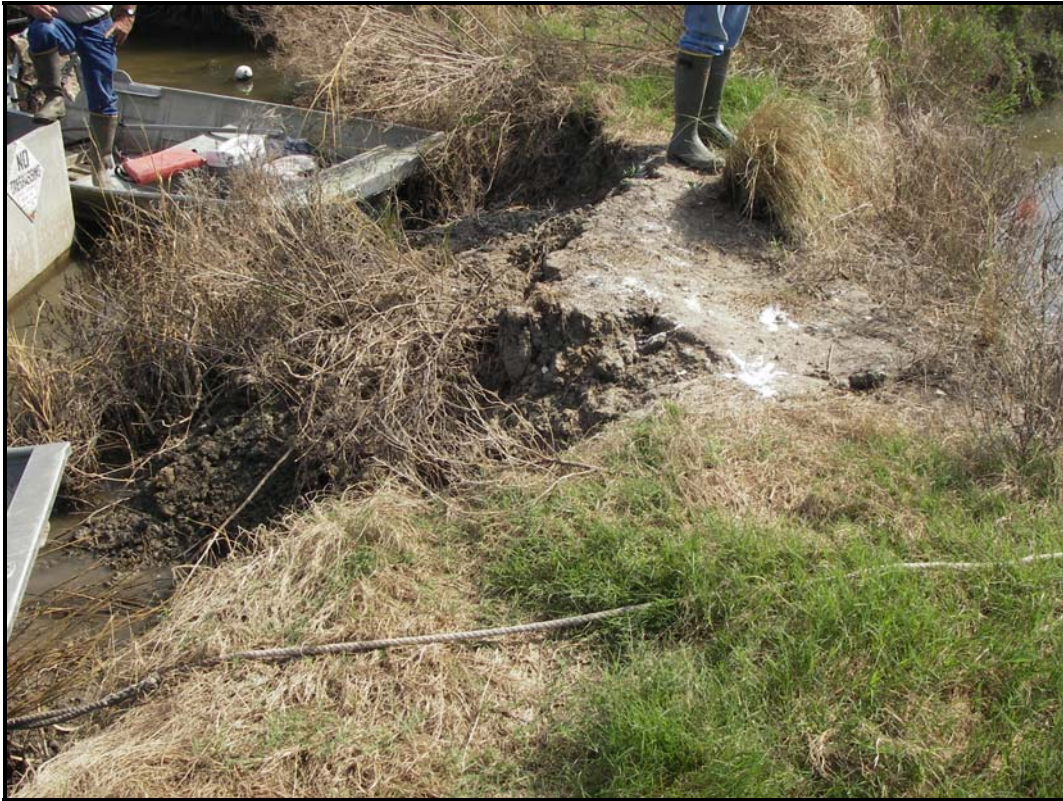
This is also a pre-existing structure that was incorporated into the CS-20 Project. The wooden walkways on the outside and the inside of the structure are missing. The structure is silted up with marsh debris. The bank, however, is showing signs of some erosion and will require approximately 209 tons of man-size rip rap for reinforcement. Additional erosion has occurred due to Hurricane Ike. Water level on the outside staff gage was +1.9 NAVD88 and the gage on the inside was +2.05 NAVD88. (Note: these staff gages were recently replaced through the CRMS program). Water was flowing out to the exterior marsh. The padlocks on the stop log locking devices have rusted and cannot be operated. OCPR and NRCS agree that maintenance work is required to add rip rap, clean out debris, replace both walkways, replace padlocks, replace lock pins and check elevation of staff gages inside and out. (Photos: Appendix B, Photo 9).

Photo No. 9, Structure No. 3, view showing additional erosion

Item	Condition	Physical Damage	Corrosion	Photo #	Observations and Remarks
Steel Bulkhead / Caps	N/A				
Steel Grating	Good				
Stop Logs	Good				
Hardware	Poor		Yes	9	Corrosion on padlocks, need to be replaced.
Timber Piles/ Walkway	Poor				Walkways on the inside and outside of the structure are missing.
Timber Wales	Good				
Galv. Pile Caps	Poor		Yes	9	Need to be replaced.
Cables	Good				
Signage / Supports	Fair				
Staff Gages	Good				Check elevation of staff gage on inside and outside of the structure.
Rip Rap (fill)	N/A				
Earthen Embankment	Fair	Yes		9	Rock armor needed both sides of structure
Channel	Poor			9	Inlet side of the structure is silted up with marsh debris.

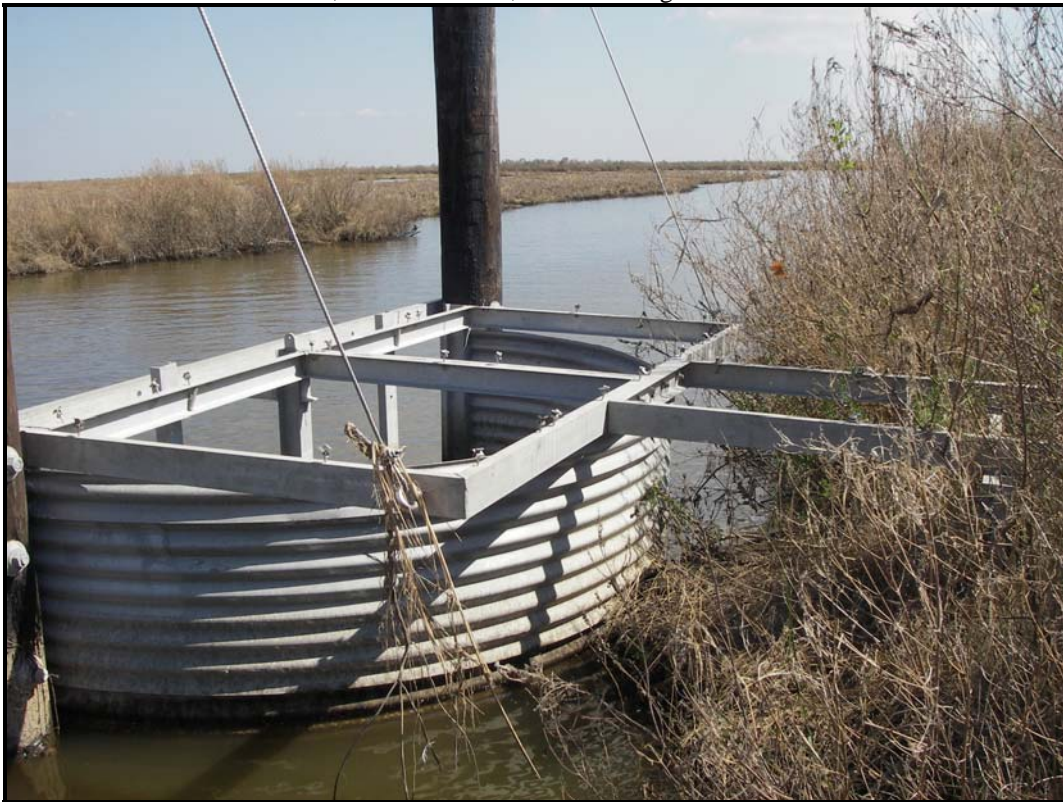
Photo No. 10, Structure No.1

Vandals have stolen all of the grating on the inlet side of the structure. The structure is silted up with marsh debris. The bank, however, is showing signs of some erosion and will require approximately 470 tons of man-size rip rap for reinforcement. Water level on the gage on the inside was +1.9 NAVD88. (Note: these staff gages were recently replaced through the CRMS program). Water was flowing out to the exterior marsh. The padlocks on the stop log locking devices have rusted and cannot be operated. The metal pile cap covers have rusted out. The wooden boardwalk needs to be extended. OCPR and NRCS agree that maintenance work is required to add rip rap, clean out debris, extend the boardwalk, replace metal pile caps, replace grating, replace lock pins, replace padlocks, and check elevation of staff gages inside and out. (Photo: Appendix B, Photo 10).

Item	Condition	Physical Damage	Corrosion	Photo #	Observations and Remarks
Steel Bulkhead / Caps	N/A				
Steel Grating	Fair			10	Replace all sections of grating that are missing.
Stop Logs	Good				
Hardware	Poor		Yes	10	Corrosion on padlocks, need to be replaced.
Timber Piles	Good				
Timber Walkway	Poor				Need to extend walkway.
Timber Wales	Good				
Galv. Pile Caps	Poor		Yes	10	Need to be replaced.
Cables	Good				
Signage / Supports	Good				
Staff Gages	Good				Need to check elevation of staff gage inside and replace outside gage.
Rip Rap (fill)	N/A				
Earthen Embankment	Poor			10	Rock armor needed both sides of structure.

- ES-1 – rock rip rap for bank erosion, extend boardwalk, replace metal pile cap covers and padlocks, check elevation of staff gages, replace outside staff gage.

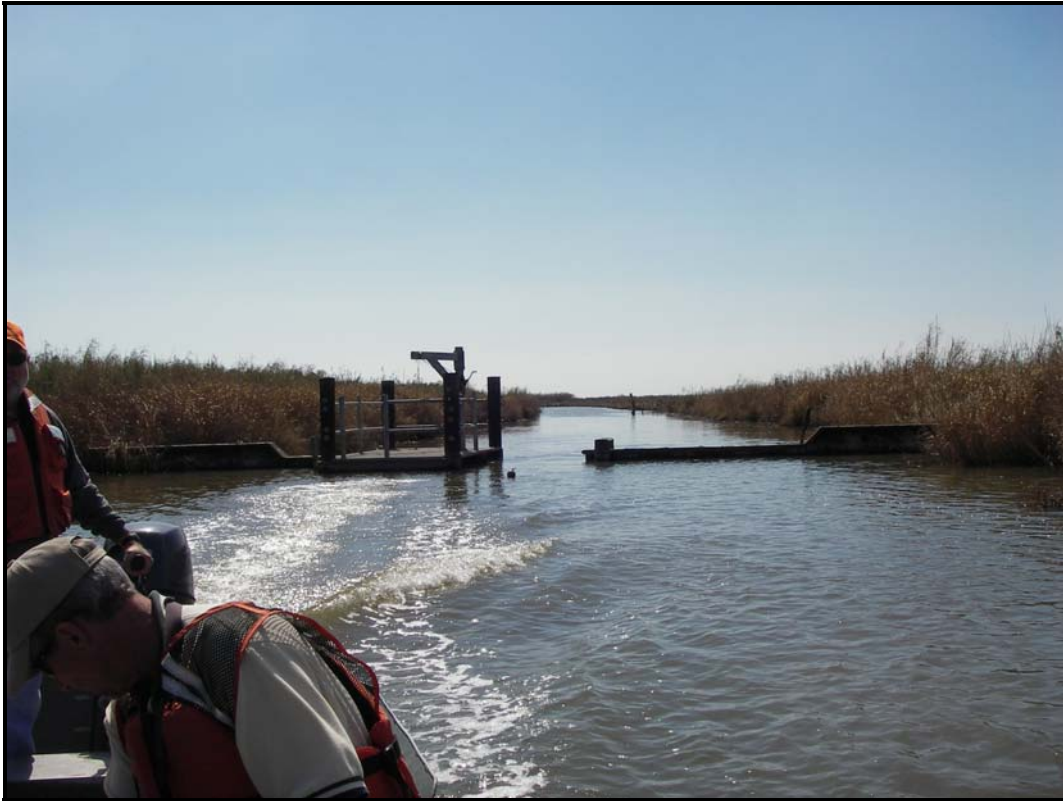
Photo No. 11, Structure No. 17

The sheet pile cap is severely rusted out on both sides of the structure. The locking tabs on the landing side of the stop log slots are missing. The warning sign is missing. The padlocks on the stop log locking devices have rusted and cannot be operated. The metal pile cap covers

are rusted out. Water level on the outside staff gage was +1.0 NAVD88 and the gage on the lake side was +1.0 NAVD88. (Note: these staff gages were recently replaced through the CRMS program). Erosion is also occurring on each end of the sheet pile wall. OCPR and NRCS agree that maintenance work is required to replace sign and pile cap on sheet pile wall, check elevation of staff gages, replace metal pile cap covers, replace padlocks, and replace locking tabs, however due to budget constraints will not be undertaken with the proposed maintenance event of 2009. Consideration is also being given to replacing the entire sheet pile wall in the future. (Photos: Appendix B, Photo 11).

Item	Condition	Physical Damage	Corrosion	Photo #	Observations and Remarks
Steel Bulkhead / Caps	Poor		Yes	11	Steel sheet pile and cap show signs of corrosion. Pile cap needs to be replaced.
Steel Grating	Good				
Stop Logs	Fair			11	The locking tabs on the stop log slots are missing.
Hardware	Poor		Yes	11	Padlocks corroded and need to be replaced.
Timber Piles	Good				
Timber Wales	Good				
Galv. Pile Caps	Poor			11	Need to be replaced.
Cables	Good				
Signage / Supports	Poor			11	Warning sign is missing.
Staff Gages	Good			11	Check elevation of staff gages.
Rip Rap (fill)	N/A				
Earthen Embankment	Good

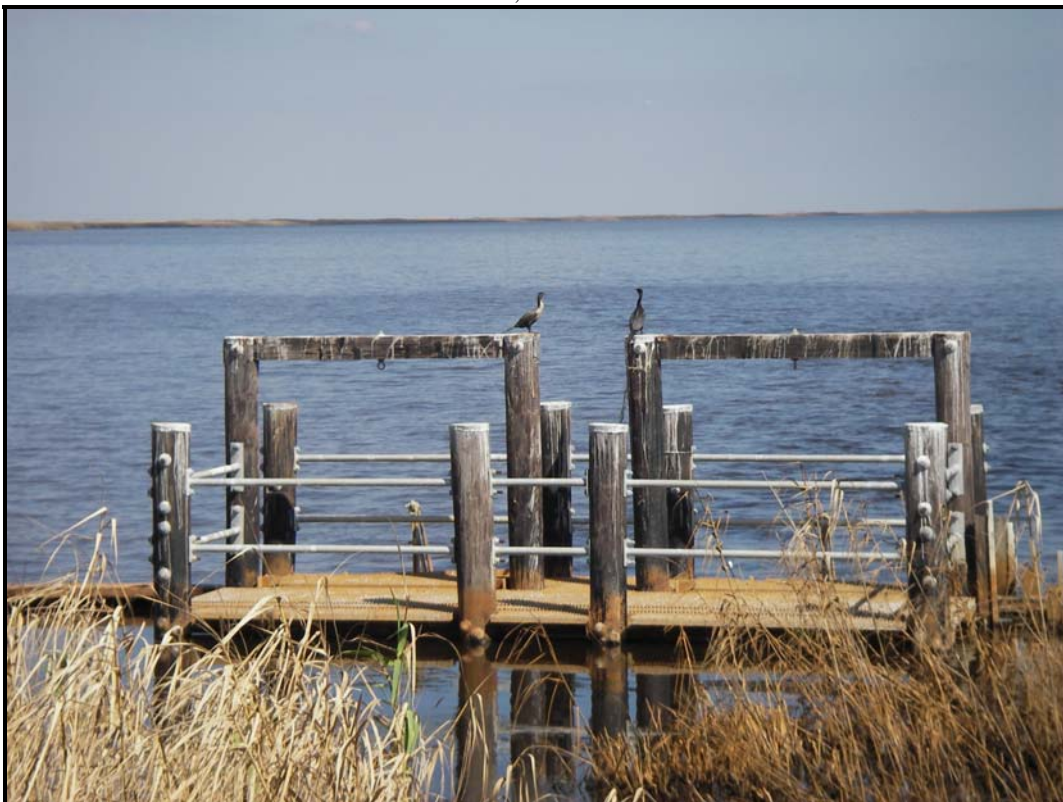
Photo No. 12, Structure No. 13

The warning sign is missing. Staff gages outside and inside were not readable. The structure is silted up with marsh debris. The padlocks on the stop log locking devices have rusted and cannot be operated. The metal pile cap covers have rusted out. The sheet pile cap on top of the sheet pile wall is severely rusted. Water was flowing into the interior marsh at the time of the inspection. OCPR and NRCS agree that maintenance is required to replace the warning sign, replace the metal pile cap covers, replace staff gages inside and out, clean out marsh debris, replace padlocks, replace locking pins, and replace sheet pile cap on both sides of structure. (Photos: Appendix B, Photo 12).

Item	Condition	Physical Damage	Corrosion	Photo #	Observations and Remarks
Steel Bulkhead / Caps	Poor		Yes	12	Some rusting of pile cap is present, needs to be replaced.
Steel Grating	Good				
Stop Logs	Good				
Hardware	Poor		Yes		Padlocks corroded, need to be replaced.
Timber Piles	Good				
Timber Wales	Good				
Galv. Pile Caps	Poor				Need to be replaced.
Cables					
Signage / Supports	Poor			12	Warning sign is missing, needs to be replaced.
Staff Gage	Poor			12	Staff gages need to be replaced inside and out.
Rip Rap (fill)	N/A				
Earthen Embankment	Good

- ES-13 – replace warning sign, replace metal pile cap covers, replace staff gages, clean out debris, replace padlocks, replace metal pile cap on sheet pile wall.
