**2008/2009 Annual Inspection
Report**

**HWY. 384 HYDROLOGIC
RESTORATION PROJECT
(CS-21)**

State Project Number CS-21
Priority Project List 2

October 14, 2008
Cameron Parish

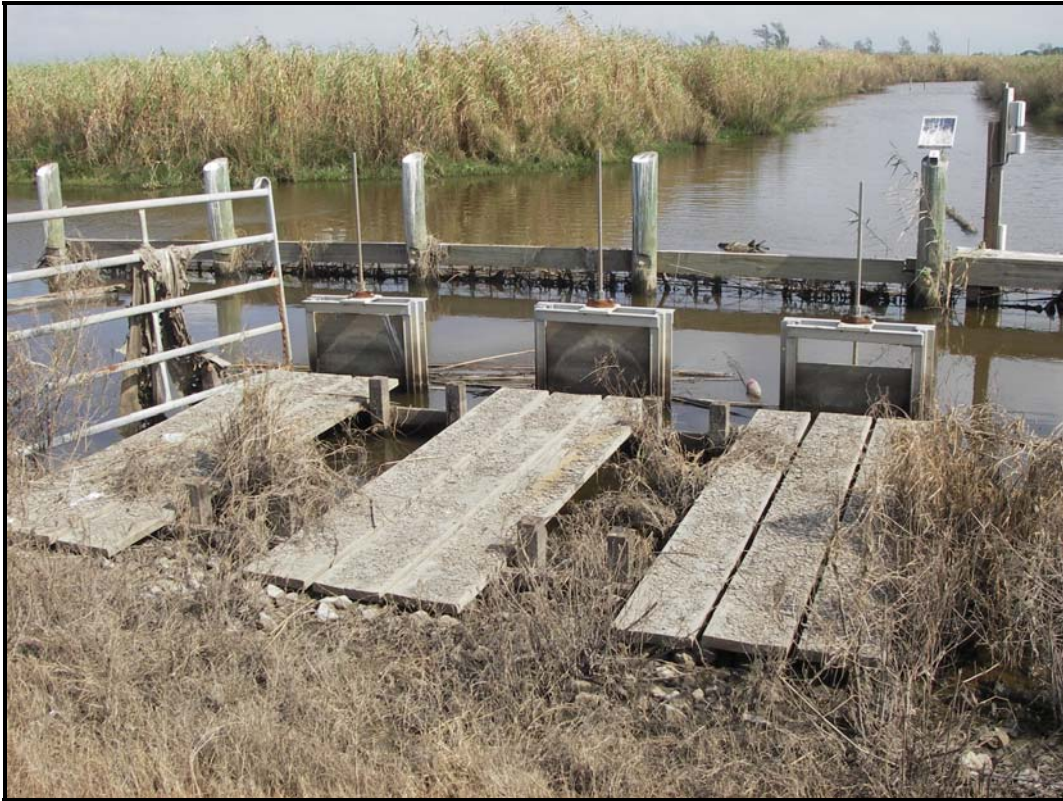
The structure is in good condition and does not appear to have sustained any major damage from Hurricane Ike. Water level on the outside was elevation +1.7 NAVD88 and the level inside could not be determined because the staff gage was not readable. The inside staff gage will need to be replaced. Rock placed on the bank during the maintenance event of June 2002 is stable and in no need of repair. The hyacinth fence is in good condition; however there is trash accumulating on the outside of the fence which needs to be removed. The road/levee leading up to the structure is in good condition since it was repaired in June 2006. The recently installed Portable Multi-Parameter Water Quality Troll 9500 – 29r operation sonde has been removed and will need to be replaced due to storm damage. The solar panel should be cleaned and bird excluder devices installed. (Photos: Appendix B, Photos 1-3).

Photo No. 1, Structure No.1, inlet side.

- Structure No. 1 – install bird excluder device on solar panel, replace inside staff gage, remove trash from outside of the hyacinth fence, replace operation sonde.
- Structure No. 12 – replace metal pile cap covers, install bird excluder device on solar panel, replace operation sonde, replace padlocks and inside staff gage.
- Structure No. 8 (Rock Plug) – install staff gauges both lake and marsh sides.

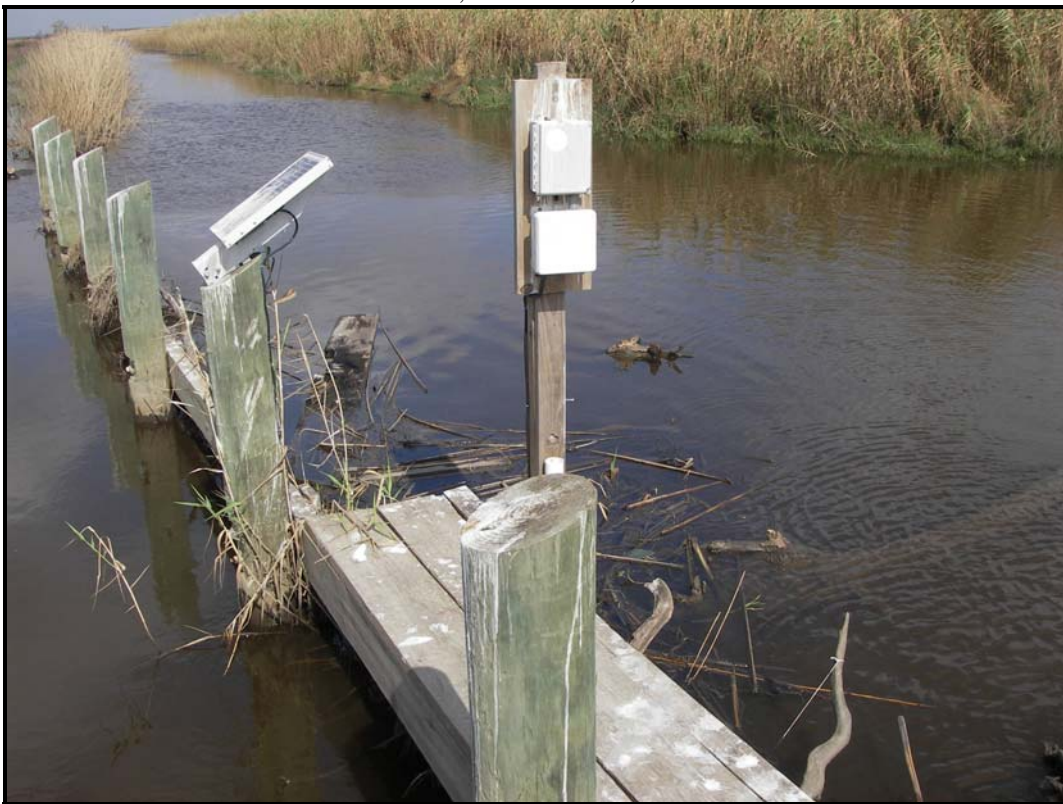
Photo No. 2, Structure No.1, trash along fence and operational sonde.

Item	Condition	Physical Damage	Corrosion	Photo #	Observations and Remarks
Steel Bulkhead / Caps	N/A				
Flapgates/Outlet Pipe	Good			3	
Stop Logs	N/A				
Hardware/Sluiceways	Good			1	
Hyacinth Fence	Fair			1	Trash accumulating on outside of hyacinth fence.
Timber Piles	N/A				
Timber Wales	N/A				
Galv. Pile Caps	N/A				
Cables	N/A				
Signage /Supports	N/A				
Staff Gages	Poor				Staff gage outlet side of structure not readable.
Rip Rap (fill)	Good				
WQ Troll 9500 - 29r	Poor			2	Needs to be replaced.
Earthen Embankment					
Access Roadway	Good

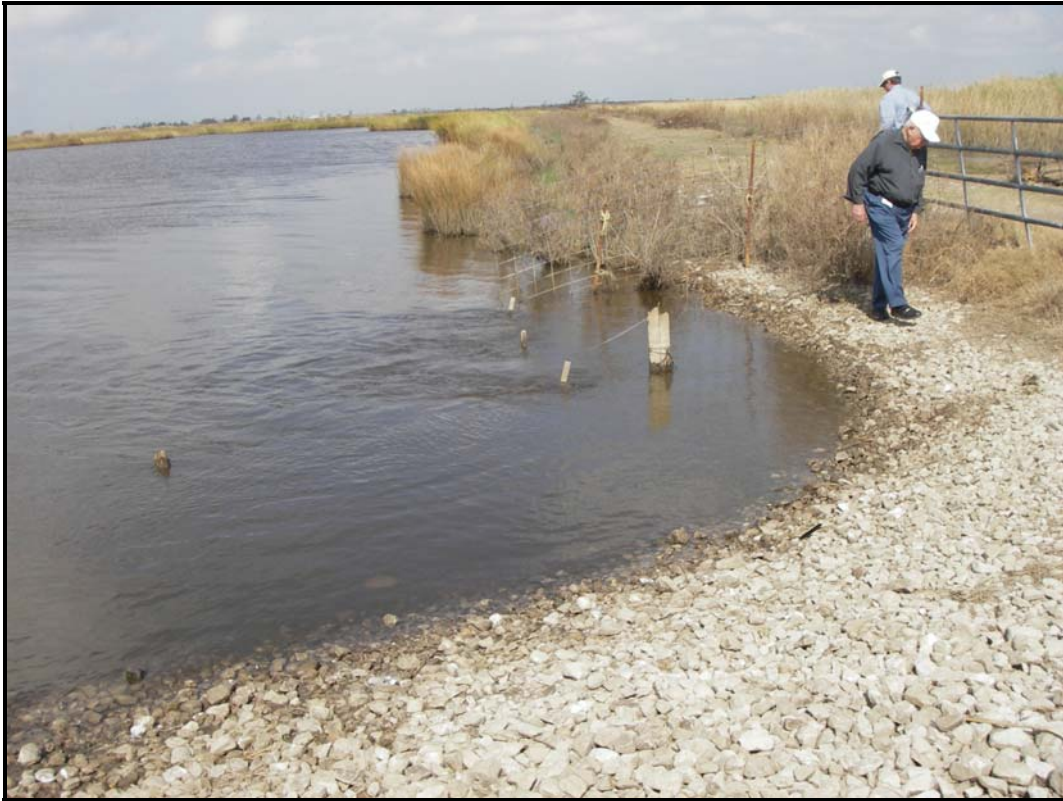
Photo No.3, Structure No.1, outlet side.

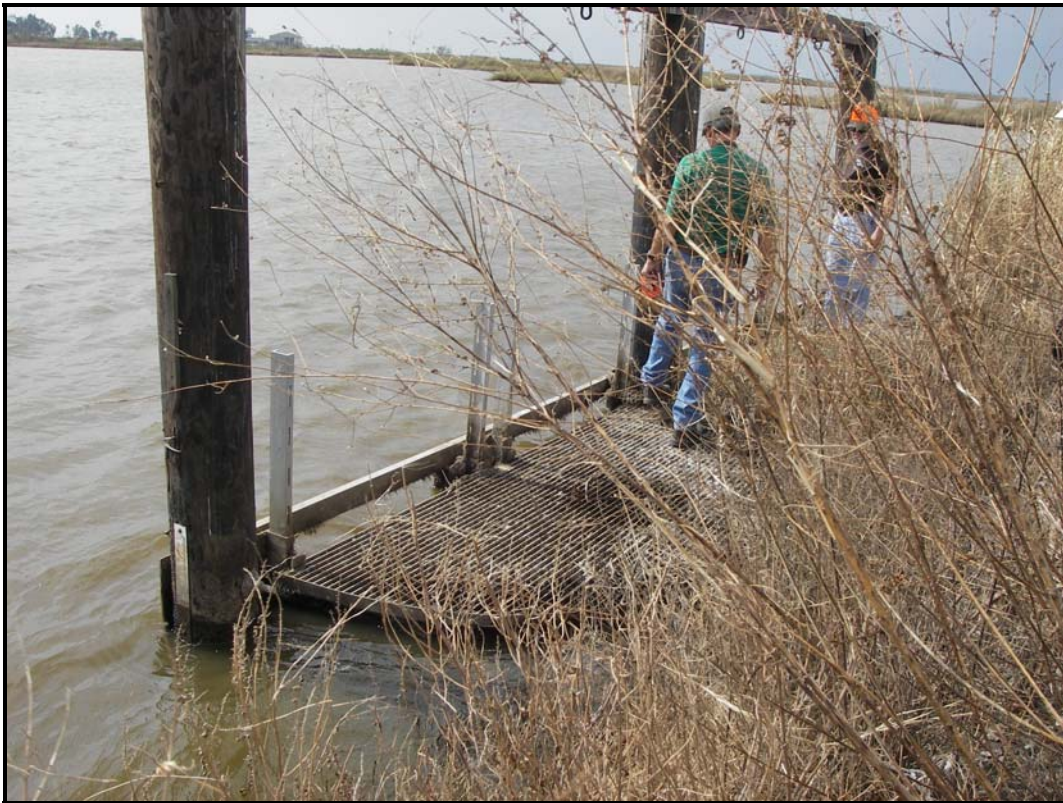
The structure is in good shape and the inlet and outlet sides appear undamaged from the storm. Water level on the outside was elevation +1.6 NAVD88 and the level inside could not be determined because the staff gage was not readable. Pile caps on the outlet side and the padlocks on the stop log locking devices have rusted and will eventually need to be replaced. Rock that was placed during the maintenance of Nov. 2000 is stable. A bird excluder device should be installed on solar panel and operation sonde replaced. The road/levee leading up to the structure is in good condition since it was repaired in June 2006. (Photos: Appendix B, Photos 4-5).

Photo No. 4, Structure No. 12, inlet side.

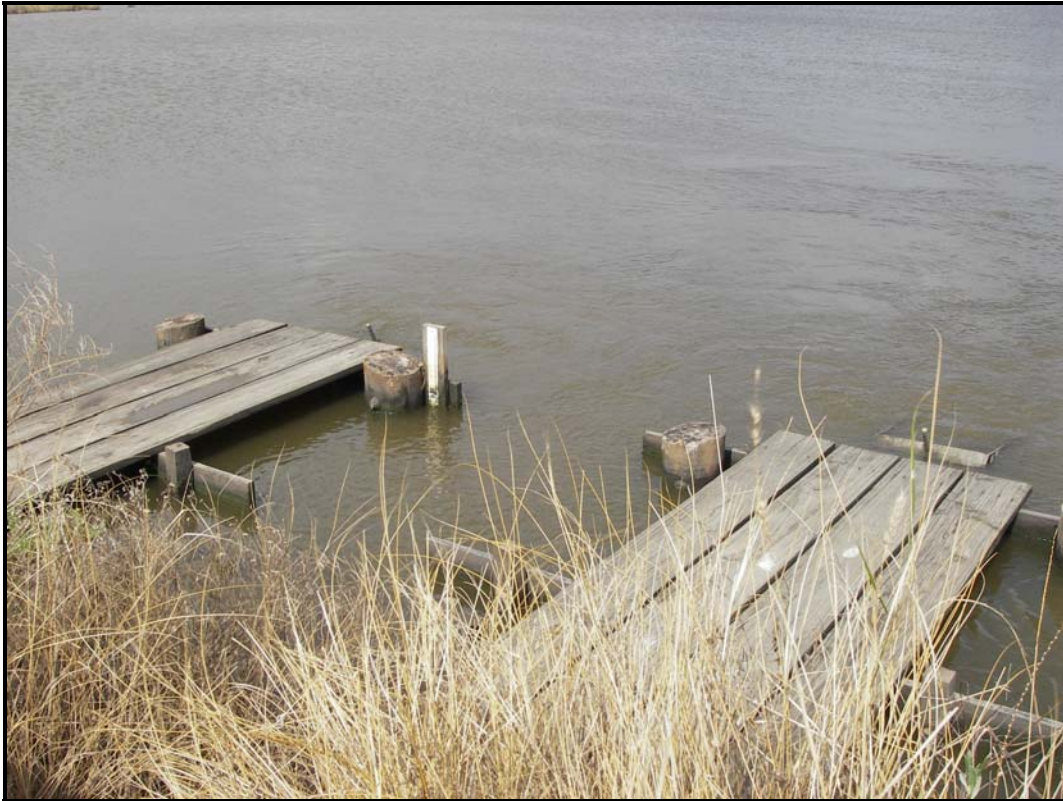
Photo No. 5, Structure No. 12, outlet side.

Item	Condition	Physical Damage	Corrosion	Photo #	Observations and Remarks
Steel Bulkhead / Caps	N/A				
Steel Grating	Good			4	
Stop Logs	Good				Replace padlocks.
Hardware/Flapgates	Good				
Timber Piles	Good				
Timber Wales	N/A				
Galv. Pile Caps	Good			5	Pile caps on outlet structure are corroded and will eventually need to be replaced.
Cables	N/A				
Signage /Supports	N/A				
Staff Gages	Fair				Staff gage on inlet side not readable.
Rip Rap (fill)	Good				
WQ Troll 9500 - 15r	Good				
Earthen Embankment					
Access Roadway	Good

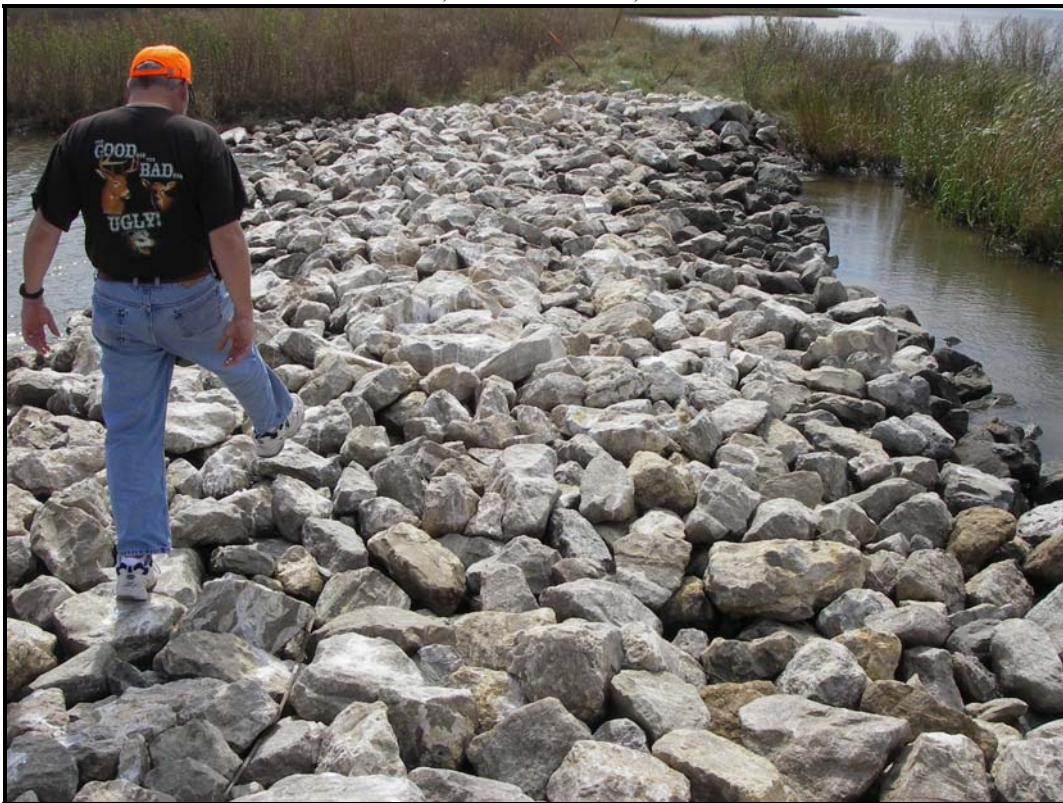
The rock plug is in good condition and appears undamaged from the storm surge. Water levels could not be determined because the outside staff gage is missing and the inside staff gage was leaning and not readable. Both staff gages will need to be replaced. The recently completed maintenance work in May 2005 to repair the plug from vandalism held up well under the high storm surge waters. The interior area of the rock plug is showing signs of new vegetative growth in locations that were previously open water. (Photos: Appendix B, Photo 6).

Photo No. 6, Structure No. 8, rock plug showing accretion occurring on lake side.
