2008 Annual Inspection Report

LAKE CHAPEAU SEDIMENT INPUT AND HYDROLOGIC RESTORATION PROJECT (TE-26)

State Project Number TE-26
Priority Project List 3

May 16, 2008
Terrebonne Parish

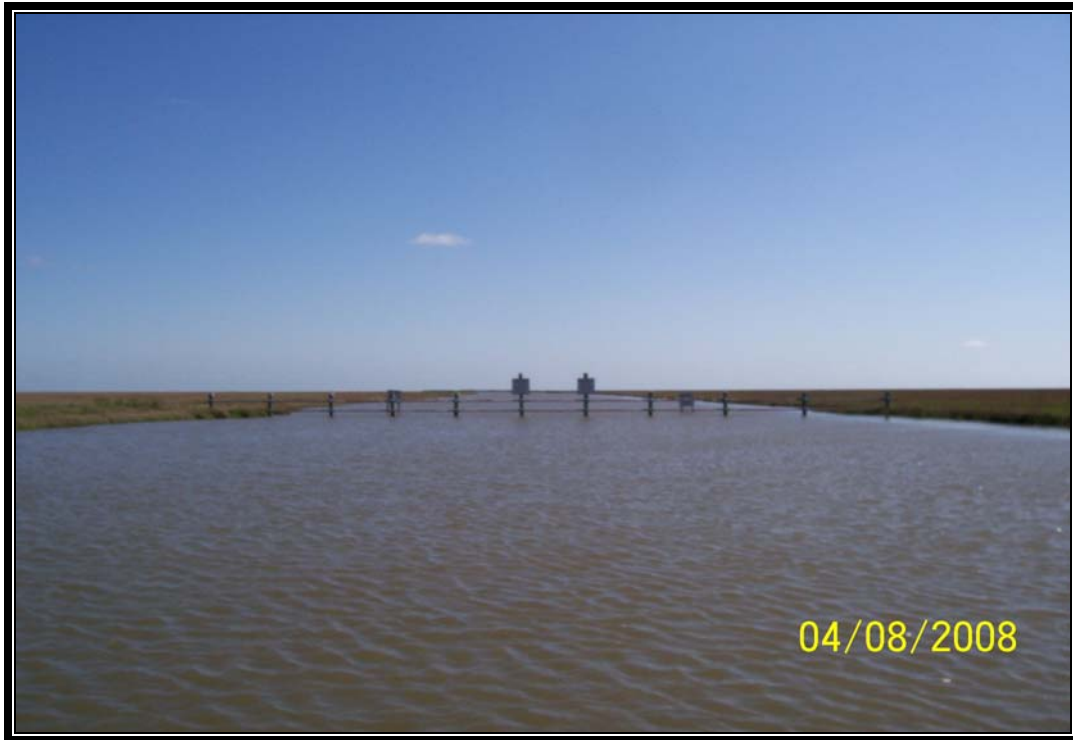
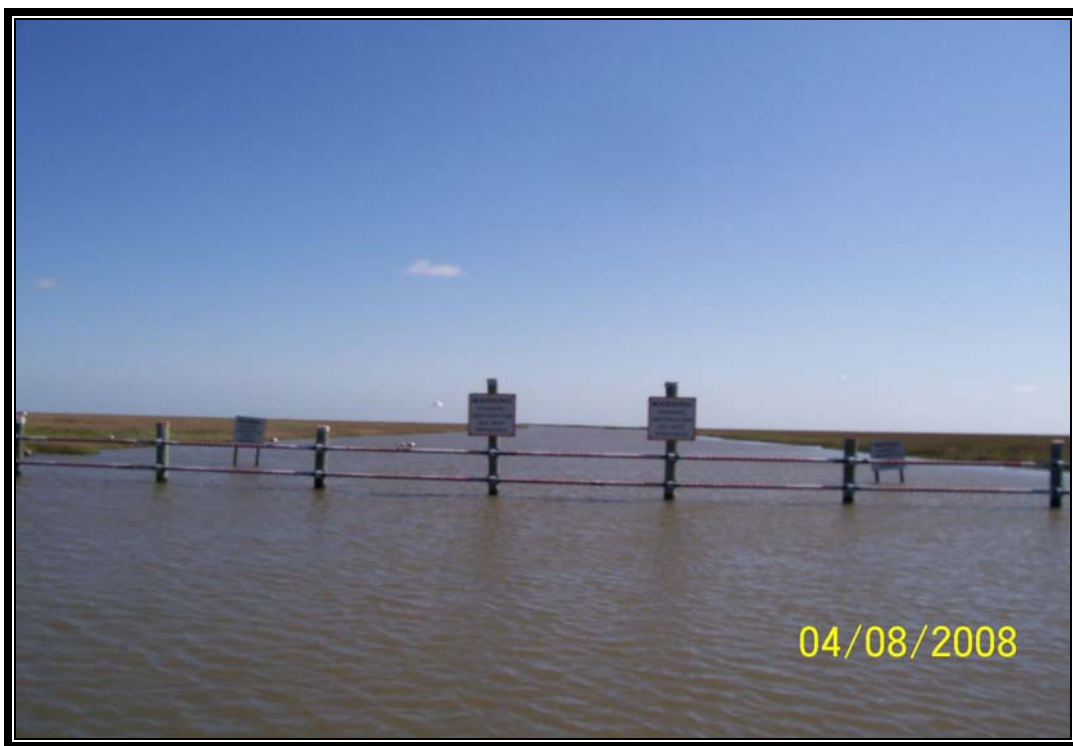
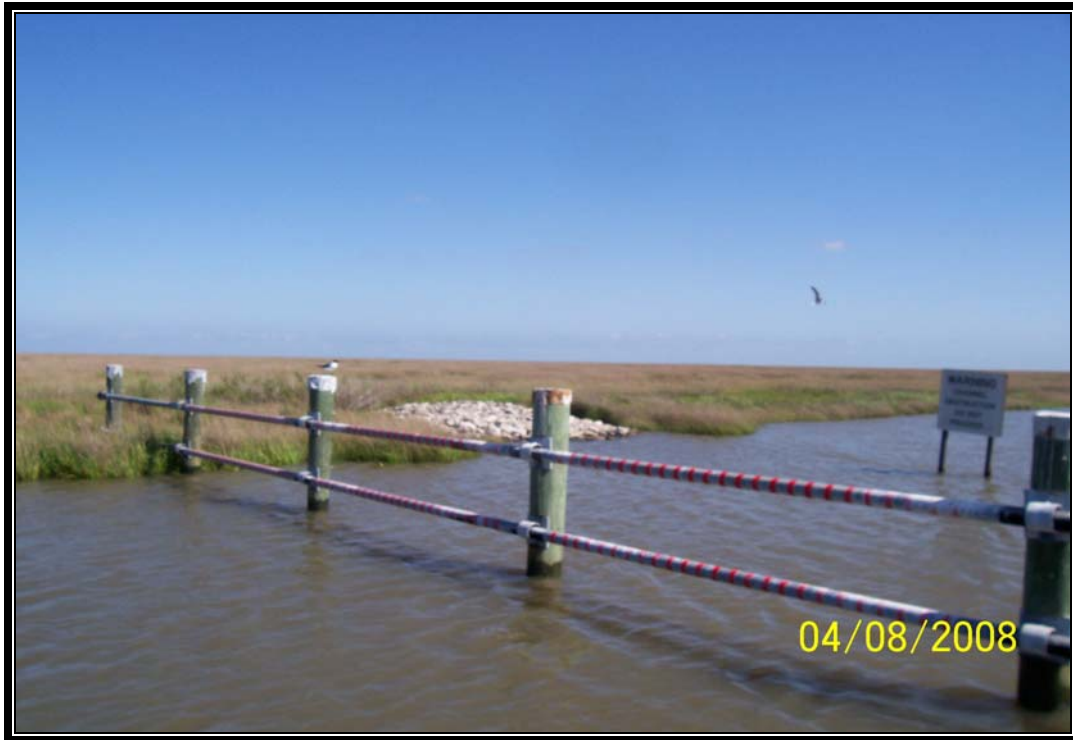
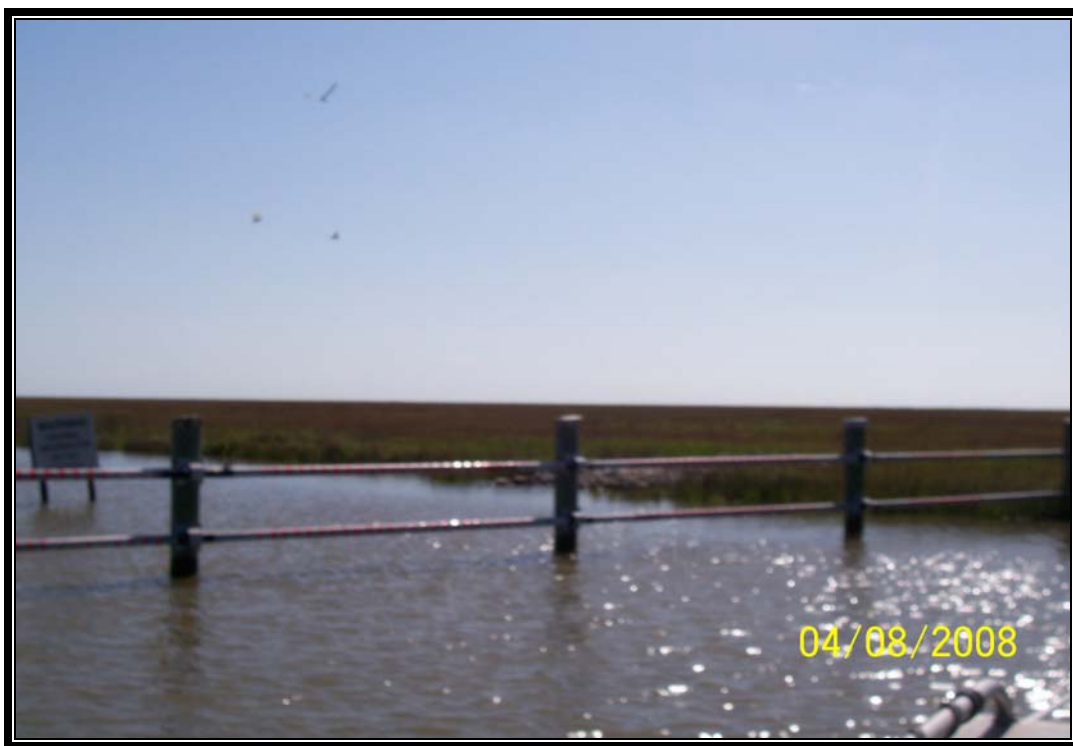
Overall, the rock weir appeared to be in good condition with no apparent erosion or breaching around the ends of the weir. The timber barricade system and warning signs were also in good condition with no visual signs of damage or corrosion. With the timber barricade system extending across the channel, we were unable to access the rock weir to measure water depths above the crest. However, from previous survey data collected in 2004 by Acadian Engineers, we estimated that the rock weir has settled approximately 1.39' from its original designed crest elevation. There are no indications that further settlement has occurred from the 2004 estimates. The water level at the time of the inspection, based on gauge readings at station TE26-03, was 1.45' NAVD (Appendix B, Photos 1 through 4).

Photo No. 1 - view of (Structure 1) on the interior of Lake Chapeau looking northeast.

Photo No. 2 – view of timber barricade system and rock weir (Structure 1) looking northeast.

Photo No.3 – view of rock weir blanket on the west marsh bank and timber barricade system (Structure 1).

Photo No. 4 – view of rock weir blanket on the east marsh bank and timber barricade system (Structure 1).

Item	Condition	Physical Damage	Corrosion	Photo #	Observations and Remarks
Rock Rip-Rap	Good	Some settlement		1 thru 4	Observation: Structure was in good condition with suspected settlement of the rock weir
Signage/Supports	Good				Timber Barracade system and signage was in good condition.
Warning Capsule Buoys	Removed in 2004				Remarks: From the survey profile performed in 2004 by Acadian Engineers, it is estimated that the rock weir had settled an average of 1.4ft since construction. The comparison was made between the 2004 survey data and the design elevations. No as-built elevations were collected.
Earthen Embankment	Good				
Timber Barracade System	Good		None		The existing water gage located near the site (TE-26-03) indicated that the water elevation at the time of the inspection was at 1.45' NAVD at approximately 9:30 a.m.

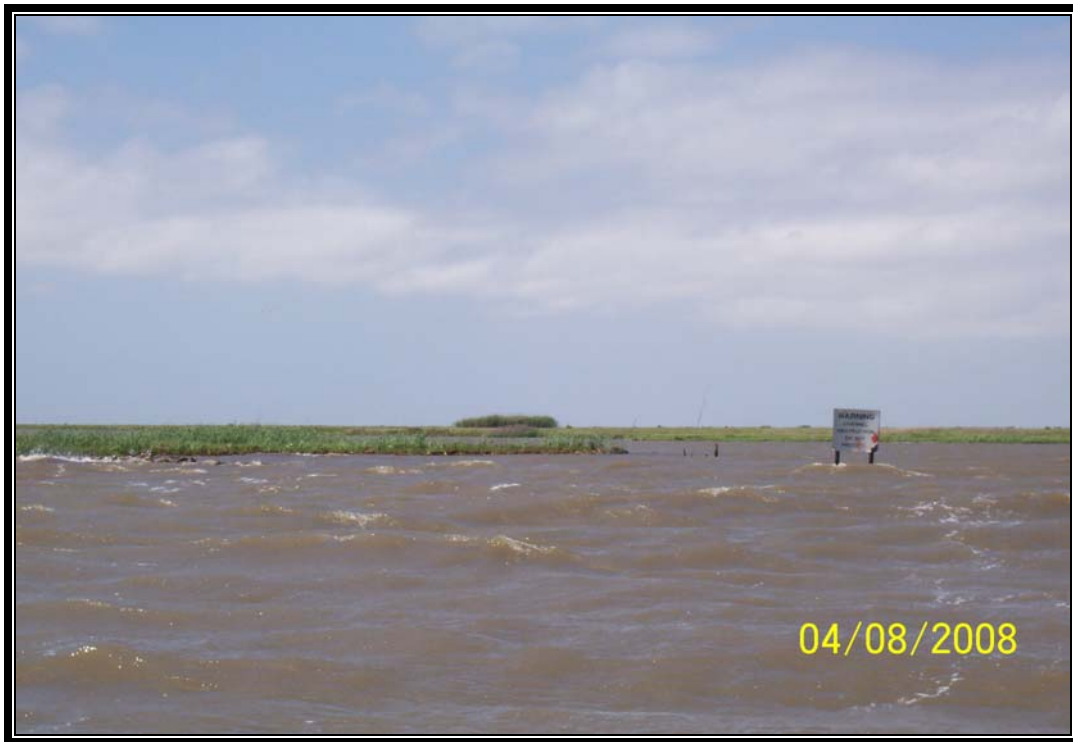
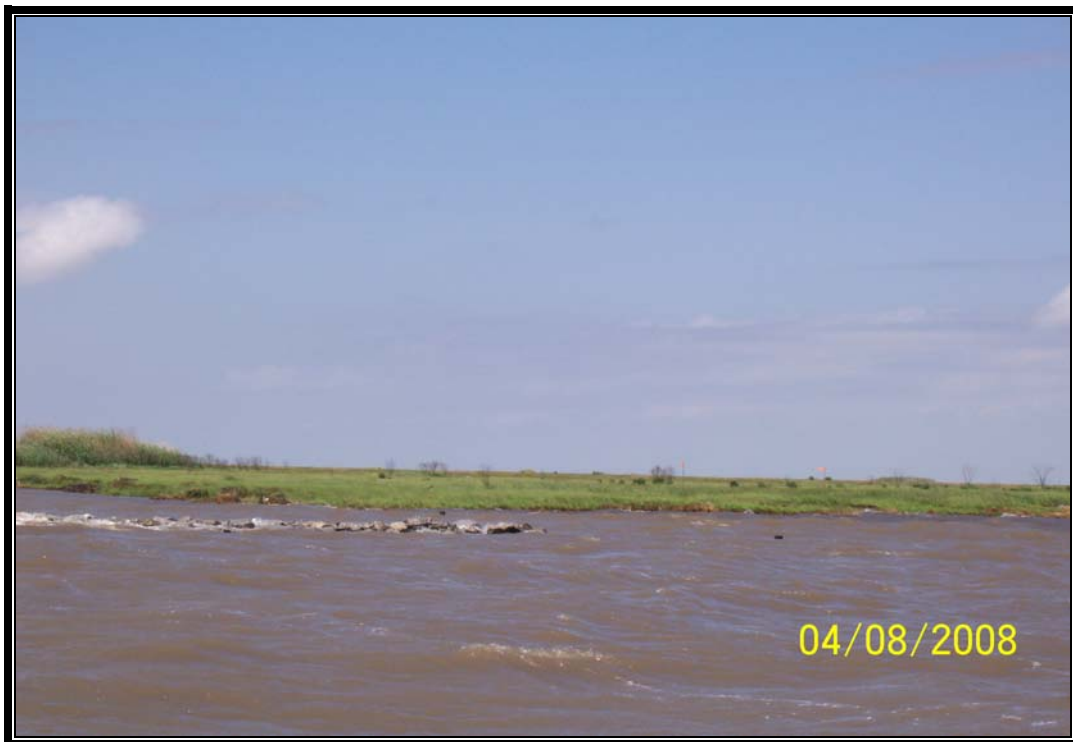
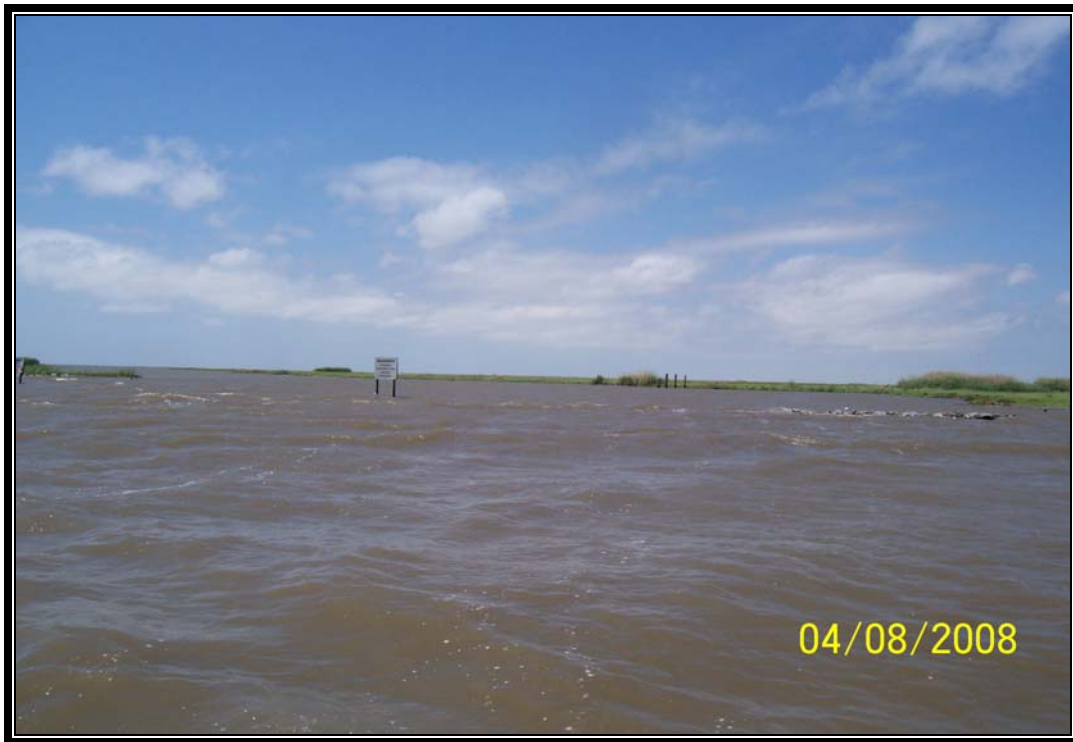
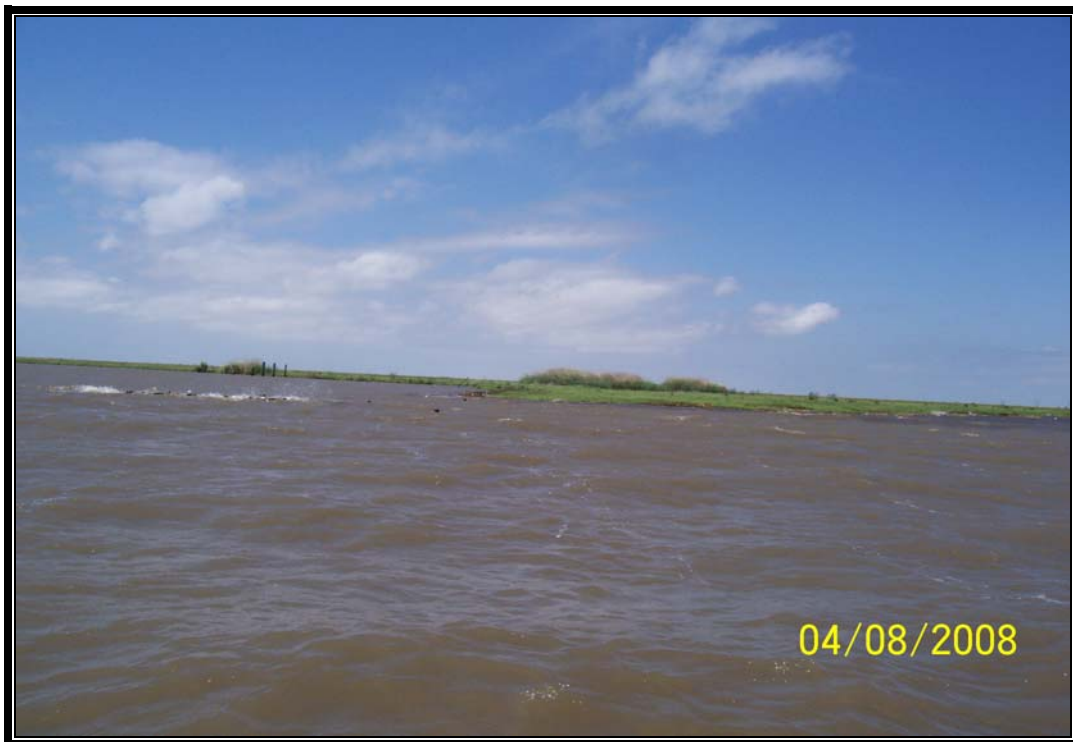
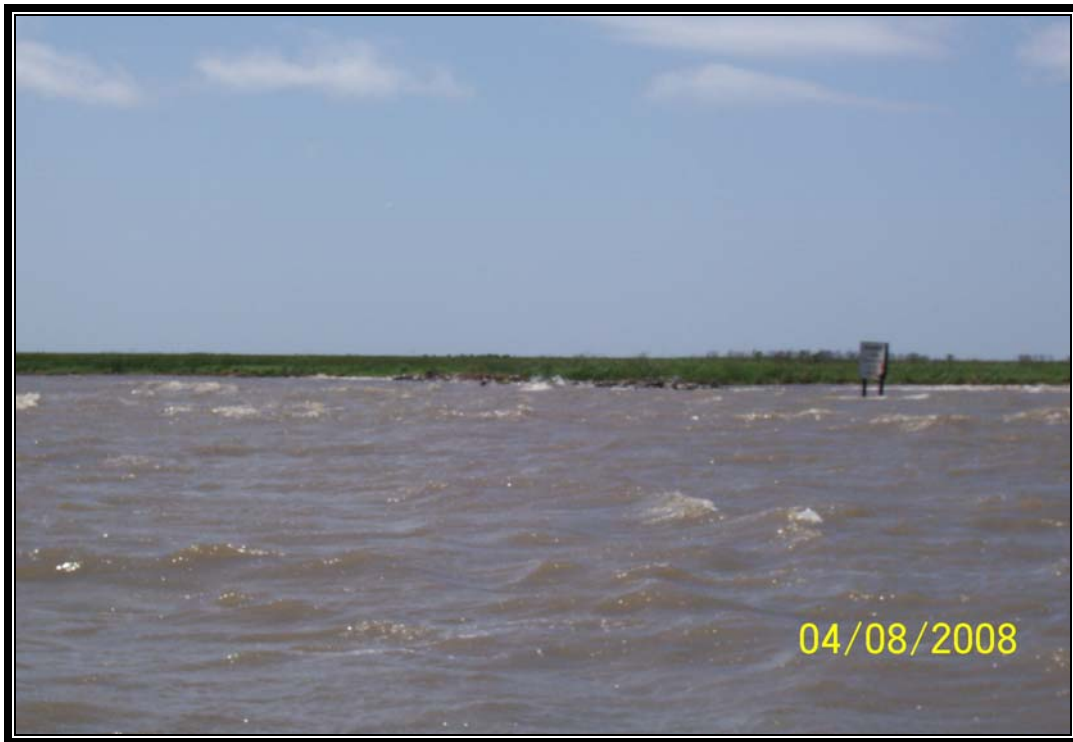
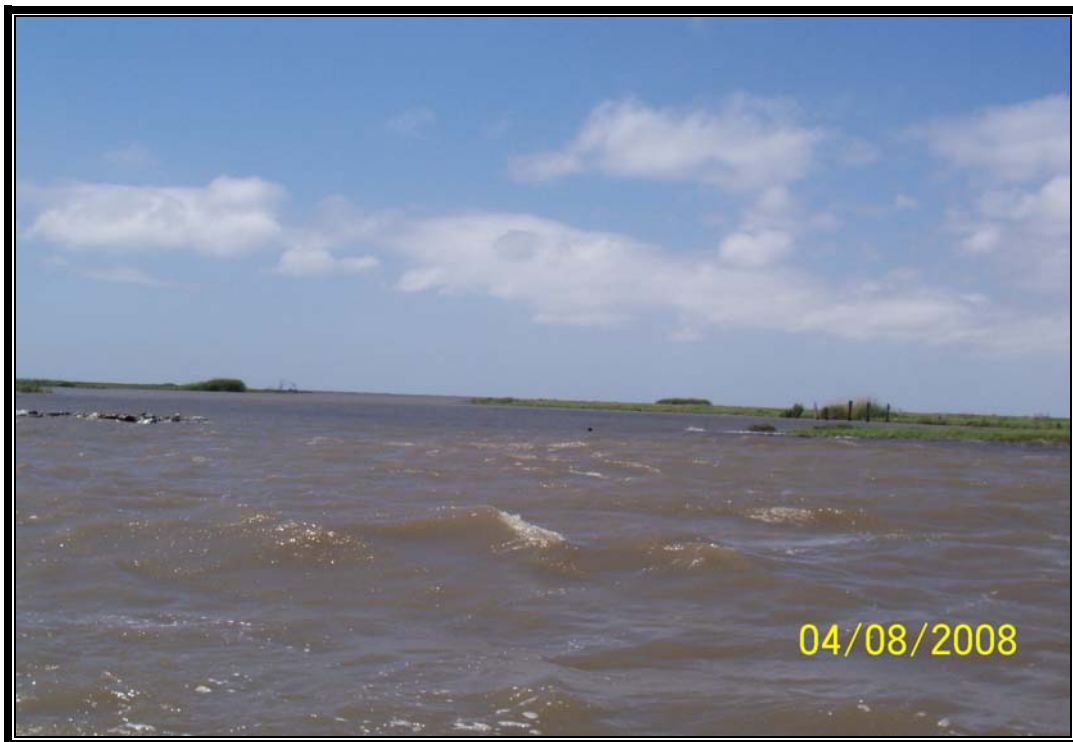
The north side of rock weir was found to be in poor condition with a large breach from the end of the weir on the north side to the existing marsh. It is estimated that the breach is approximately 50 to 60 ft. wide. The marsh on the south side of the structure has experienced significant erosion but remains in fair condition. The installation of a rock rip rap closure and articulated mats in 2003 has provided adequate protection of the marsh shoreline on the south side. A large portion of the weir crest was below the waterline at the time of the inspection due to high tides. The 2004 survey data indicates that the rock weir has settled approximately 1.0' from the design elevation since construction (Appendix B, Photos 5 through 10).

Photo No. 5 – view of southern end of rock weir and marsh tie-in (Structure 3).

Photo No. 6 – view of northern end of rock weir adjacent to existing marsh breach (Structure 3)

Photo No.7 – view of rock weir and boat bay left of existing signage (Structure 3)

Photo No. 8 – view of marsh breach on the north side of the rock weir at Structure 3.

Photo No. 9 – view of rock weir and articulated mats on the south side of Structure 3.

Photo No. 10 – view of marsh breach located on the northern end of the rock weir (Structure 3).

Item	Condition	Physical Damage	Corrosion	Photo #	Observations and Remarks
Rock Rip-Rap	Good			5 thru 10	Observations: The structure at site no.3 appears to be in poor condition. A large breach has developed on the north side of the rock weir. The breach appears to be approximately 50 to 60 feet wide and 6 to 7 ft. deep. LDNR has contracted Shaw Coastal to engineer and design the breach repair. Design surveys are completed with plans and specifications to be submitted in mid May 2008.
Signage/Supports	Good				The repair shall included closing the breach using rock rip rap and a rock revetment structure extending approximately 200' north of the breach to a more stable marsh
Timber Barracade System	not installed at this location				All signs and supports are in good condition.
Earthen Embankment	Poor	Breach on north side of structure			Remarks: From the June 2004 survey of this structure, it was determined that the rock weir had settled approximately 1.0' since construction. A comparison between the 2004 surveys and design elevations were made to determine settlement.

On April 15, 2008, through a faxed vote, OCPR and NMFS received additional maintenance funding from the CWPPRA Task Force in the amount of \$326,764 for repairs to north side of Structure 3 of the Lake Chapeau Hydrologic Restoration Project. Additional authorizations for permitting were obtained by NMFS (Appendix E – Project Permits). LDNR has contracted Shaw Coastal, Inc. of Houma, in the amount of \$25,922, to perform design surveys and prepare plans and specifications for the breach closure project. The breach repair shall include an extension of the existing rock weir using rock riprap and the armorment of an additional

200 linear feet of shoreline northward of the weir to stabilize the existing shoreline. The maintenance project will likely go to bids by the end of June 2008, with construction beginning in August 2008. **Due to the additional damage to the marsh on the north side of Structure 3 resulting from Hurricanes Gustav and Ike (September 2008), the proposed breach closure and repairs were canceled.**

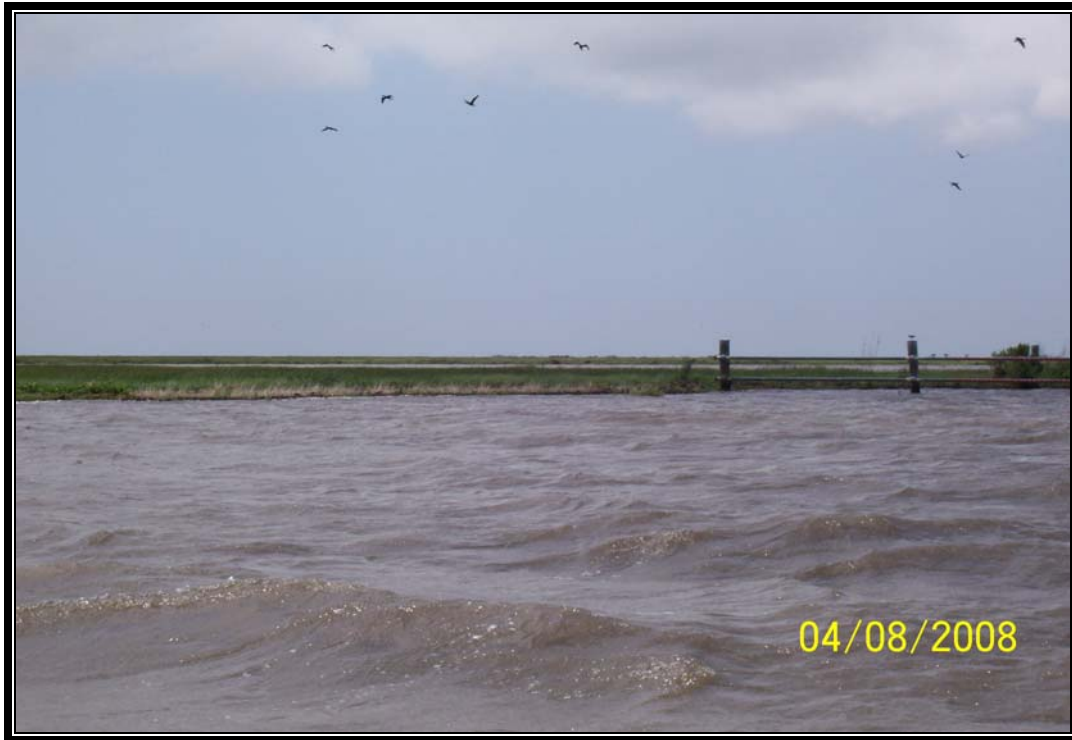
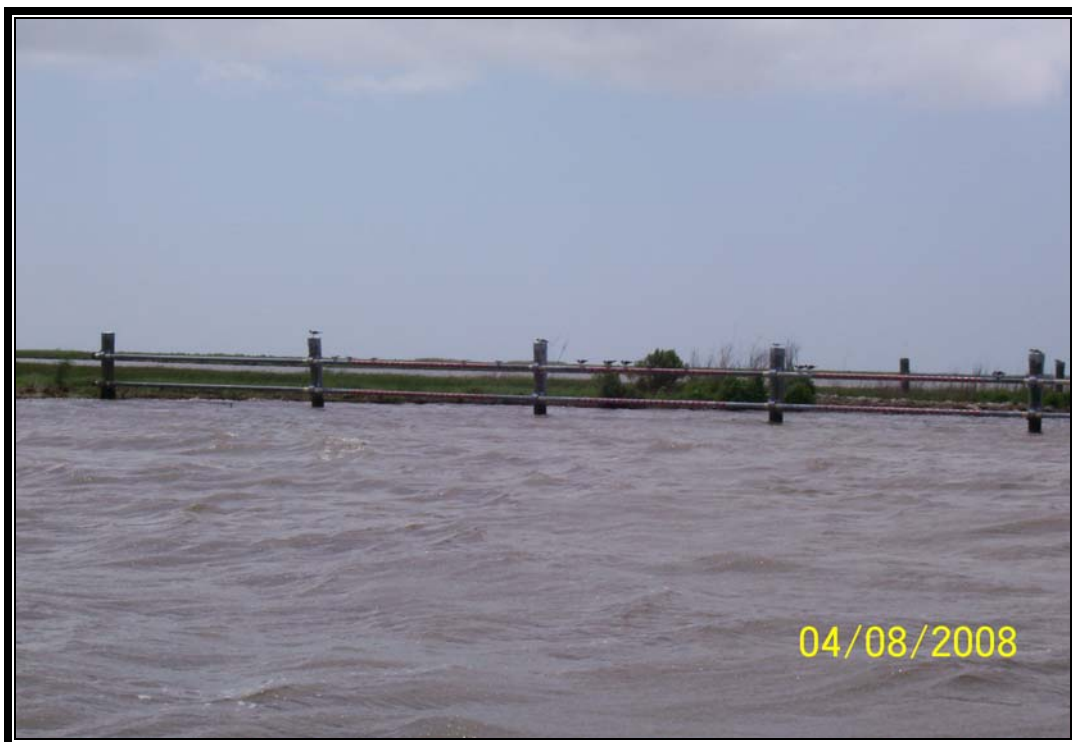
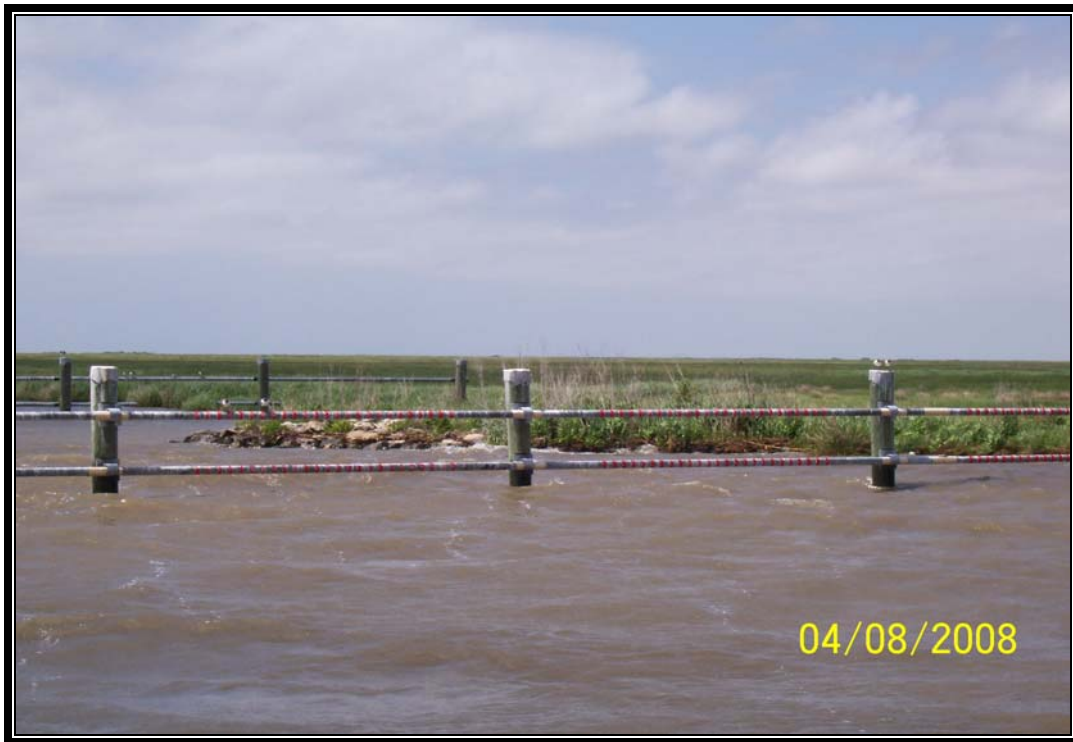
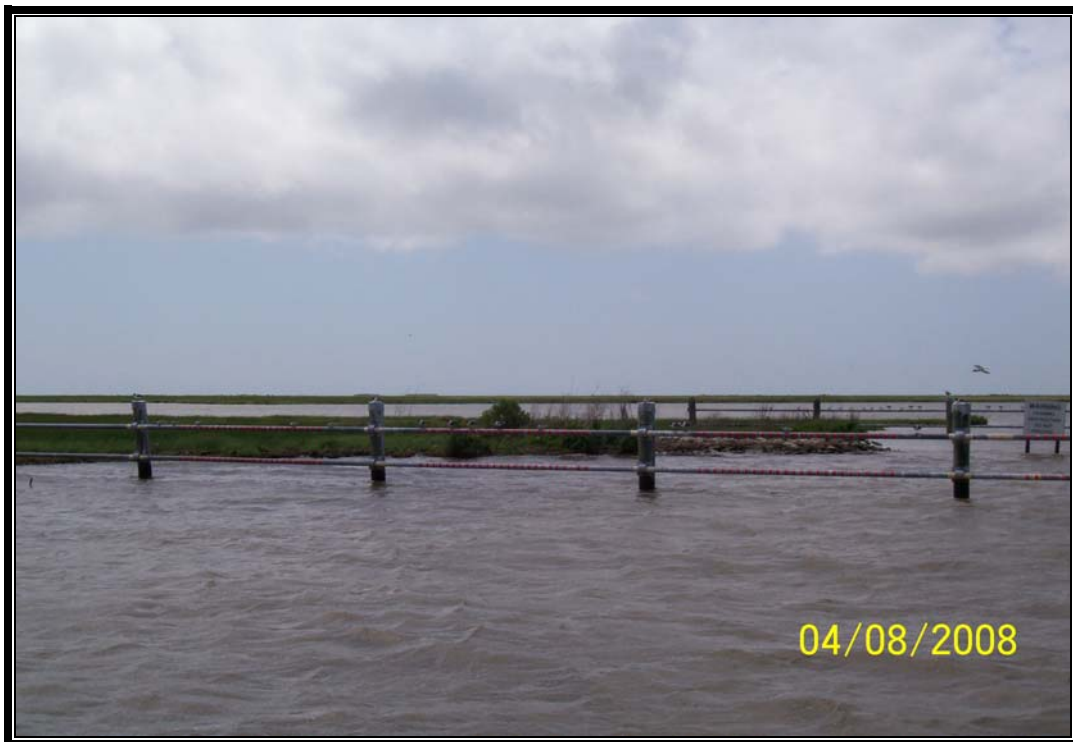
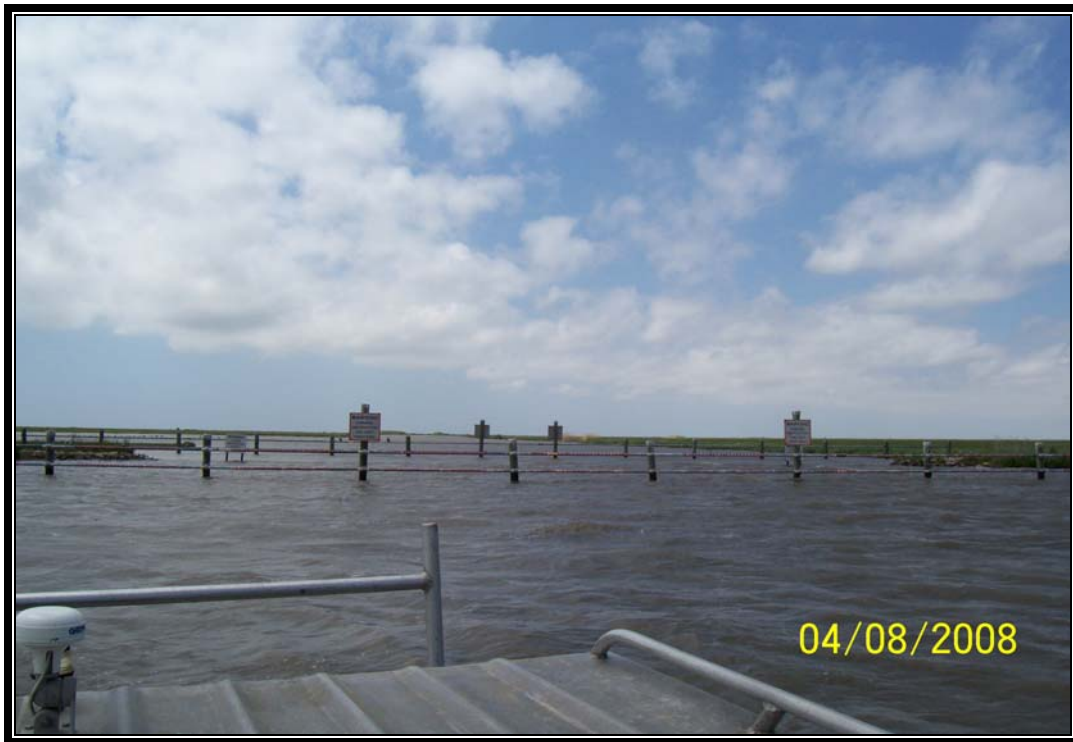
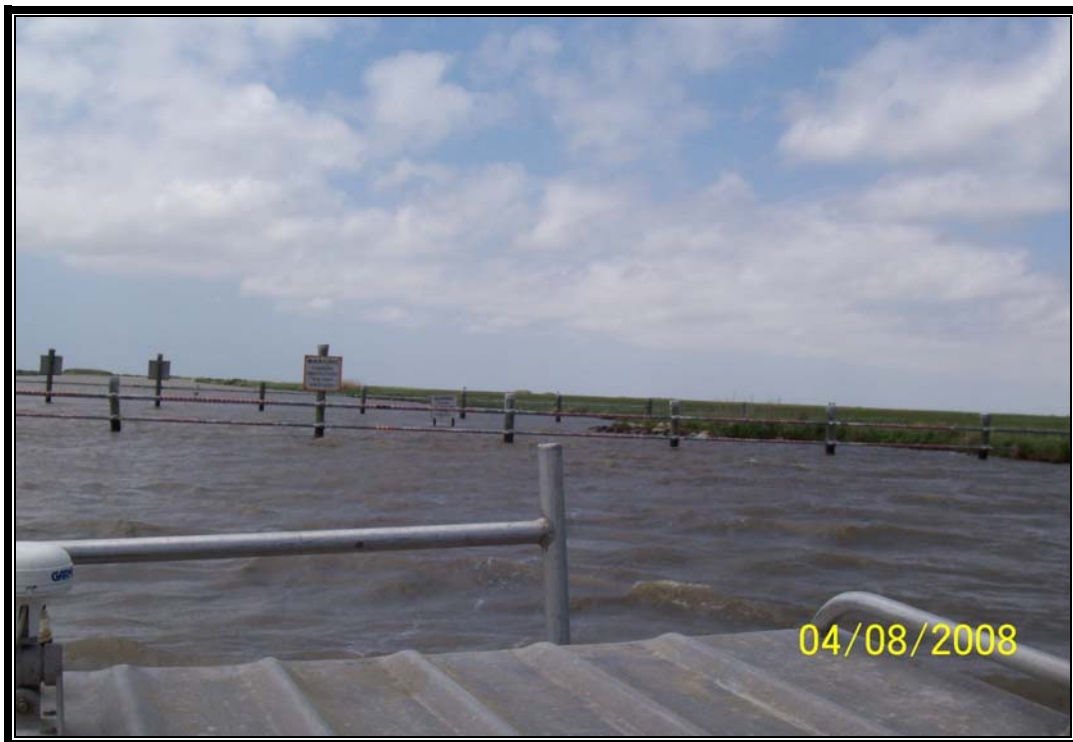
The rock weir appeared to be in good condition with no breaching around the ends. Although there was no breaching, we did observe that the existing marsh strip, tying the structure to land, was very thin and narrow. Situated between Four League Bay and a large open body of water, there is a potential for breaching to develop should erosion continue on the south side of the structure. The timber barricade system and signage appeared to be in good condition. As reported in previous inspections, the two (2) center pilings, with signs attached to them, were found to be slightly unstable. A combination of the inadequate embedment depths and poor soil conditions could have caused the slight instability in these two (2) piling. With the lateral support provided by the two (2) horizontal steel pipe members, we do not believe that minor instability in the center piles is a cause for concern. The rock plug itself appeared to be in good condition. As determined from survey data collected in 2004 by Acadian Engineers, Inc., the average settlement along the length of the structure was approximately 1.1'. (Appendix B, Photos 11 through 16).

Another area of concern is the marsh tie-in on the south side of Structure 4. Although there was no breaching in this area, we did observe that the existing marsh strip, tying the structure to land, was very thin and narrow. Based on the observed condition of the existing marsh and obvious erosion along the shoreline, we believe that there is a potential for breaching to develop should the shoreline continue to retreat westward. In an effort to prevent breaching, a rock riprap revetment structure can be erected along the shoreline, southward to a location where the marsh platform is higher and wider. Another alternative would be to initiate a small dredge project to pump sediment from Four League Bay to reconstruct the shoreline and marsh on the south side of the structure. Although this would be the most desirable solution, the enormous cost associated with hydraulic dredging projects makes this alternative economically unfeasible for a maintenance project. Although the potential for breaching exists, we are not recommending corrective actions at this time; however, we will continue to monitor the condition of the marsh in this area.

Photo No. 11 – view of rock weir to marsh tie-in and timber barricade system on the southern end of Structure 4.

Photo No. 12 - a view of the existing marsh to rock tie-in and barricade system on the southern end of Structure 4.

Photo No. 13 – view of rock weir to marsh tie-in on the north side of Structure 4.

Photo No. 14 – view of rock weir to marsh tie-in on the south side of Structure 4.

Photo No. 15 – an overall view of the rock weir and timber barricade system at Structure 4.

Photo 16 – view of the southern end of the rock weir and barricade system on the north side of Structure 4.

Item	Condition	Physical Damage	Corrosion	Photo #	Observations and Remarks
Rock Rip-Rap	Good			11 thru 16	Observations:
Signage/ Supports	Good				The rock plug, barricade system, warning signs and supports were all in good condition
Warning Capsule	Removed in 2004				The earthen embankments were in fair condition. Most notable, the existing marsh on the south side of the structure where the rock weir terminates appears to be low and very thin. With a large area of open water on the interior and Four League Bay on the exterior, further erosion of this area will likely result in breaching of the rock rock weir on the south side of the structure.
Eathen Embankment	Fair				Remarks:
Timber Barrade System	Good				As noted in previous inspections, The two timber piling supporting the barricade system and signage in the center of the channel were found to be a little unstable. This is due to the piling being located in an existing channel where the embedment of the piling is not as deep. At this time, we did not notice any change from previous inspections. DNR will continue to monitor the stability of the center piling.

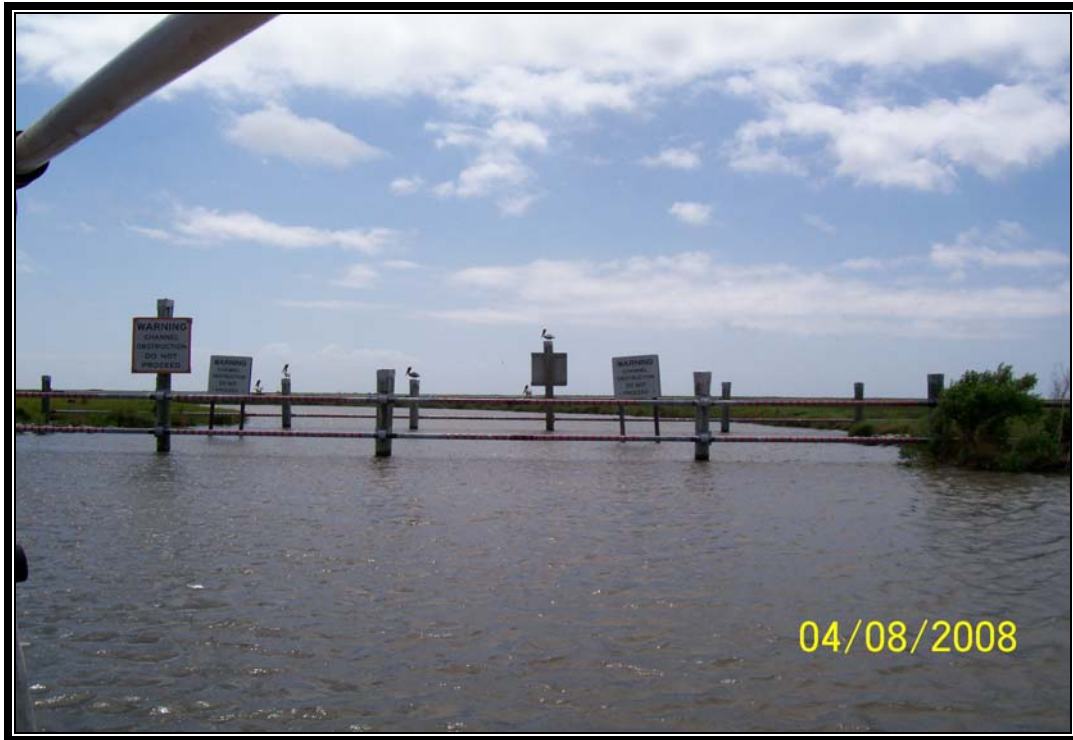
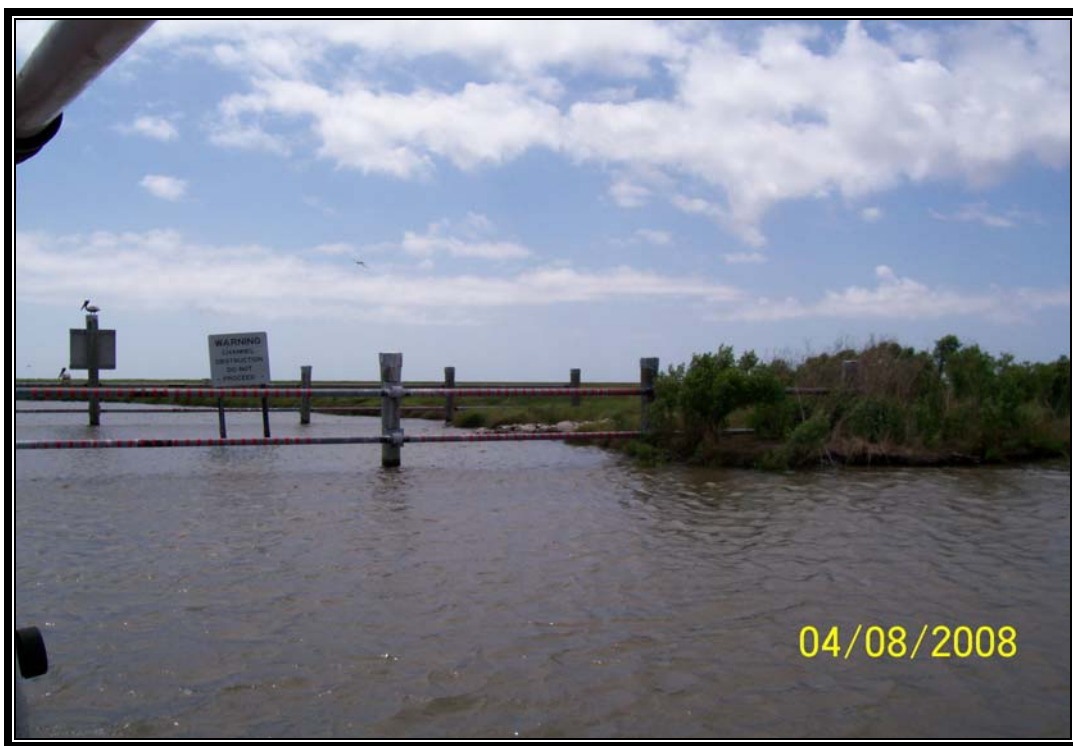
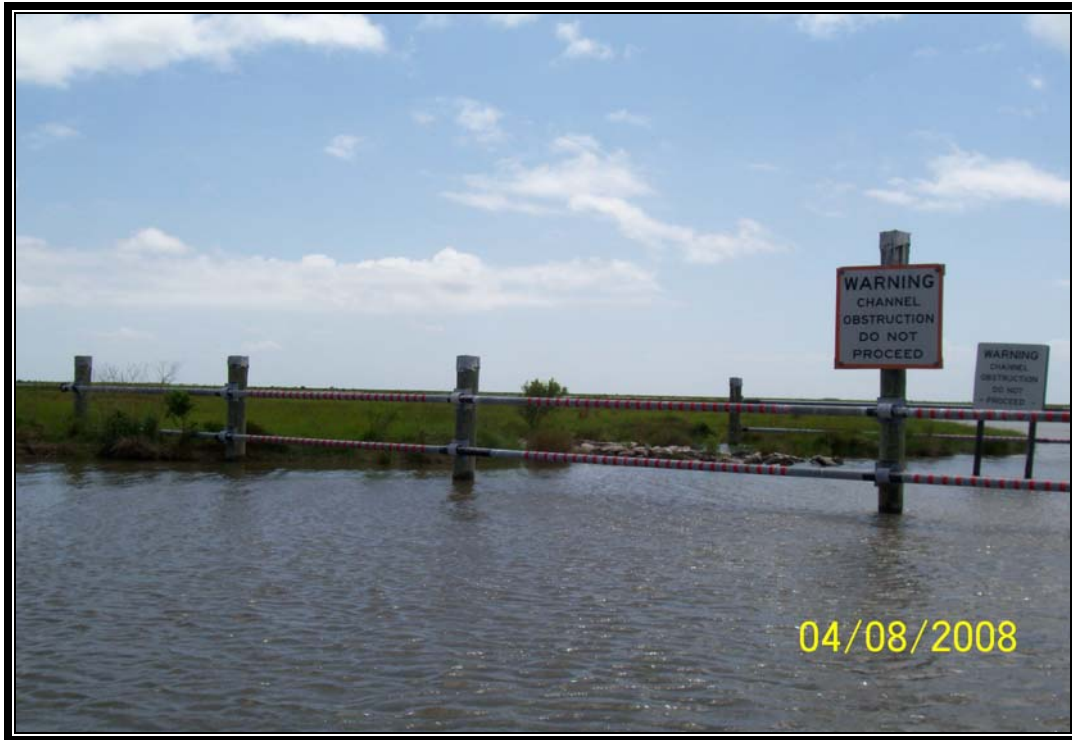
The rock plug, tie-ins, earthen embankments, barricade system, warning signs and supports appeared to be in good condition with no visual signs of marsh erosion adjacent to the structure or damage to the barricade system. Based on the 2004 survey profile, it was determined that the rock weir had settled an average of 0.14' from the designed elevation. (Appendix B, Photos 17 through 19)

Photo No. 17 – an overall view of the rock weir and barricade system (Structure 5).

Photo No. 18 – view of the southwest side of the rock weir and barricade system (Structure 5).

Photo No. 19 – view of the northeast side of the rock weir and barricade system (Structure 5).

Item	Condition	Physical Damage	Corrosion	Photo #	Observations and Remarks
Rock Rip-Rap	Good	Some settlement		17 thru 19	Observation:
Signage/ Supports	Good				The rock weir, earthen tie-ins, embankments, barricade system, warning signs and supports all appeared to be in good condition. Due to Structure 5's location, interior island, erosion of the existing marsh is not a problem.
Warning Capsule	Removed in 2004				Remarks:
Earthen Embankment	Good				As indicated from the 2004 maintenance survey, it was determined that the rock weir has settled an average of 0.14' from the original design elevation of -0.14 NAVD.
Timber Barricade System	Good				No as-built drawings were prepared for this project.

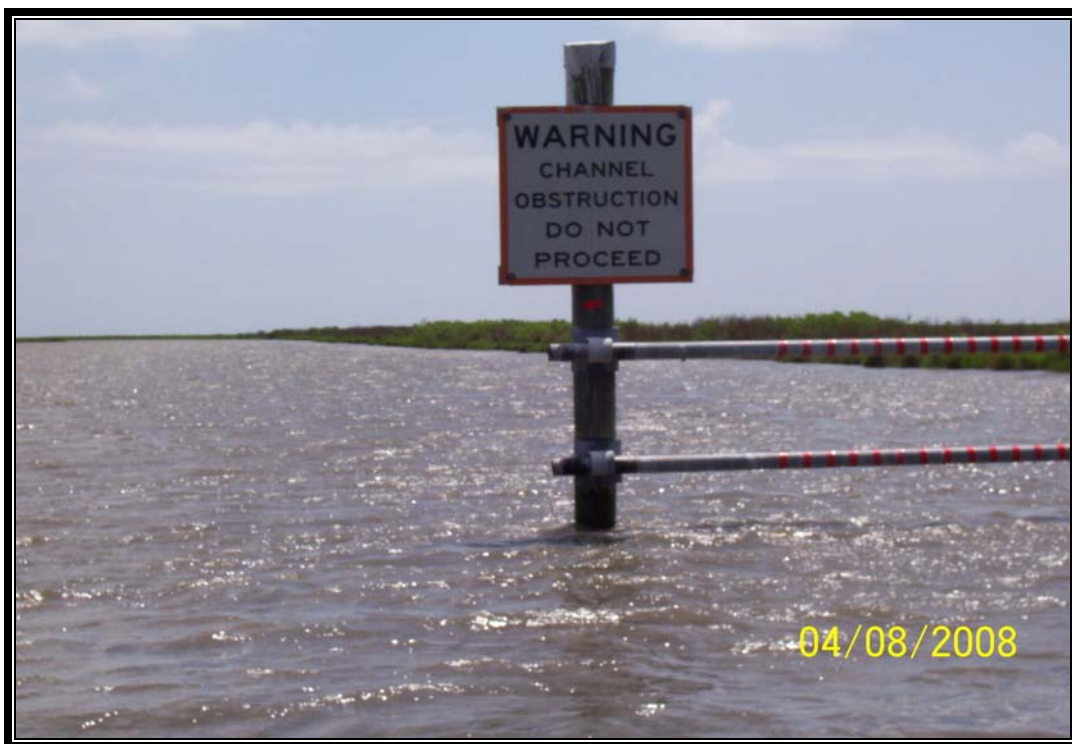
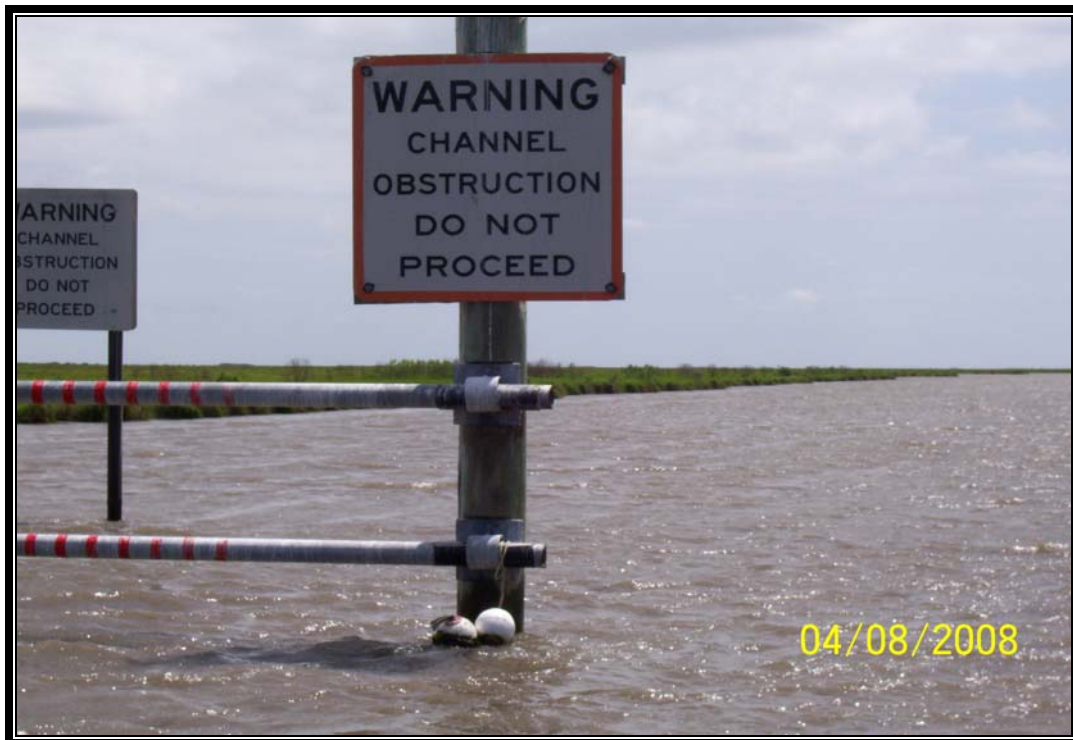
Upon arriving to the location of Structure 6, it was evident that the timber barricade system had been vandalized. A ten (10) foot section of the two (2) steel pipe cross members between the center piles had been cut with a torch and were missing. It was obvious that the steel pipe sections were removed to gain access across the weir to the open bodies of water east of the structure. It is our opinion that any attempt to repair the damage to the barricade system, preventing access across the weir, would be unsuccessful due to the strong will and determination of vandals' intent on traveling this channel. Therefore, we do not recommend repairs at this time. Other than the damage to the barricade system, the rock weir, earthen embankments, warning signs and supports were in very good condition. From the 2004 profile survey of the structure, it was determined that the rock weir had settled an average of approximately 1.1 ft. from the designed elevations. (Appendix B, Photos 20 through 24)

The most disturbing observation made during this inspection was the vandalism of the timber barricade system at Structure 6. A ten (10) foot section of the two (2) steel pipe cross members between the center piles had been cut with a torch and were missing. It was obvious that the steel pipe sections were removed to gain access across the weir to canals and open bodies of water east of the structure. Other than stationing uniform patrol officers on each side of the structure for the duration of the project life, we believe that any attempt to repair the damage to the barricade system would be unsuccessful in preventing vandalism in the future. Therefore, we are not recommending corrective actions at this time.

Photo No. 20 – view of the right center section of timber barricade system (Structure 6). The steel pipes were cut with torch.

Photo No. 21 – view of the left center section of timber barricade system (Structure 6). The steel pipes were cut with torch.
