2008 Annual Inspection Report

LAKE CHAPEAU SEDIMENT INPUT AND HYDROLOGIC RESTORATION PROJECT (TE-26)

State Project Number TE-26
Priority Project List 3

May 16, 2008
Terrebonne Parish

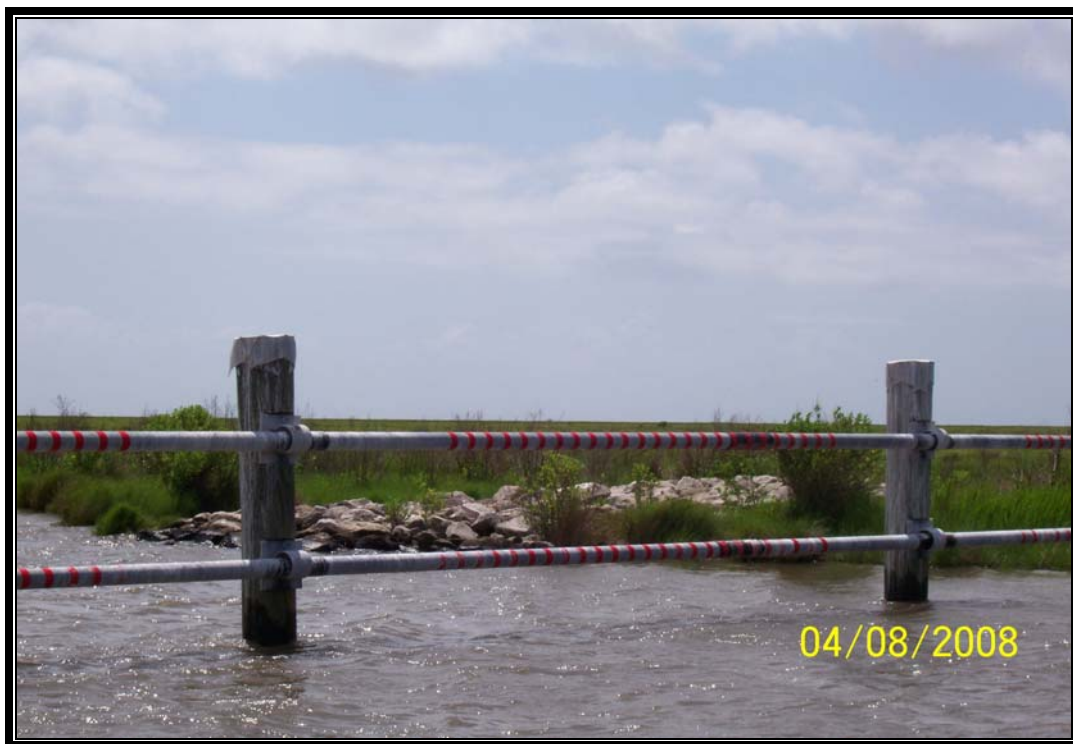
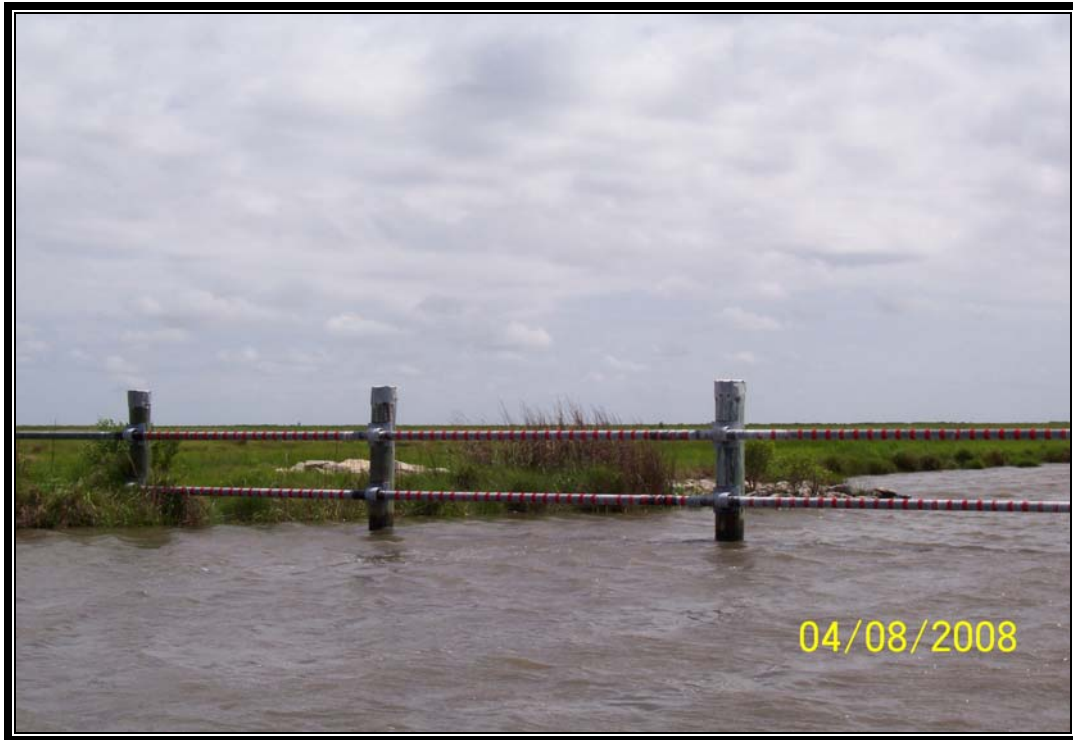
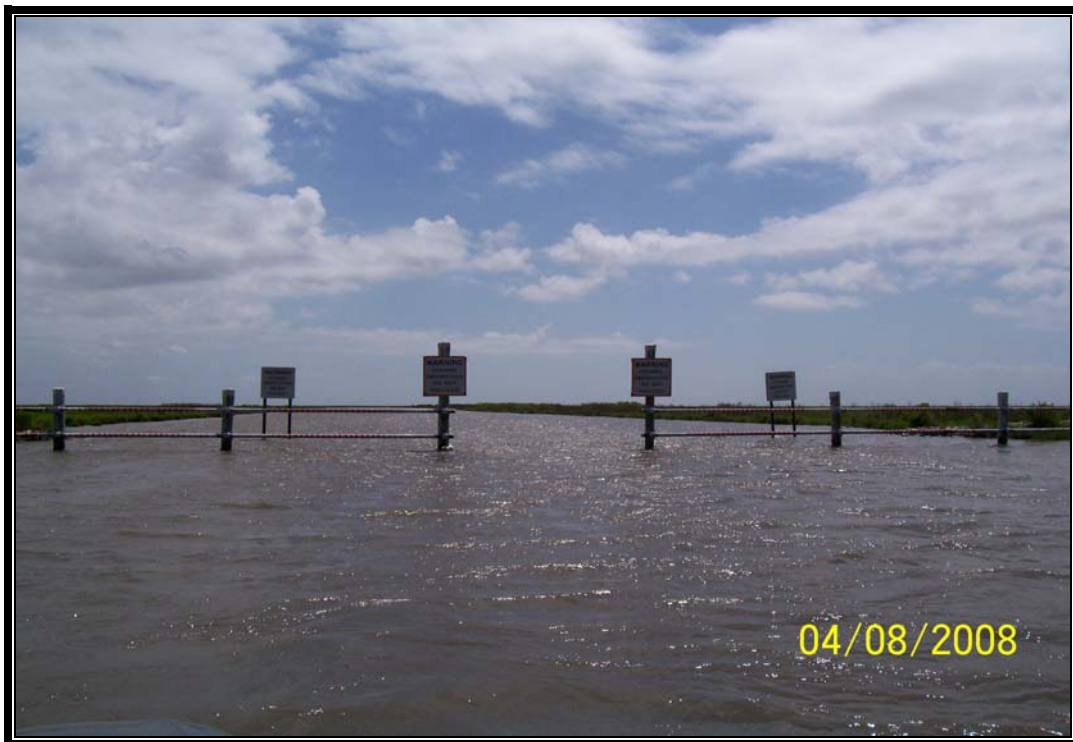
Upon arriving to the location of Structure 6, it was evident that the timber barricade system had been vandalized. A ten (10) foot section of the two (2) steel pipe cross members between the center piles had been cut with a torch and were missing. It was obvious that the steel pipe sections were removed to gain access across the weir to the open bodies of water east of the structure. It is our opinion that any attempt to repair the damage to the barricade system, preventing access across the weir, would be unsuccessful due to the strong will and determination of vandals' intent on traveling this channel. Therefore, we do not recommend repairs at this time. Other than the damage to the barricade system, the rock weir, earthen embankments, warning signs and supports were in very good condition. From the 2004 profile survey of the structure, it was determined that the rock weir had settled an average of approximately 1.1 ft. from the designed elevations. (Appendix B, Photos 20 through 24)

Photo No. 22 – view of the southern end of the rock weir and timber barricade system (Structure 6).

Photo No. 23 – view of the northern end of the rock weir and timber barricade system (Structure 6).

Photo No. 24 – overall view of the timber barricade system and rock weir (Structure 6).

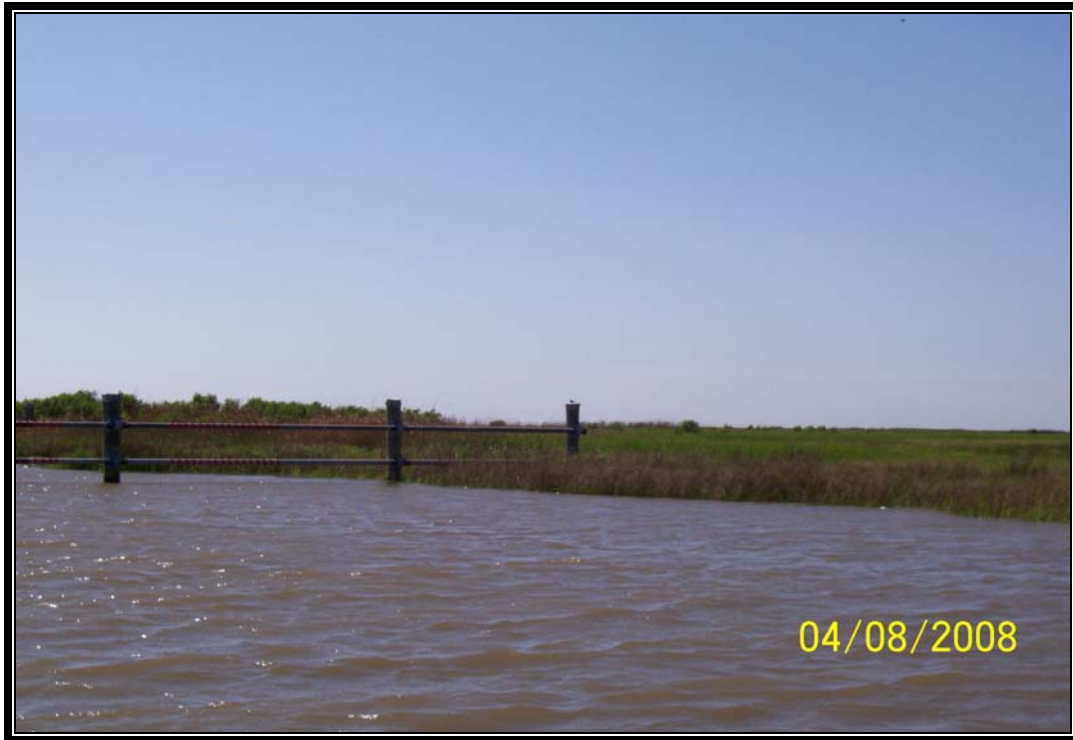
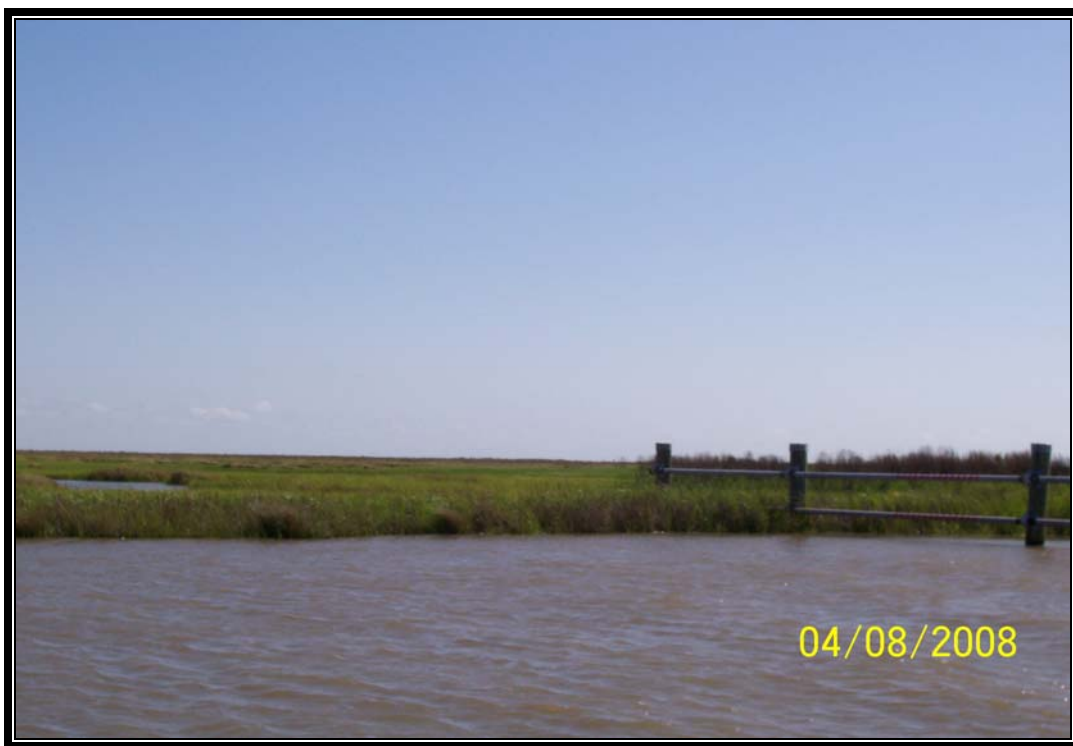
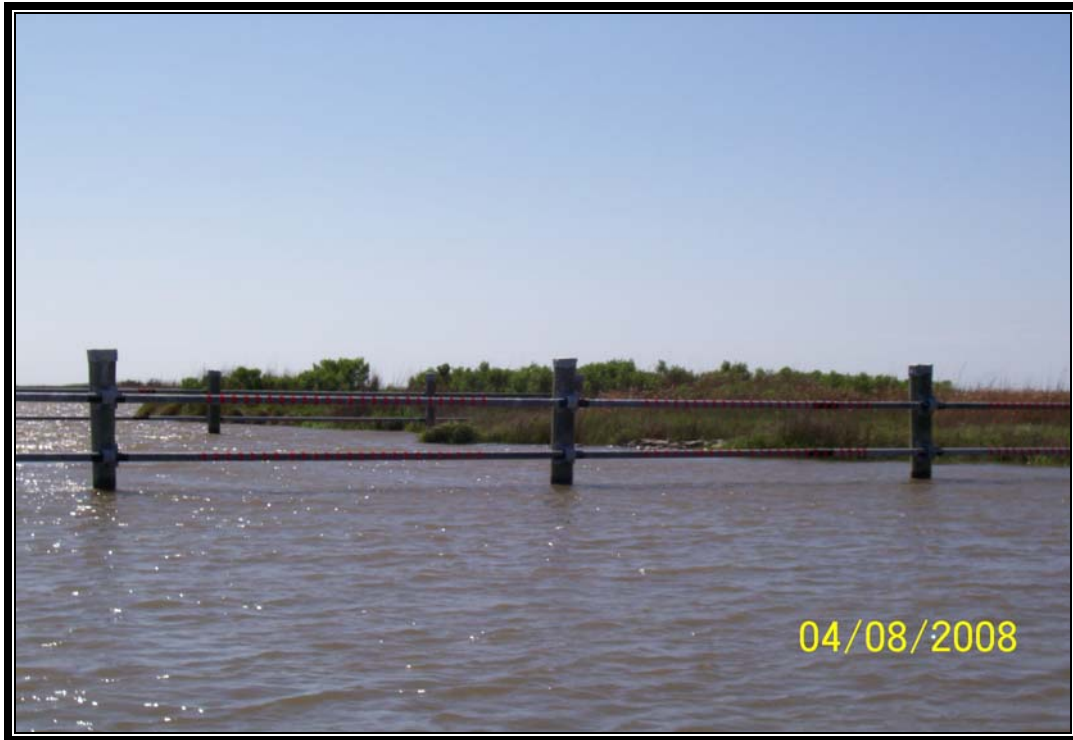
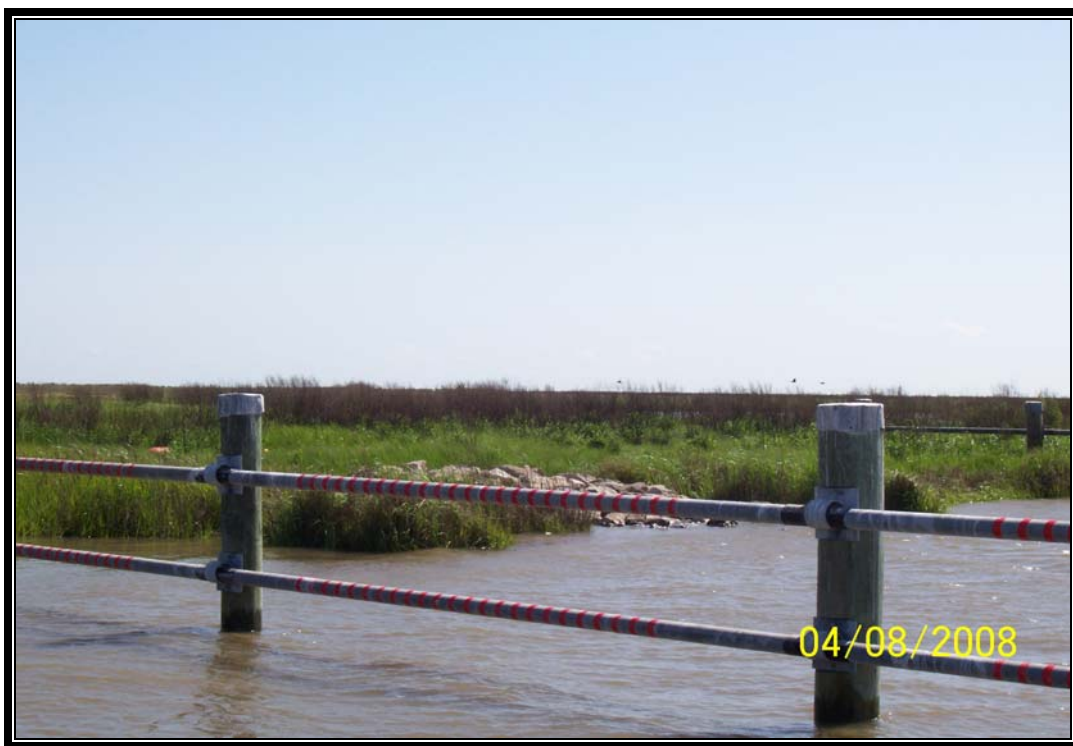
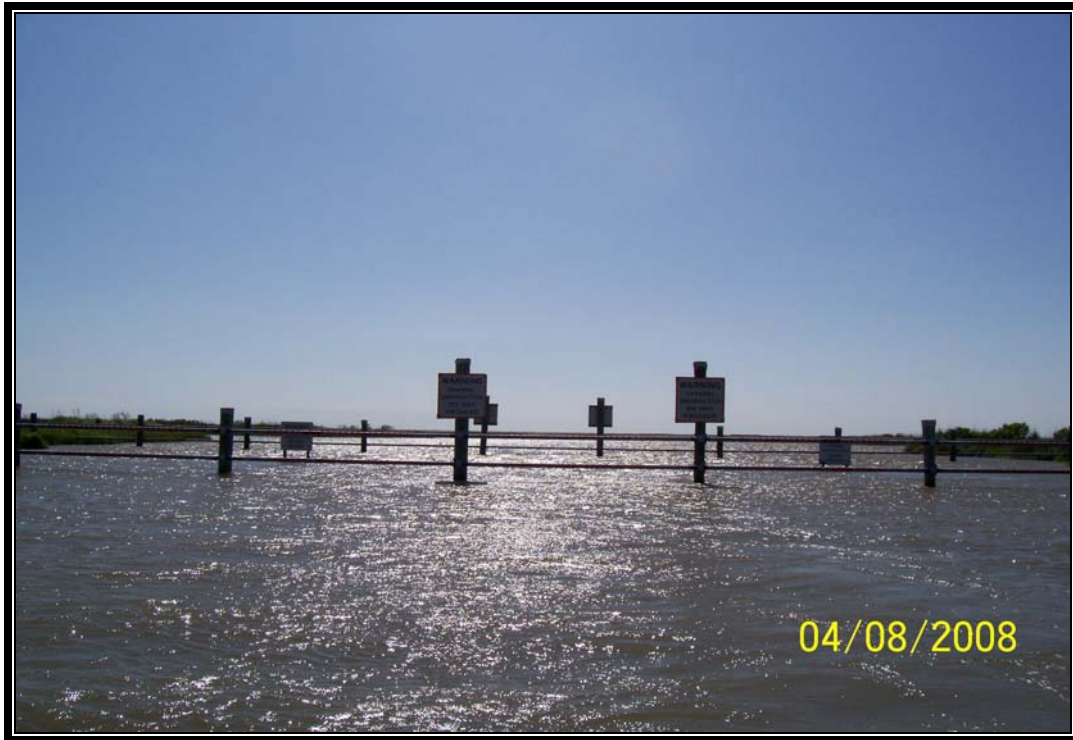
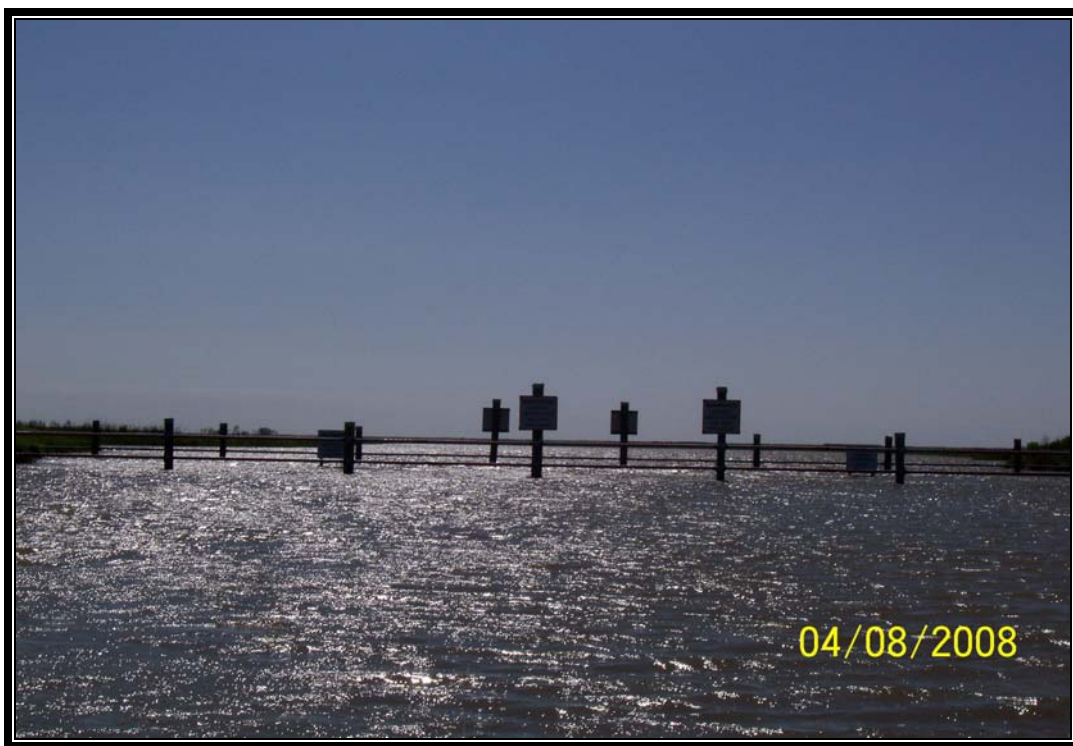
The rock weir, earthen embankments, timber barricade system and signs and supports were all in very good condition with no apparent structure damage or erosion problems. Based on a survey profile of the rock weir in 2004, the structure has settled approximately 1.7' from its designed elevation (Appendix B, Photos 25 through 30).

Photo No.25 – view of the southeastern end of the rock weir and barricade system (Structure 7).

Photo No.26 – view of the northwestern end of the rock weir and barricade system (Structure 7).

Photo No.27 – view of the barricade system and rock weir on the southeastern end of Structure 7.

Photo No.28 – view of the northern end of the rock weir and barricade system on the northwest side of Structure 7.

Photo No. 29 – an overall view of rock weir and timber barricade system (Structure 7) looking southeast.

Photo No. 30 – an overall view of the rock weir and timber barricade system (Structure 7) looking southeast.

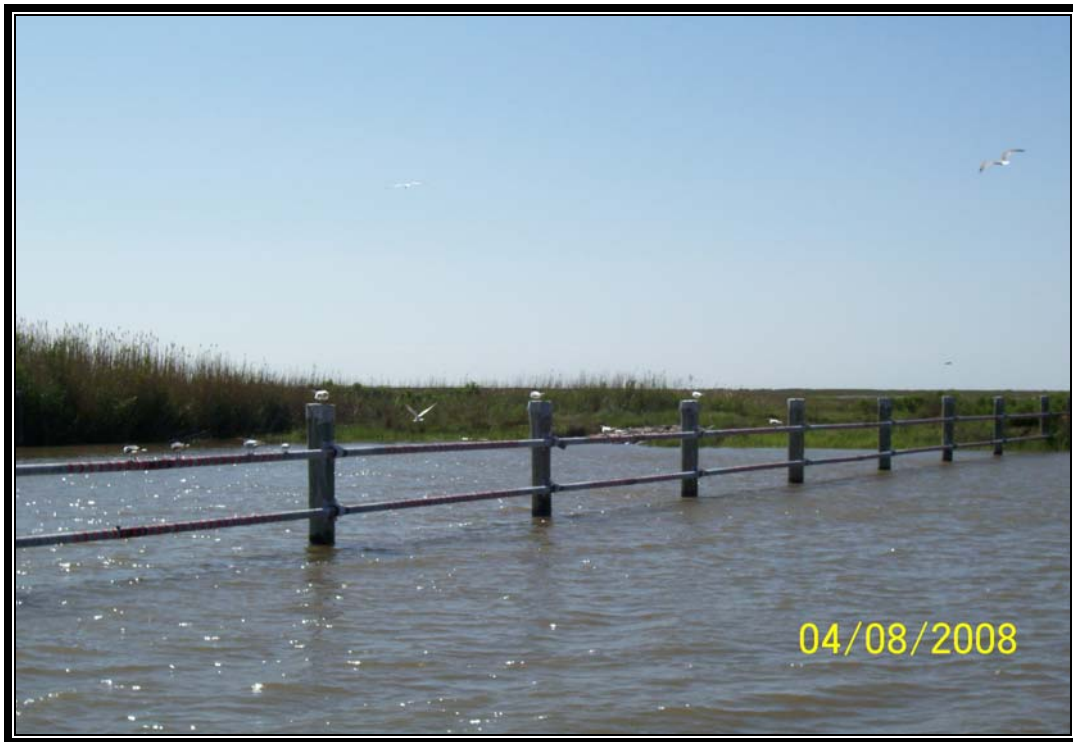
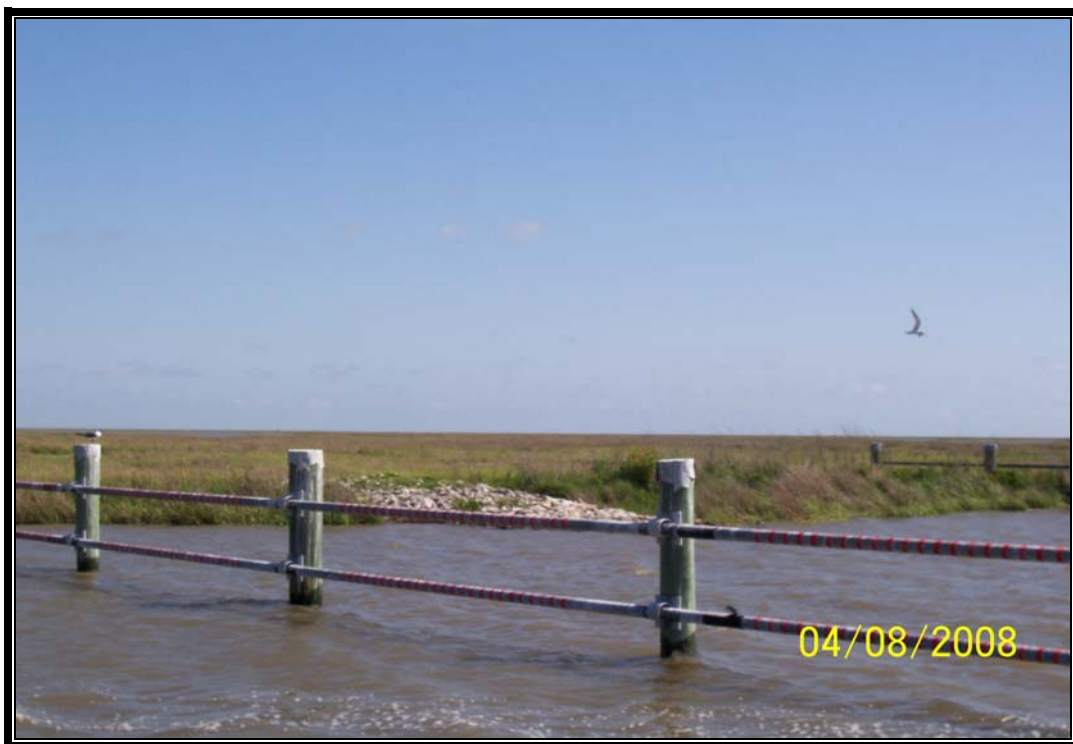
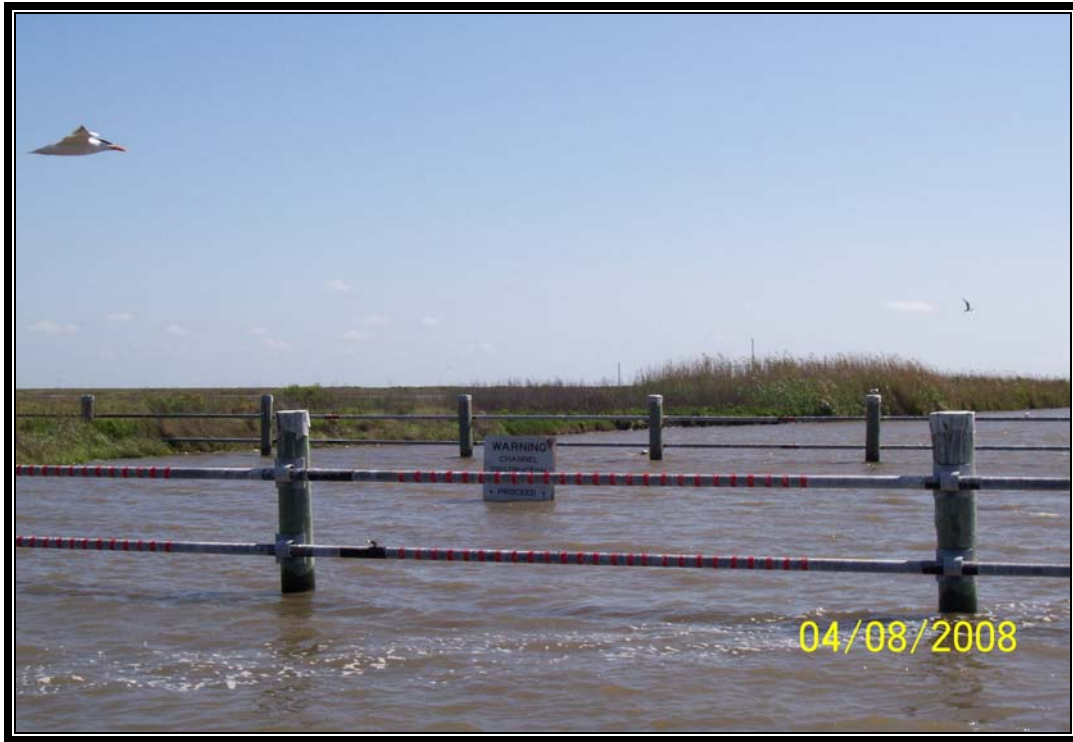
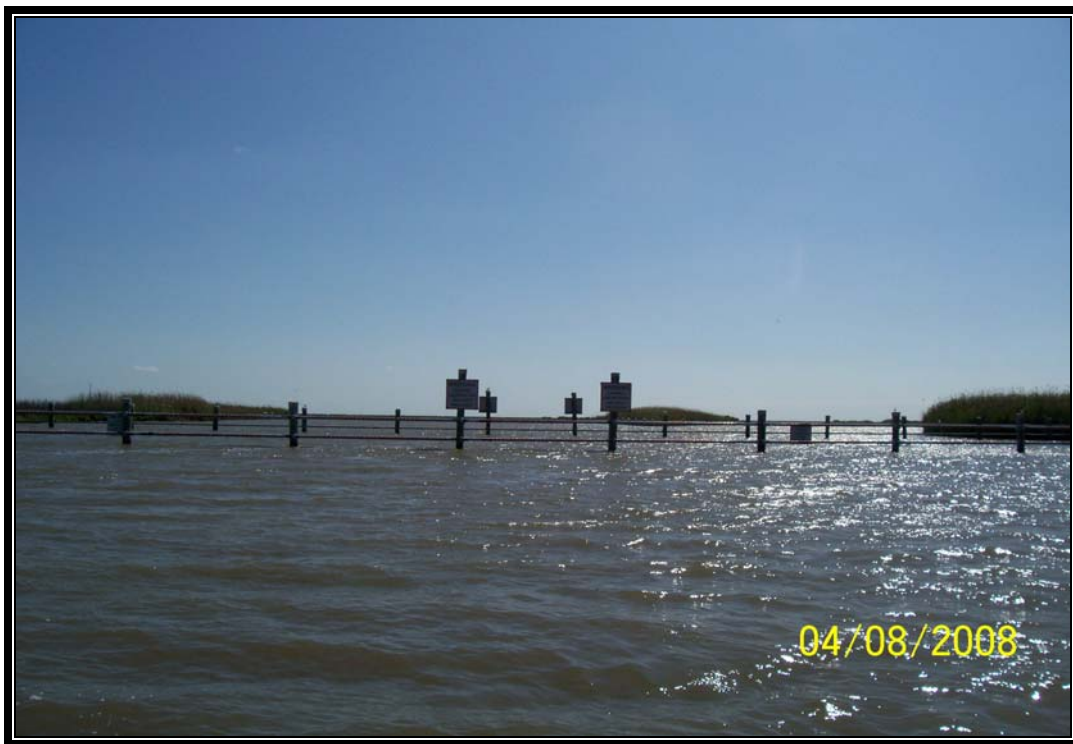
The rock weir at this location was in good condition with no noticeable damage to the timber barricade system or erosion around the ends of the weir. Based on the 2004 survey profile of the structure, it was determined that the rock weir had settled an average of 1.7' from the designed elevation (Appendix B, Photos 31 through 34).

Photo No. 31 – view of the southern end of the rock weir and timber barricade system (Structure 9).

Photo No.32 – view of the northern end of rock weir and timber barricade system (Structure 9).

Photo No.33 – view of the timber barricade system on the eastern and western side of the rock weir looking east.

Photo No.34 – overall view of the rock weir and barricade system (Structure 9) looking east.

Item	Condition	Pysical Damage	Corrosion	Photo #	Observations and Remarks
Rock Rip-Rap	Good			31 thru 34	Observations: The rock weir, tie-ins, earthen embankments, timber barricade system, signs and supports were all in good condition with no apparent damage or breaches.
Signage/ Supports	Good				The warning signs marking the location of the rock weir were nearly submerged.
Warning Capsule	Removed in 2004				The tides at the time of the inspection were approximately 1.5' NAVD.
Buoys					
Earthen Embankment	Good				Remarks: From the profile survey of the structure in 2004, it was estimated that the structure has settled approximately 1.7' since construction. Settlement was determined by comparing the average survey profile and design elevations. No as-builts were taken after construction.
Timber Barricade System	Good

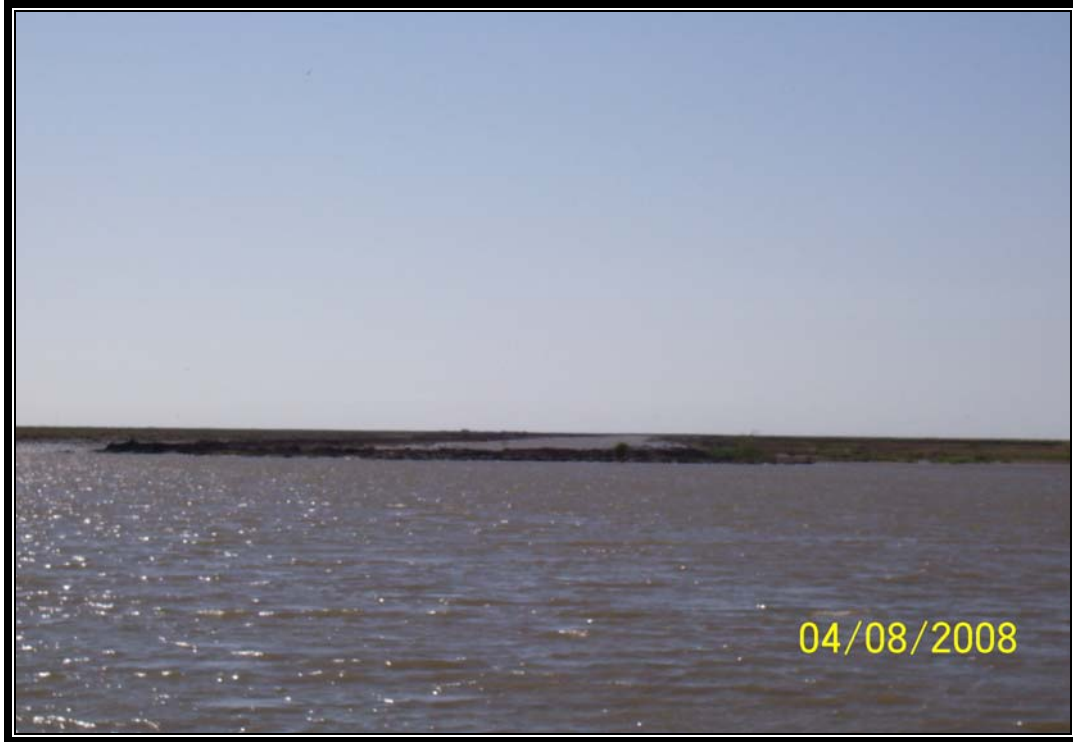
Photo No.35 – Earthen plug at the entrance of the old corridor along the shoreline of the east bank of the Atchafalaya Bay.

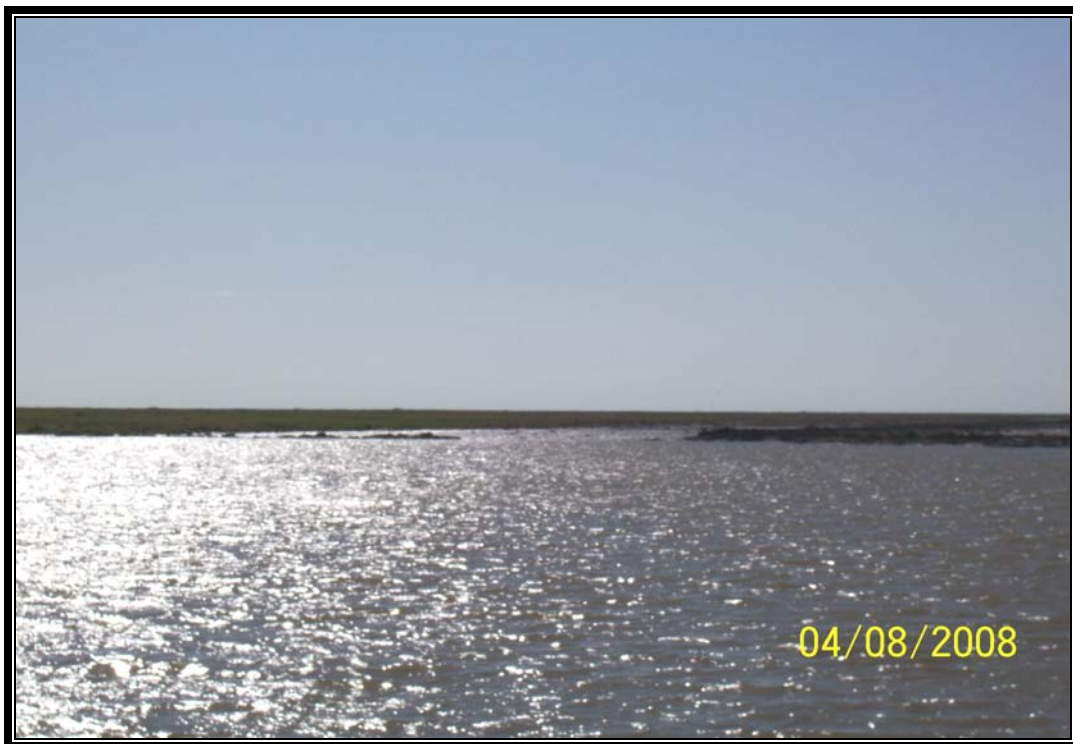
Photo No. 36 – the access corridor used in the construction of the Point au Fer Island Dedicated Dredge Project completed in 2007.

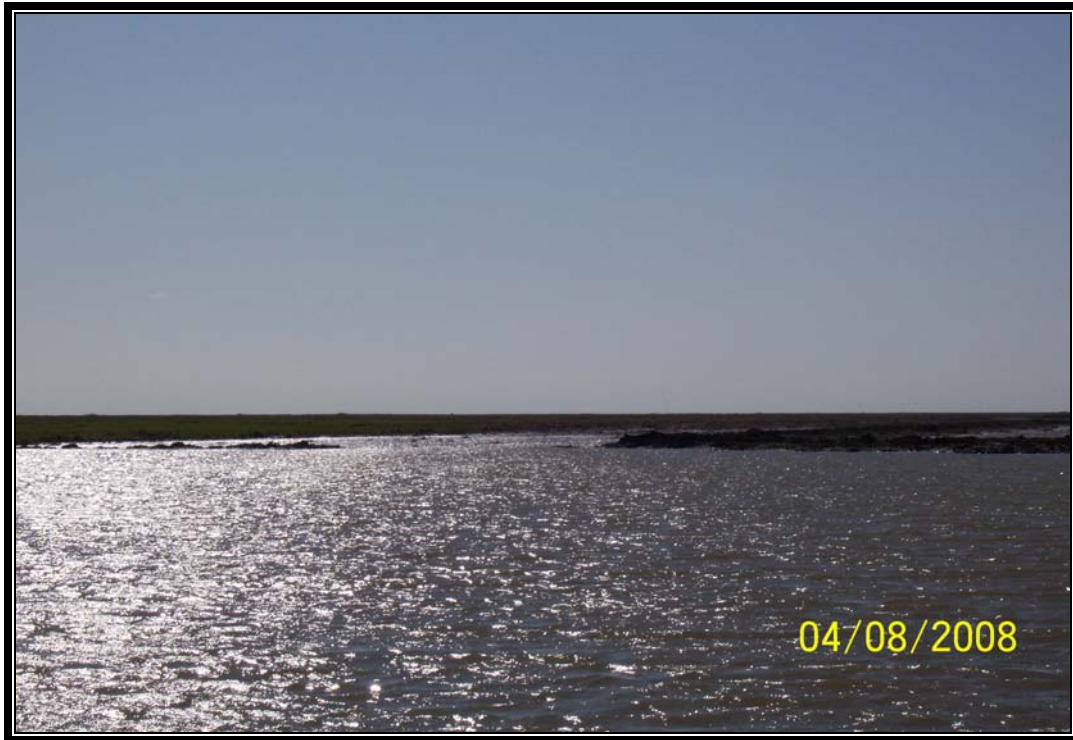
Photo No. 37 - view of the access corridor used in the construction of the Point au Fer Island Dedicated Dredge Project completed in 2007.

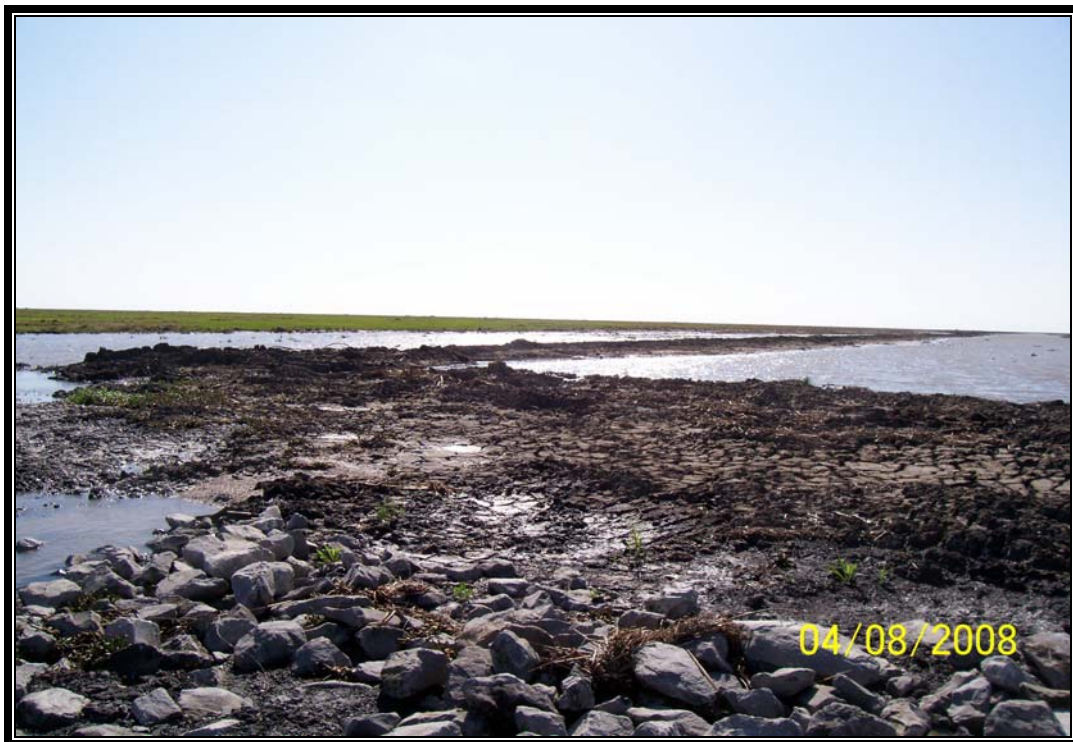
Photo No. 38 – view of containment levees along the old corridor to the Lake Chapeau disposal area. Containment was constructed during the Point au Fer Island Dedicated Dredge Project.
