**Coastal Protection and Restoration  
Authority of Louisiana**

**2007/2008 Annual Inspection  
Report**

**BOSTON CANAL/VERMILION  
BAY SHORE RESTORATION  
PROJECT  
(TV-09)**

April 24, 2008  
Vermilion Parish

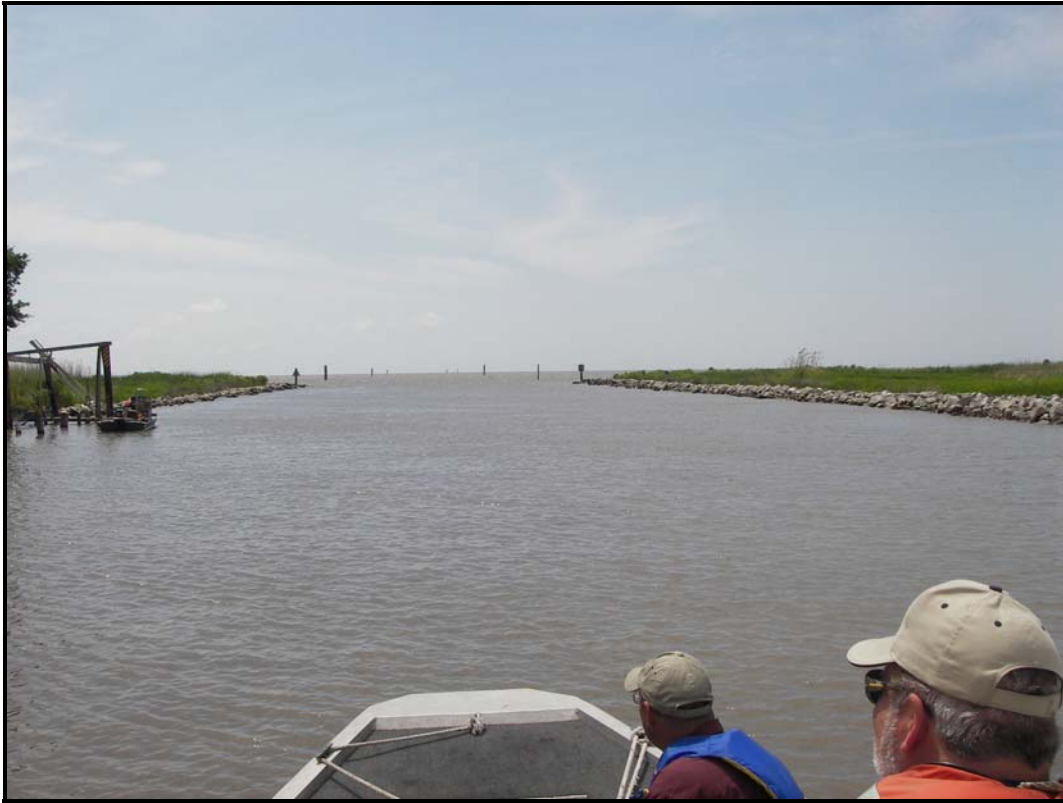
**Photo 1**—view of Boston Canal looking south

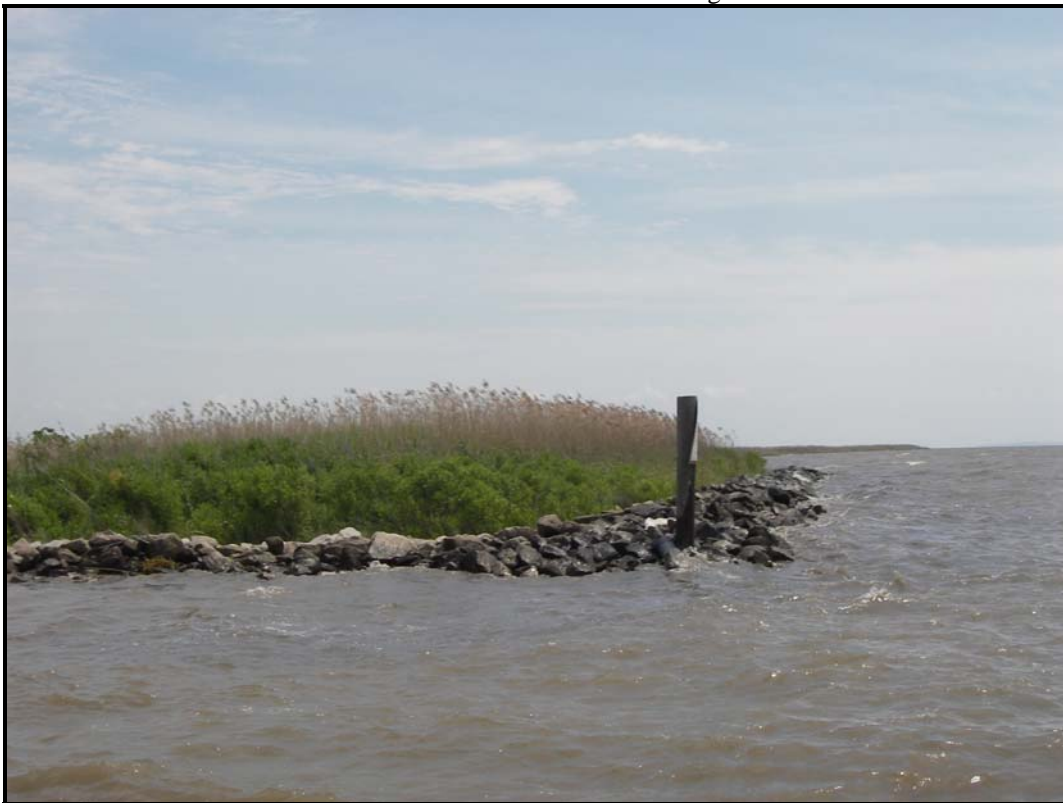
**Photo 2**—south east side of Boston Canal at shoreline

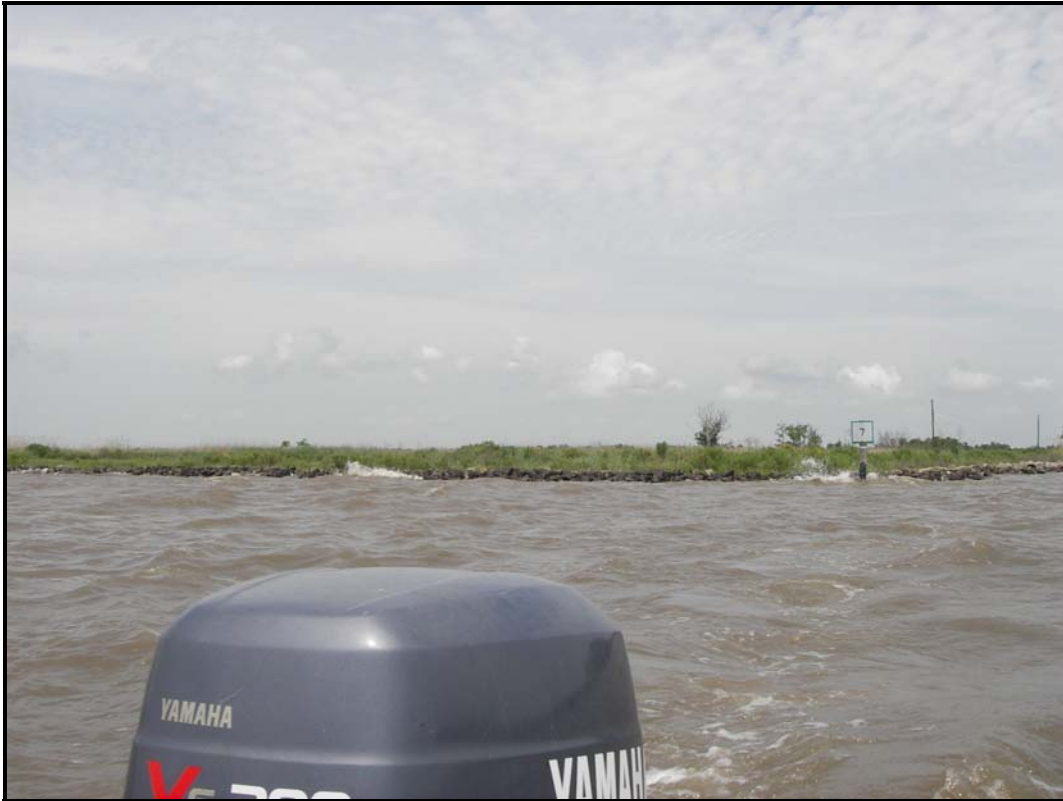
**Photo 3**—south west side of Boston Canal at shoreline

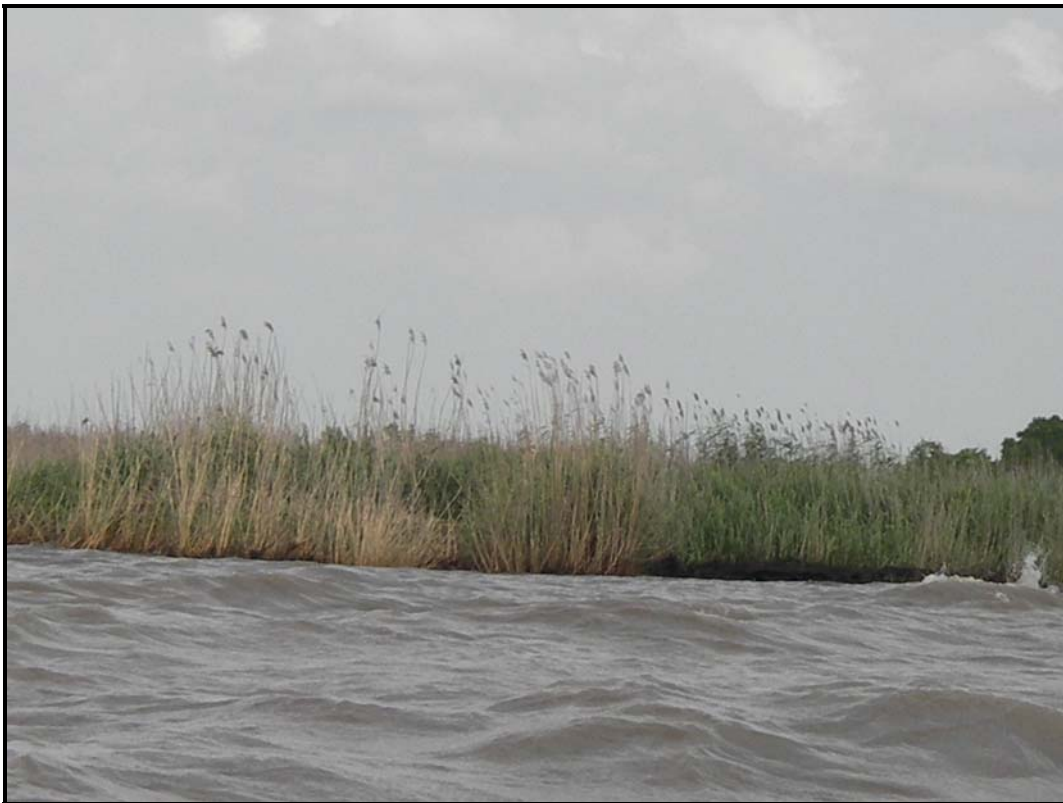
For the most part, the breakwaters are in excellent post construction condition. There is no apparent toe scour or rock displacement. The western end of the dike where it ties into the Vermilion Bay shoreline has not significantly worsened. A small gap left during original construction appears to have caused this problem. While the situation is similar on the SE tie-in, it is not as severe. No gap was left on this end during construction. Recommendations made to repair these gaps during the O & M inspection of June 2003 have been reconsidered due to costs and logistics associated with such repairs. These areas have been and will continue to be closely monitored, and should the situation significantly worsen, steps will be taken to close/stabilize these areas. Signage and associated pilings are stable and functioning. (Photos: Appendix B, Photos 1 - 4)

**Photo 4**—area of shoreline just west of southwest rock tie-in
